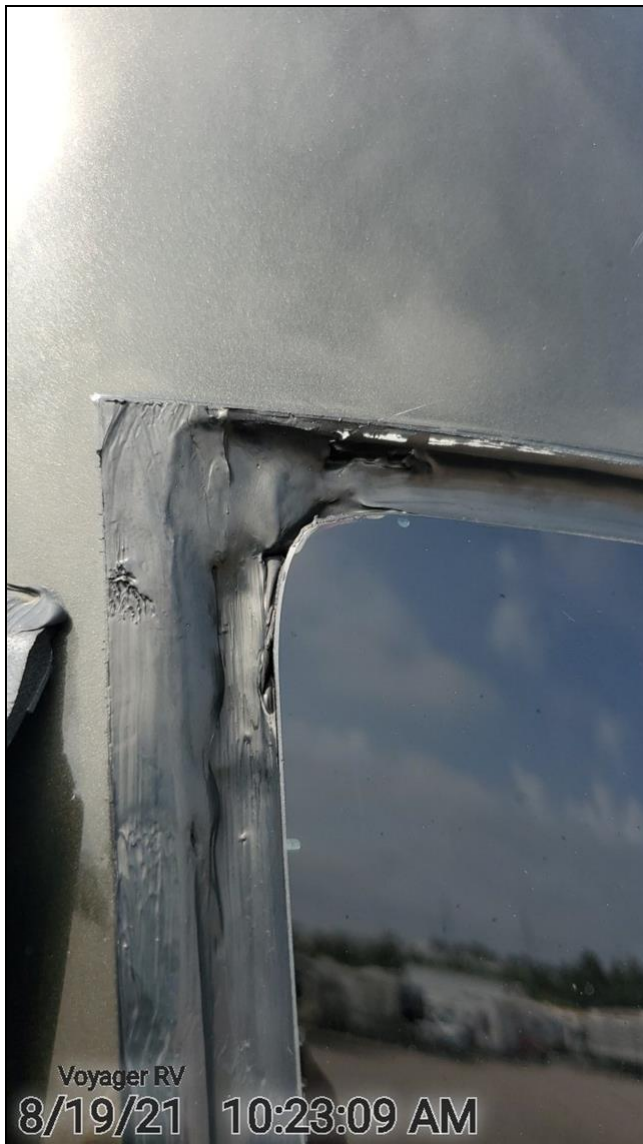
Curbside Top Corner Windshield Sealant

Observed inconsistent sealant application along windshield. No evidence of leakage noted.

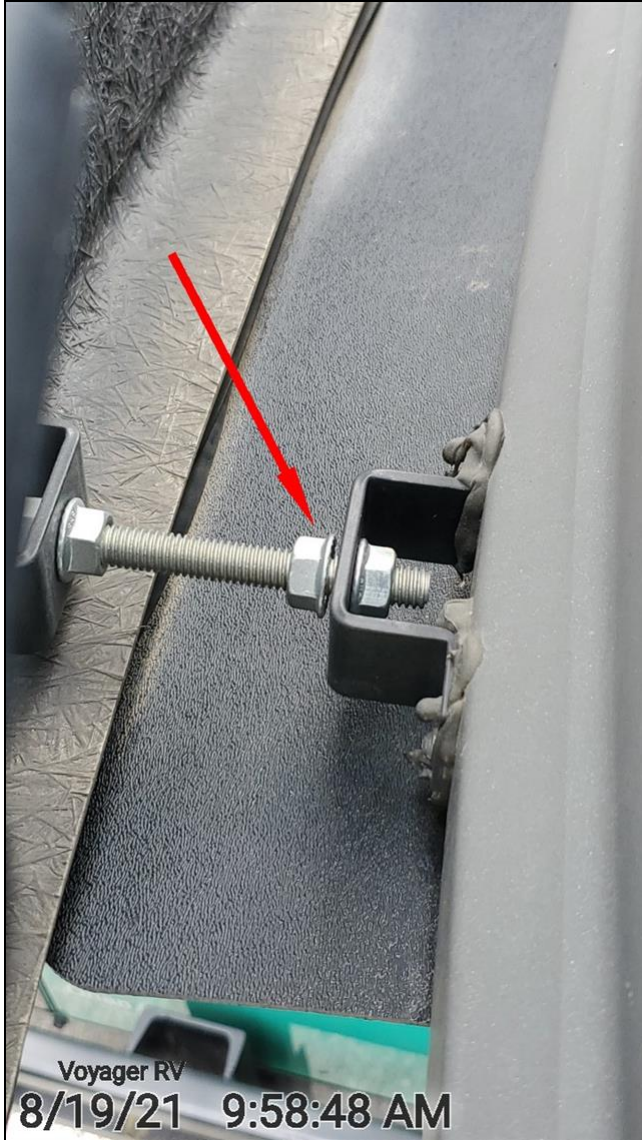
Streetside Support Hardware

Observed loose support fasteners between front cap and windshield wiper fairing. Recommend repair by a qualified RV Technician.
