SBC Property Inspections

Condition and Status Report 123 Nightcliff Beach Drive, Nightcliff

Re: Building Condition Report for 123 Nightcliff Beach Drive, Nightcliff
Purchasers: S & B Summers

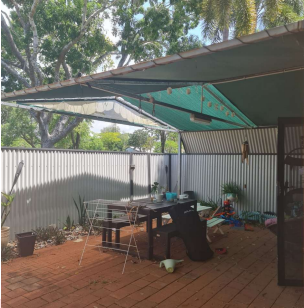
Pergola	Unapproved	<p>The pergolas at the rear of the property is not shown on the approved drawings and approval was not located in the Building Advisory services files.</p>

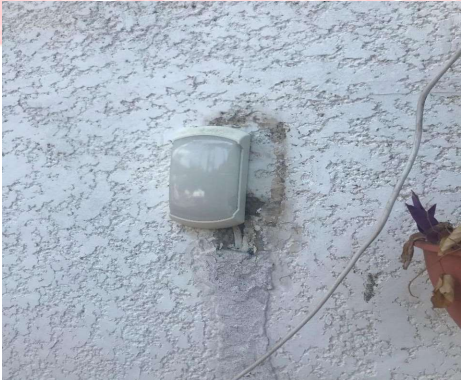
EXTERNAL WALLS	
<p>Power inlet for split system is not sealed against the wall,</p> <p>External light has exposed wires and is not sealed against the wall,</p>

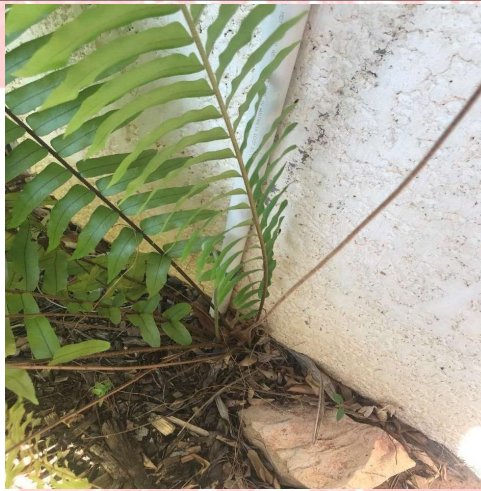
Condensation pipe from Split system needs to be diverted away from house,

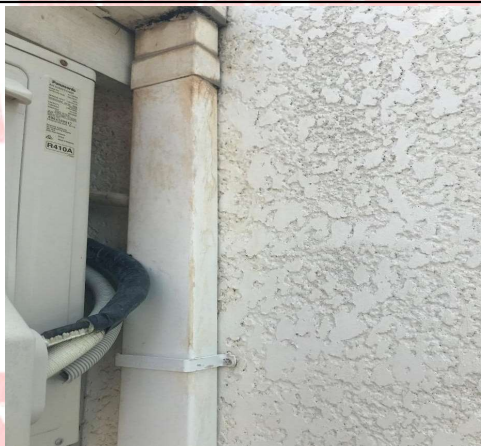
Down pipe is leaking and adding to the water pooling at the back door,

Condensation pipe from Split system runs into metal down pipe, this will cause premature rust in the down pipe.

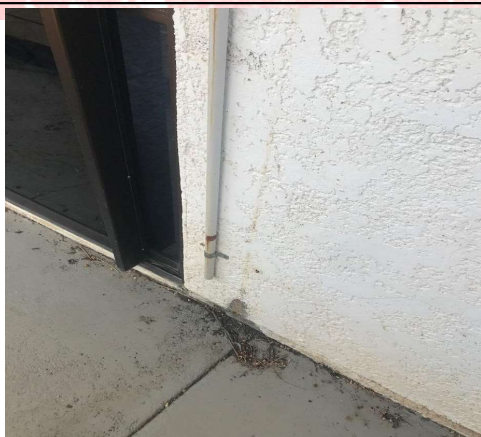
Condensation pipe from Split system needs to be diverted away from house

This has caused the render to prematurely corrode where the pipe was previously fixed on the wall to the right of existing.

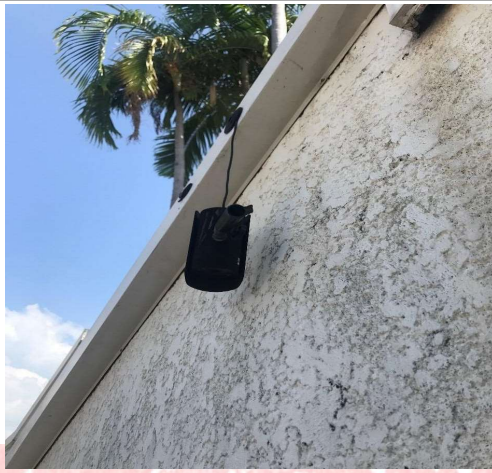
Security camera has become detached from the wall.

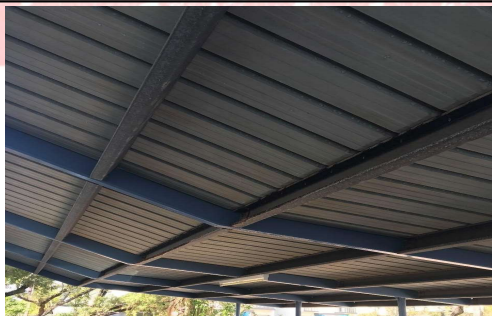
Rust has started to form on the carport purlins.

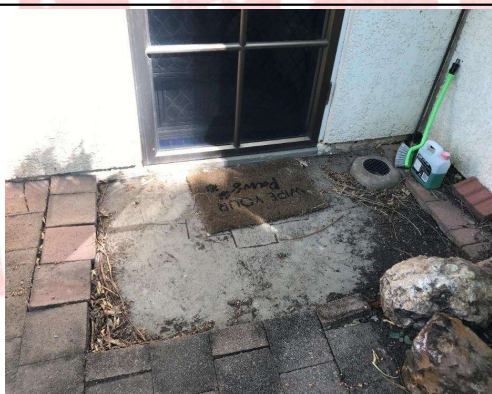
Paving at the back door is lower than the drain resulting in water pooling,

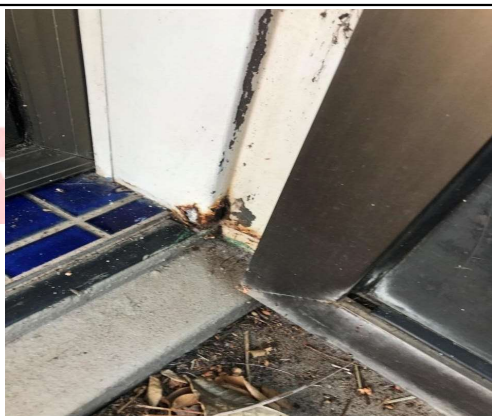
Rust has started in the back door jamb leading into kitchen,

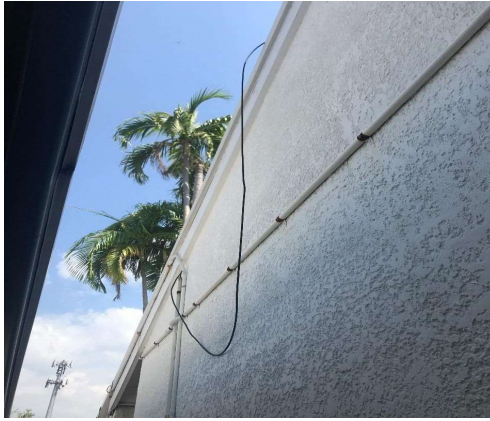
Antenna cable has detached from wall,

External wall finish is due to be repainted to effectively seal the blockwork

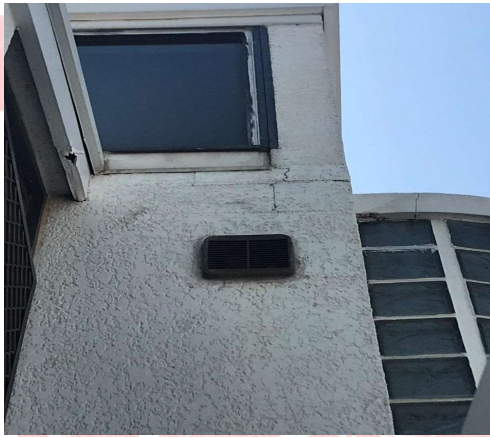
Mild cracks in blockwork and concrete roof over ensuite,

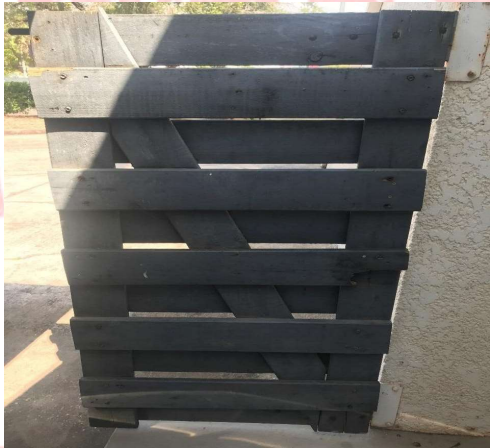
Both gates suffering from decay and require repainting to prevent them from further issues,

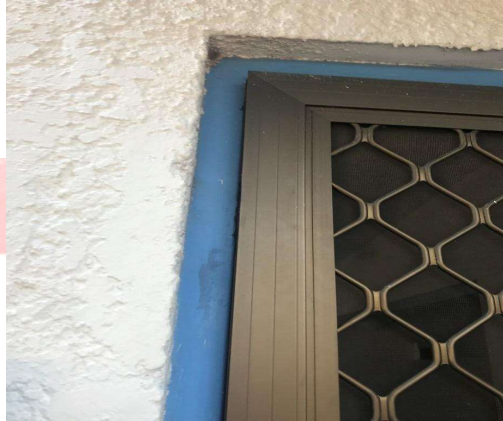
Front screen door is an exception from the above as the margin is very tight and causes the door to rub, door requires adjusting or possible replacement,

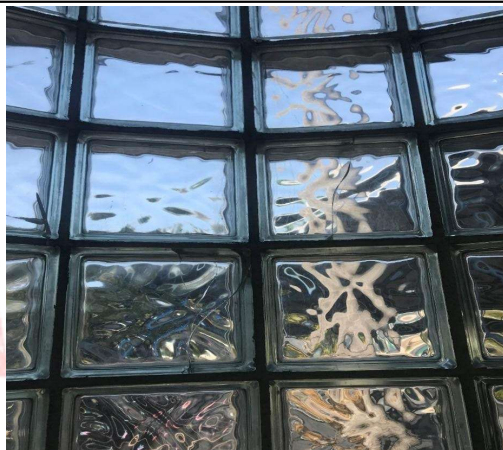
Multiple cracked glass bricks in both the Bathroom / Laundry and Ensuite,

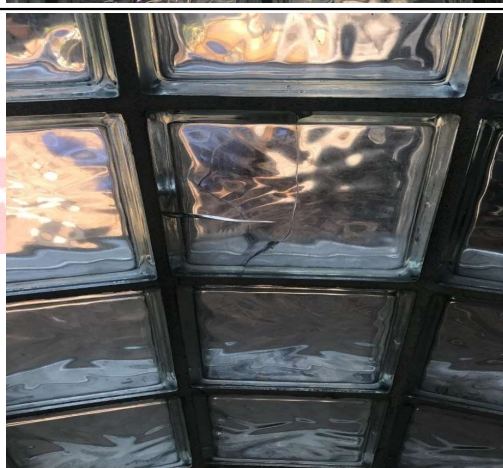
Multiple cracked glass bricks in both the Bathroom / Laundry and Ensuite,

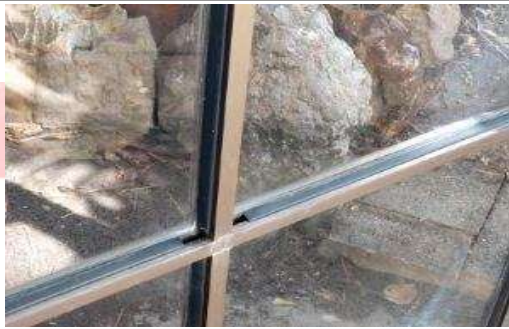
Glazing seals have retracted and require replacing,

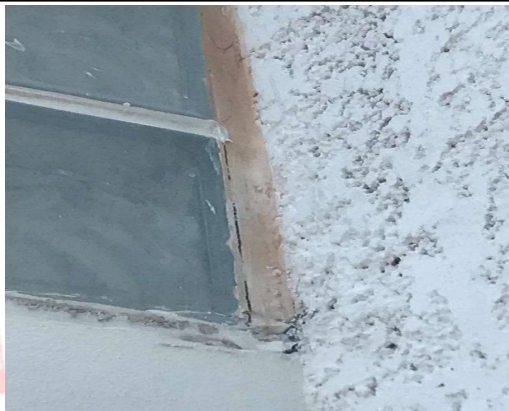
Sealant around glass brick has retracted and cracked on the outside in multiple places,

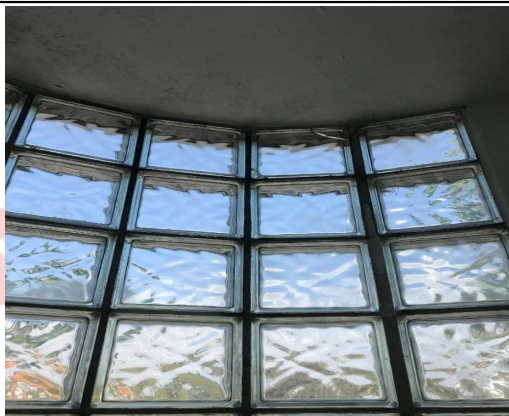
Multiple cracked glass bricks in both the Bathroom / Laundry and Ensuite,

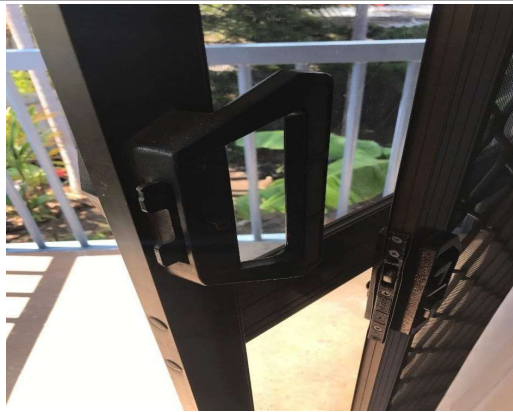
Lever on lock to B1 is missing preventing this door from locking,

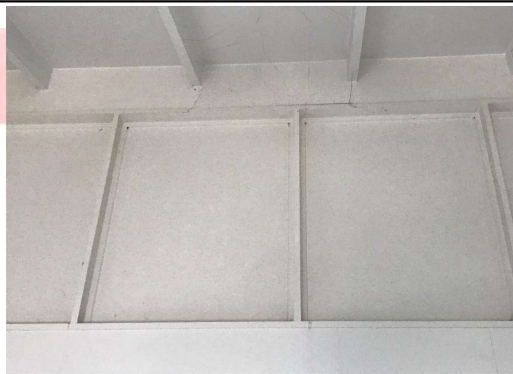
Highlight windows in B1 have been blocked out,

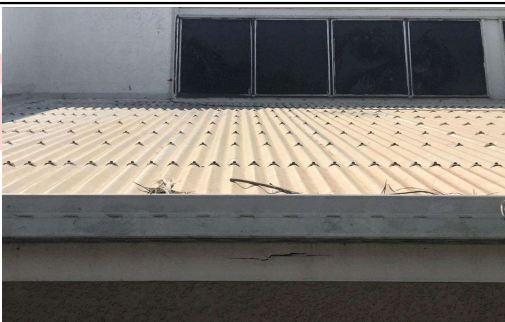
Roof cladding appears to be in good condition for the age of the building, Fixings will require replacing in the near future as they have begun to rust, observation of the sealants on the roof was not attained in this inspection.

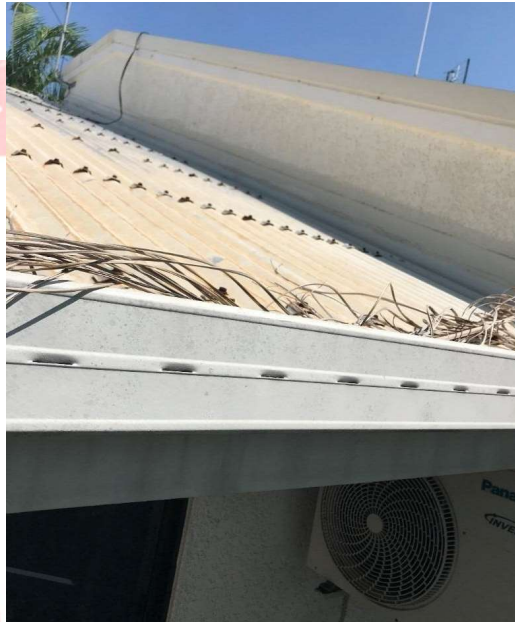
Gutters have a build leaf letter and require cleaning,

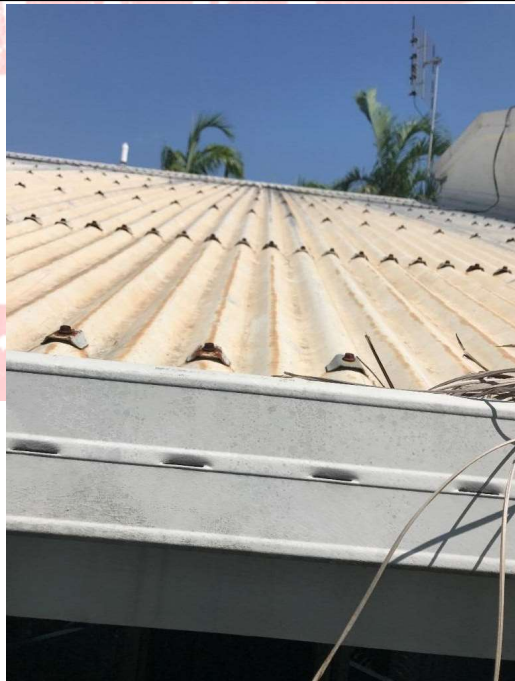
Roof cladding appears to be in good condition for the age of the building, Fixings will require replacing in the near future as they have begun to rust, Gutters have a build leaf letter and require cleaning,

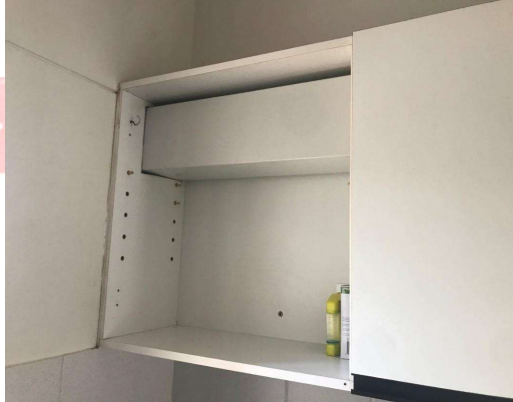
Doors and shelf missing from cabinet,

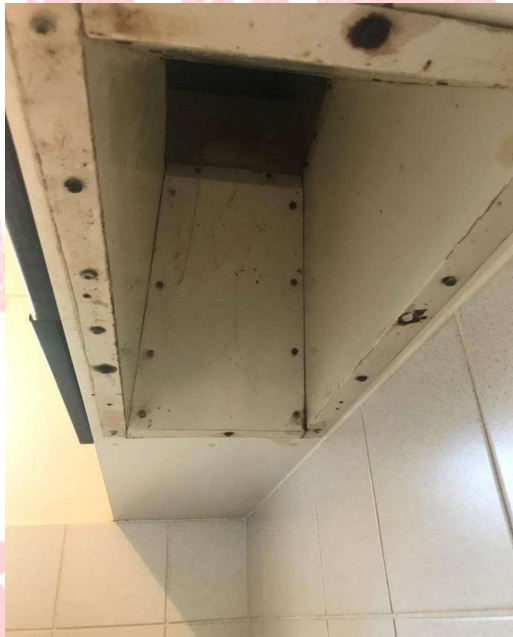
No exhaust fan above hotplate,

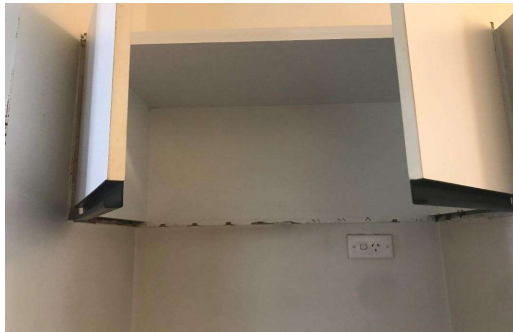
Bottom of cabinet missing from cabinet above fridge,

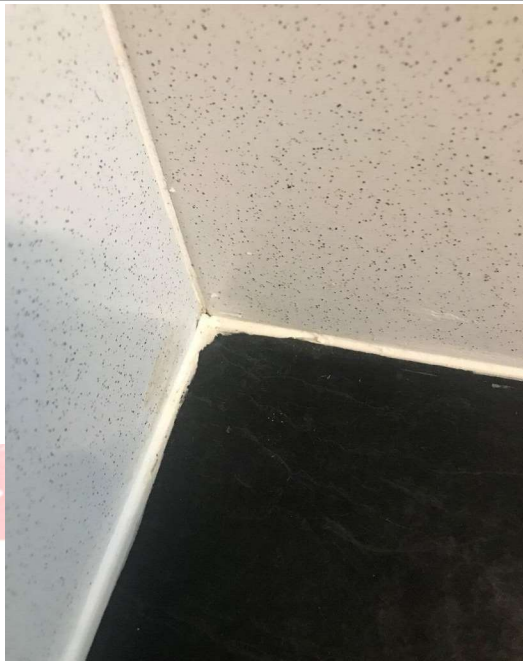
Cracked sealant between splash back and bench top behind kitchen sink,

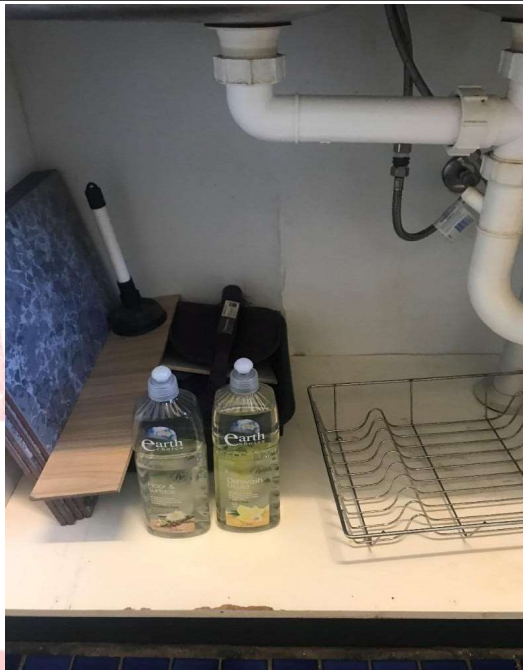
Cabinet suffering from water damage under kitchen sink,

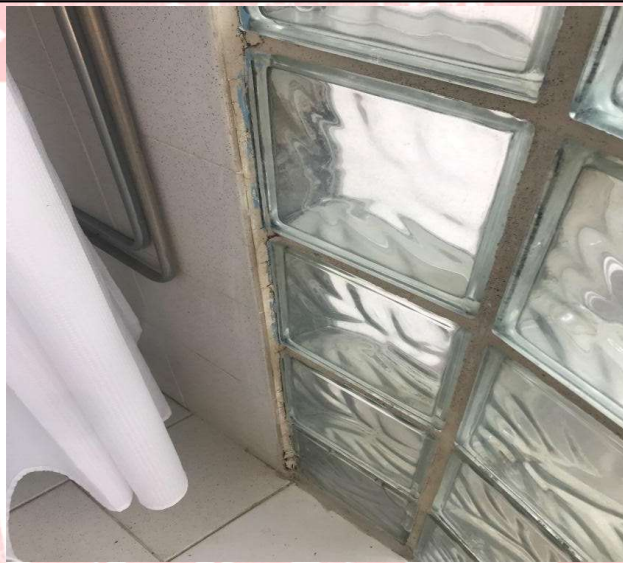
Bathroom / Laundry join between tiles and glass bricks requires sealing, this area is exposed to the shower and vitally important,

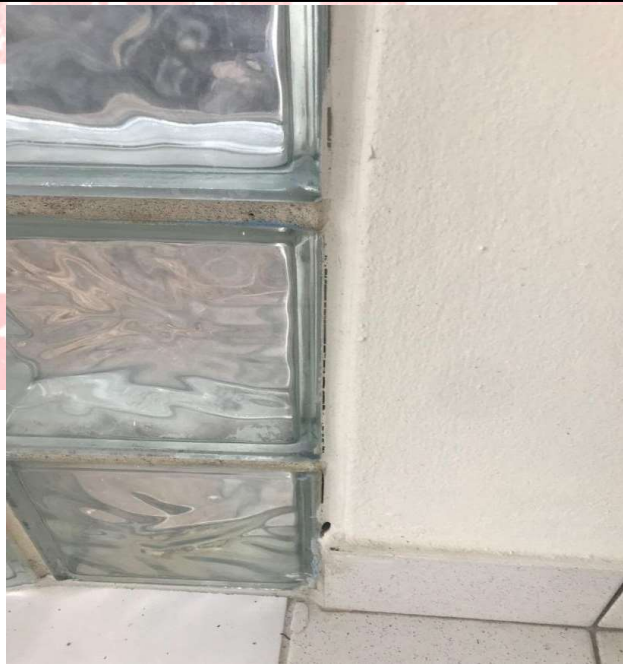
Bathroom / Laundry join between glass bricks and wall requires sealing, this area is exposed to the shower and vitally important,

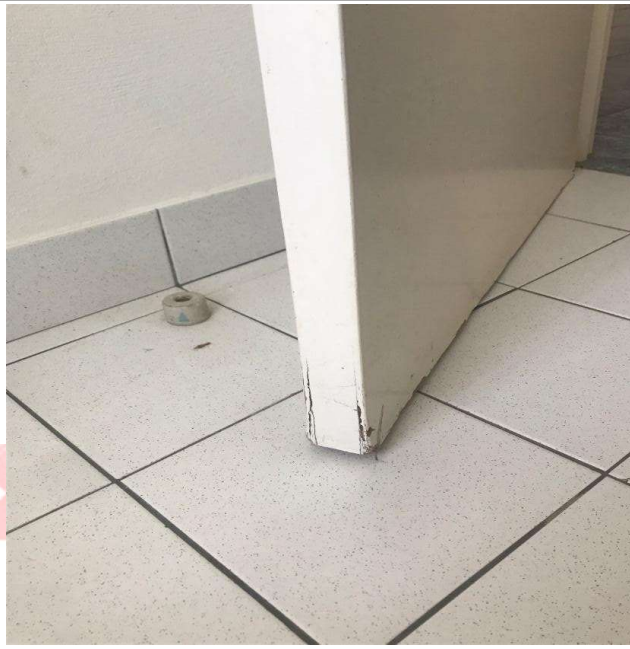
Bathroom / Laundry
internal door has
began to
delaminate,

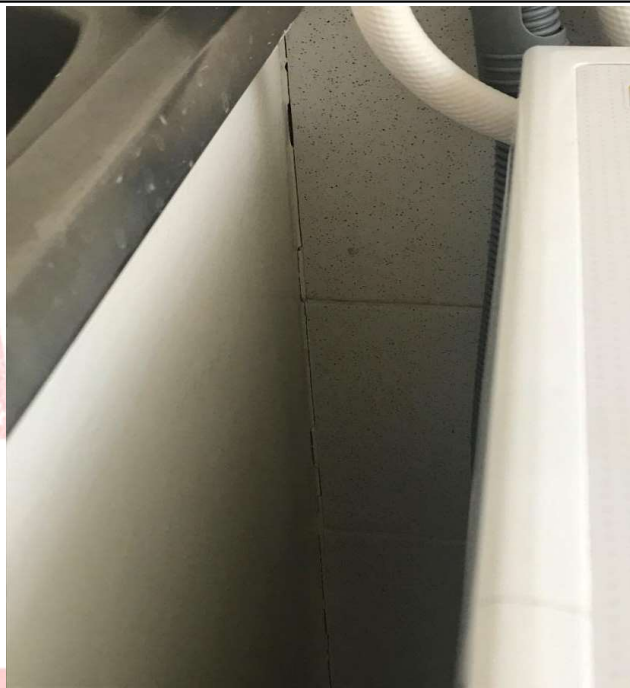
Bathroom / Laundry
join between trough
and tiles requires
sealing,

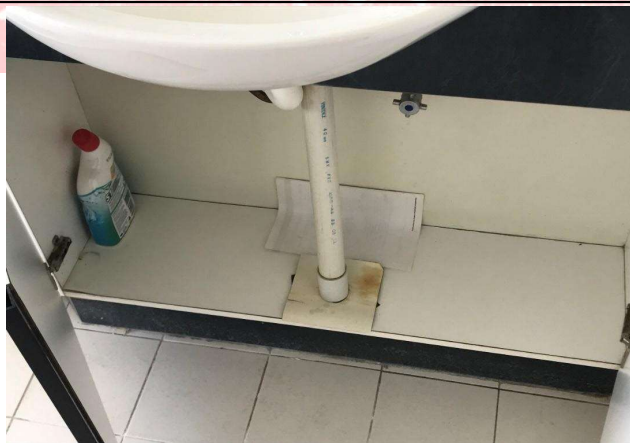
Ensuite vanity unit
shows signs of mild
water damage and
delamination of
cabinetry,

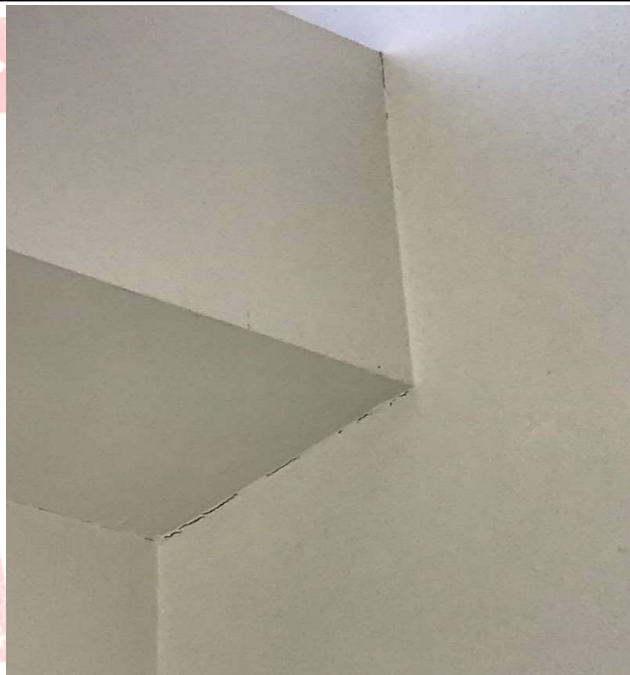
Esuite walls show signs of small movement consistent with the age of the home,

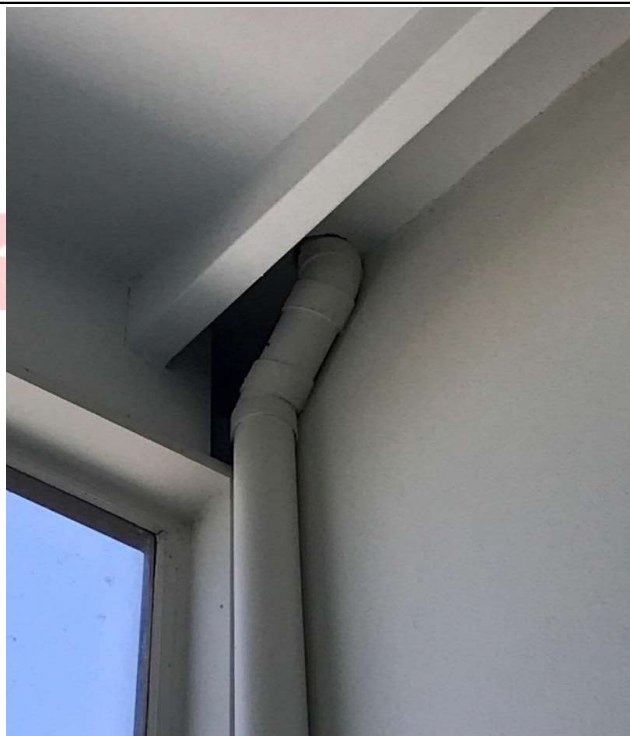
Ensuite vent not completed in a tradesman like manner.

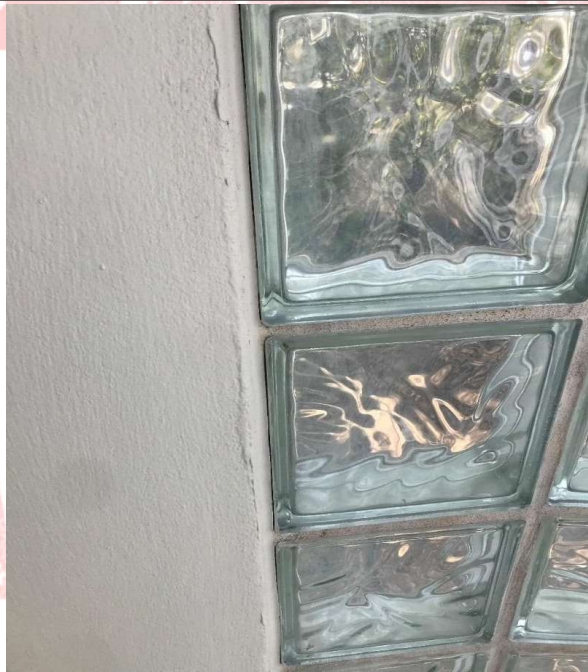
Esuite walls show signs of small movement consistent with the age of the home,

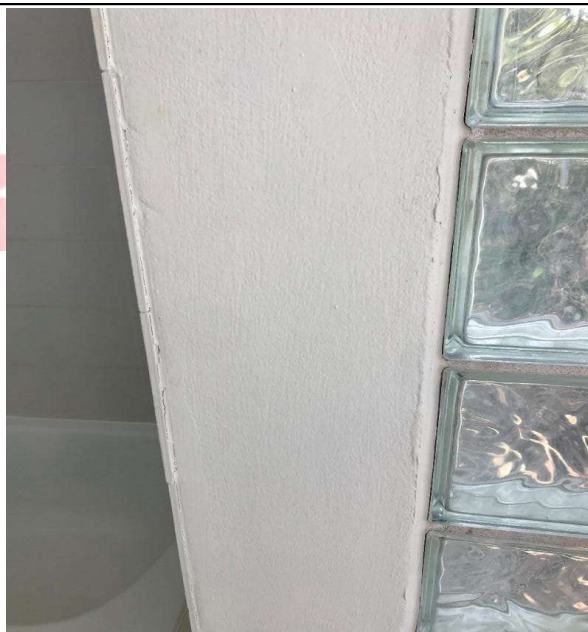
Esuite walls show signs of small movement consistent with the age of the home,

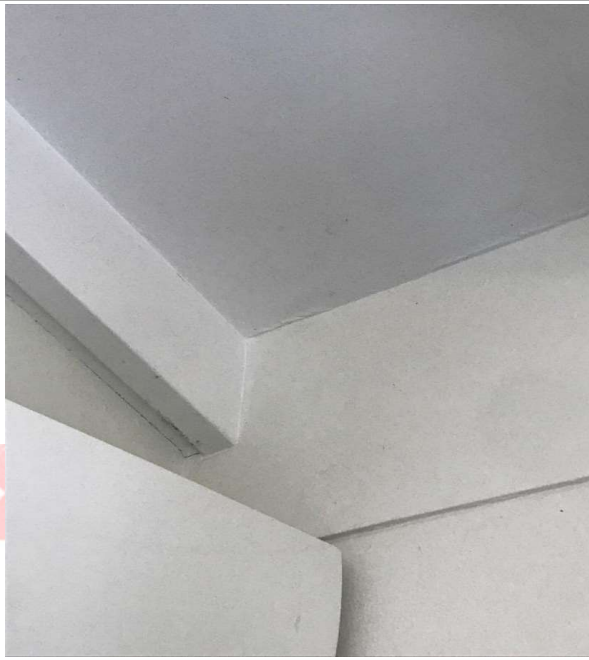
Esuite walls show signs of small movement consistent with the age of the home,

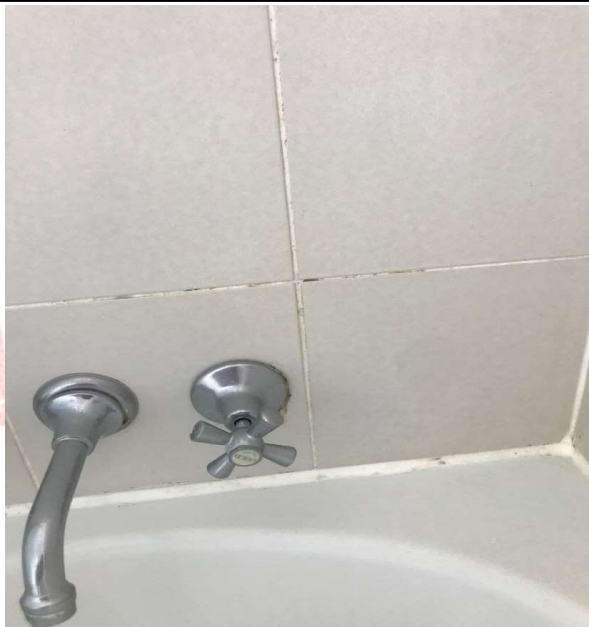
Ensuite tiles has areas of grout missing,

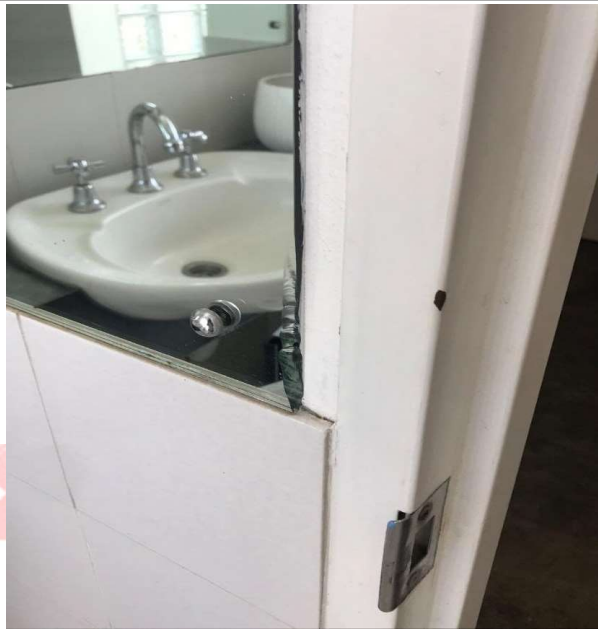
Ensuite mirror is damaged and has a sharp edge,

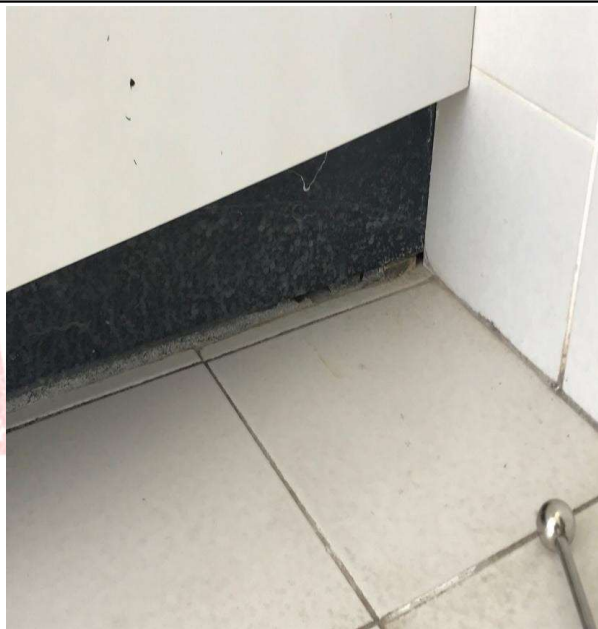
Ensuite tiles run towards a gap under the vanity unit, this may lead to water running under the unit and causing damage in an area unable to be inspected,

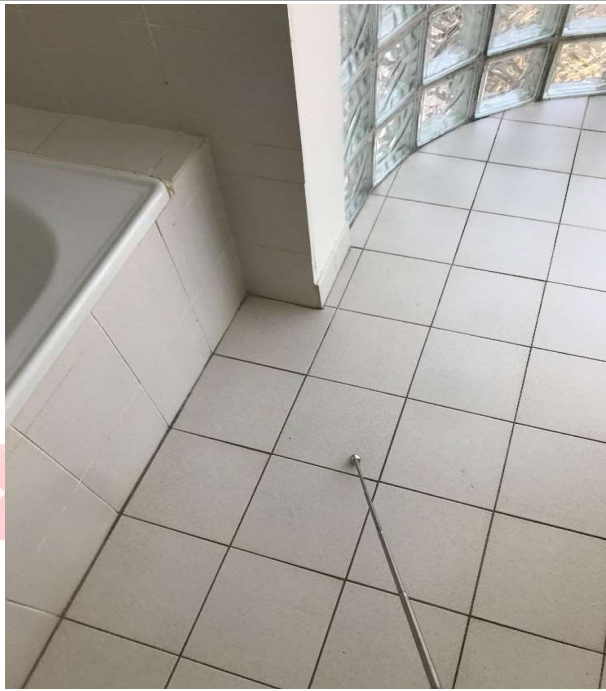
Ensuite has areas of drumming tiles which is consistent with the tiles separating from the surface behind them,

Drummy tiles are an indication that the adhesive bond between the tiles and wall / floor has failed. While drummy tiles may provide a serviceable finish for some time they may crack and or become loose or pop up at any time.

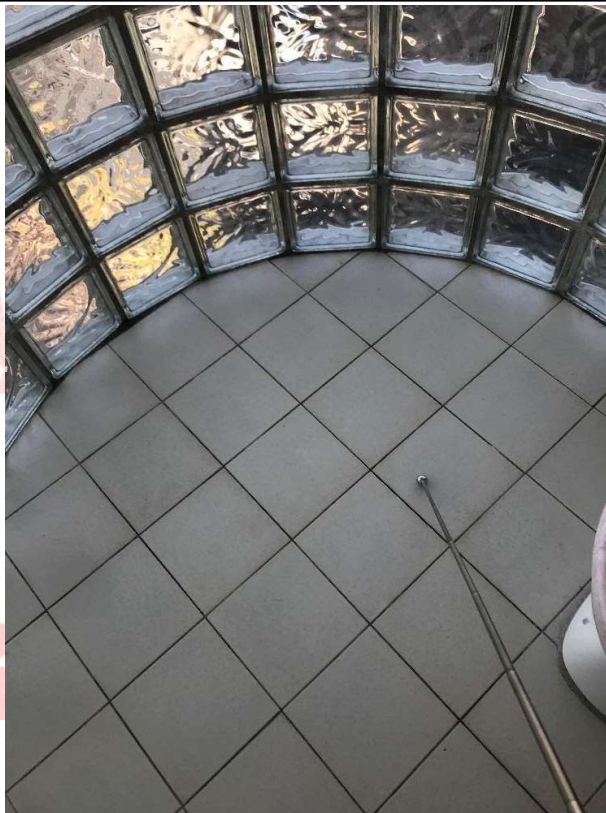
Ensuite has areas of drumming tiles which is consistent with the tiles separating from the surface behind them,

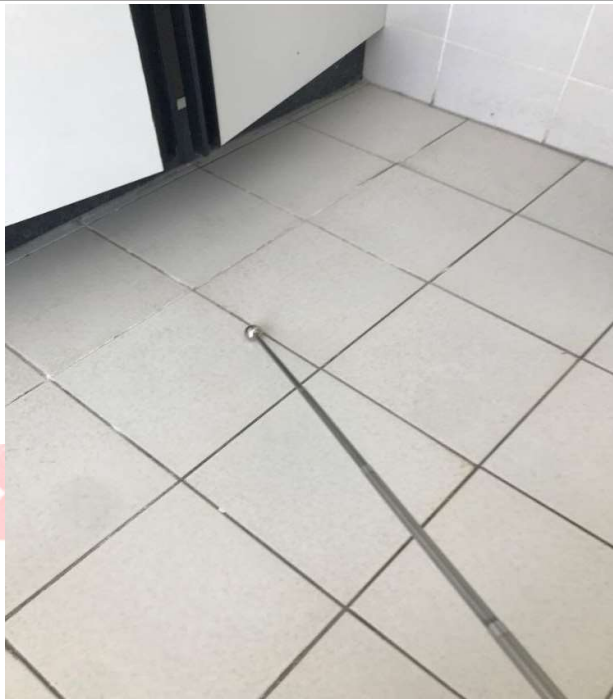
Ensuite tiles in front of the vanity unit show signs of lifting as they are drumming and uneven,

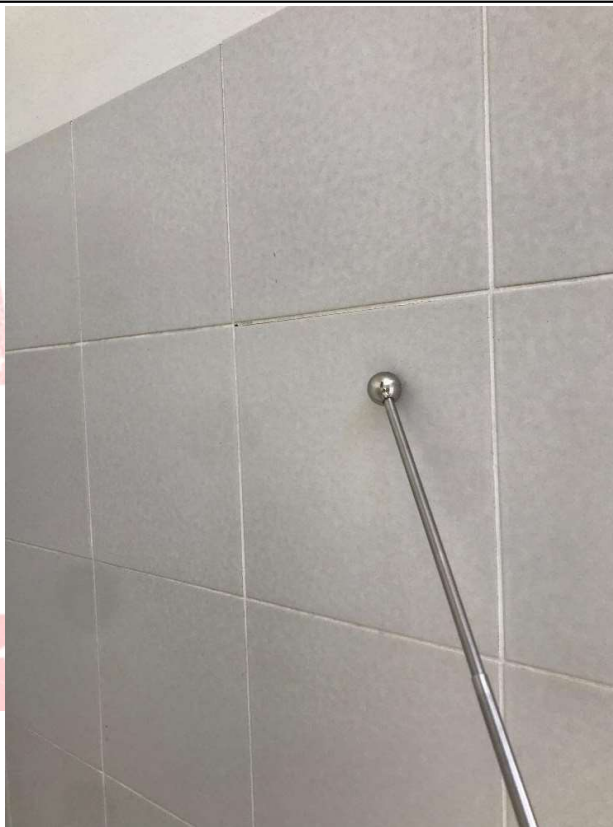
Ensuite has areas of drumming tiles which is consistent with the tiles separating from the surface behind them,

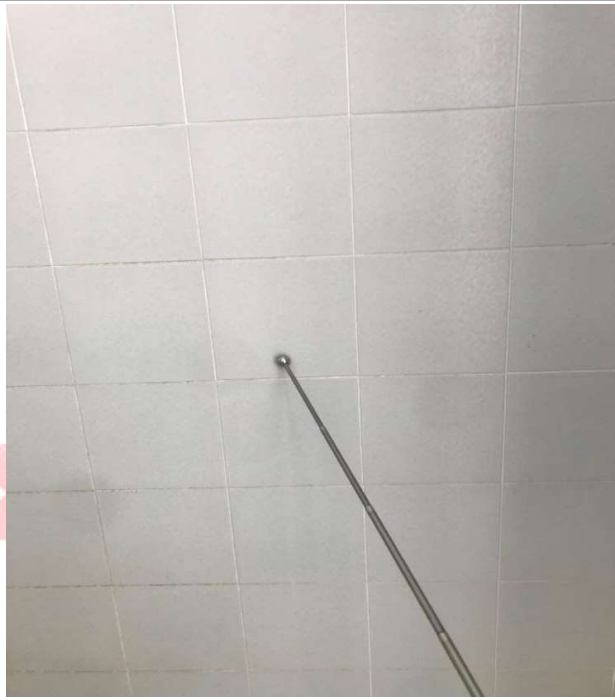
Ensuite has areas of drumming tiles which is consistent with the tiles separating from the surface behind them,

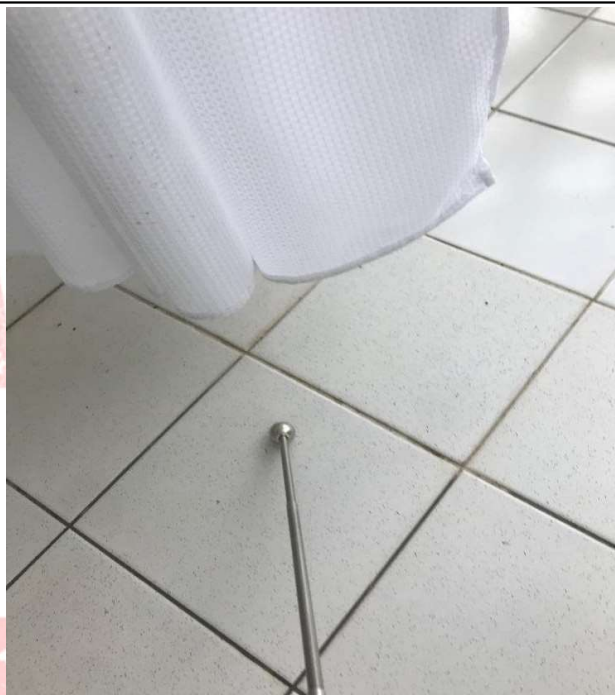
Bathroom / Laundry has areas of drumming tiles which is consistent with the tiles separating from the surface behind them,

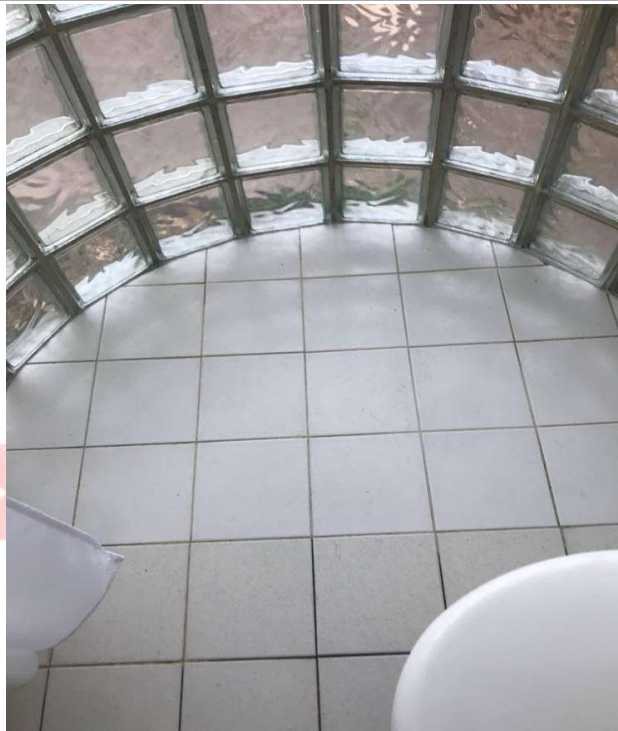
Bathroom / Laundry floor tiles in shower has areas of drumming which is consistent with the tiles separating from the surface behind them, these tiles have also been replaced and are not consistent with the rest of the room,

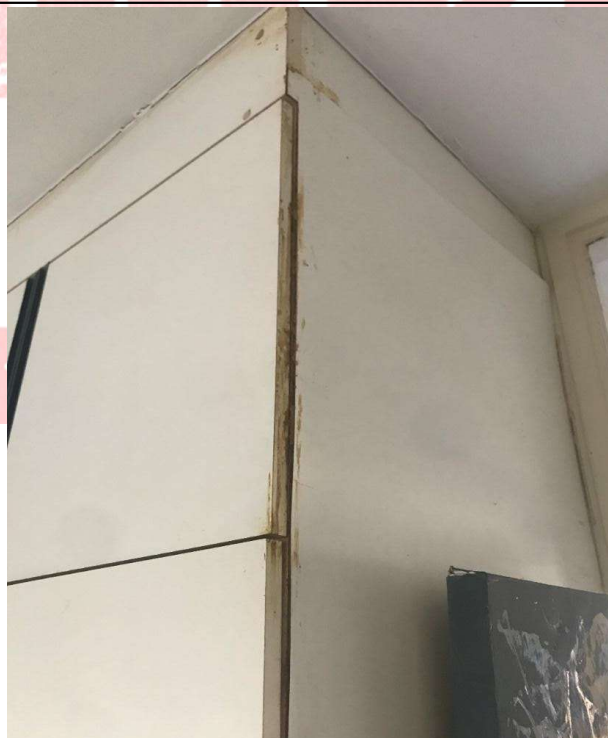
B2 BIR edging has been glued back on and not completed in a tradesman like manner.

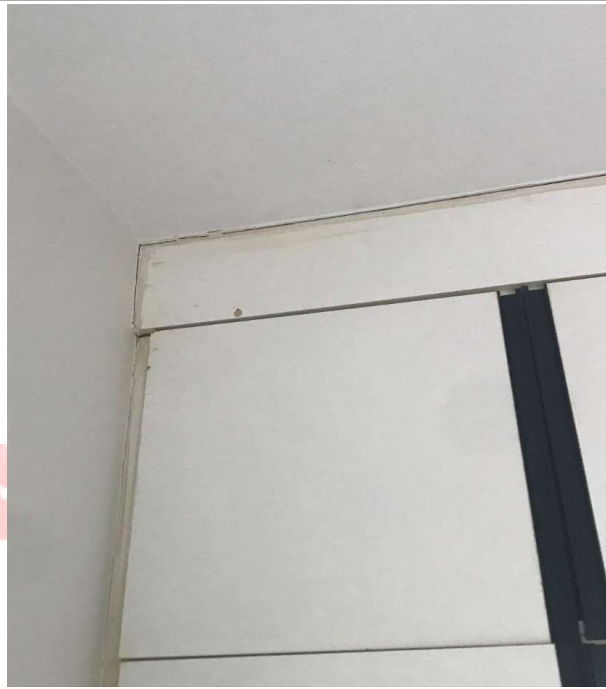
B2 BIR has dropped due to water damage and rote in its base causing it to crack along the ceiling,

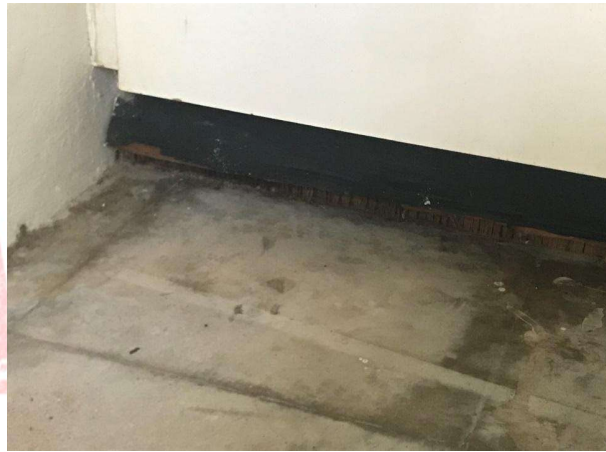
B2 BIR has dropped due to water damage and rote in its base causing it to crack along the ceiling,

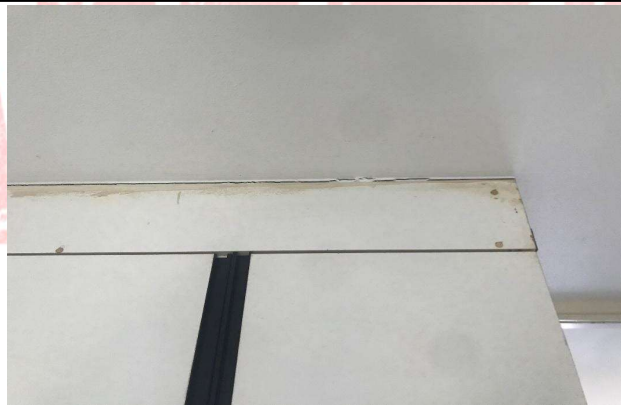
B2 BIR has dropped due to water damage and rote in its base causing it to crack along the ceiling,

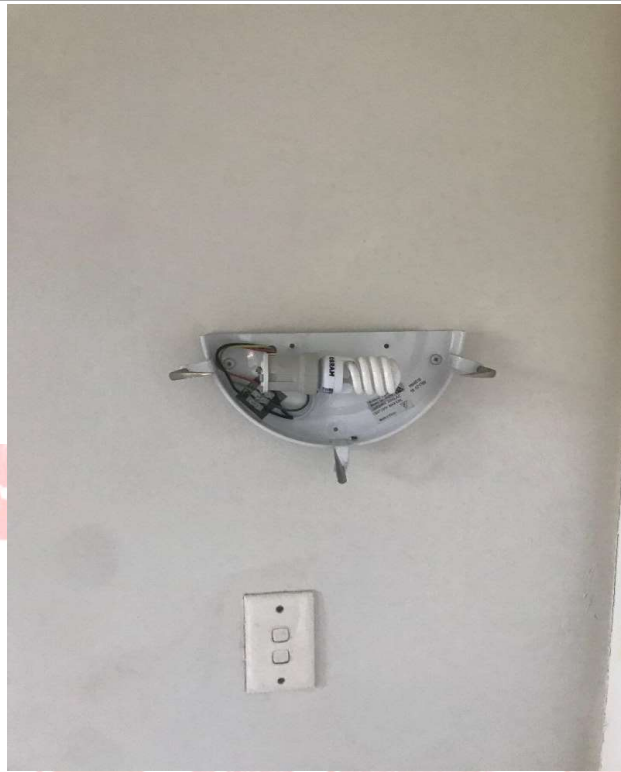
B2 light fitting is missing exposing the wires and should be replaced,

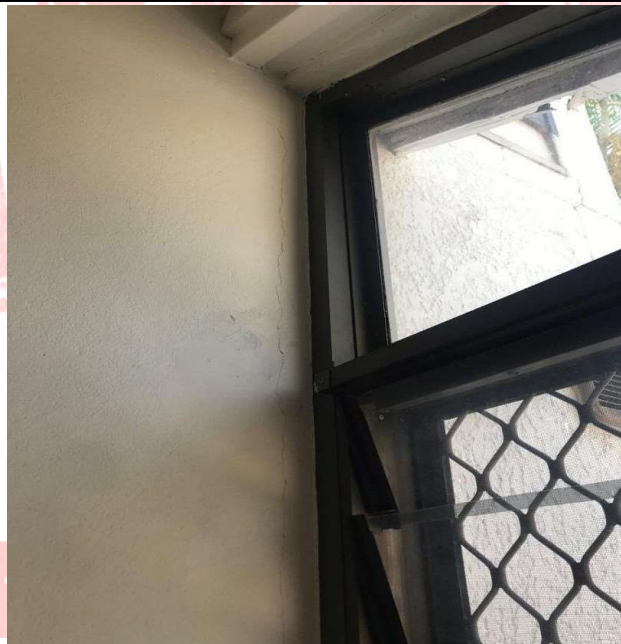
First floor landing near window has a small crack in the wall, this is near the external crack in the blockwork and roof over ensuite mentioned earlier in this report,

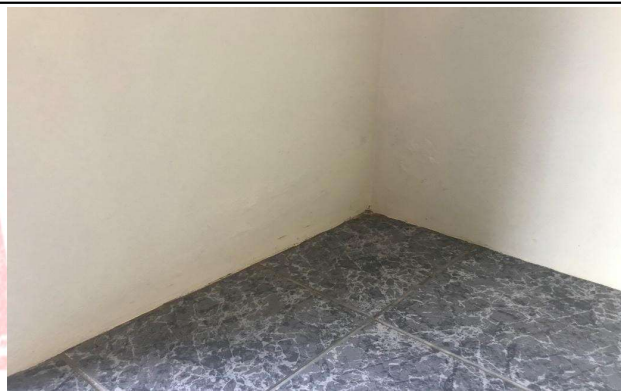
Base of stairs wall has paint blistering, this can be a sign of poor prep work or rising damp,

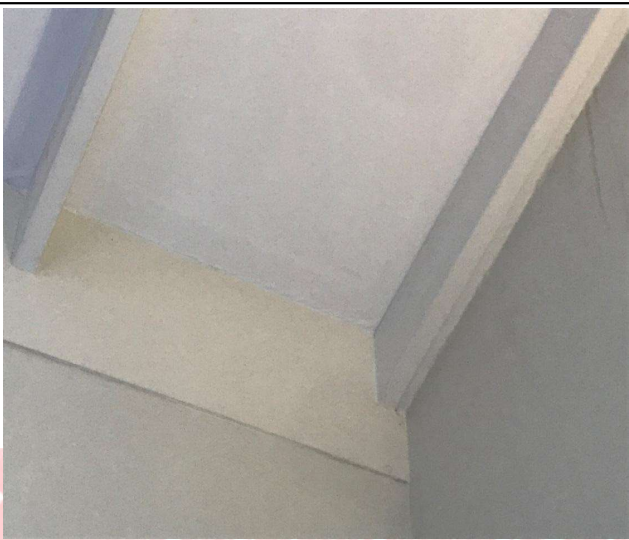
Movement between ceilings and walls at the base of the stairs,

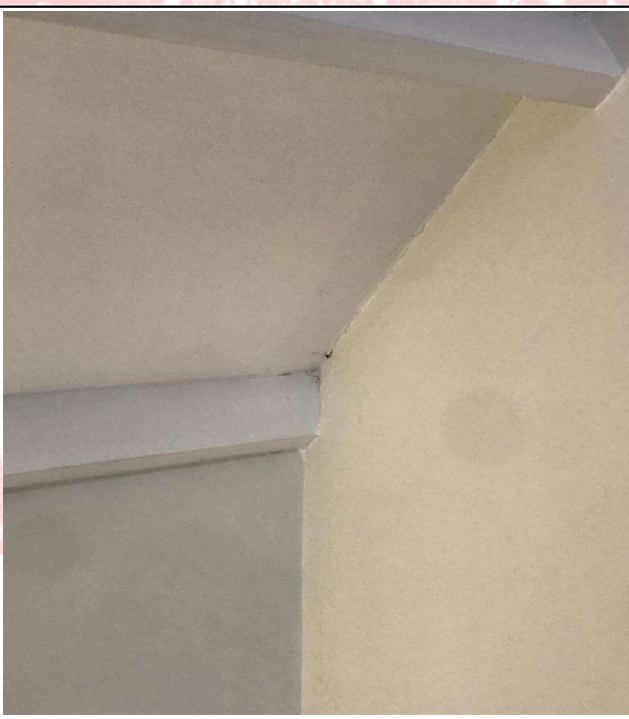
Movement between ceilings and walls at the top of the stairs,

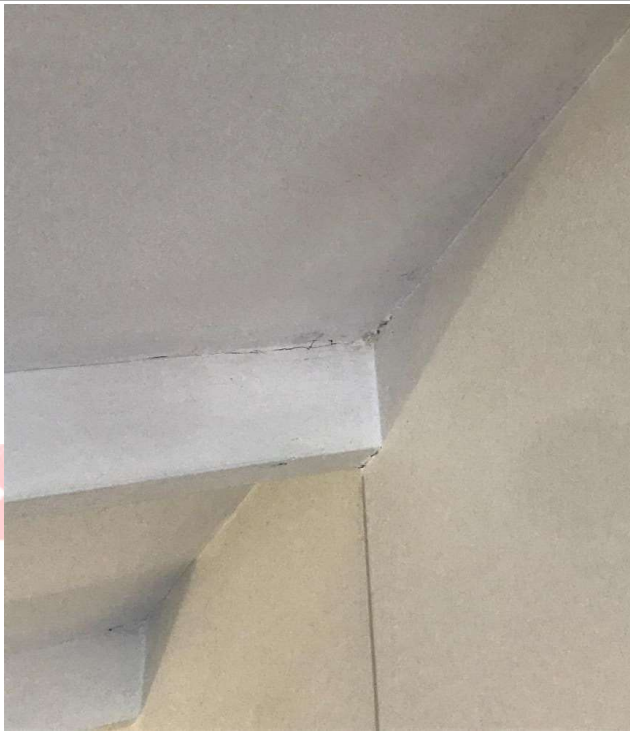
Movement between ceilings and walls at the top of the stairs,

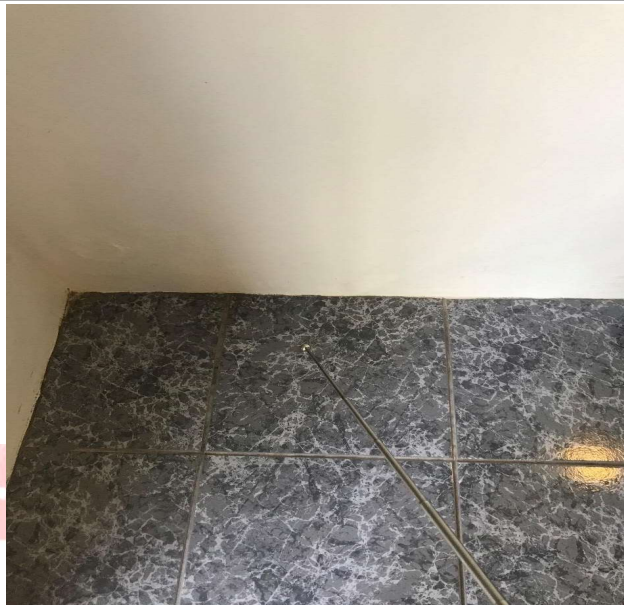
Base of stairs has areas of drumming tiles which is consistent with the tiles separating from the surface behind them,

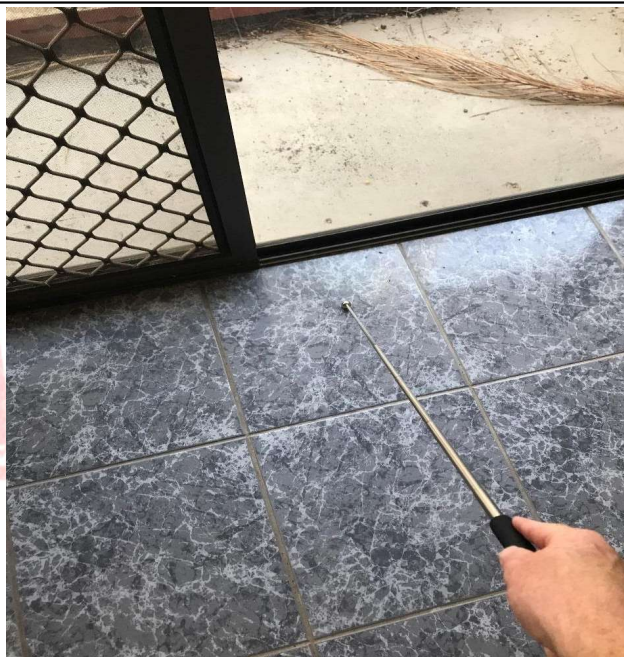
Near sliding door has areas of drumming tiles which is consistent with the tiles separating from the surface behind them,

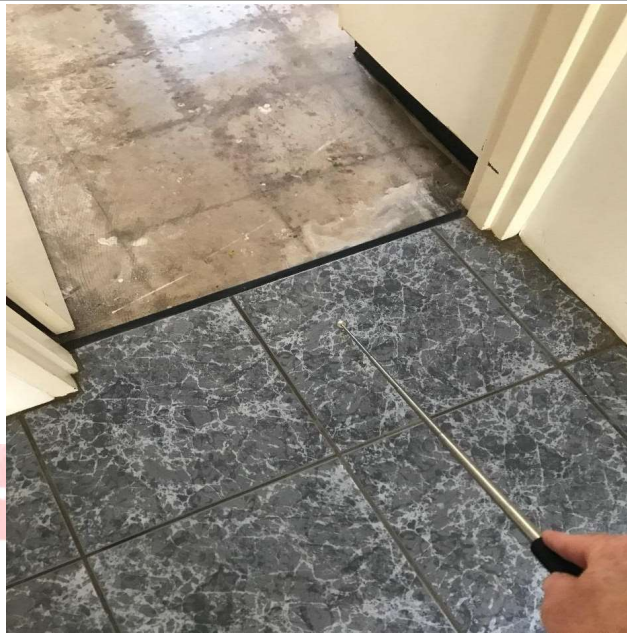
Outside B2 door has areas of drumming tiles which is consistent with the tiles separating from the surface behind them,

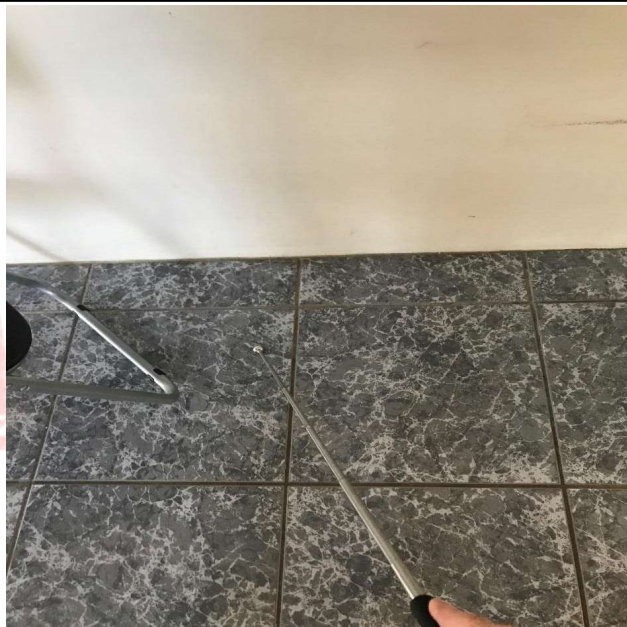
Near kitchen has areas of drumming tiles which is consistent with the tiles separating from the surface behind them,

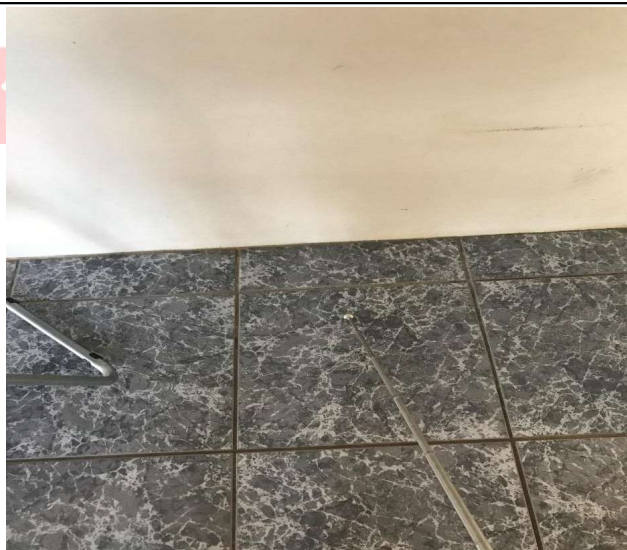
Near kitchen has areas of drumming tiles which is consistent with the tiles separating from the surface behind them

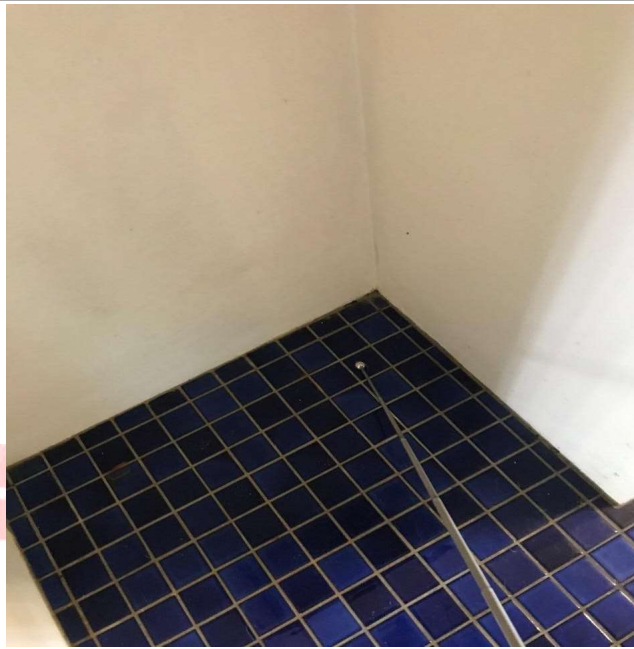
Kitchen has areas of drumming tiles which is consistent with the tiles separating from the surface behind them,

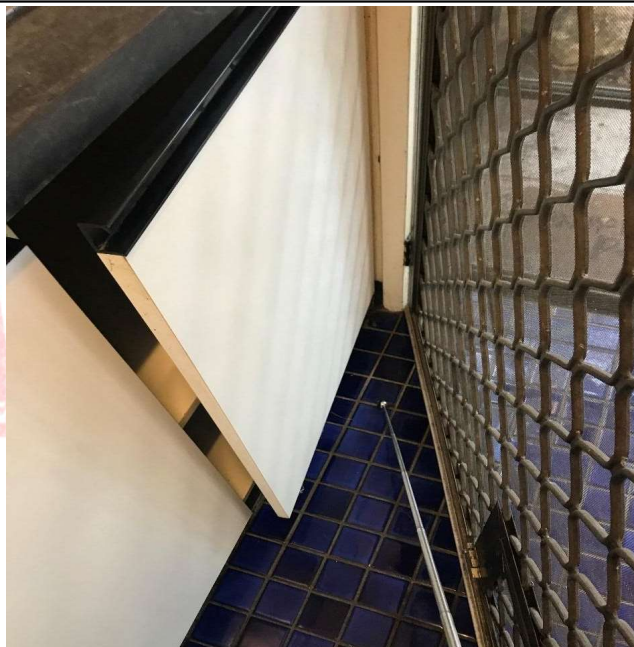
Kitchen has areas of drumming tiles which is consistent with the tiles separating from the surface behind them,
