SBC Property Inspections

Condition and Status Report 123 Nightcliff Beach Drive, Nightcliff

Re: Building Condition Report for 123 Nightcliff Beach Drive, Nightcliff
Purchasers: S & B Summers

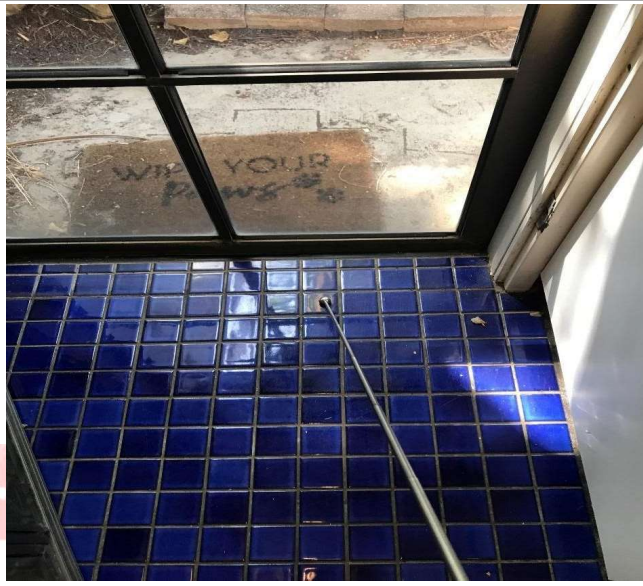
Kitchen has areas of drumming tiles which is consistent with the tiles separating from the surface behind them,
