# Condition Report

## 123 Nightcliff Beach Drive, Nightcliff

### **Re: Building Condition Report for 123 Nightcliff Beach Drive, Nightcliff Purchasers: S & B Summers**

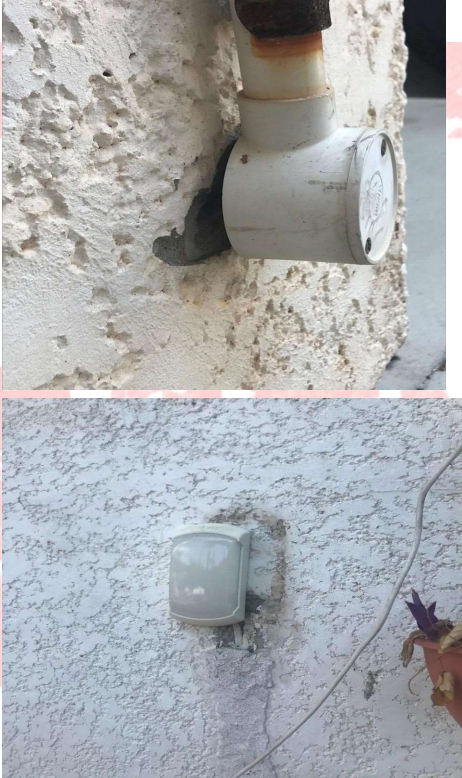
EXTERNAL WALLS	
<p>Power inlet for split system is not sealed against the wall,</p> <p>External light has exposed wires and is not sealed against the wall,</p>

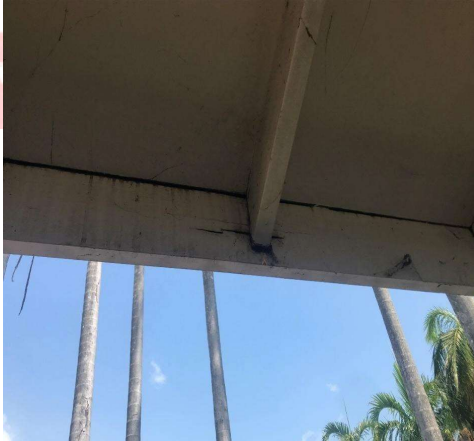
<p><b>Fungal Decay</b>  <b>Information for below areas</b></p>	<p>Fungal decay occurs in timber with a moisture content above 25%, the ideal temperature range for the growth of fungal blooms on timber is between 25 ° 40° C making the tropical north of Australia a high risk area for fungal decay. Wood grain or cut ends of timber components are particularly prone to fungal decay and painted finishes can disguise or conceal previous fungal decay damage or issues which once again are not able to be identified without the removal of fittings, fixtures of the building components or linings.</p>
<p>Timber barge has obvious signs of decay and requires replacing in multiple areas,.</p>	 
<p>Timber barge has obvious signs of decay and requires replacing in multiple areas,</p>	 
<p>Timber Facia has obvious signs of decay and requires replacing in multiple areas,</p>

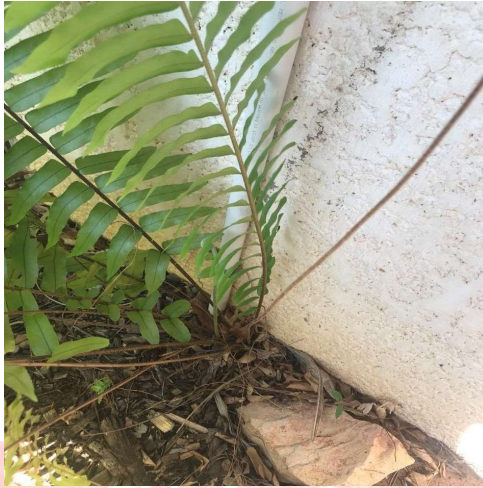
Condensation pipe from Split system needs to be diverted away from house,

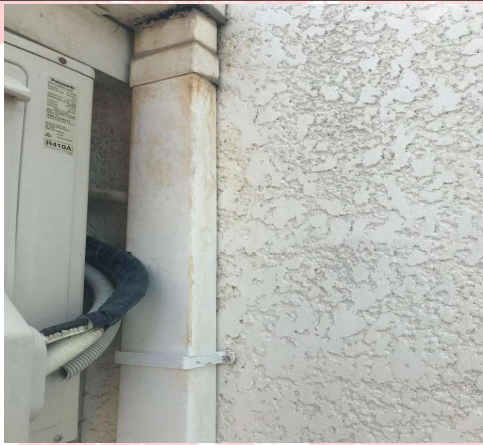
Down pipe is leaking and adding to the water pooling at the back door,

Condensation pipe from Split system runs into metal down pipe, this will cause premature rust in the down pipe.

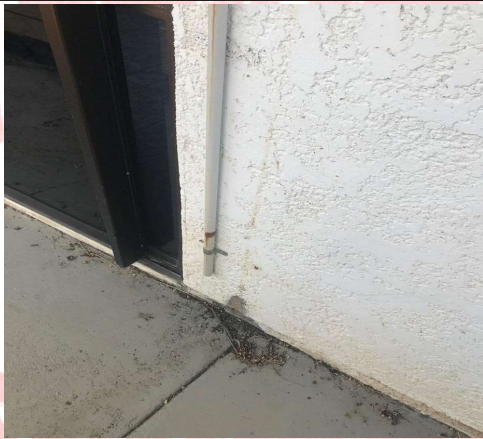
Condensation pipe from Split system needs to be diverted away from house

This has caused the render to prematurely corrode where the pipe was previously fixed on the wall to the right of existing.

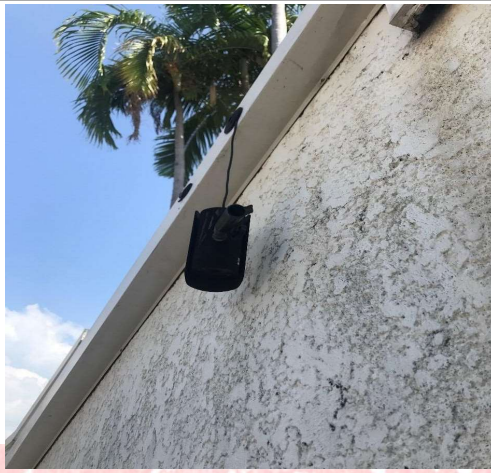
Security camera has become detached from the wall.

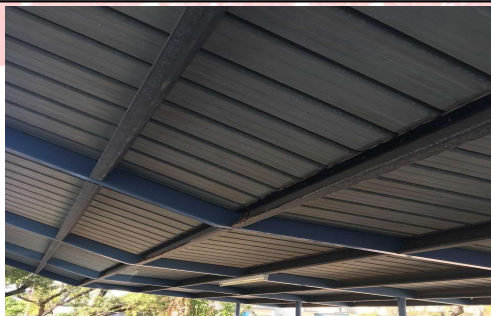
Rust has started to form on the carport purlins.

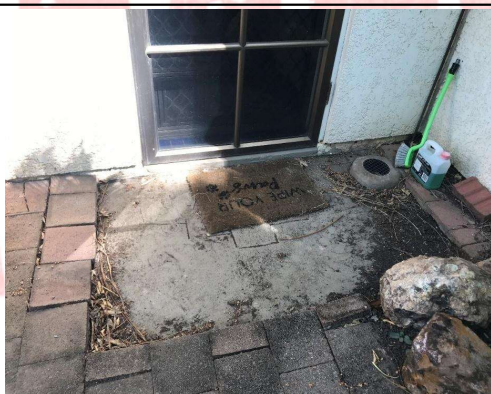
Paving at the back door is lower than the drain resulting in water pooling,

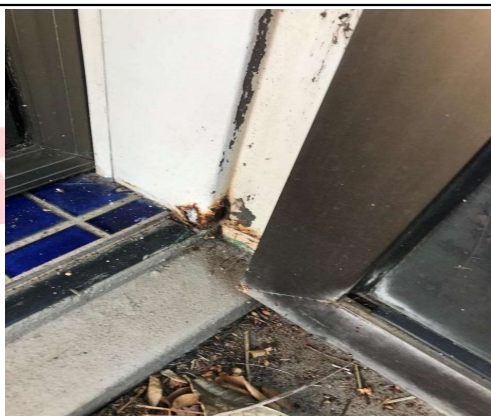
Rust has started in the back door jamb leading into kitchen,

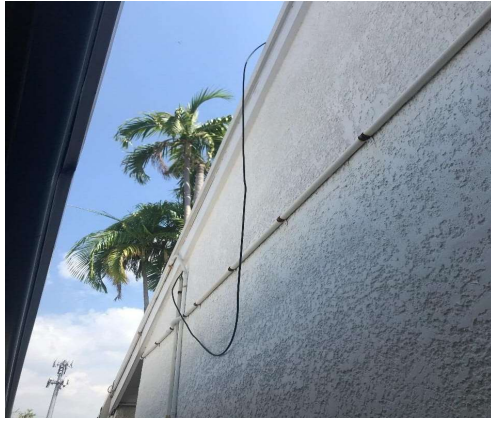
Antenna cable has detached from wall,

External wall finish is due to be repainted to effectively seal the blockwork

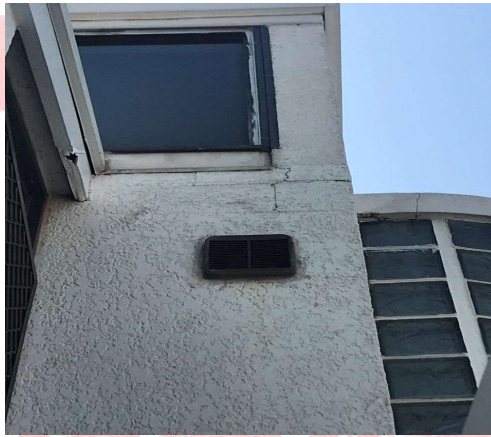
Mild cracks in blockwork and concrete roof over ensuite,

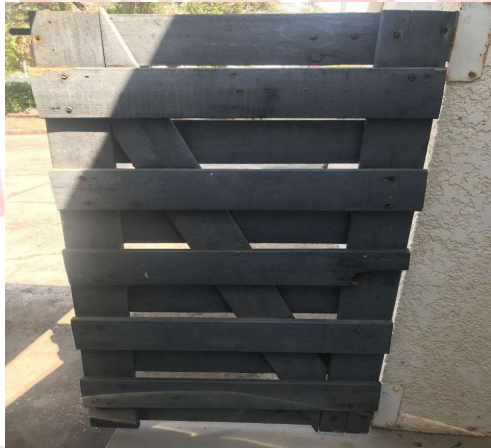
Both gates suffering from decay and require repainting to prevent them from further issues,

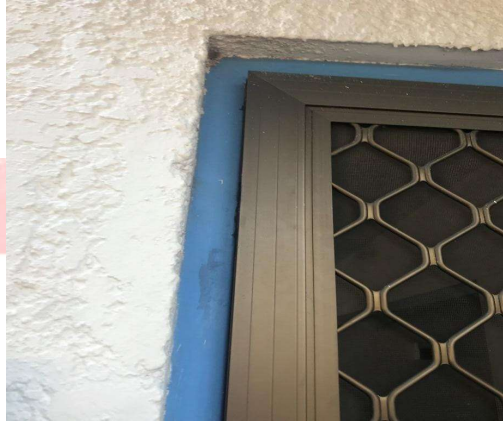
Front screen door is an exception from the above as the margin is very tight and causes the door to rub, door requires adjusting or possible replacement,

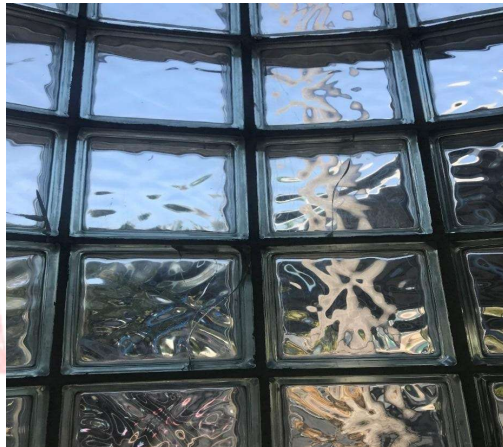
Multiple cracked glass bricks in both the Bathroom / Laundry and Ensuite,

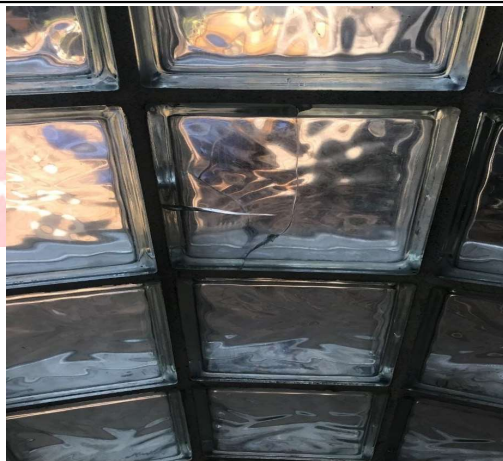
Multiple cracked glass bricks in both the Bathroom / Laundry and Ensuite,

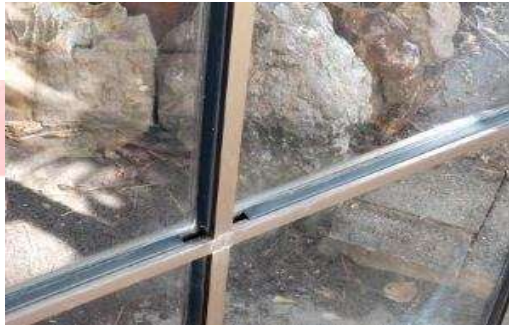
Glazing seals have retracted and require replacing,

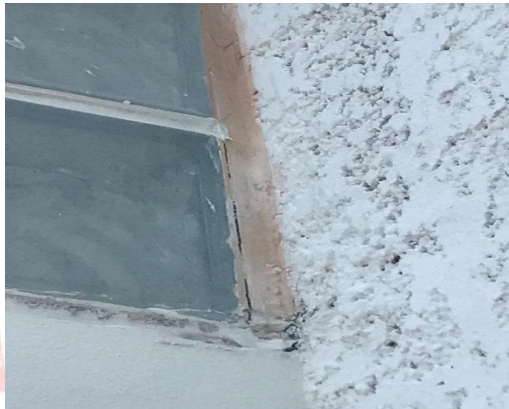
Sealant around glass brick has retracted and cracked on the outside in multiple places,

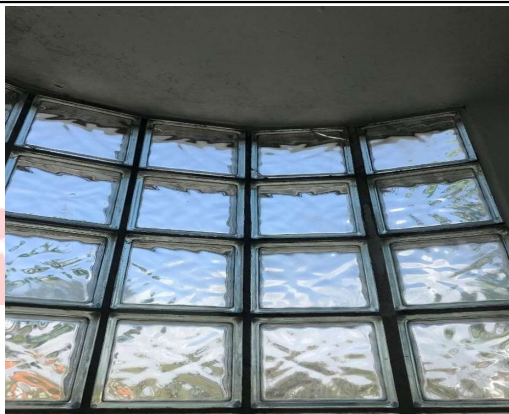
Multiple cracked glass bricks in both the Bathroom / Laundry and Ensuite,

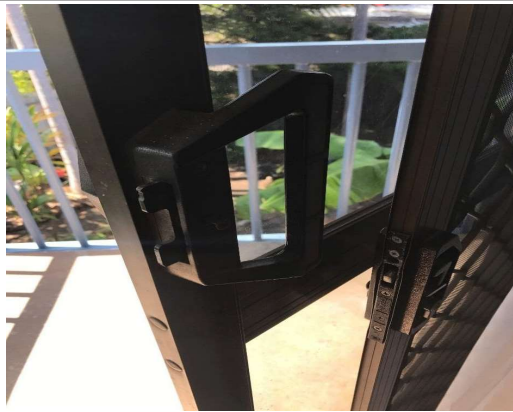
Lever on lock to B1 is missing preventing this door from locking,

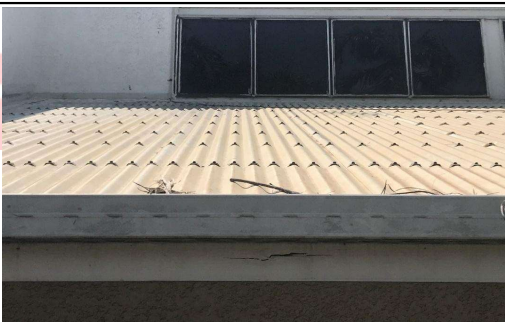
Roof cladding appears to be in good condition for the age of the building, Fixings will require replacing in the near future as they have begun to rust, observation of the sealants on the roof was not attained in this inspection.

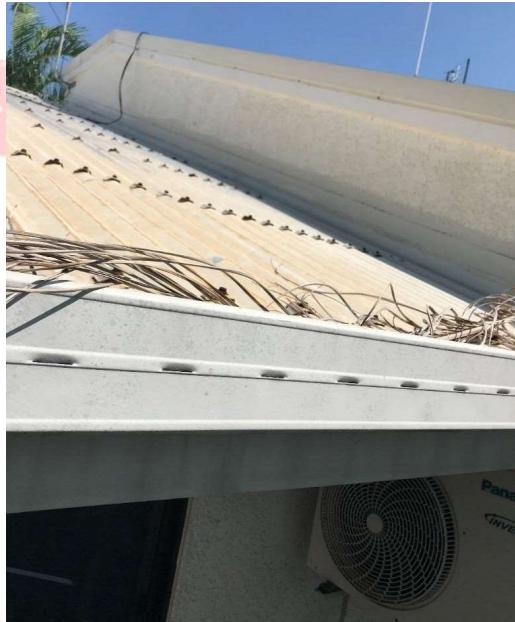
Gutters have a build leaf letter and require cleaning,

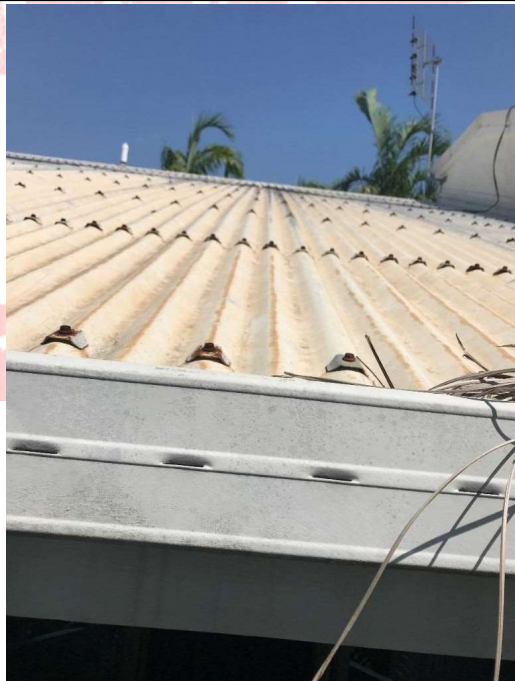
Roof cladding appears to be in good condition for the age of the building, Fixings will require replacing in the near future as they have begun to rust, Gutters have a build leaf letter and require cleaning,

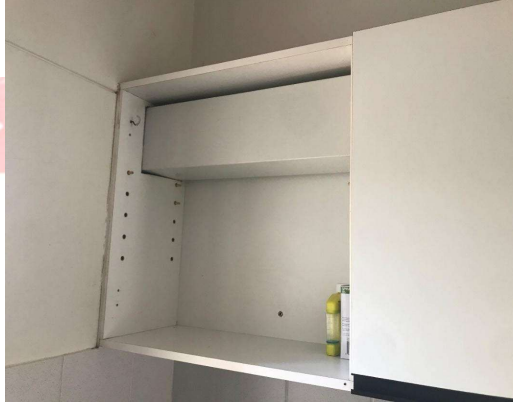
Doors and shelf missing from cabinet,

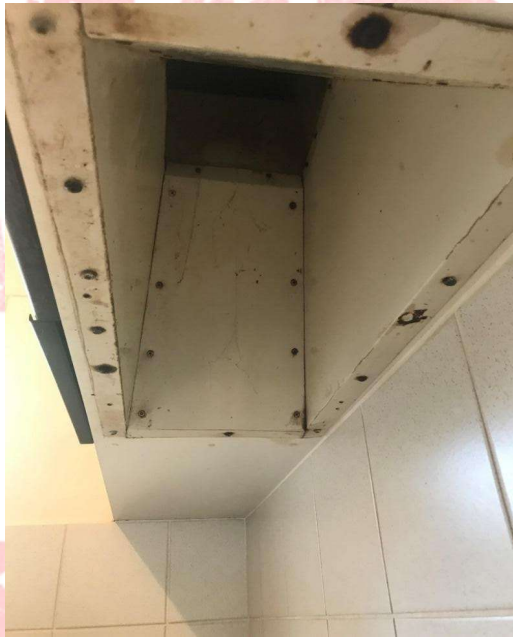
No exhaust fan above hotplate,

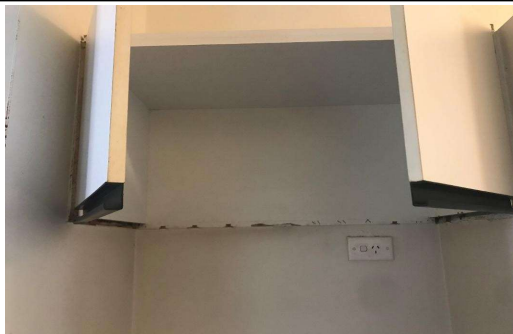
Bottom of cabinet missing from cabinet above fridge,

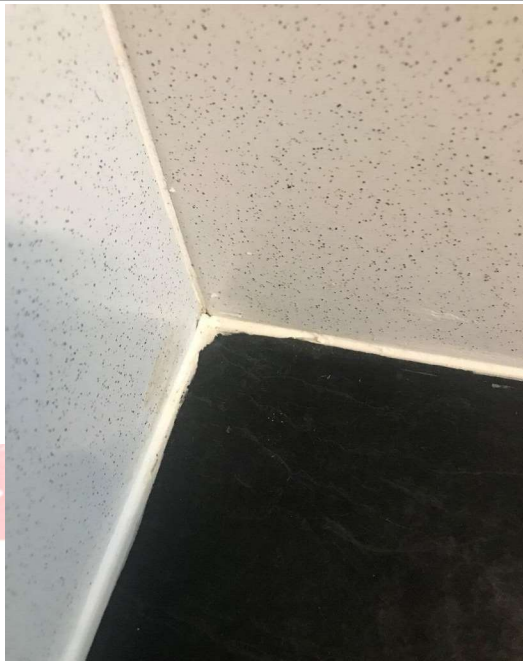
Cracked sealant between splash back and bench top behind kitchen sink,

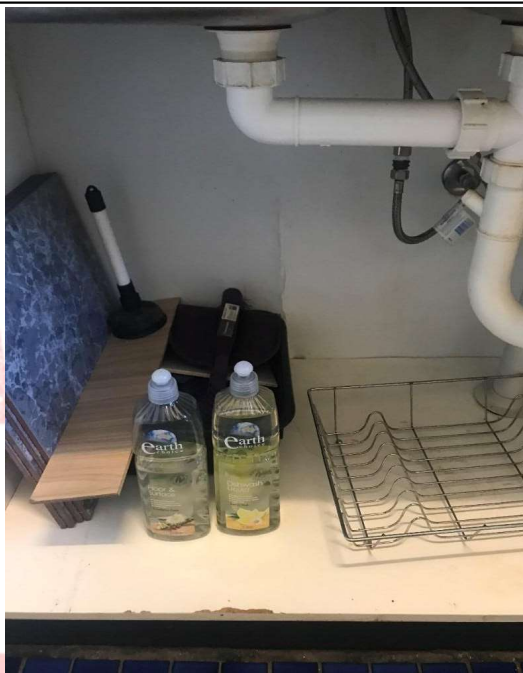
Cabinet suffering from water damage under kitchen sink,

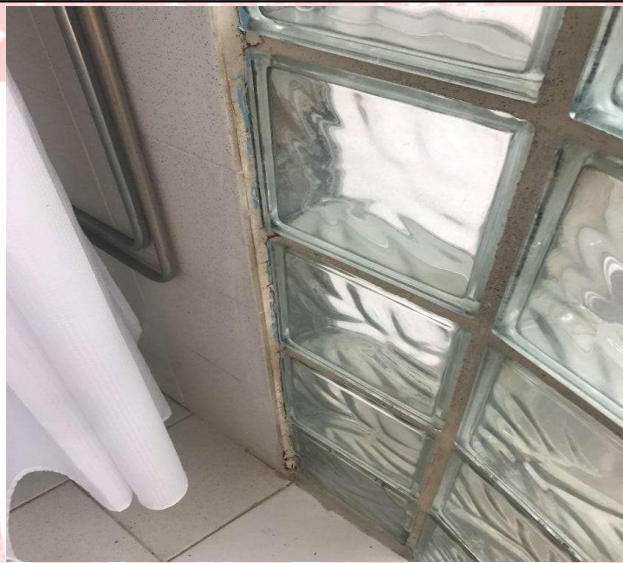
Bathroom / Laundry join between tiles and glass bricks requires sealing, this area is exposed to the shower and vitally important,

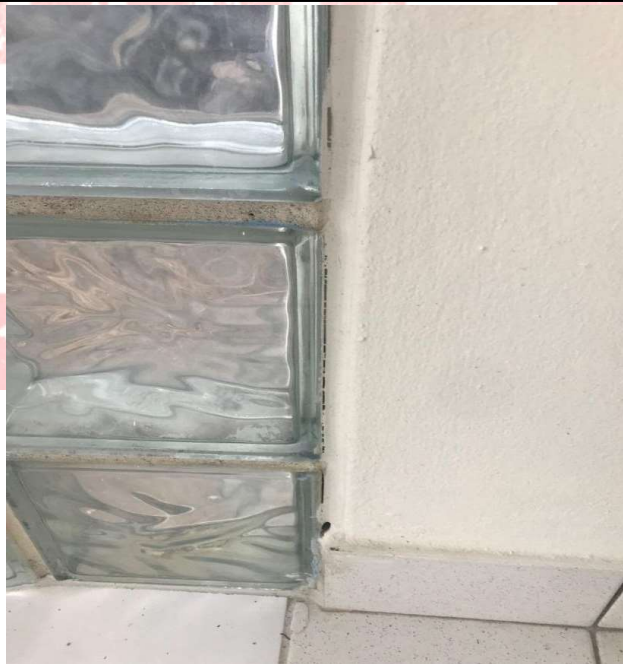
Bathroom / Laundry join between glass bricks and wall requires sealing, this area is exposed to the shower and vitally important,

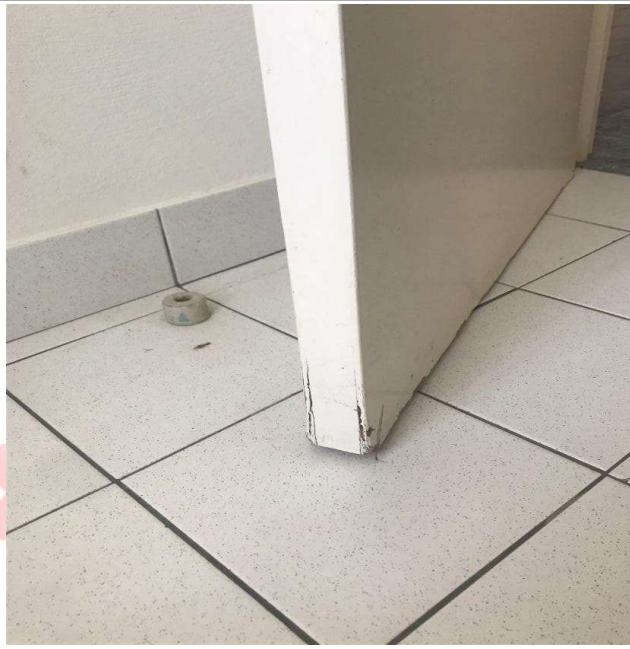
Bathroom / Laundry internal door has begun to delaminate,

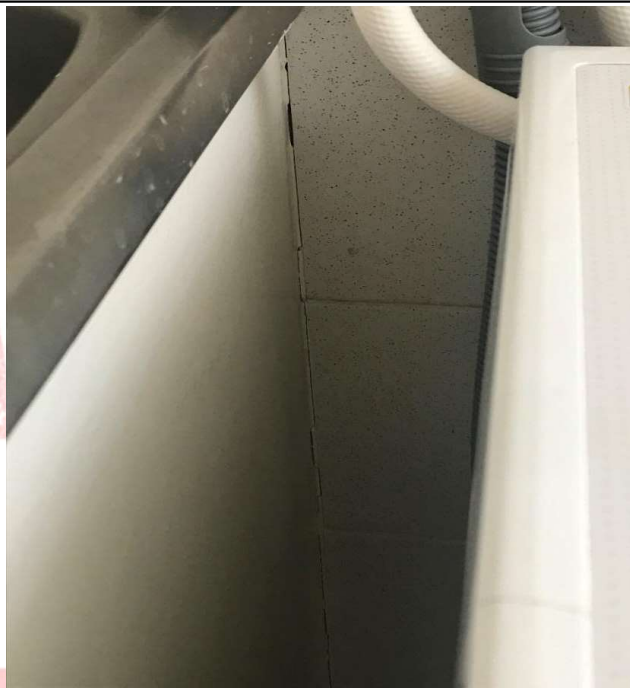
Bathroom / Laundry join between trough and tiles requires sealing,

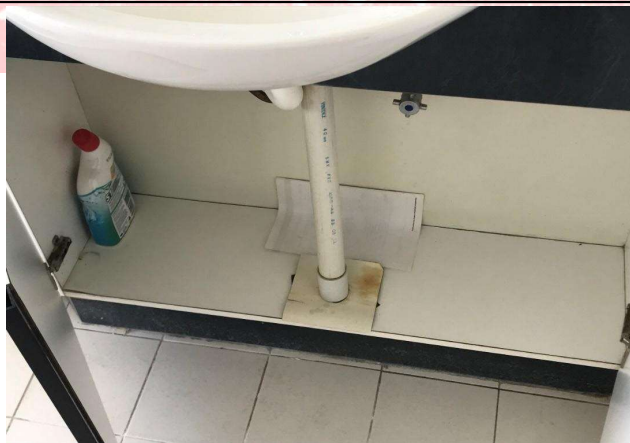
Ensuite vanity unit shows signs of mild water damage and delamination of cabinetry,

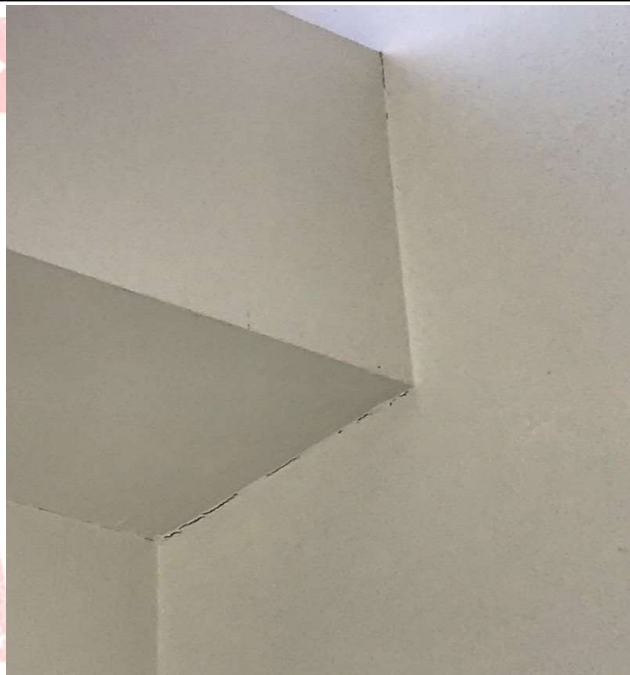
Esuite walls show signs of small movement consistent with the age of the home,

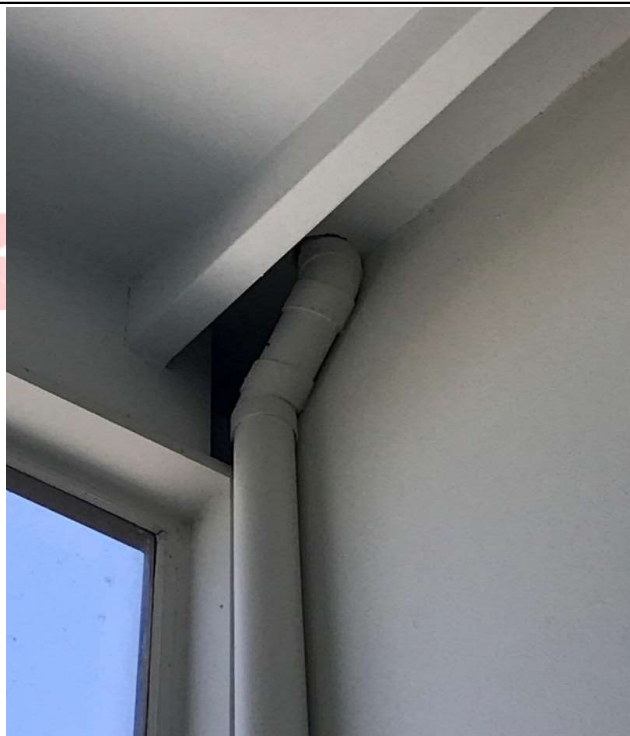
Ensuite vent not completed in a tradesman like manner.

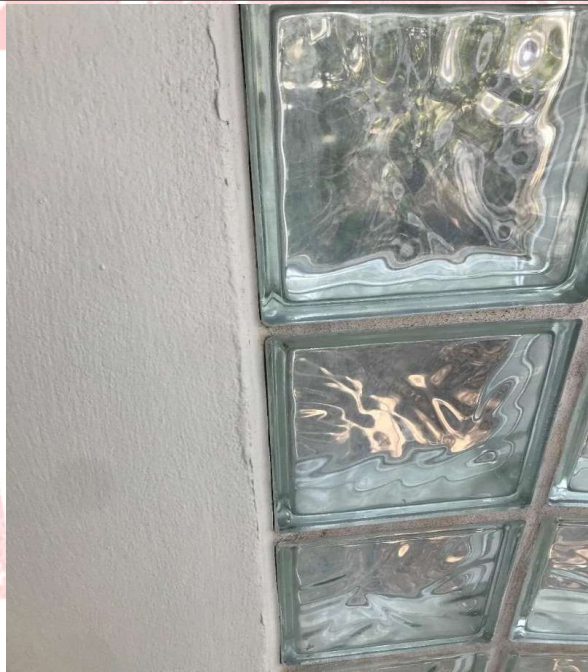
Esuite walls show signs of small movement consistent with the age of the home,

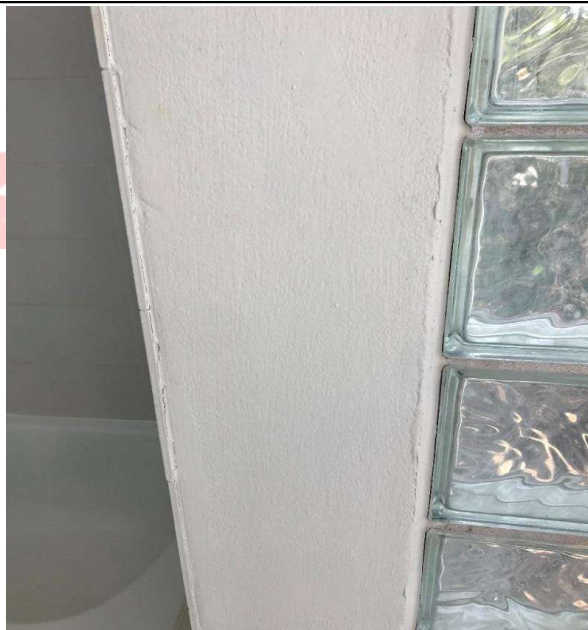
Esuite walls show signs of small movement consistent with the age of the home,

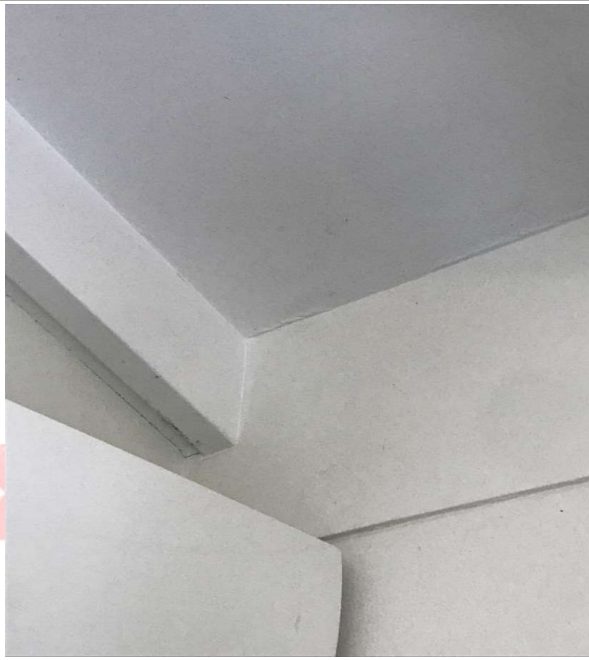
Esuite walls show signs of small movement consistent with the age of the home,

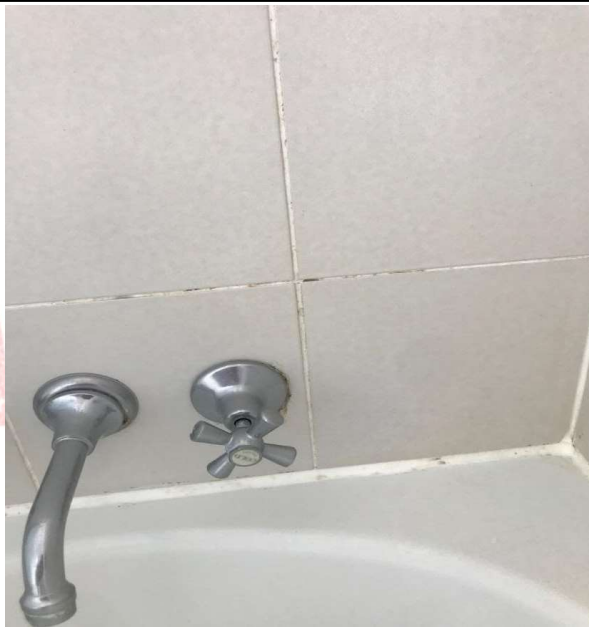
Ensuite tiles has areas of grout missing,

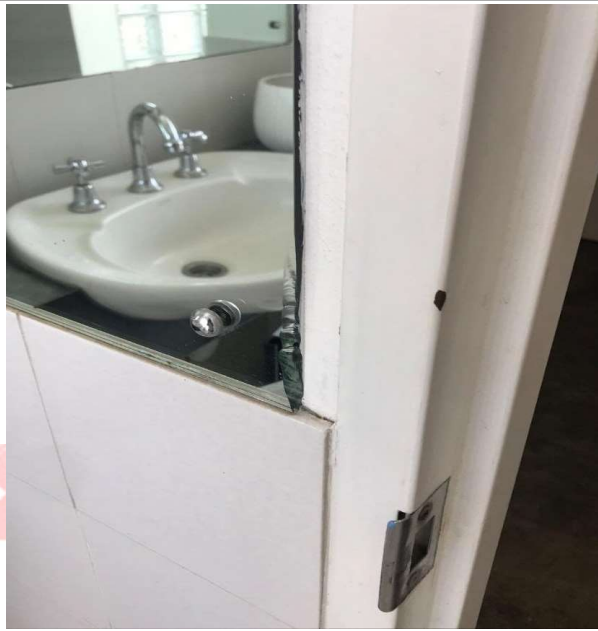
Ensuite mirror is damaged and has a sharp edge,

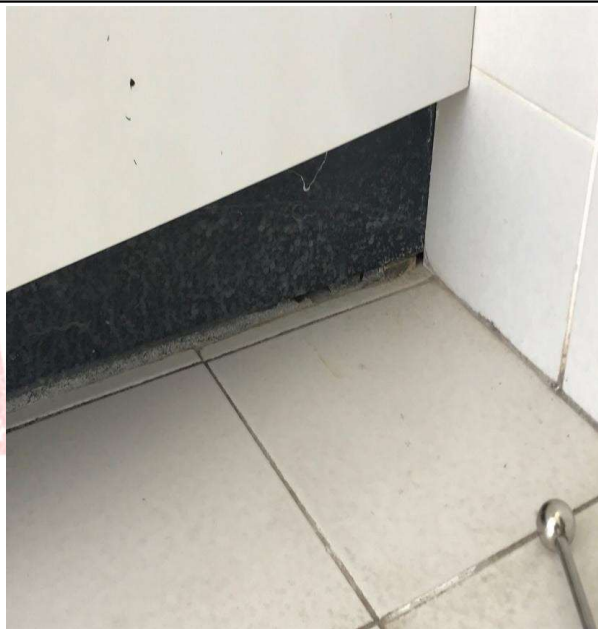
Ensuite tiles run towards a gap under the vanity unit, this may lead to water running under the unit and causing damage in an area unable to be inspected,

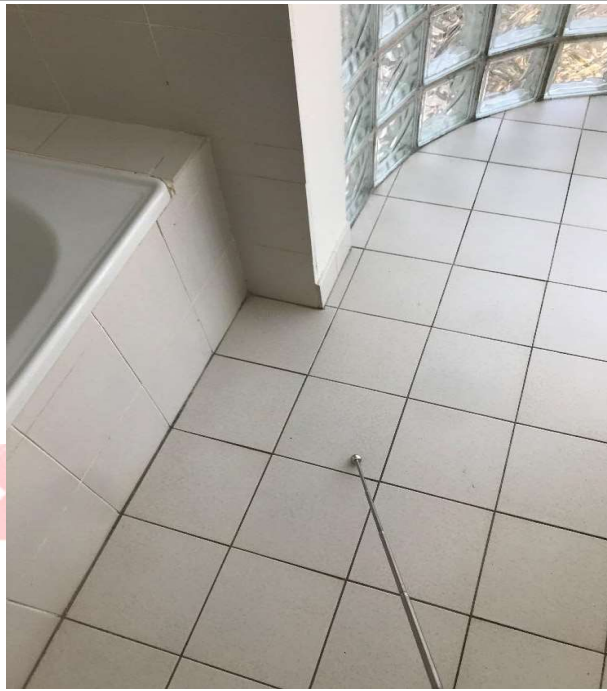
Ensuite has areas of drumming tiles which is consistent with the tiles separating from the surface behind them,

Drummy tiles are an indication that the adhesive bond between the tiles and wall / floor has failed. While drummy tiles may provide a serviceable finish for some time they may crack and or become loose or pop up at any time.

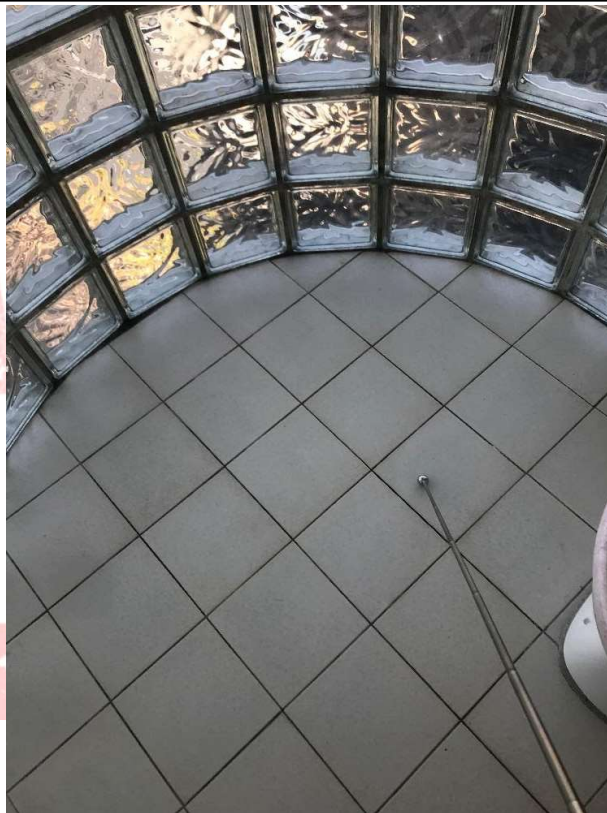
Ensuite has areas of drumming tiles which is consistent with the tiles separating from the surface behind them,

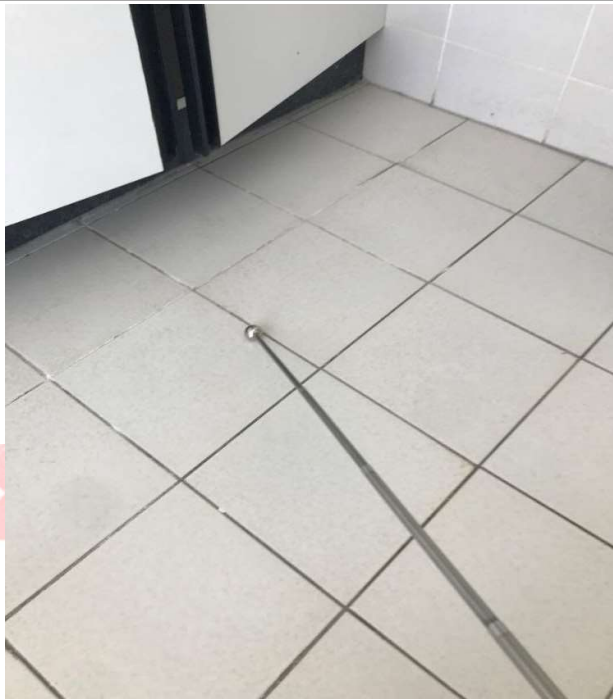
Ensuite tiles in front of the vanity unit show signs of lifting as they are drumming and uneven,

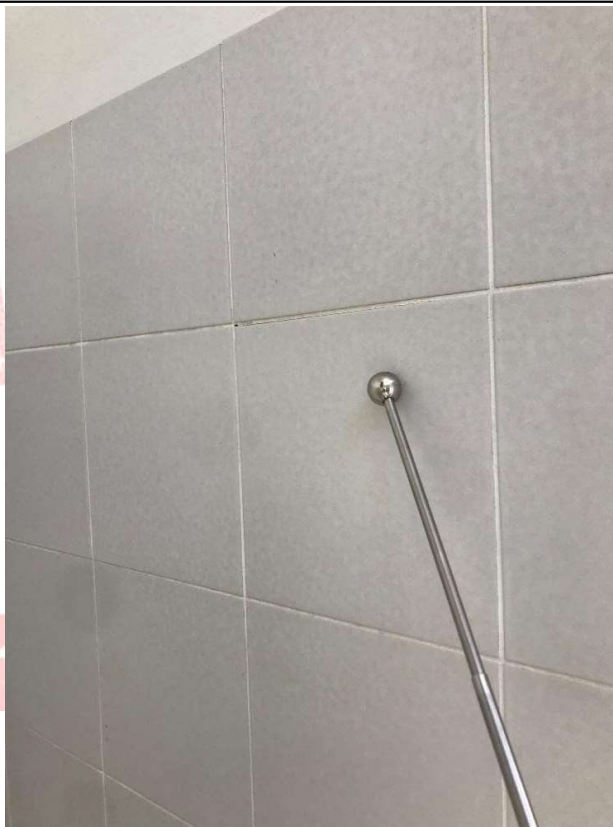
Ensuite has areas of drumming tiles which is consistent with the tiles separating from the surface behind them,

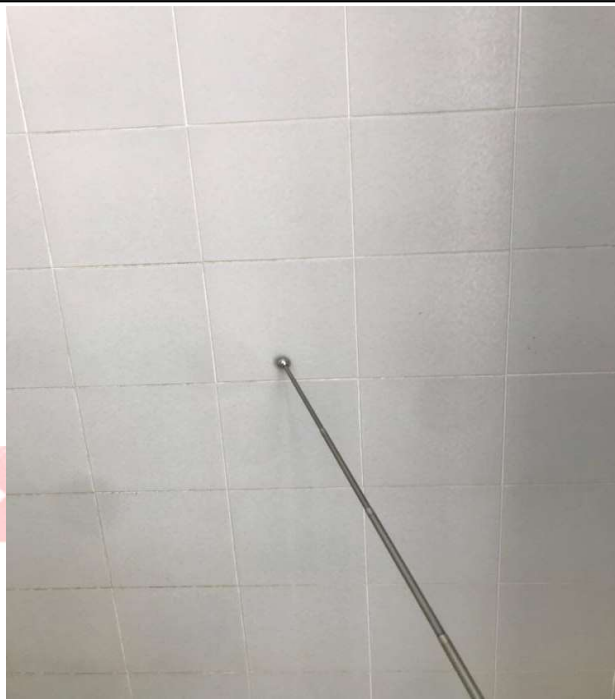
Ensuite has areas of drumming tiles which is consistent with the tiles separating from the surface behind them,

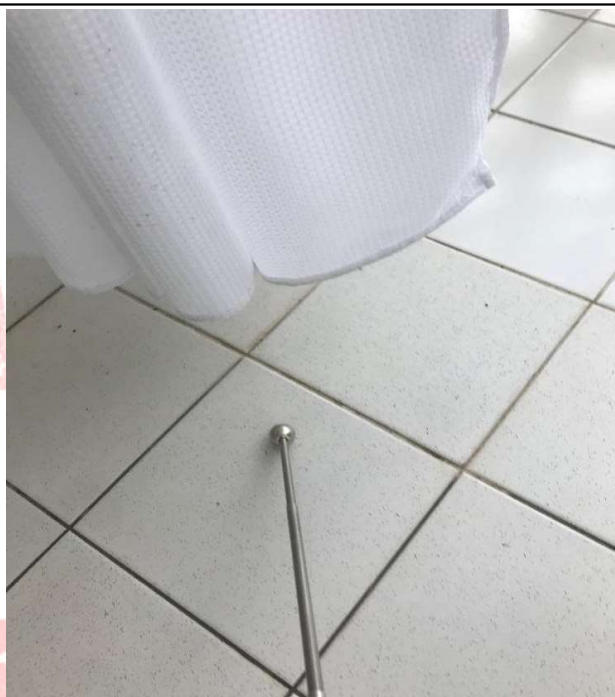
Bathroom / Laundry has areas of drumming tiles which is consistent with the tiles separating from the surface behind them,

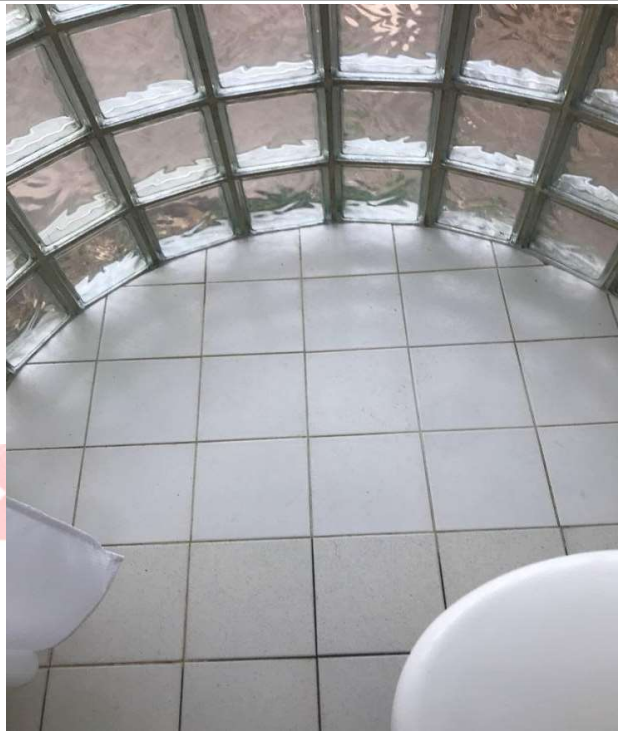
Bathroom / Laundry floor tiles in shower has areas of drumming which is consistent with the tiles separating from the surface behind them, these tiles have also been replaced and are not consistent with the rest of the room,

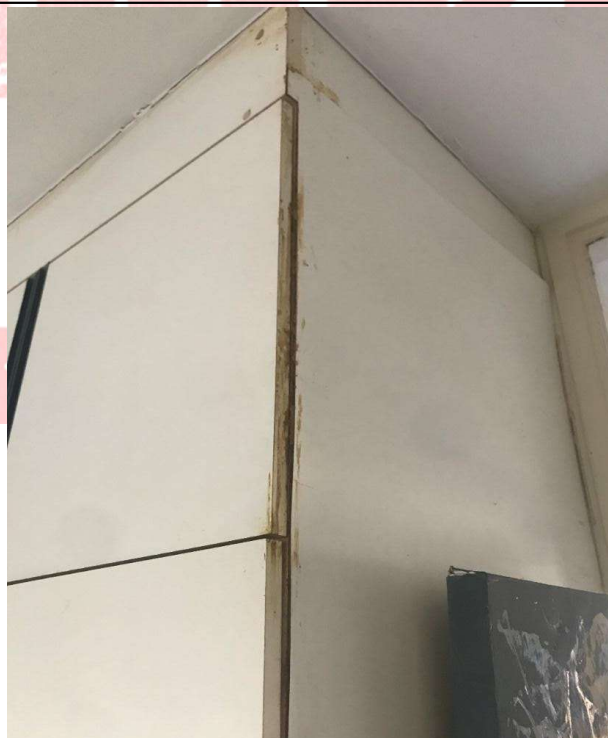
B2 BIR edging has been glued back on and not completed in a tradesman like manner.

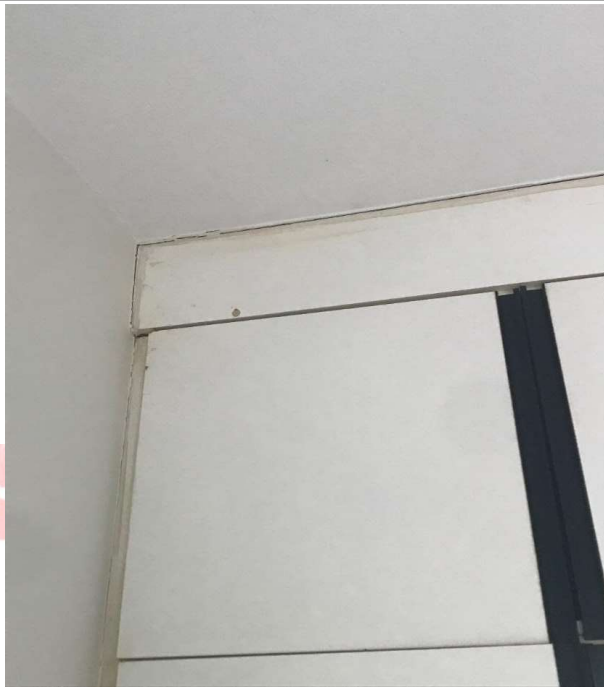
B2 BIR has dropped due to water damage and rote in its base causing it to crack along the ceiling,

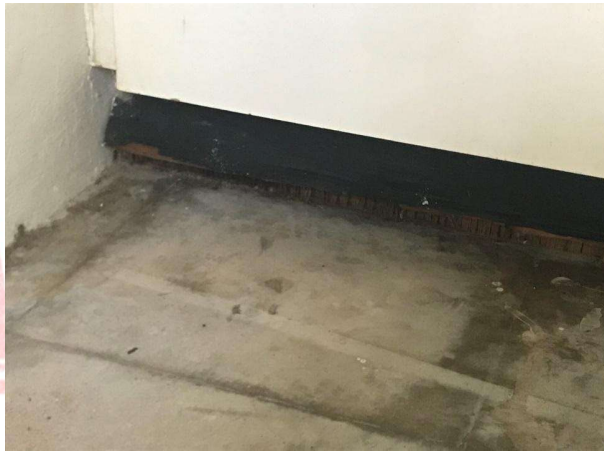
B2 BIR has dropped due to water damage and rote in its base causing it to crack along the ceiling,

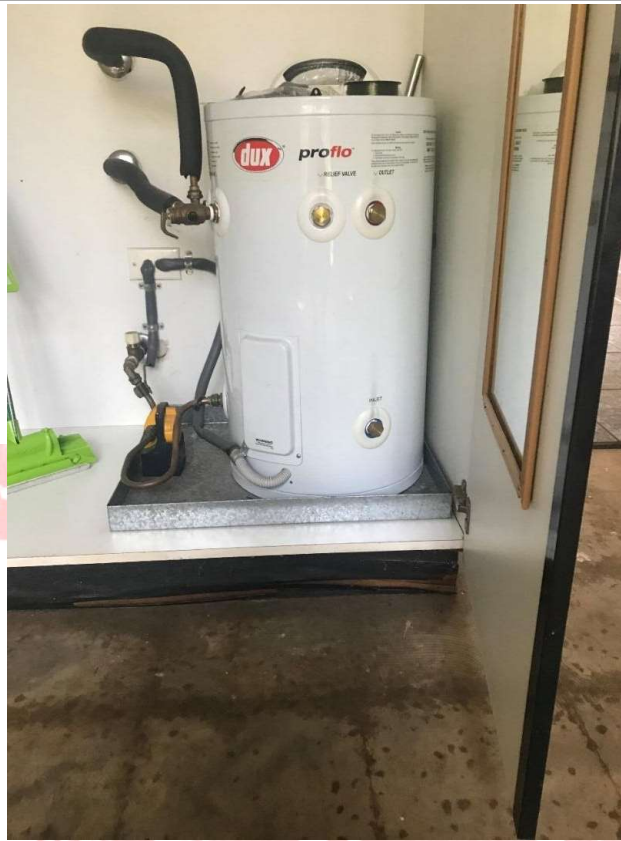
B2 BIR has dropped due to water damage and rote in its base, causing cracks between the BIR and the ceiling,

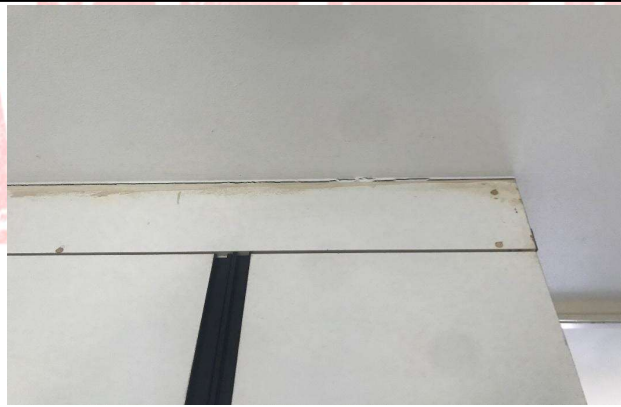
B2 BIR has dropped due to water damage and rote in its base causing it to crack along the ceiling,

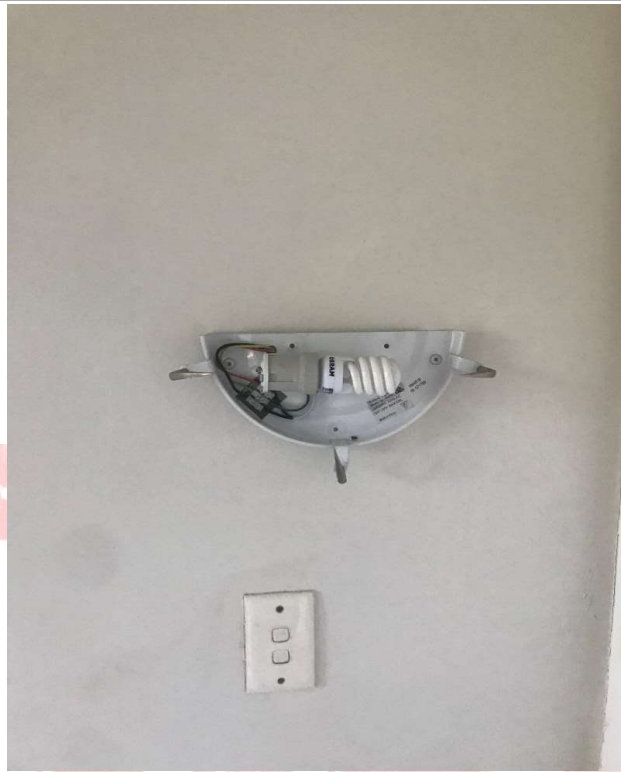
B2 light fitting is missing exposing the wires and should be replaced,

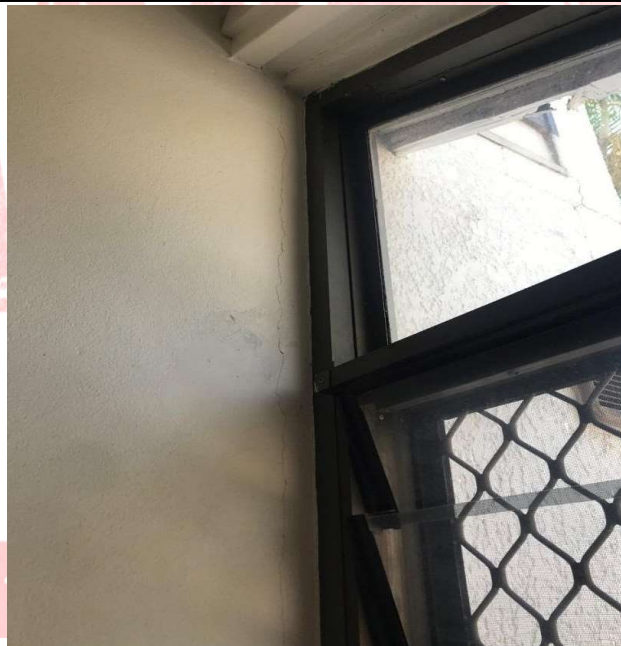
First floor landing near window has a small crack in the wall, this is near the external crack in the blockwork and roof over ensuite mentioned earlier in this report,

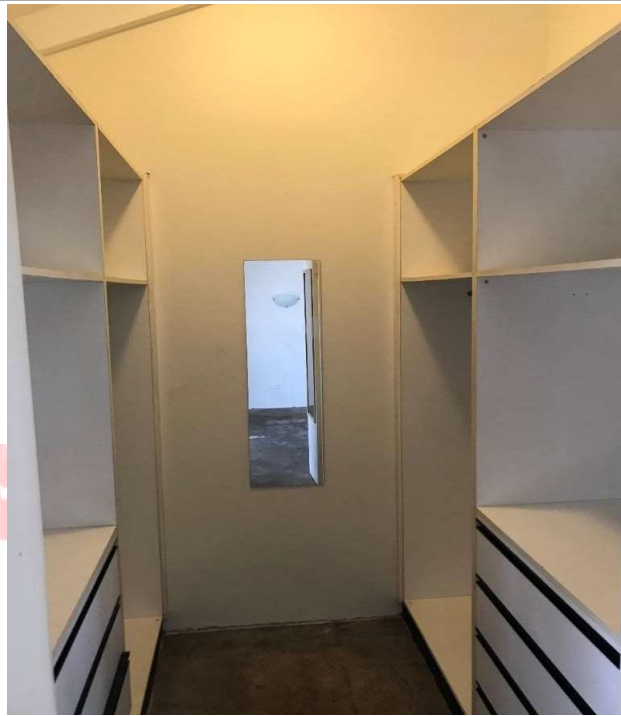
WIR cabinetry is consistent with the age of the property,

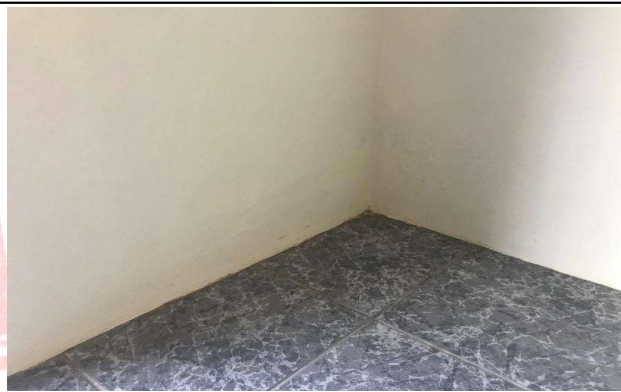
Base of stairs wall has paint blistering, this can be a sign of poor prep work or rising damp,

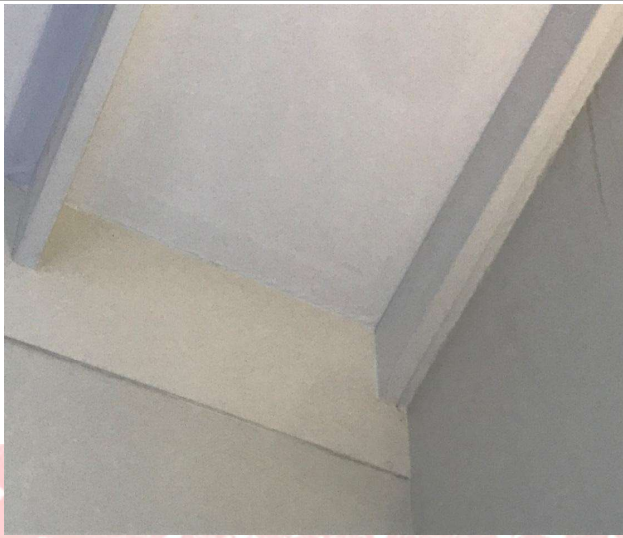
Movement between ceilings and walls at the base of the stairs,

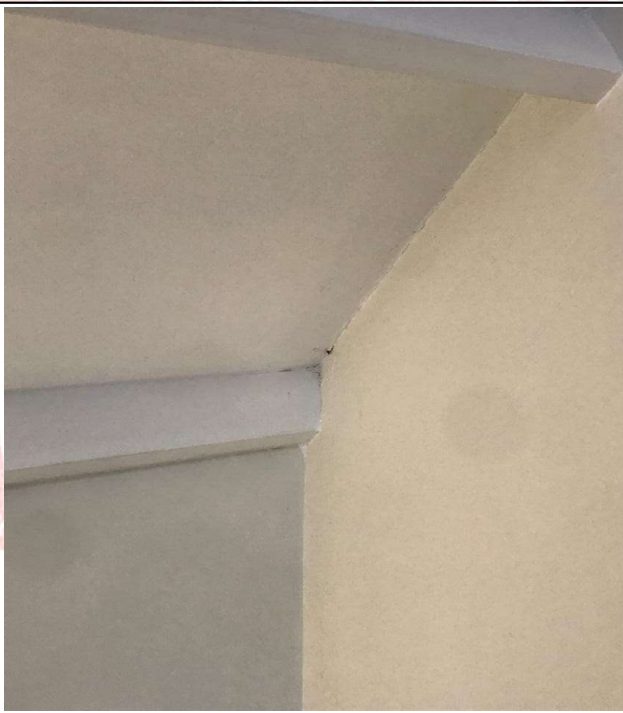
Movement between ceilings and walls at the top of the stairs,

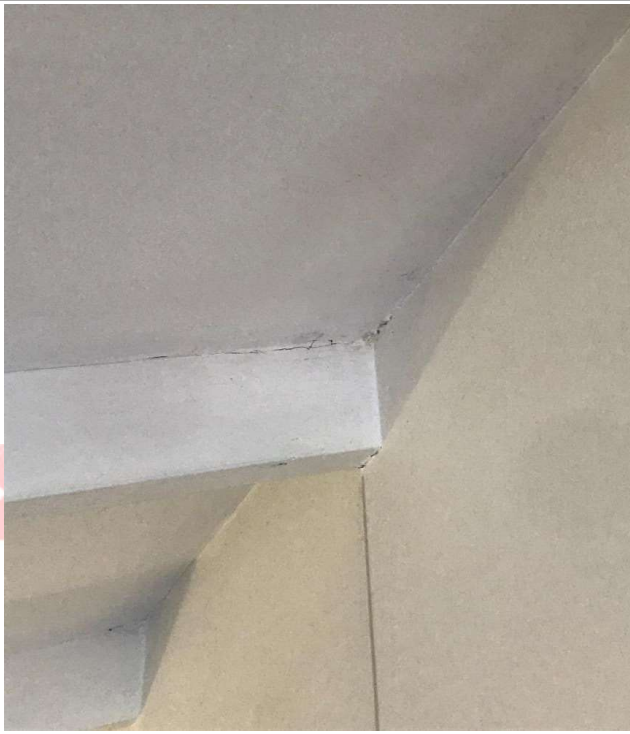
Movement between ceilings and walls at the top of the stairs,

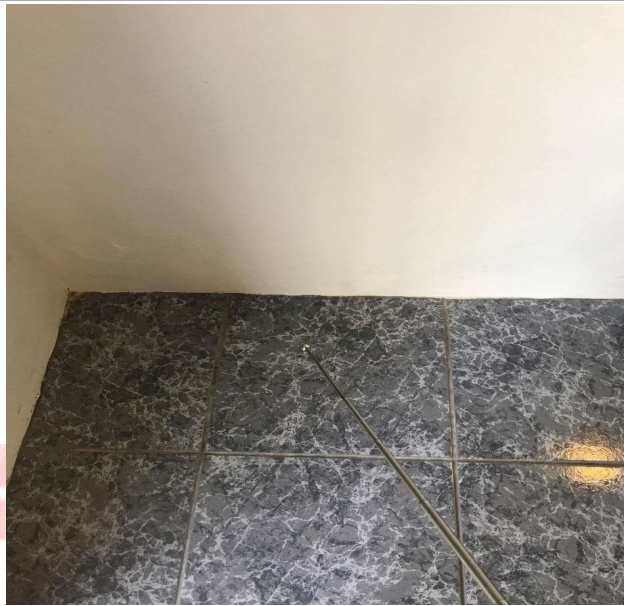
Base of stairs has areas of drumming tiles which is consistent with the tiles separating from the surface behind them,

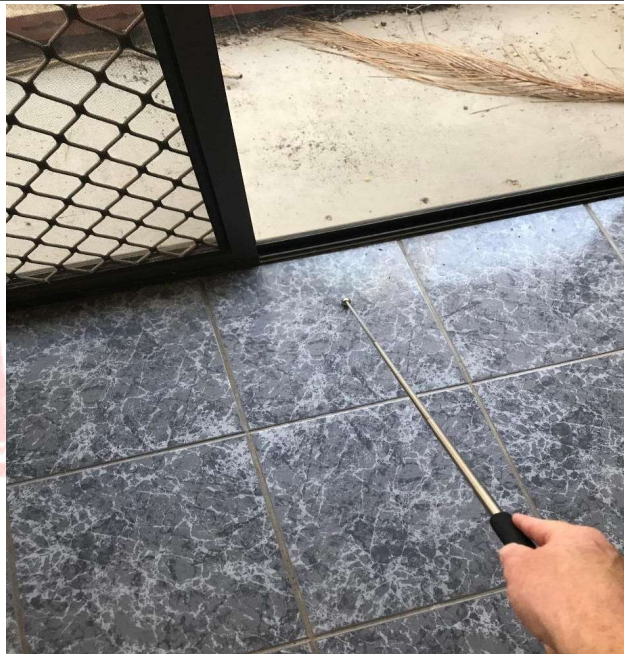
Near sliding door has areas of drumming tiles which is consistent with the tiles separating from the surface behind them,

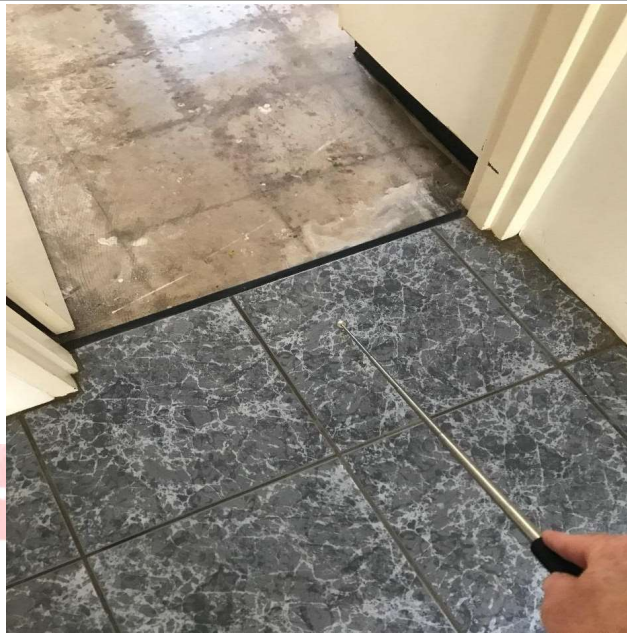
Outside B2 door has areas of drumming tiles which is consistent with the tiles separating from the surface behind them,

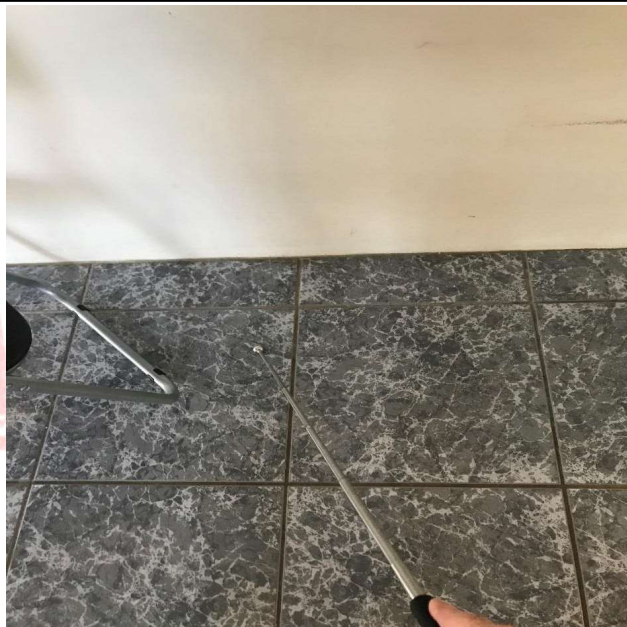
Near kitchen has areas of drumming tiles which is consistent with the tiles separating from the surface behind them,
