# Condition Report

## 123 Nightcliff Beach Drive, Nightcliff

### **Re: Building Condition Report for 123 Nightcliff Beach Drive, Nightcliff Purchasers: S & B Summers**

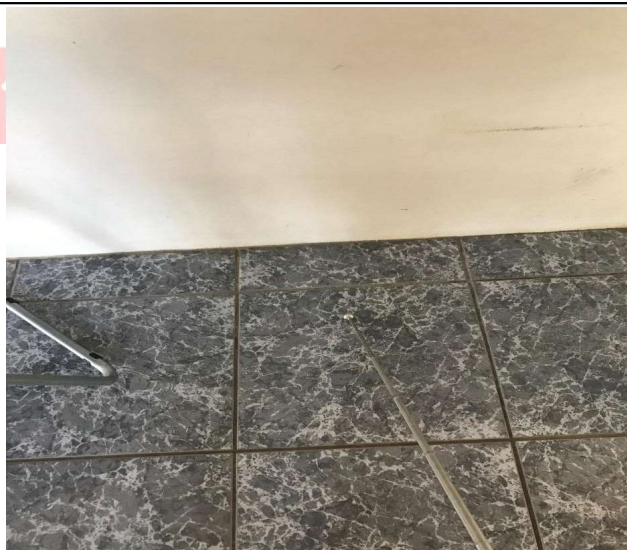
Near kitchen has areas of drumming tiles which is consistent with the tiles separating from the surface behind them

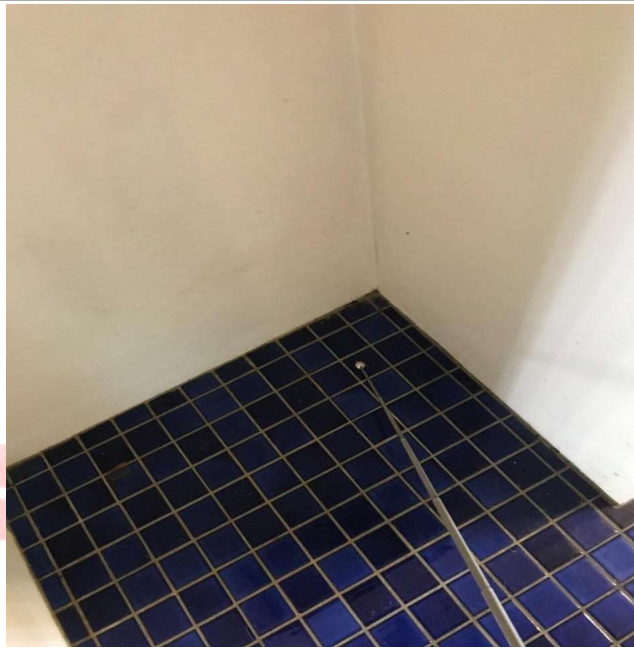
Kitchen has areas of drumming tiles which is consistent with the tiles separating from the surface behind them,

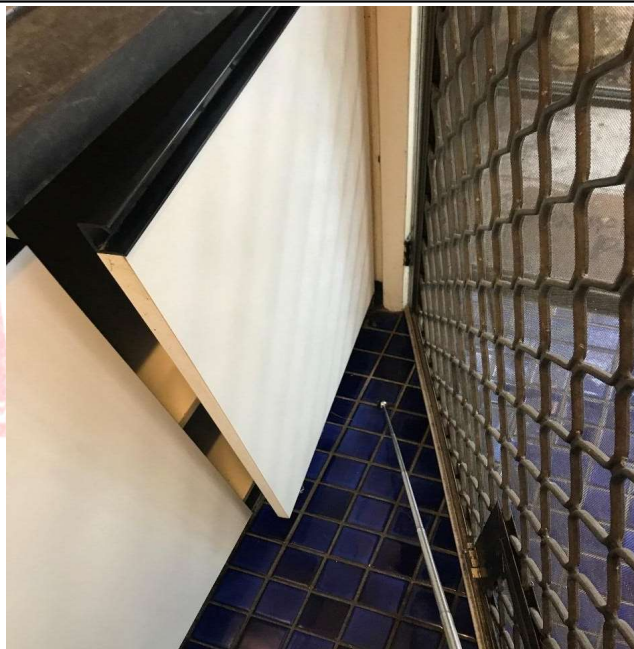
Kitchen has areas of drumming tiles which is consistent with the tiles separating from the surface behind them,

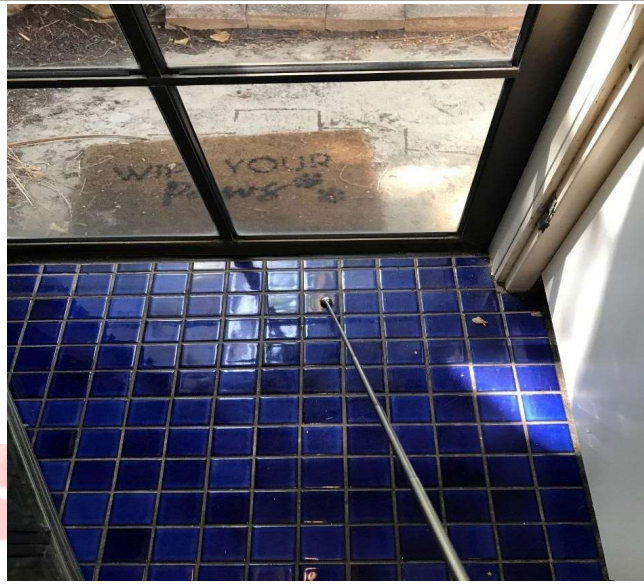
Kitchen has areas of drumming tiles which is consistent with the tiles separating from the surface behind them,
