LEAD-BASED PAINT SURVEY AND ASSESSMENT

FT. MYERS, FLORIDA - GENERAL MAIL FACILITY

November 1995

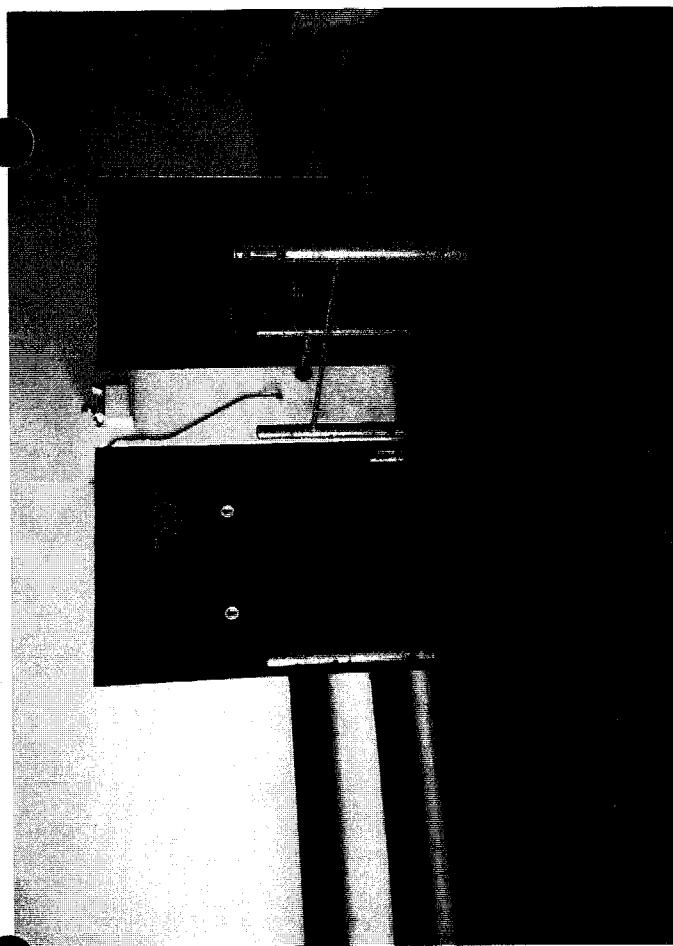
PHOTO 5. Spill curb (concrete) at doorway in room F2-101 (LBP)

<u>Component</u>	<u>Substrate</u>	<u>Condition</u>	<u>Recommendation</u>
Spill Curb at doorway F2-101 Flammable Storage	Concrete	Poor	<u>General Comments</u> - 3, 4, 5 <u>Specific Comments</u> - Abatement is recommended as soon as practical due to the poor condition of the paint on this component.
Stairs E1-118, E2-113, & G102	Cement	Good to Poor	<u>General Comments</u> - 3, 4, 5 <u>Specific Comments</u> - Abatement is recommended as soon as practical for the stairs with paint in poor condition.

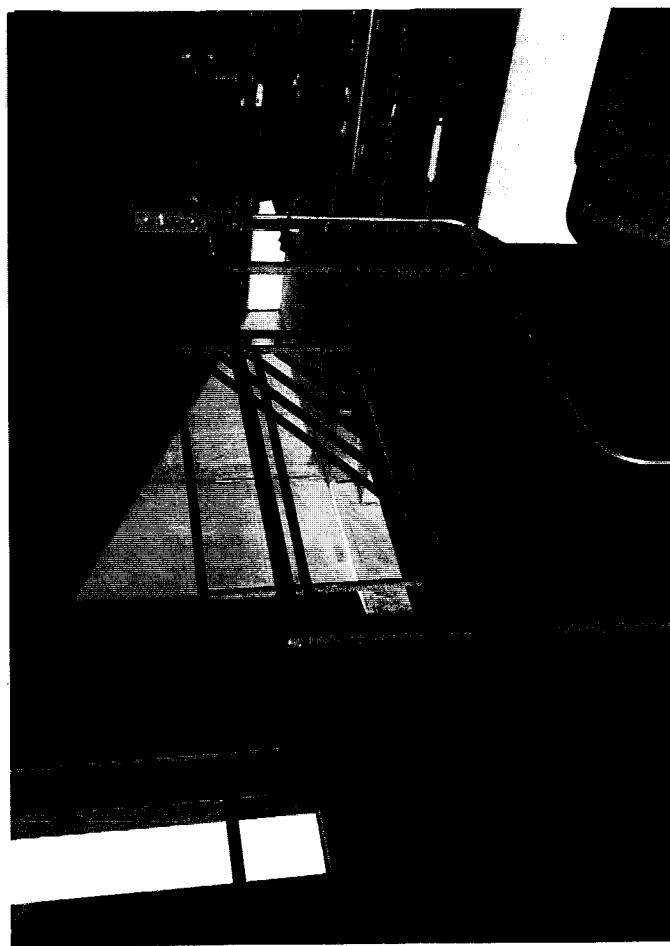
PHOTO 6. Bumper poles 8, 9, and 10, (metal) in the covered platform (room E2-104) (LBP); bumper boards (wood), and lower and upper wall (concrete) (non-LBP)

<u>Component</u>	<u>Substrate</u>	<u>Condition</u>	<u>Recommendation</u>
Bumper Poles B-137 Vestibule, E2-104 Covered Platform, Workroom	Metal	Good to Poor	<u>General Comments</u> - 2, 3, 4, 5 <u>Specific Comments</u> - Note: Not all bumper poles tested positive for LBP. See "XRF" sample log. Abatement is recommended as soon as practical for the bumper poles with paint in poor condition.
Dock Edges at spring ramps E-2-104 Covered Platform	Metal	Satisfactory	<u>General Comments</u> - 2, 3, 4, 5 <u>Specific Comments</u> - None.
Equipment Pad Edges F1-116, E2-108, G-106, E1-114, A-107, & B-105	Concrete	Good to Satisfactory	<u>General Comments</u> - 1, 3, 4, 5, 6 <u>Specific Comments</u> - Note: Not all equipment pad edges tested positive for LBP. See "XRF" sample log.
Handrails B-130 Computer Forward Sys.	Metal	Good	<u>General Comments</u> - 1, 3, 4, 5 <u>Specific Comments</u> - Note: Not all handrails in this room tested positive for LBP. See "XRF" sample log.

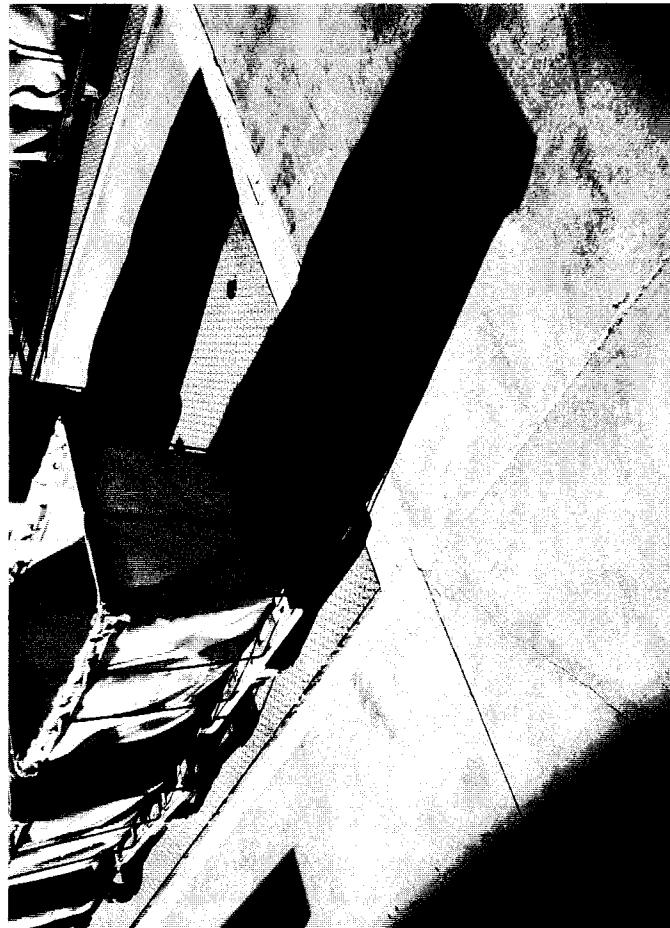
PHOTO 7. Dock edges (metal) at spring ramps in the covered platform (area E2-104) (LBP)

PHOTO 8. Railing (metal) at compactor in area E1-117 (LBP)

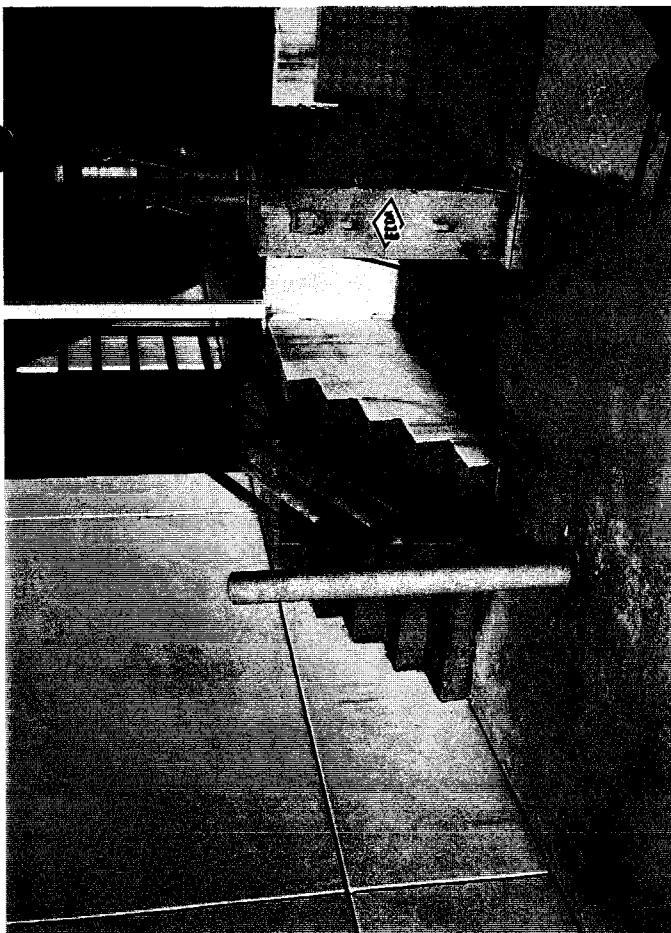
PHOTO 9. Lift and lift handrail (metal) at the maintenance dock (area G-102) (LBP)

Lift Handrail G-102 Maint. Dock	Metal	Poor	<u>General Comments</u> - 3, 4, 5 <u>Specific Comments</u> - Abatement is recommended as soon as practical due to the poor condition of the paint on this component.
Lift G-102 Maint. Dock	Metal	Poor	<u>General Comments</u> - 3, 4, 5 <u>Specific Comments</u> - Abatement is recommended as soon as practical due to the poor condition of the paint on this component.
Railings Workroom, & E1-117	Metal	Good to Poor	<u>General Comments</u> - 3, 4, 5 <u>Specific Comments</u> - Note: Not all railings tested positive for LBP. See "XRF" sample log. Abatement is recommended as soon as practical for the railings with paint in poor condition.

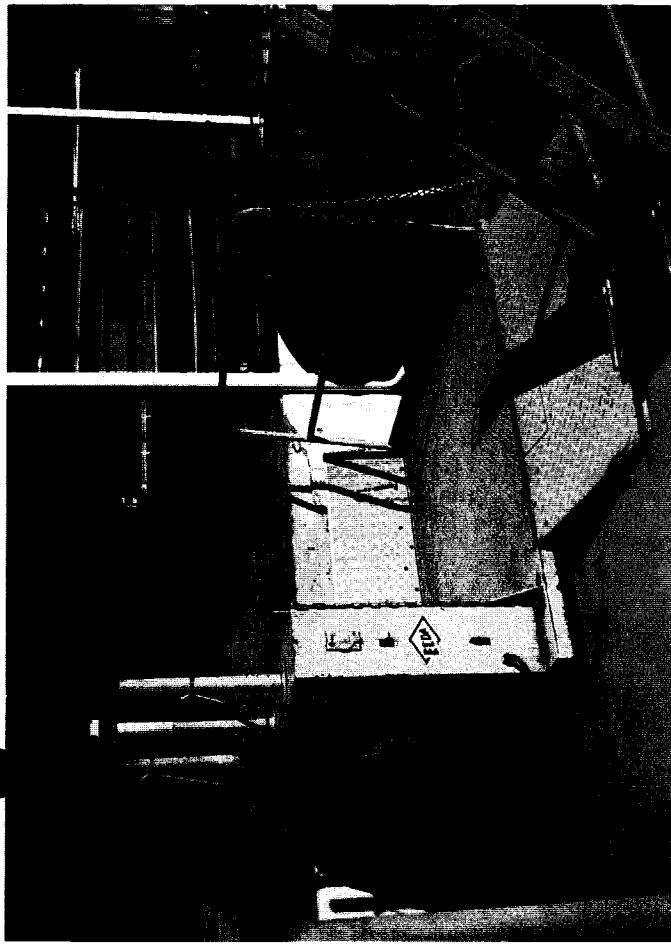
PHOTO 10. Stairs (cement) at the maintenance dock (LBP); bumper pole, handrail and support column (all metal) (non-LBP)

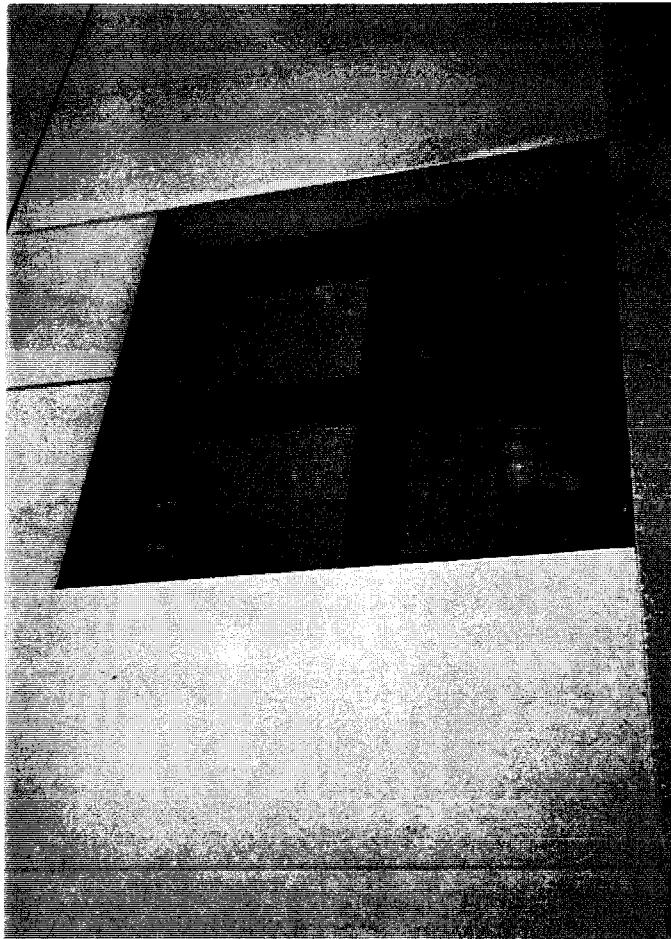
PHOTO 11. Beams, ceiling pan, portals and structural support H-5 (all metal) in the workroom (non-LBP)
