Hernando de Soto

EMERGENCY RESPONSE

I-40 Hernando de Soto Emergency Repair

Critical Actions for a Critical Find

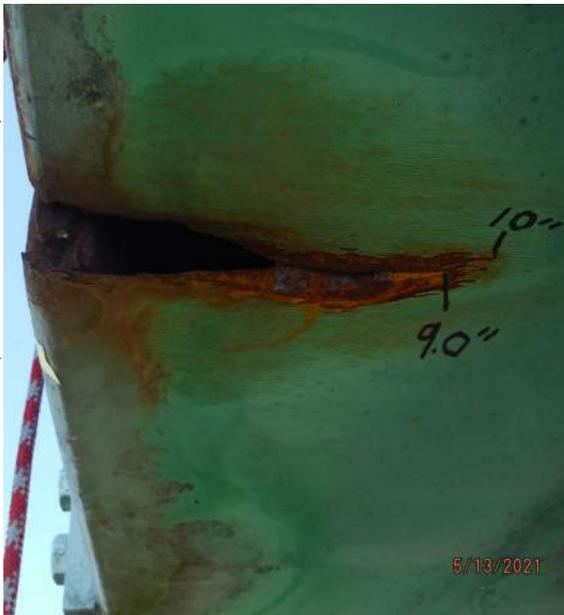
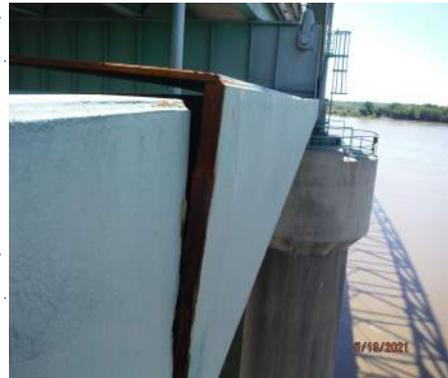
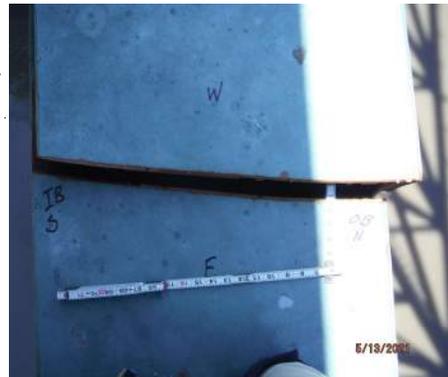
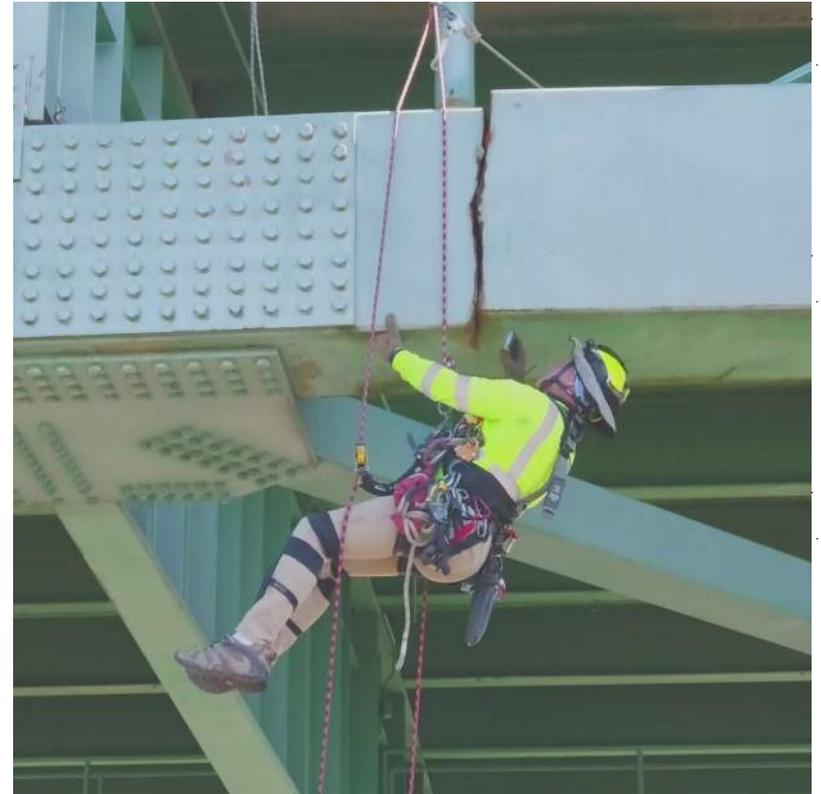
Closer Look at Fracture

- Condition
- Measurements

- T1 steel = 100 ksi (+)
 - P/A design = 38ksi
- Fracture 113 in² -> 51.5in² (**45%!**)
 - P/A after Fracture = 83ksi
- Eccentric Loading
 - Refined Analysis
- Unknowns
 - Actual force in the tie

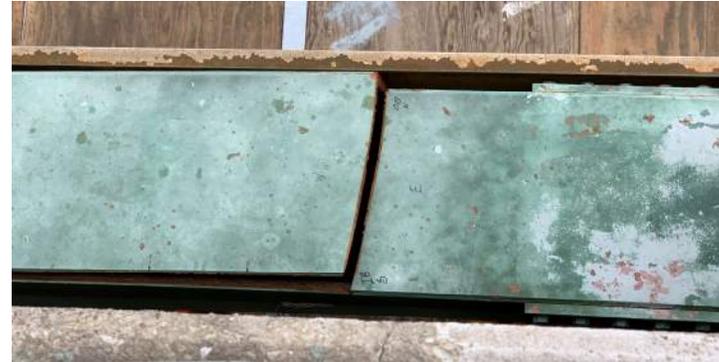
- Outboard PL placed w/ 3" of fill plates
- Cut floorbeam web for inboard plate
- Anchored beyond the girder twist
- Stiffening T's added to account for Eccentric connection moment
 - Eccentric connections highly loaded would try to crush box
 - Thin cover plates attached with poor welds

Offset Plate to clear Fracture and Ex Splice.

Stiffening Brackets

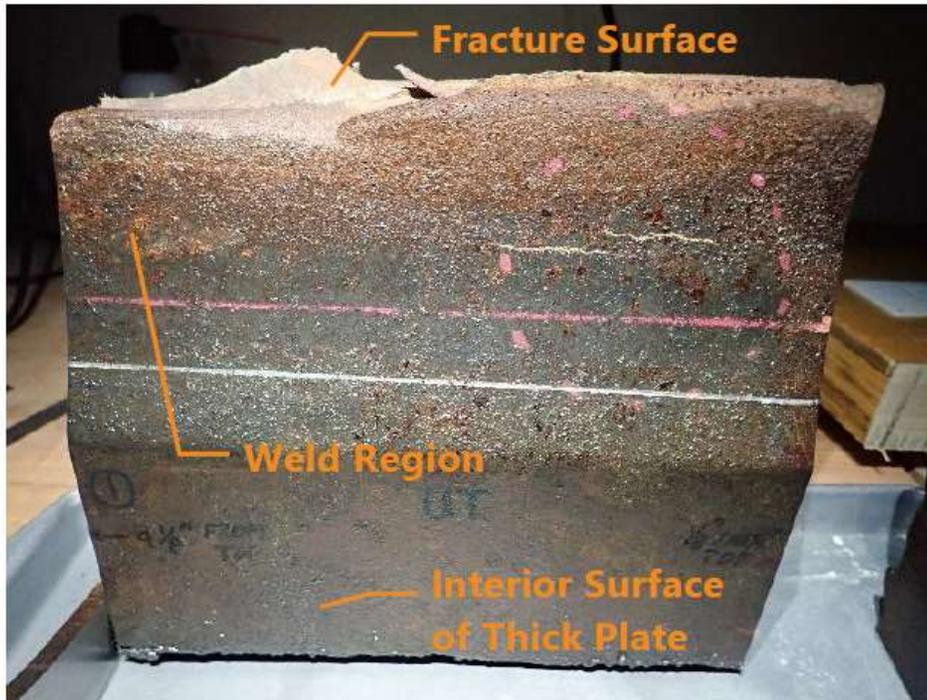
Figure 1. Sample under white light showing MT filings at crack locations.

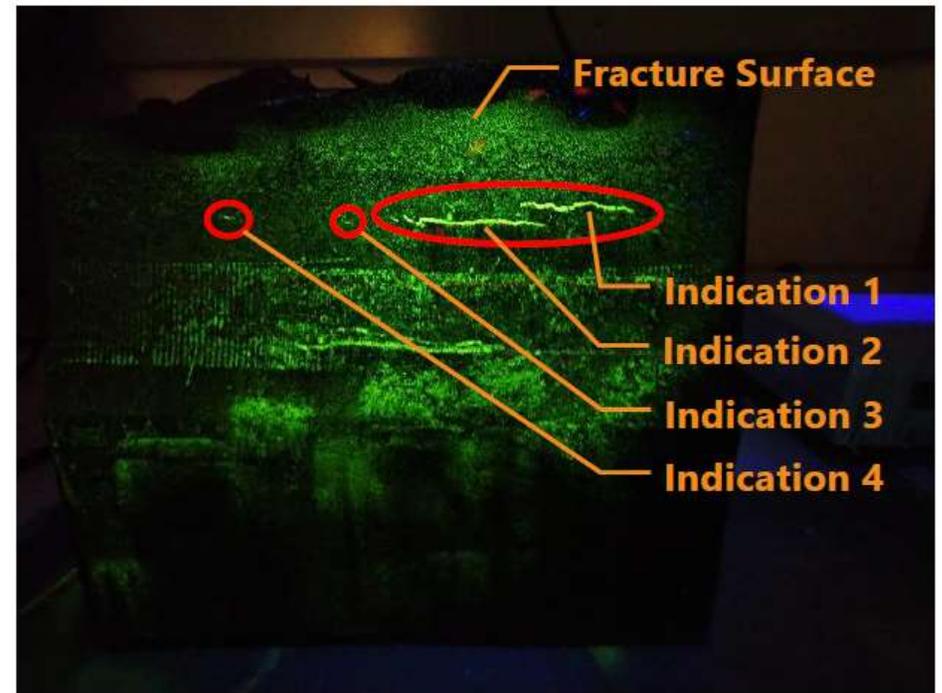
Figure 2. Sample under black light during wet fluorescent MT inspection with four MT indications (red circles)

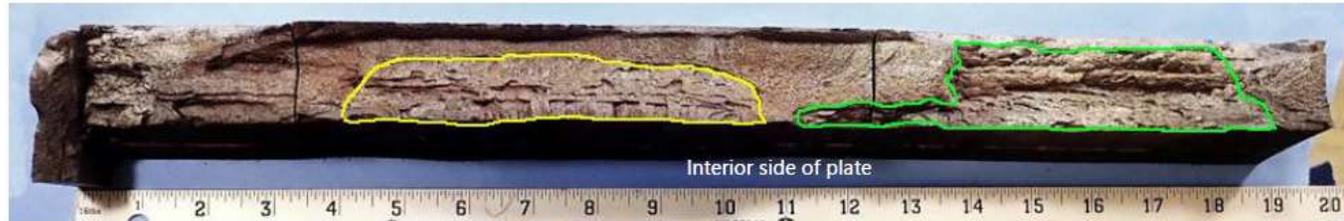
Figure 20. Lower portion of fracture showing Primary Preexisting Crack Region (yellow) and the Secondary Preexisting Crack Region (green).

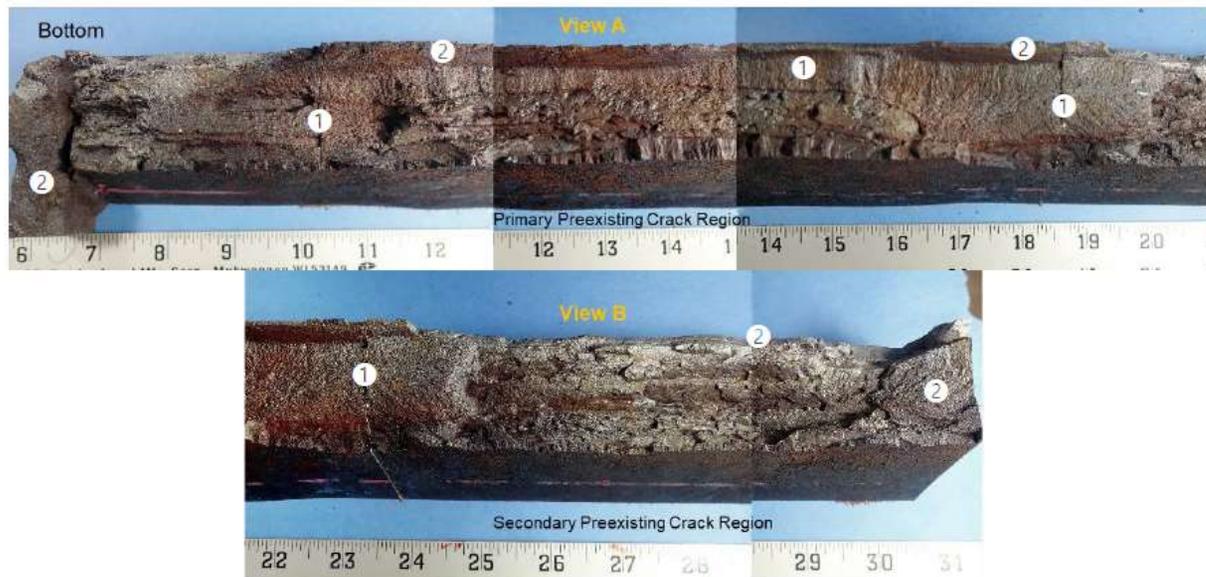
Figure 21. Higher magnification of the two preexisting crack regions after cleaning (1 first fracture and 2 second fracture).

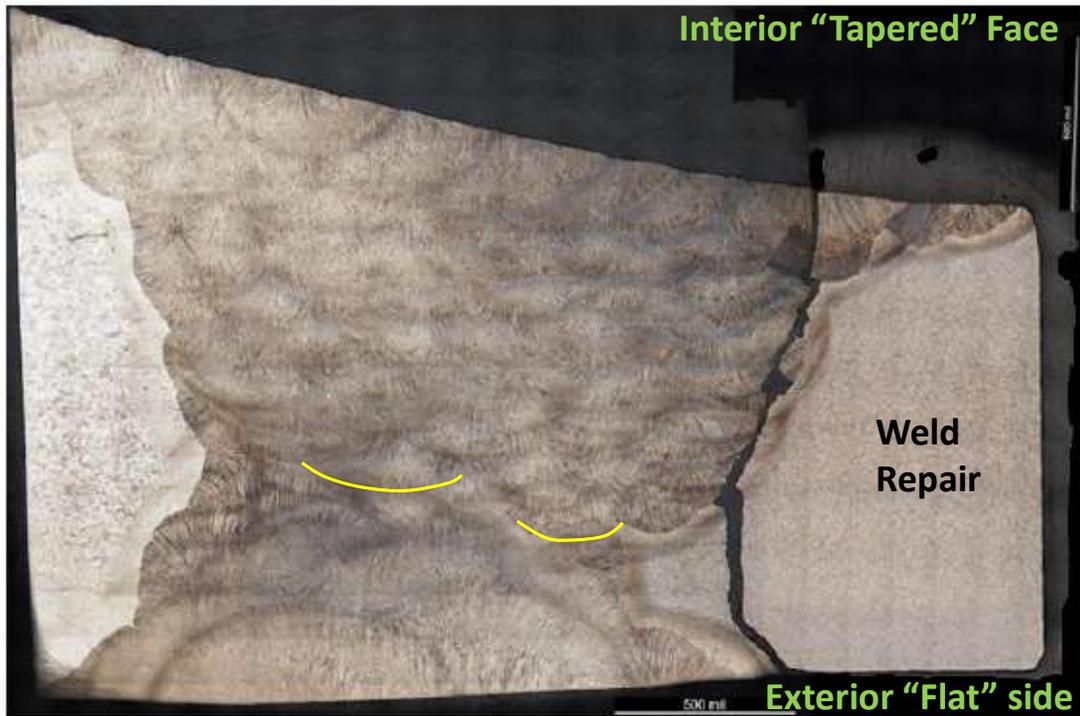
Figure 39. Primary preexisting crack weld profile.

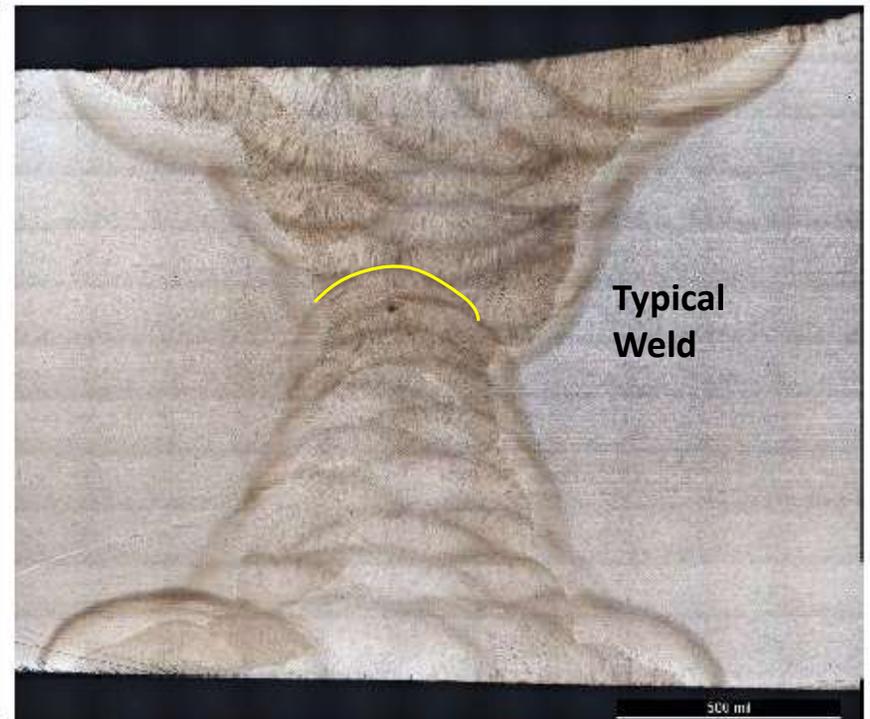
Figure 40. Core Sample SA008E weld profile.

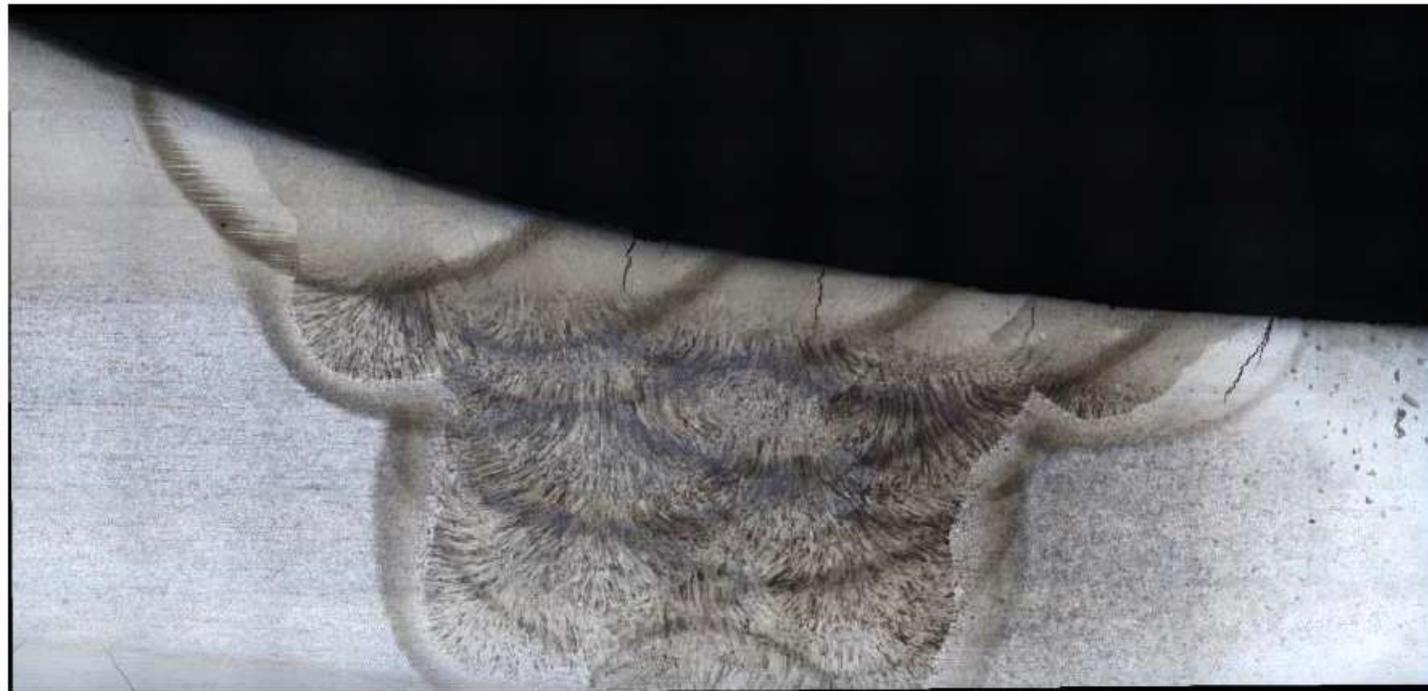
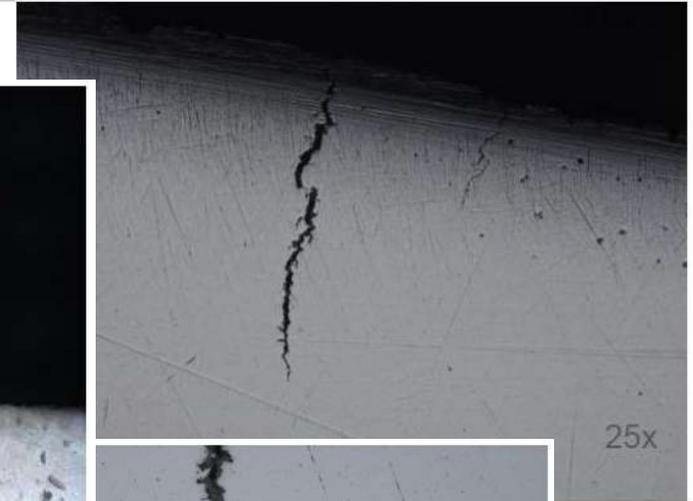
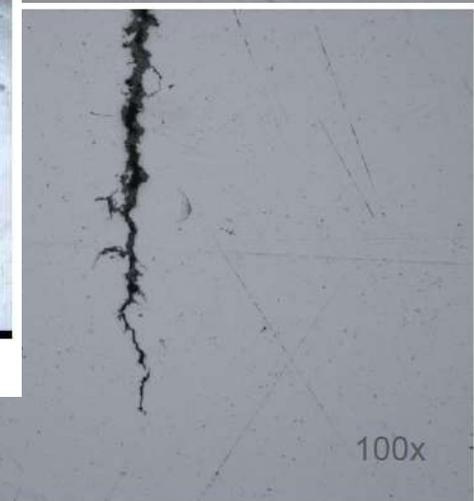
Figure 54. Cracks in the top weld passes at location SA168W

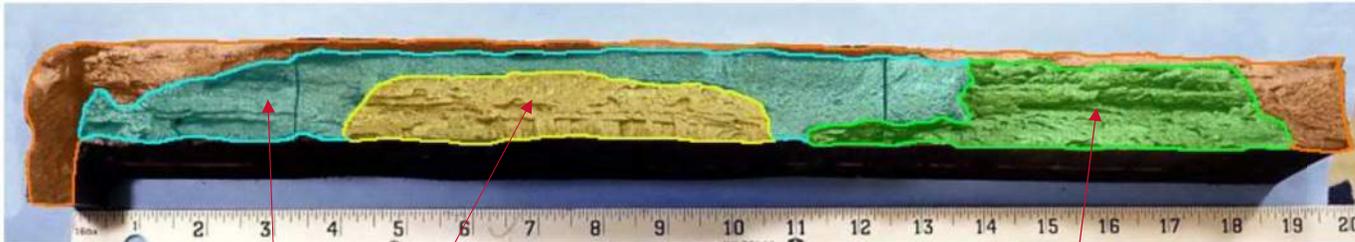
Figure 61. Lower portion of fracture, color-coded to indicate failure sequence.

Fracture Event #1

Secondary Pre-existing Crack

Primary Pre-existing Crack

Fracture Event #2

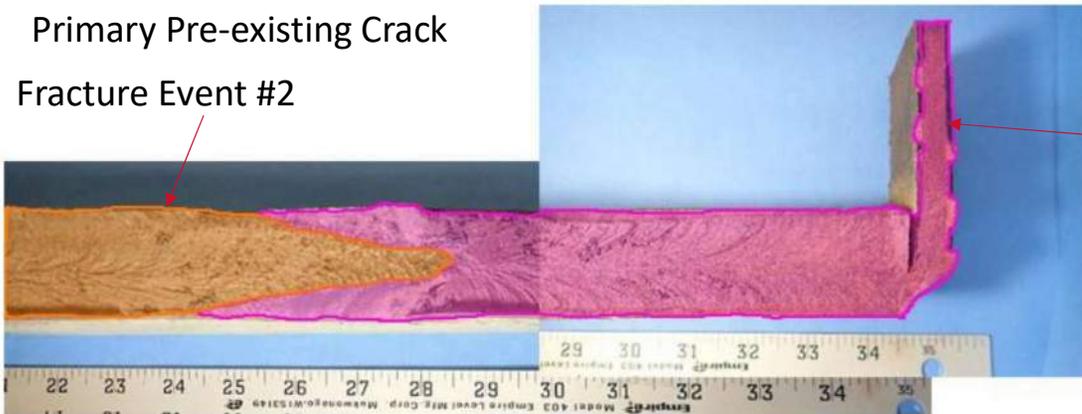
Figure 62. Upper portion of fracture, color-coded to indicate failure sequence.

Fracture Event #3
