Nighthawk **Imaging Services**

Demo Report

RE: Demo Report

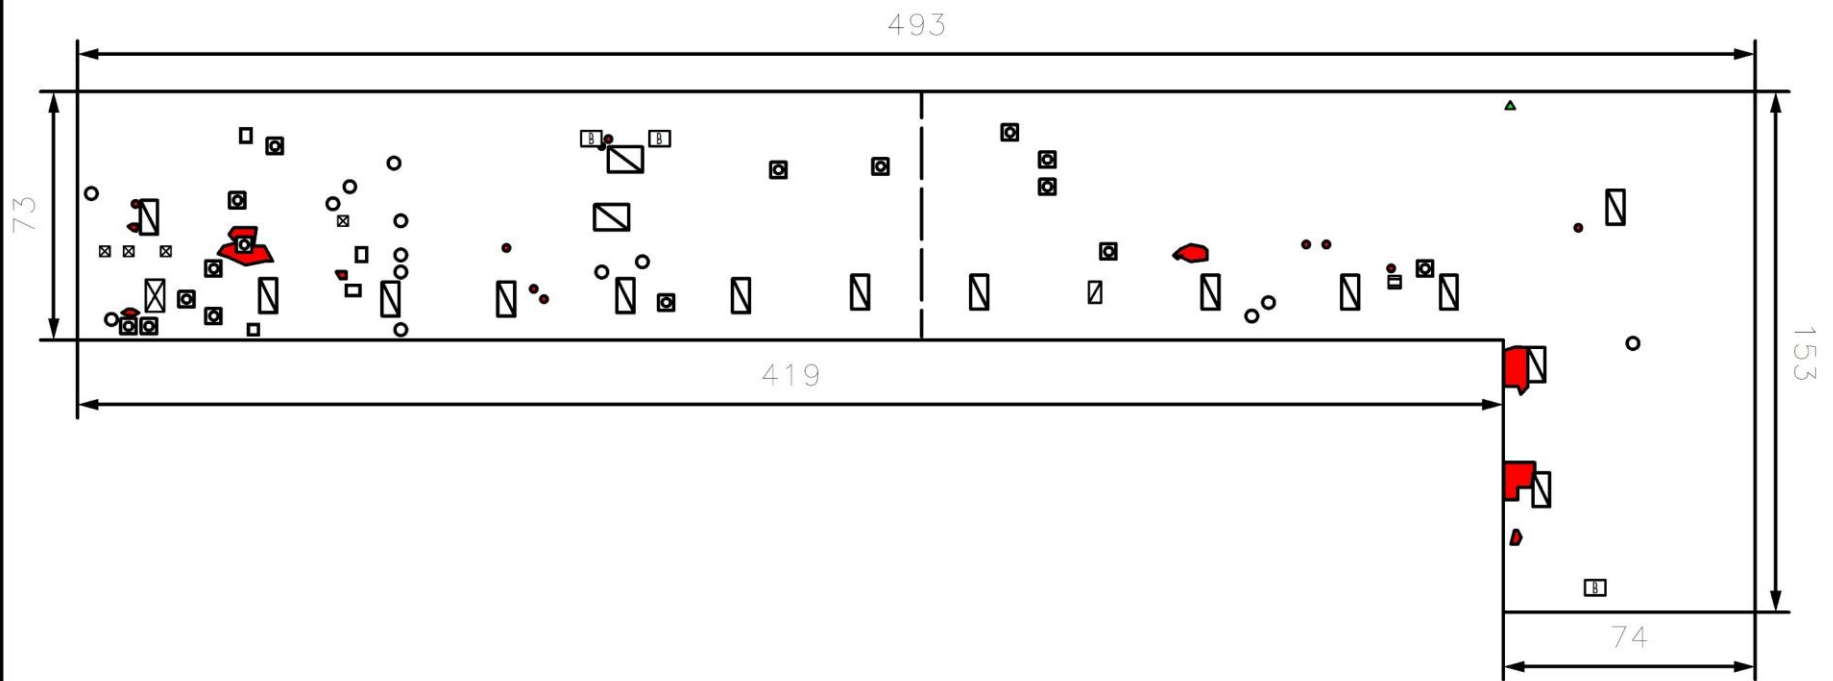
We found 18 wet areas across the roof. These were small to medium sized wet areas and totaled 351 Sq. Ft. The total square footage of the roof area inspected was approximately 41,909 sq. ft. We have documented our inspection of the facility by taking both infrared and visual photos of several regions of the roof which are included in the report. Drawings have been created to show the location and extent of the moisture infiltration into the roof system. There were several areas of moisture infiltration along the western edge of the building near some of the exhaust fan curbs, as well as one area on the eastern side of the roof.

We found that under 1% of the roof area (351 Sq. Ft.) had water infiltration. While there is relatively little water inside of the roof, The mod bit cap sheet is aged and is starting to blister in many areas across the surface of the roof. These areas could be prone to leaks, especially if there is heavy foot traffic.
