Historic Building Assessment for the Littleton Community Center Annex

120 Main Street, Littleton, New Hampshire

January 2020

Historic Building Assessment Report Funded in part by a grant from the
New Hampshire Land & Community Heritage Investment Program (LCHIP)

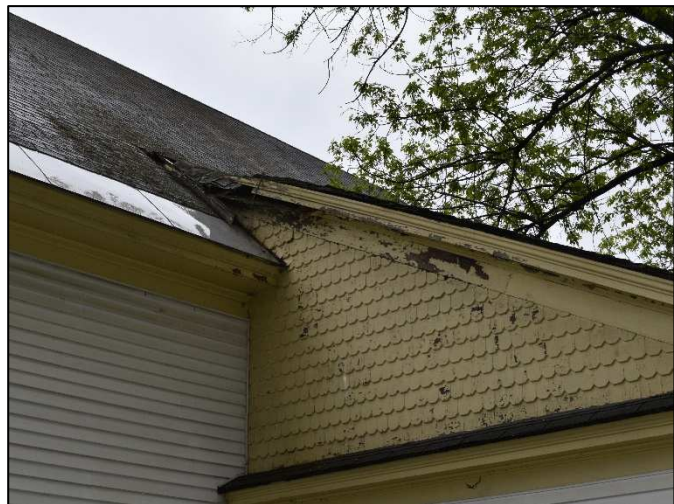
Figure III-1: Damage to roof at north side of building

intersection of the main section of the building and cow shed projection to the north (Figure III-1). The roof at this area is out of plane, and some of the underlying structure is in visible failure, with sections of the wood completely rotted away.

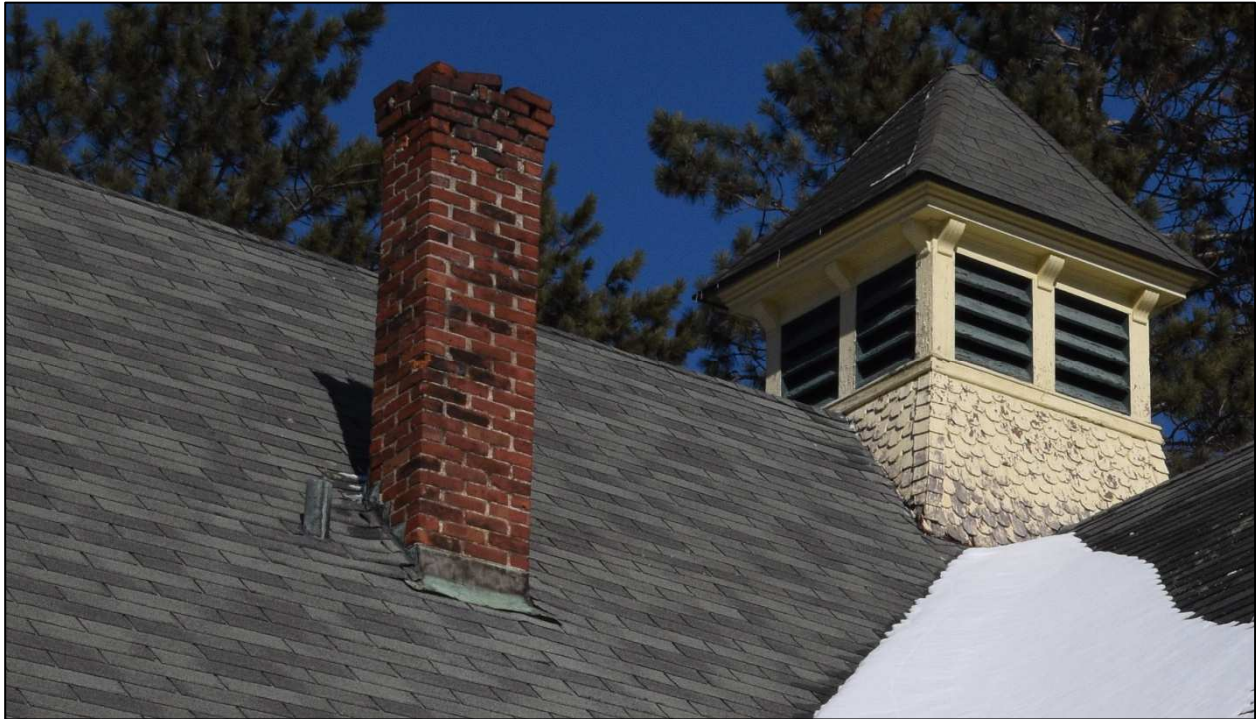
The chimney is in fair condition. Much of the mortar is worn and chipped, and the cap is in desperate need of repointing. The flashing at the base of the chimney may be loose (Figure III-2).

Figure III-2: Mortar deterioration at chimney

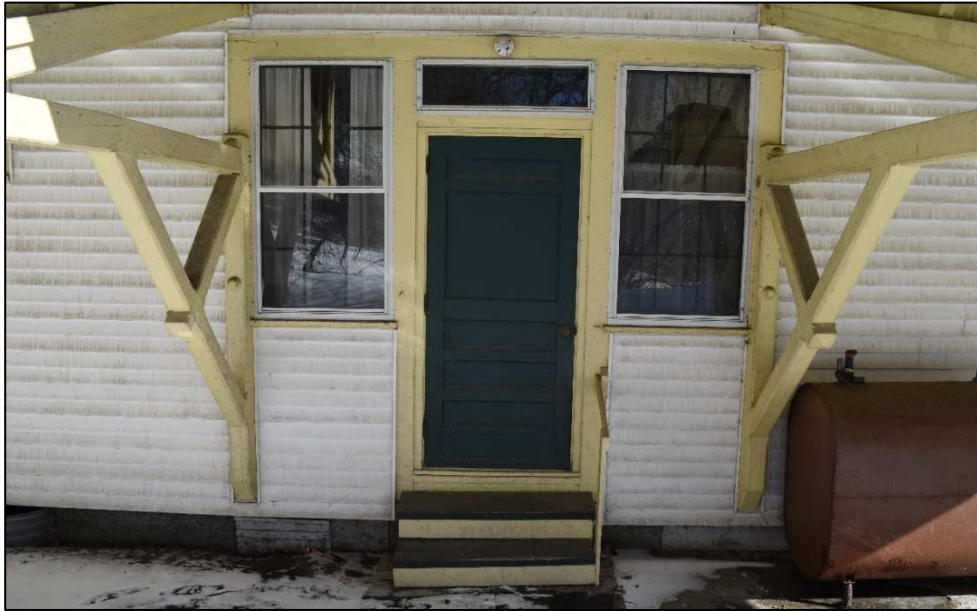
The walls of the first-floor of the Annex are sheathed in vinyl siding, which overlays the historic clapboards. The vinyl is quite dirty (Figure III-3). It is very difficult to properly assess the historic siding beneath using non-invasive techniques. The shingles of the gable ends are in generally good condition, as is the visible wooden trim of the building exterior. The lower courses of shingles at the ventilator are visibly discolored, and much of the exposed woodwork has failing paint. The windows are in generally good condition, with some locations with cracked and/or missing glazing. Only some of the building windows have exterior storms, and the windows do not appear to be well weather-stripped. A full window-inspection was not performed as part of this study.

Figure III-3: West door, showing dirty vinyl siding

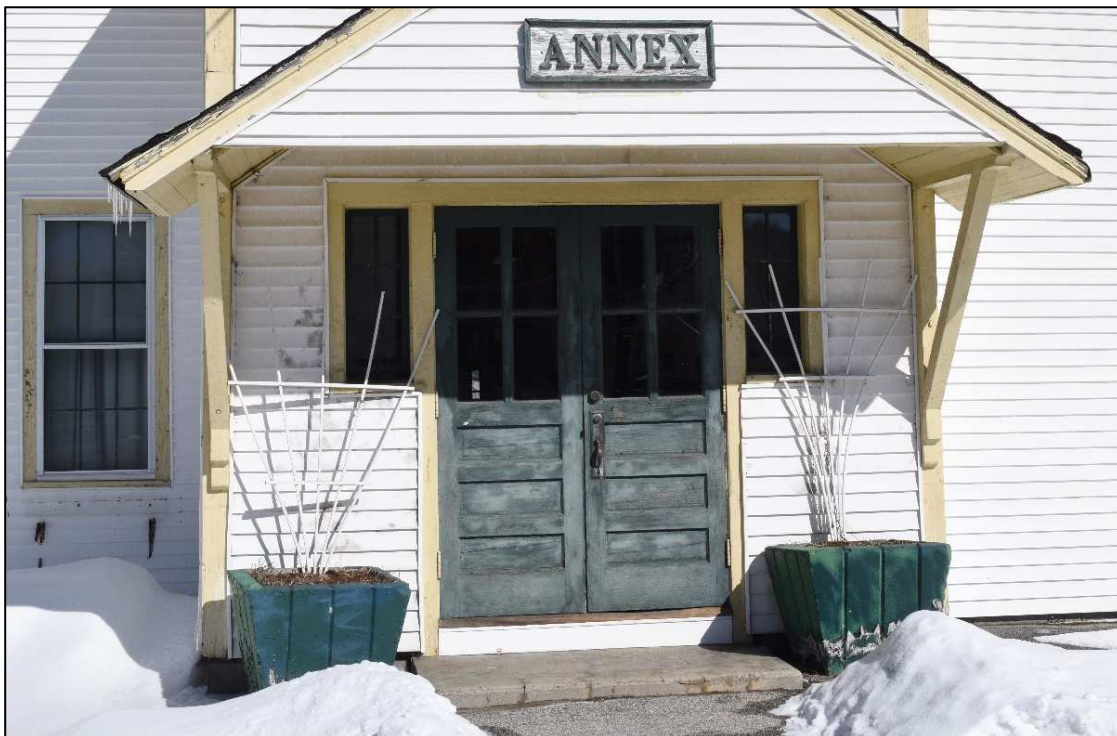
The primary entrance to the Annex is not in compliance with modern accessibility codes (Figure III-4). There is a step up from the adjacent parking area, and a threshold at the base of the door. The paired doors themselves are in fair condition, with excessively peeling paint. The historic thumb-latch door handle does not meet accessibility code.

Figure III-4: Non-ADA-compliant primary entry

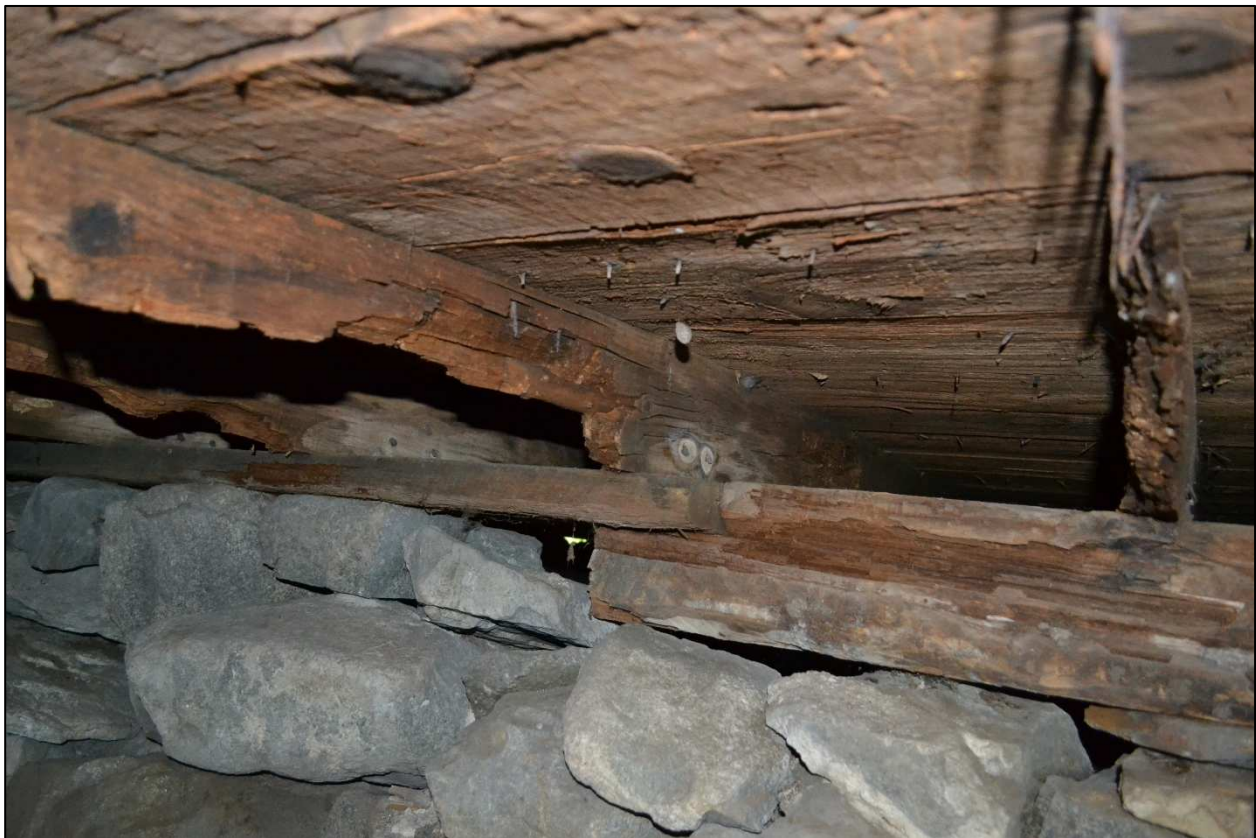
There are notable structural issues at the ground floor of the Annex, as identified in 2011 and 2013 by Jeffrey Tirey, P. E. (Appendix C). Because of over 100 years of water infiltration, much of the underlying structure of the building has disintegrated. Excessive moisture in the crawl-space beneath the building has completely eroded many of the underlying timbers (Figure III-5). Standing water, in the form of ice, was observed in the cut-out floor of the under-stair closet at the time of one of the site visits. The floor that has resulted from all of this water is uneven and “spongy” in many areas, due to extensive rot of the first-floor framing. Many of the interior load-bearing beams have rotted to such an extent to have lost more than 50% of their depth. The perimeter wood sills of the building are also rotted, as is the lower portion of the exterior wall studs bearing on the sills. The condition of the flooring system is what caused the Community Center to close the building in 2011, after Mr. Tirey deemed that it is structurally unsound. In ca. 2011, a large hole was cut in the floor of the “Frontier Room” at the rear of the building in order to easily assess the floor framing, and this hole remains open, further contributing to the unsafe nature of the floor.

Figure III-5: Rotten floor system beneath Annex (Photograph by James L. Garvin)

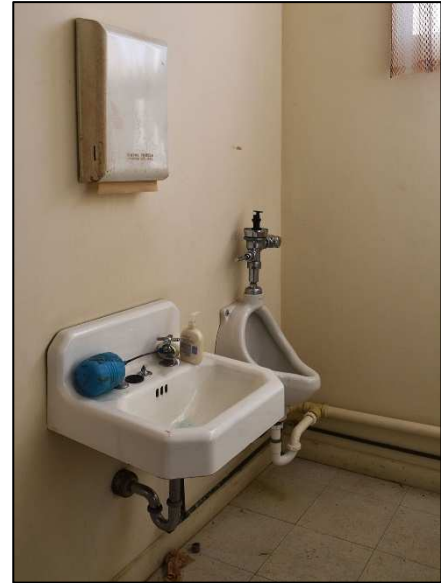
Figure III-6: Restroom fixtures

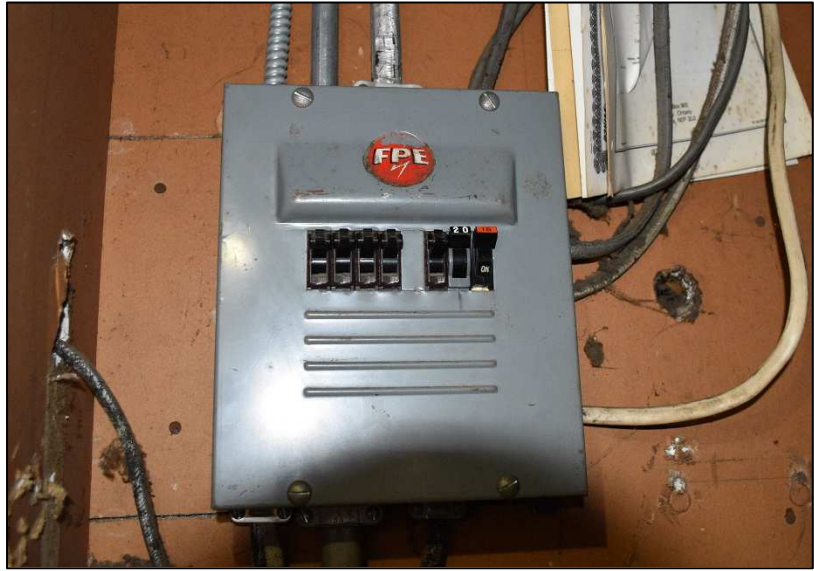
The electrical panel for the building is also located in the mechanical room (figure III-9). The early circuit breaker panel appears to date to the late 1950s or early 1960s, and was likely installed as part of the Teen Town renovations to the building. Most of the wiring throughout the building is mid-20th century woven wire, although a couple of circuits appear to be modern Romex. Given the full extent of work planned to save the building, and the probable age of the existing electrical system, the existing electrical

Figure III-9: Electrical panel

system will need to be replaced to be made compliant with the current State electrical code.

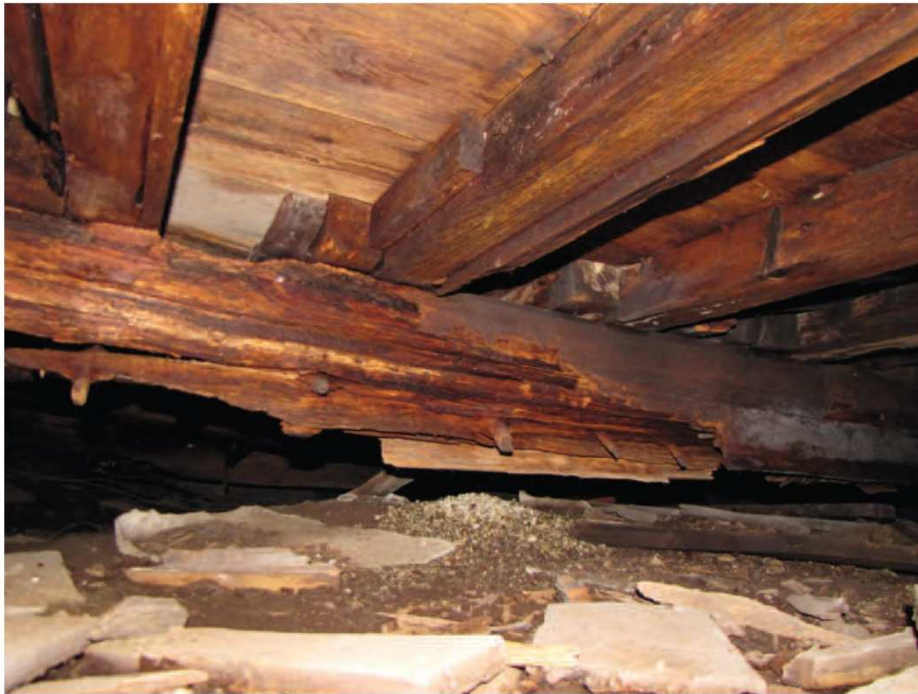
Photo 01: The northerly first floor beam in west section of the building showing it's rotted condition and loss of wood, making this beam unsafe.

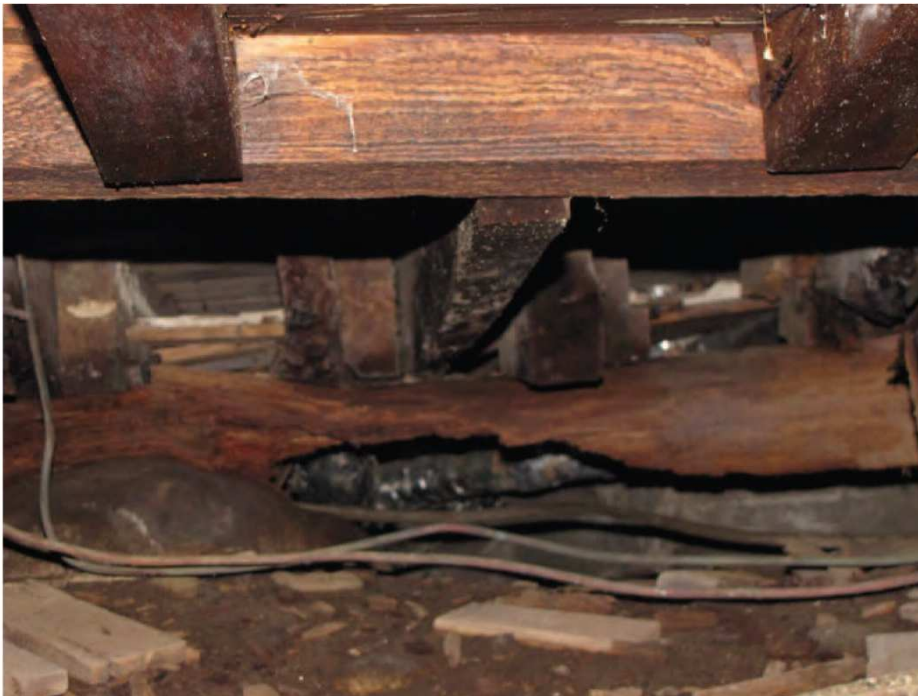
Photo 07: The southerly first floor beam in west section of the building, showing it's loss of cross-sectional depth and rotted condition, making this beam unsafe.
