EXAMPLE
ENGINE/COMPONENT SUMMARY REPORT

Unit: PW530A

Serial No: DA0000

Reason for removal: Scheduled Overhaul

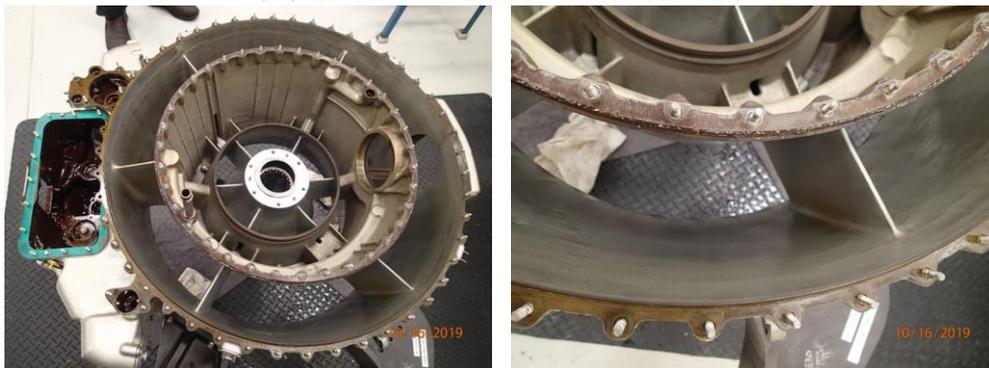
1.2 IC Case noted as normal for time-x condition with minor corrosion on flanges

IC Case front face clean minor corrosion

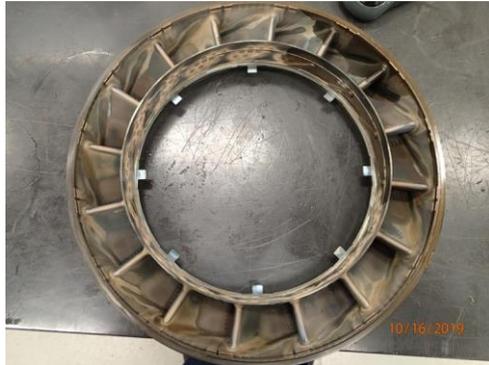
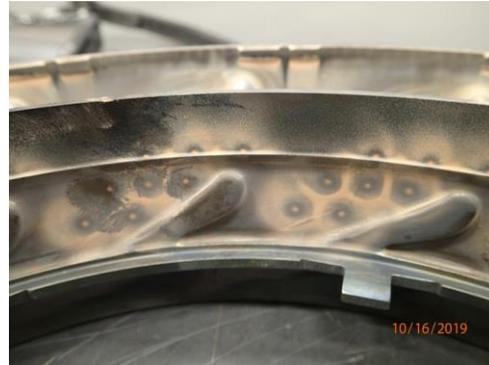
1.3 HPT Stator Vane Assy exhibited no obvious defects, the part will be processed through NDT for further review

HPT Stator no obvious defects noted

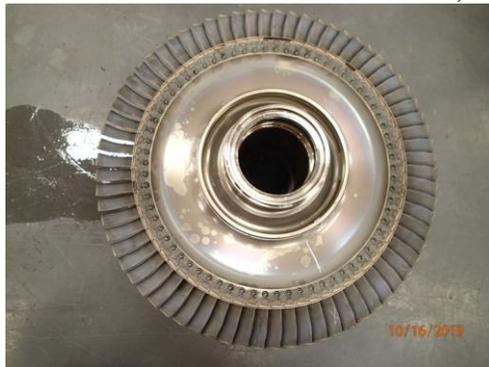
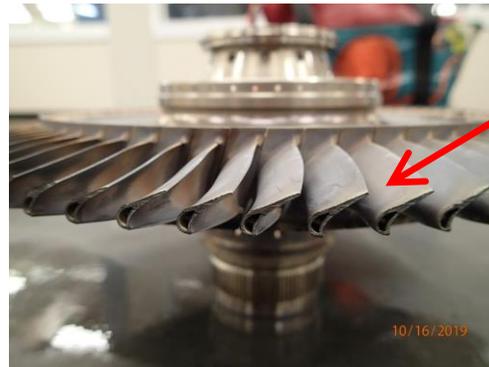
1.4 HPT Blades exhibited heavier than normal tip rub and heat erosion

1.4.1 This is normally associated with blade growth and puts the blades at high risk of being out side of growth limits of 0.006”

HPT Blades, tip erosion and rub

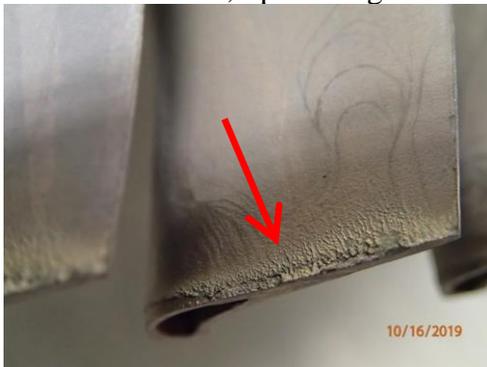
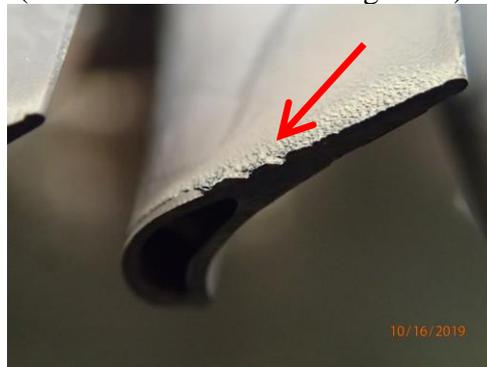
HPT Blades, tip burning due to rub (blades to be measured for growth)

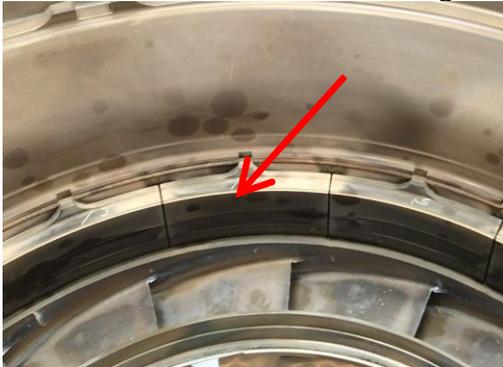
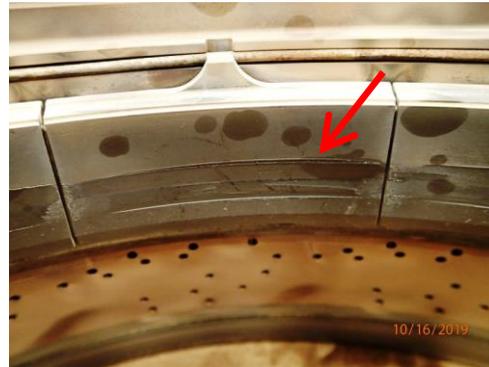
1.5 HPT Shroud Segments exhibited blade rub with metal transfer

1.5.1 Usually noted from HPT Blade growth

HPT Shroud Segment rub with metal transfer

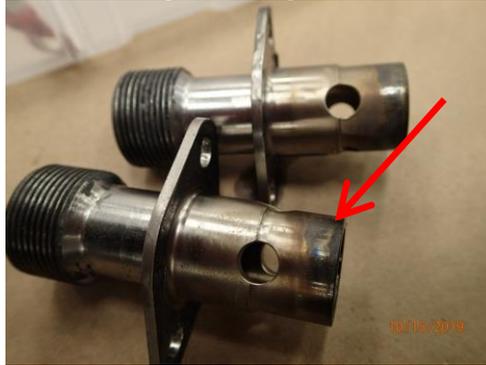
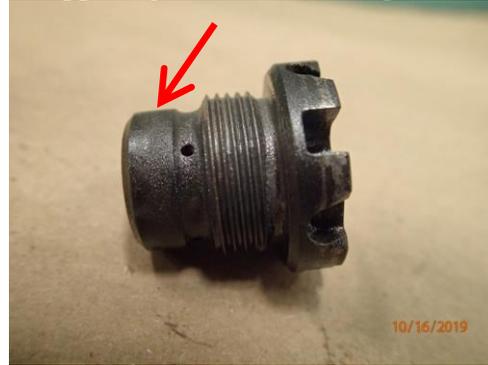
Fretting/Chaffing wear on CC Liner support igniter sleeves and pin

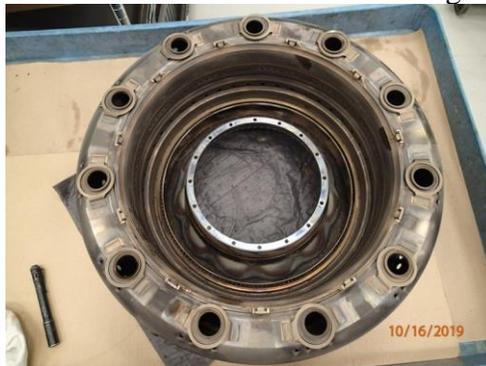
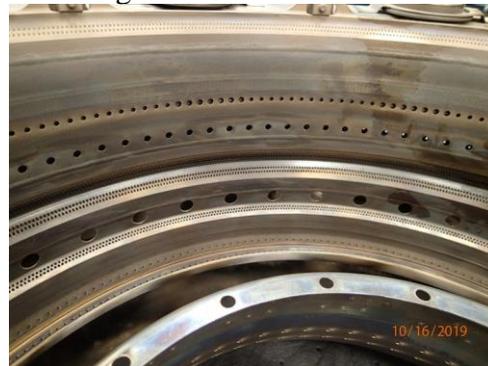
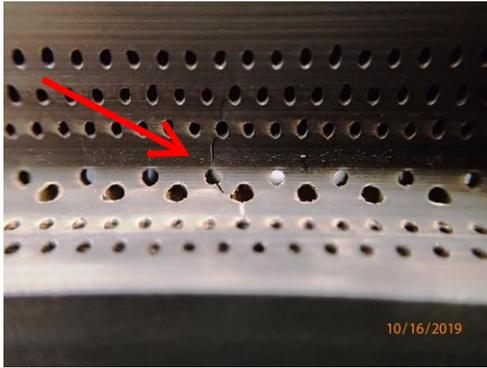
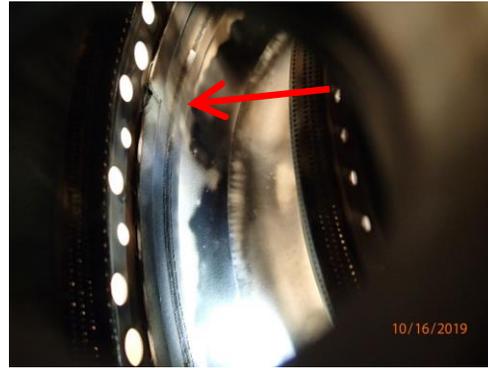
CC Liner Noted cooling hole cracking and heat erosion

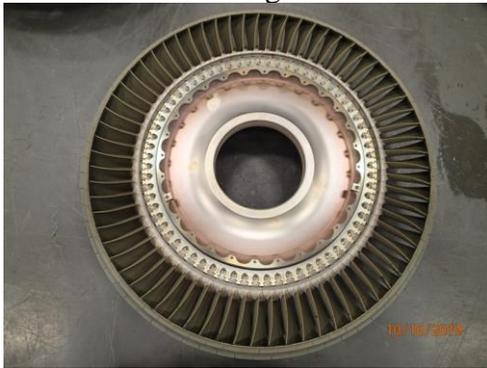
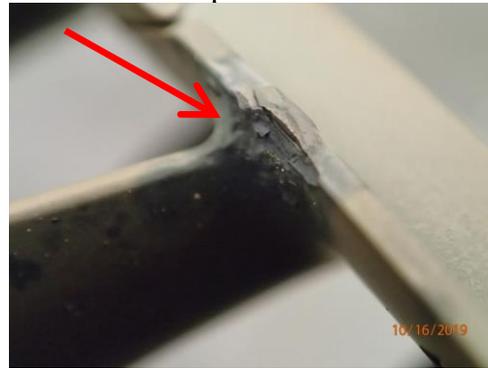
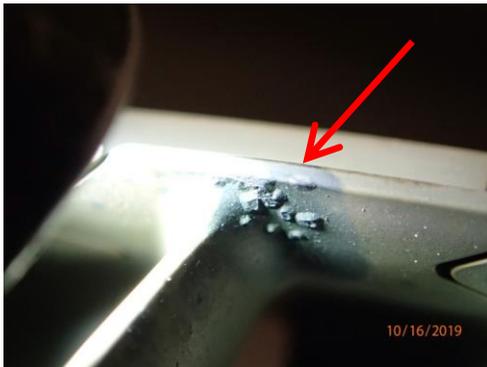
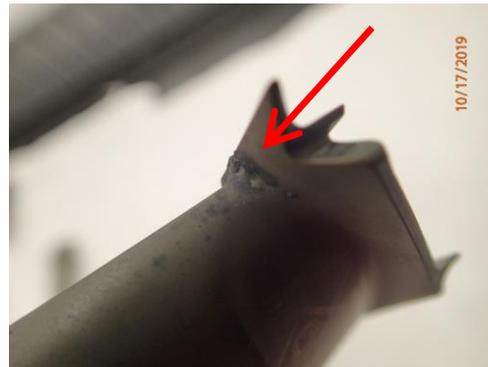
2nd Stage Low Pressure Turbine Blade Sulphidation

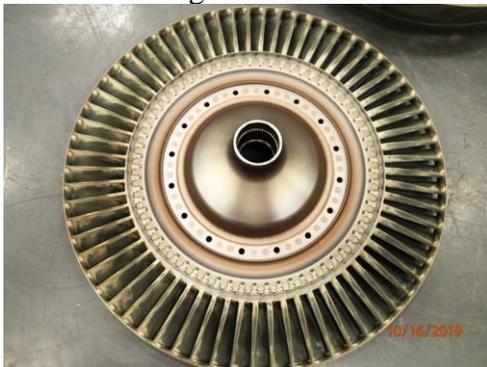
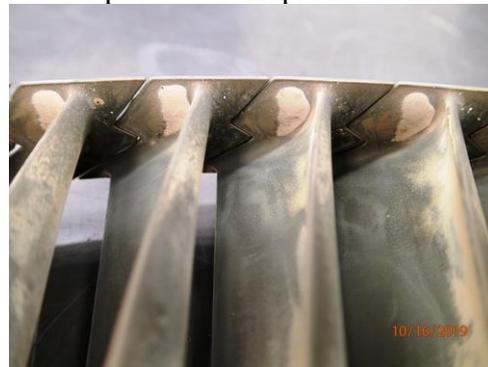
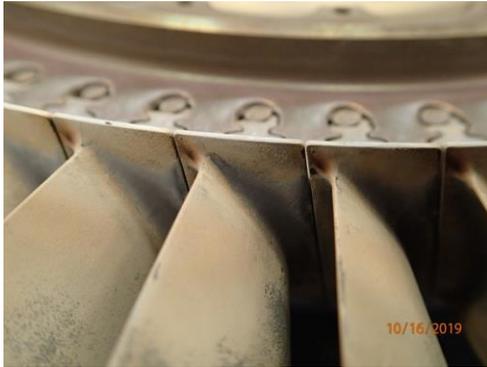
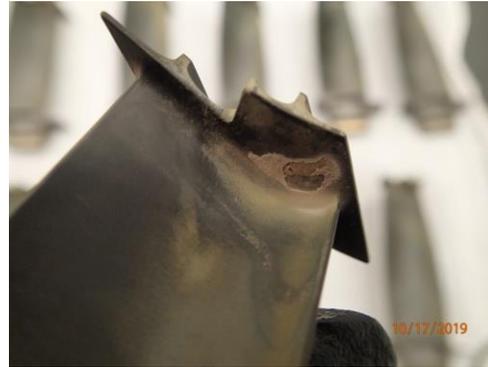
3rd Stage Low Pressure Turbine Blades pockets of sulphidation

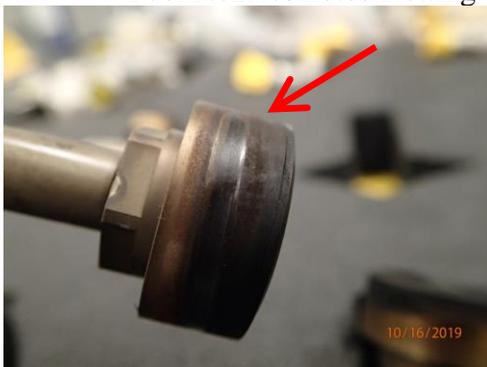
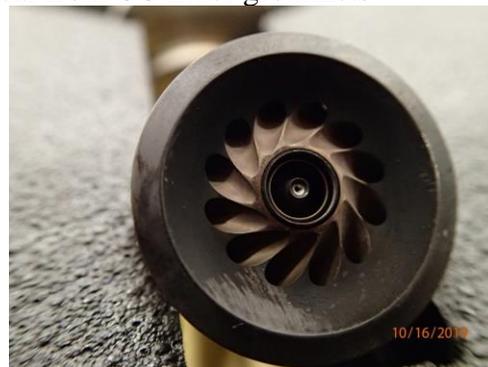
Fuel Nozzles noted fretting wear from CC Liner grommets

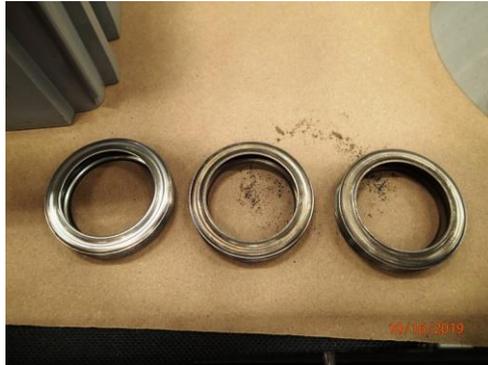
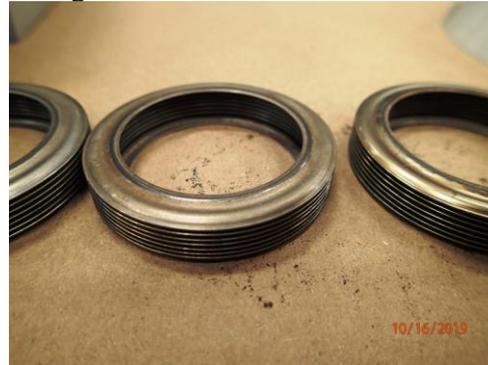
Bellows Tube with noted fretting wear on seal faces

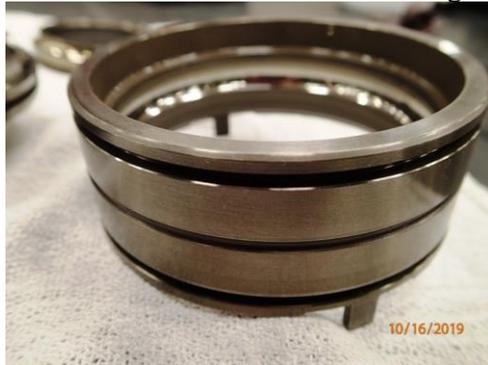
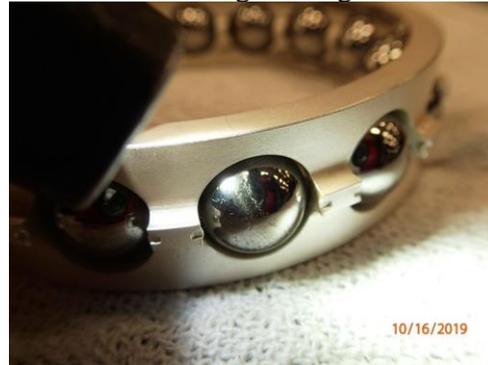
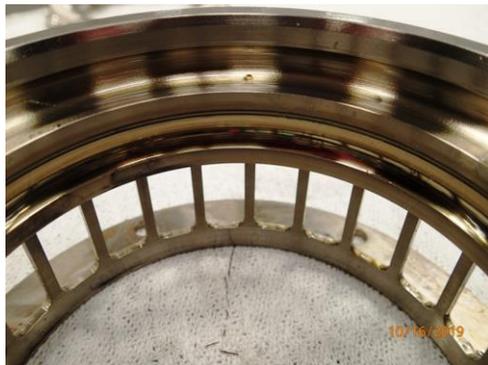
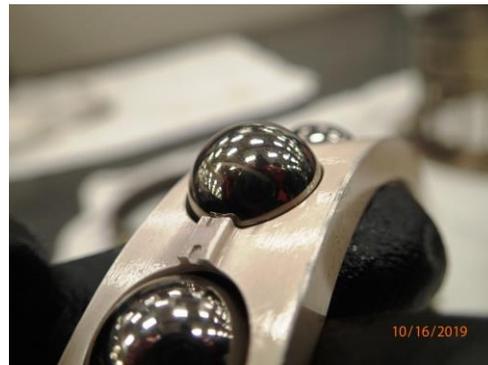
Mainline Thrust Bearings exhibited ball bearing scoring

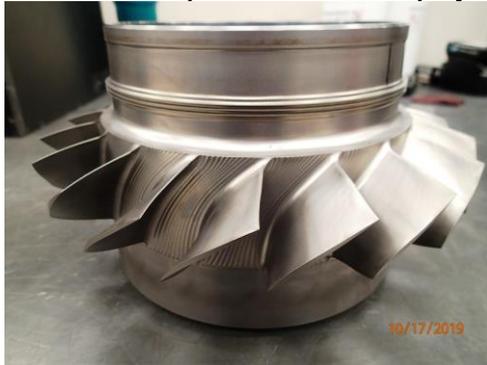
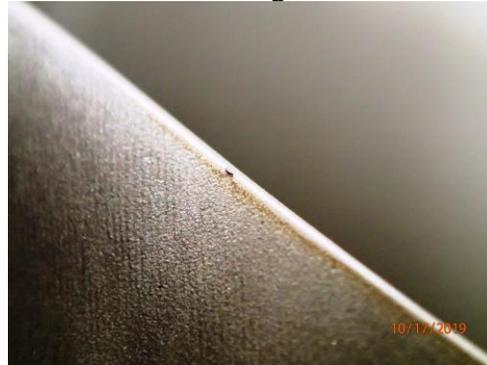
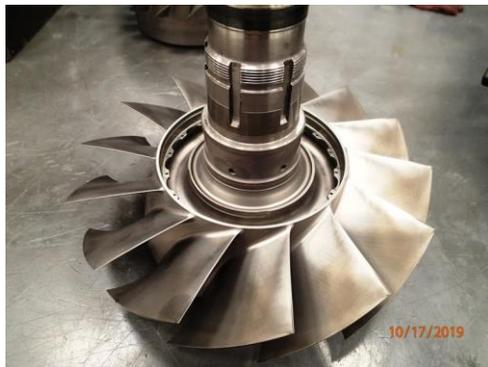
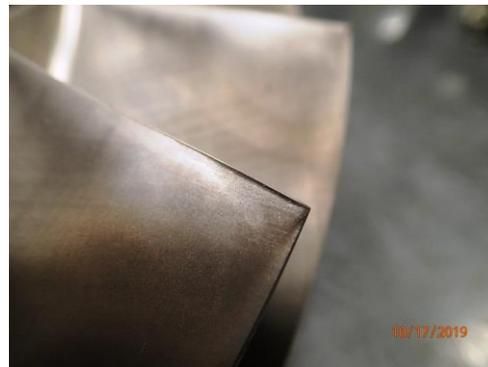
Compressor Rotors displayed normal erosion and light nicks

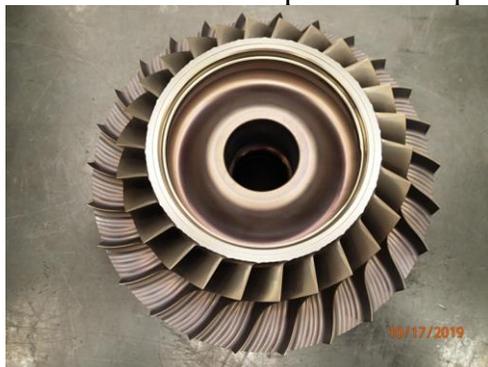
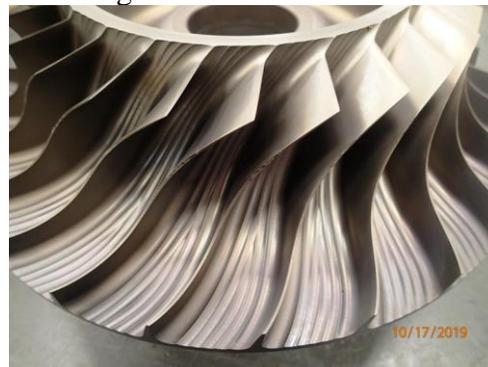
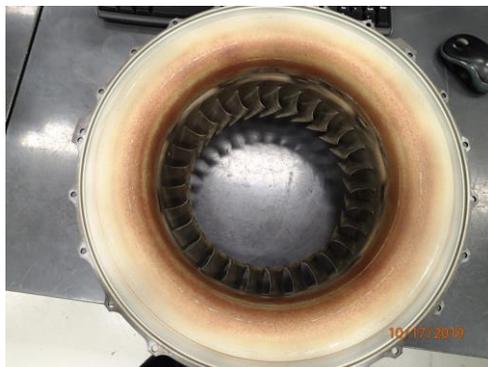
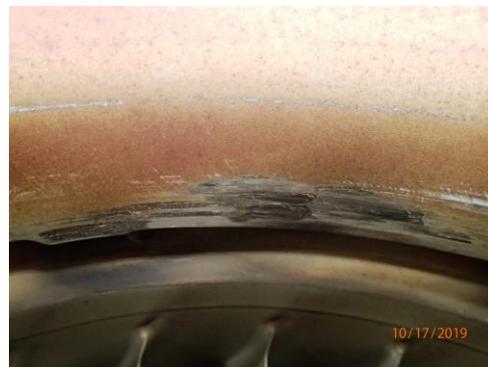
Impeller and Impeller Housing Note rub
