Report No: Sample

**SAMPLE
ENGINE/LOGBOOK REVIEW**

Unit: PW530A Serial No: PCE-DA0000

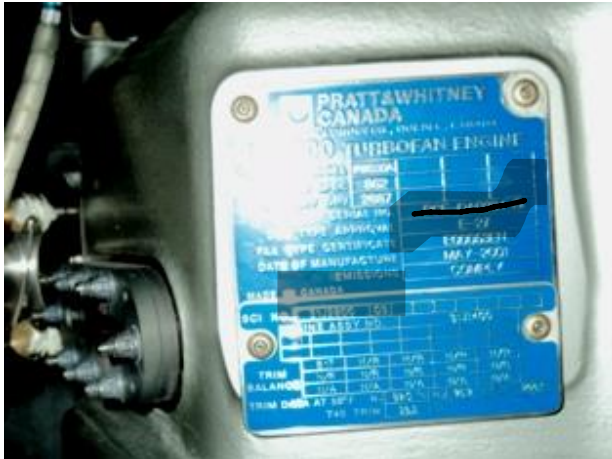
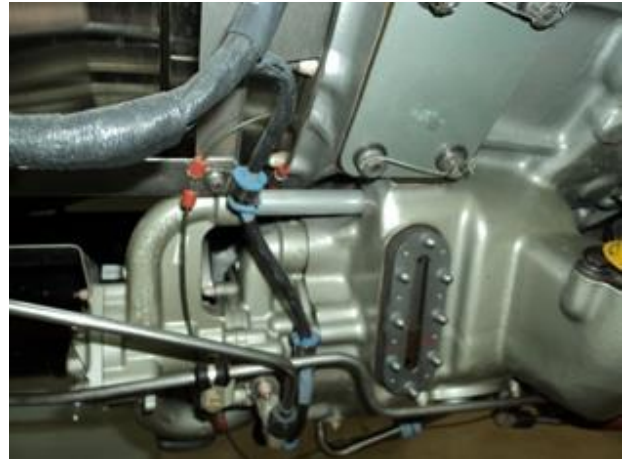
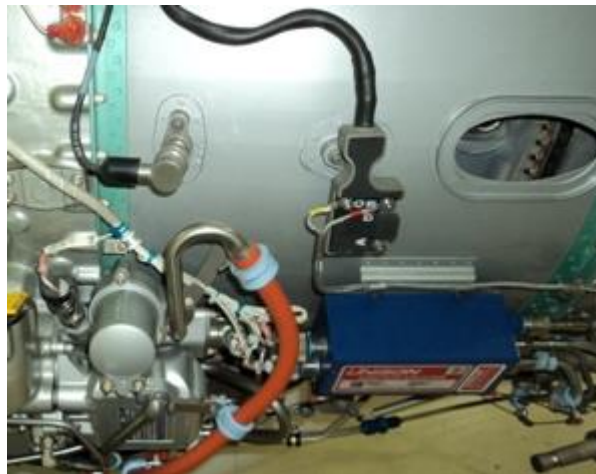
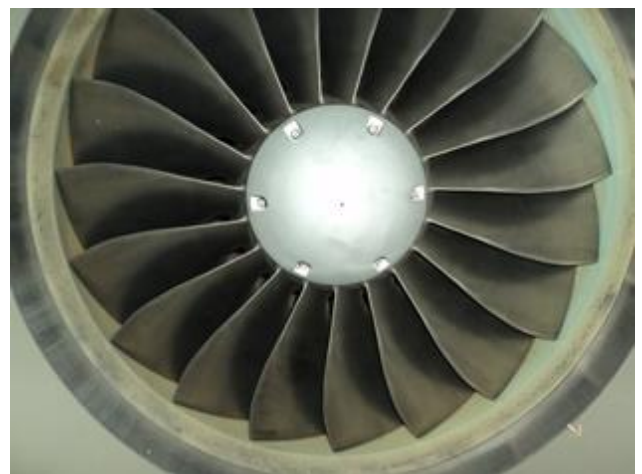
External Engine Views

4.2.1 It was noted that the engine exhibited no external protective coating loss.

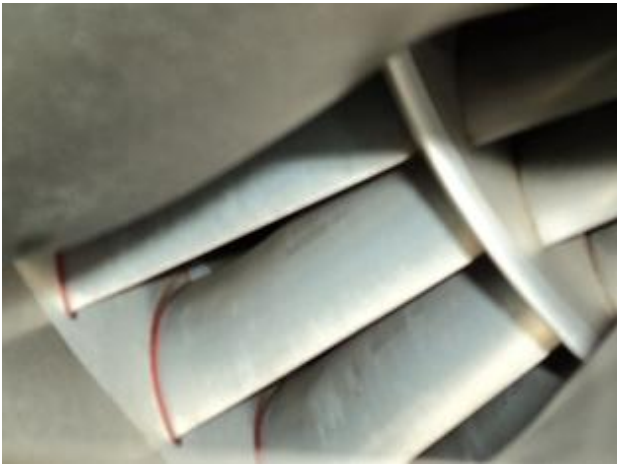
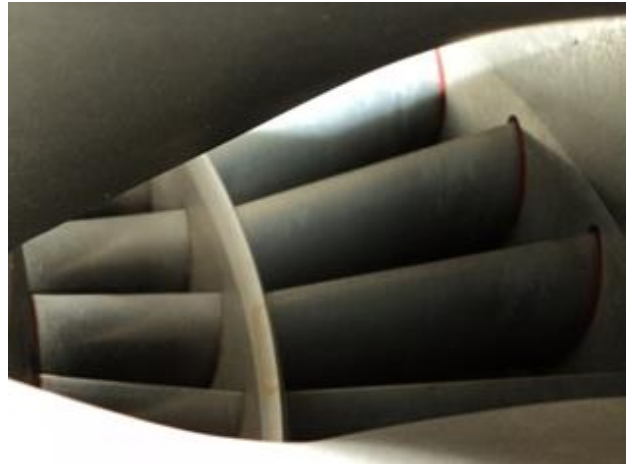
Inlet Compressor Stator Assembly

3.10 The Fan Compressor Stator exhibited minor leading-edge erosion with no obvious corrosion noted.

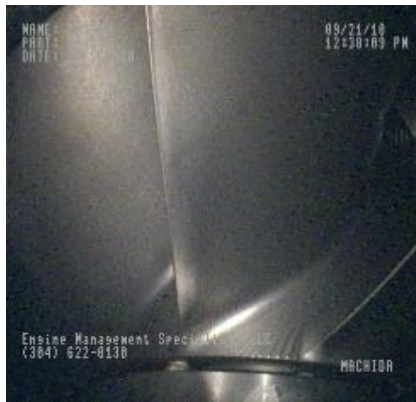
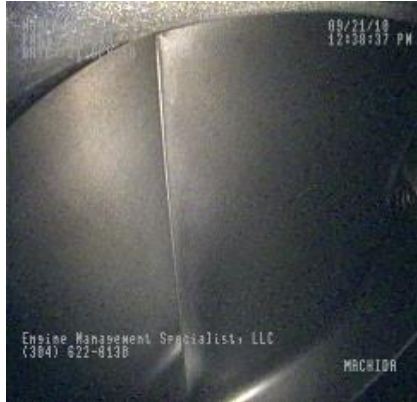
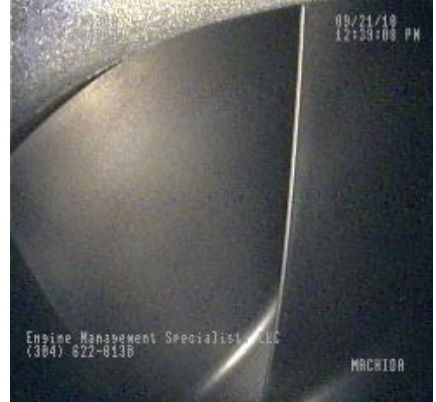
High Pressure Compressor Inlet

4.3.5 The High Pressure Compressor area is noted as clean with no obvious defects.

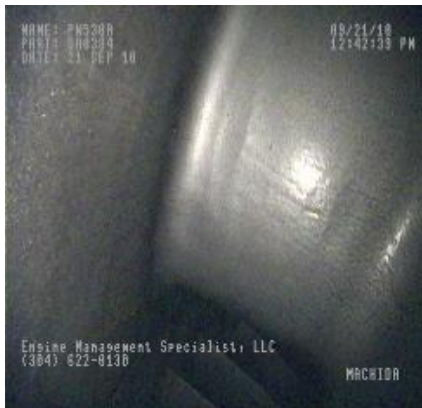
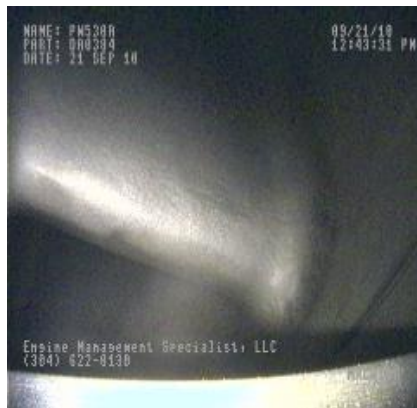
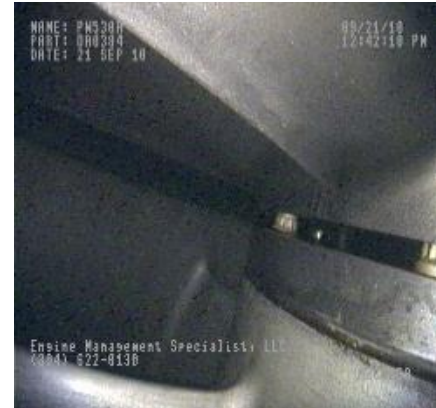
Inlet Compressor Case Area

4.3.6 IC Case internal housing condition was clean with no corrosion or heavy erosion being noted.

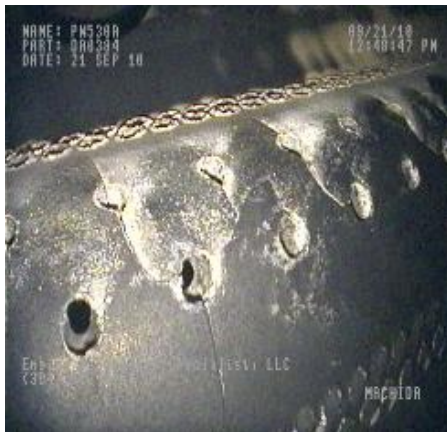
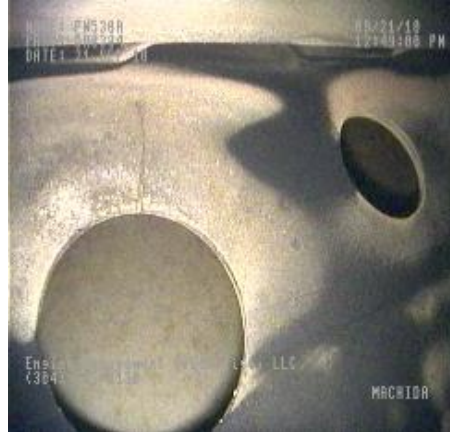
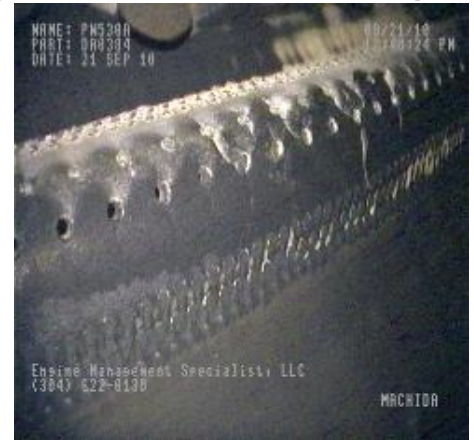
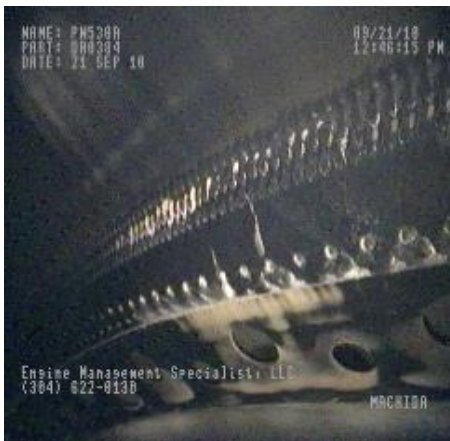
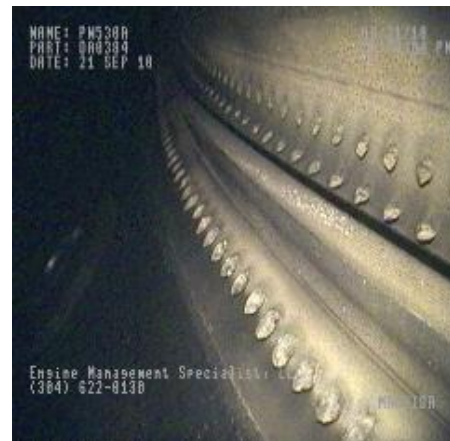
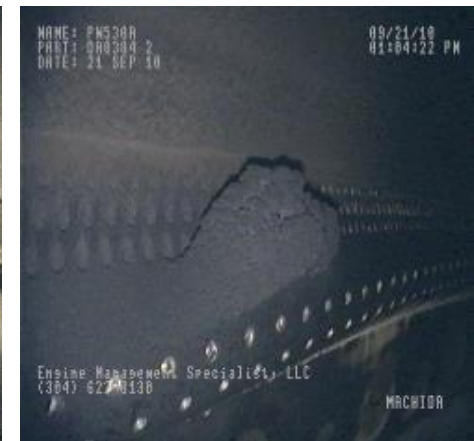
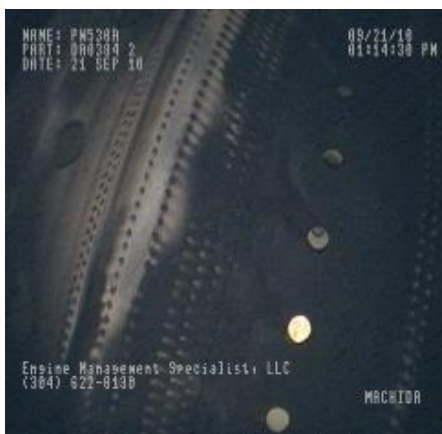
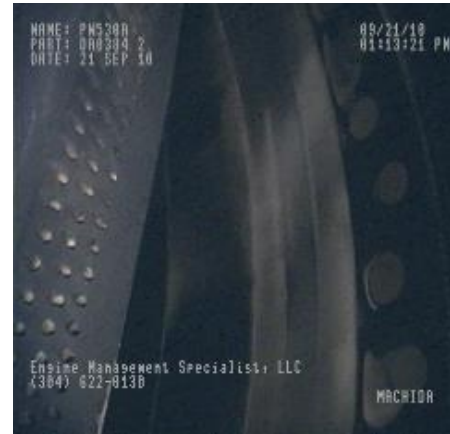
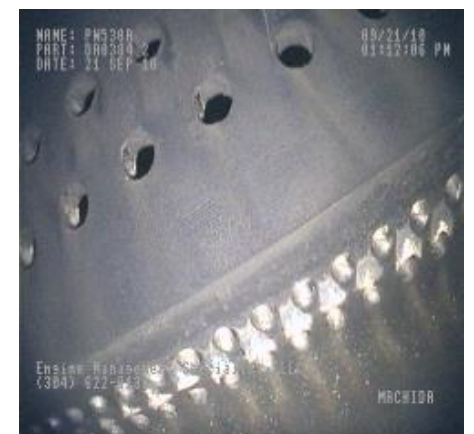
4.3.2 CC Liner exhibited heat distress.

CC Liner Area (Note heat distress, cracking and carbon buildup)

4.3.2.1 The CC Liner will require extensive rework during up coming overhaul event and has a risk of being unrepairable.

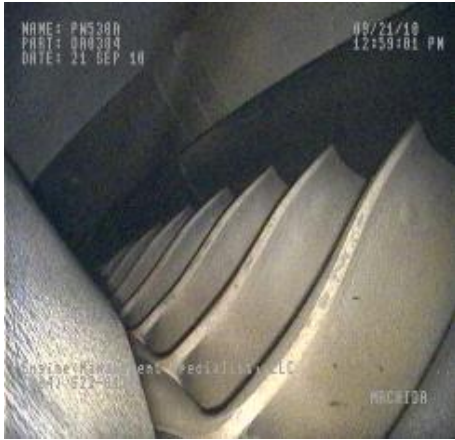
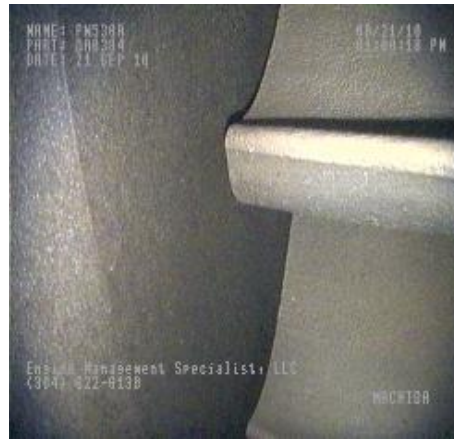
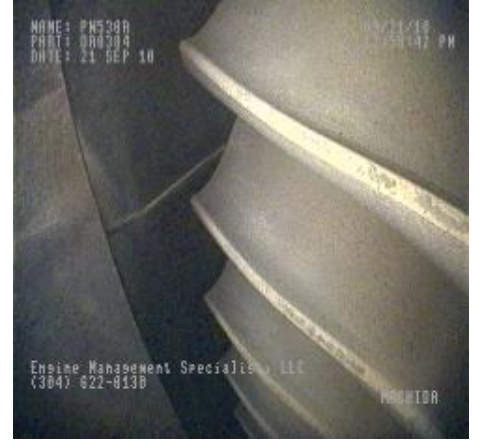
HP Blade Turbine Area

4.3.1 HP Blade normal erosion.

4.3.1.1 The HP Blades visual borescope inspection should be considered clean.

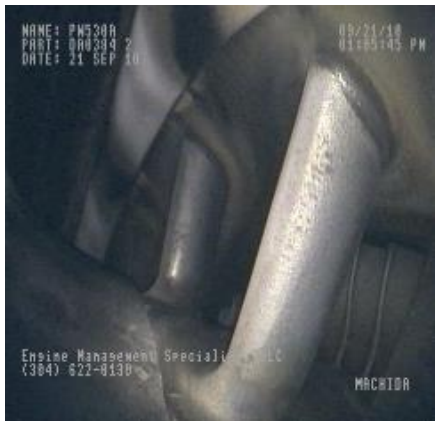
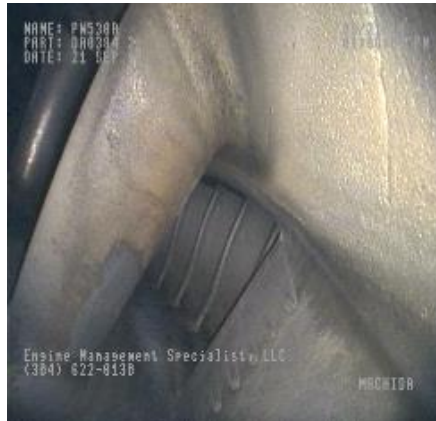
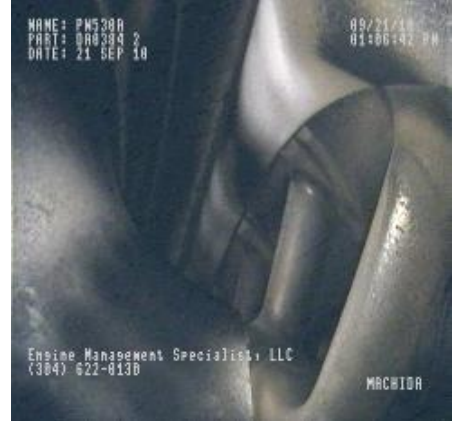
HP Vane Area

4.3.3 The HP Vane exhibited no obvious heat distress and the visual borescope inspection of the vane should be considered clean.
