Report No: EMS-509-08-CF0243

ENGINE/COMPONENT SUMMARY REPORT

Customer: Sample Aviation, Inc.

Unit: PW308C Serial No: CF0243

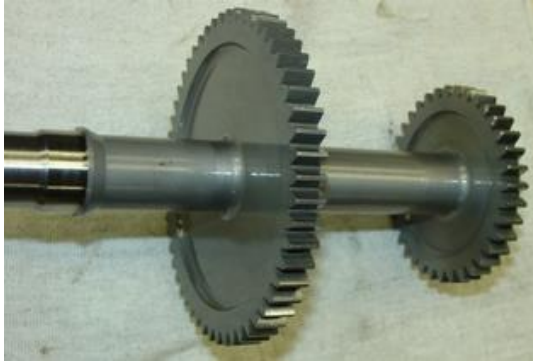
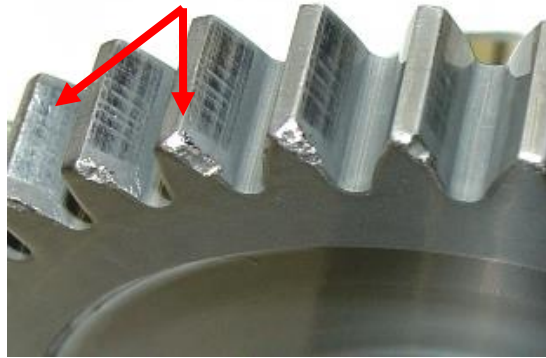
Photos 1 & 2

2.2 The HMU and Oil Pump drive exhibited gear teeth mesh damage, most of the damage was noted on outer tooth edges (Ref. Photo 1 & 2).

HMU & Oil Pump drive gear

Oil Pump drive gear mesh damage
Mostly noted on outer tooth edges

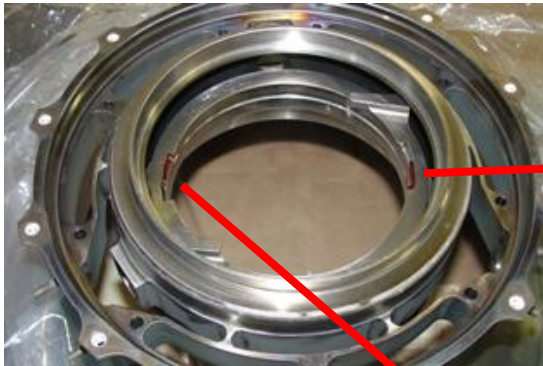
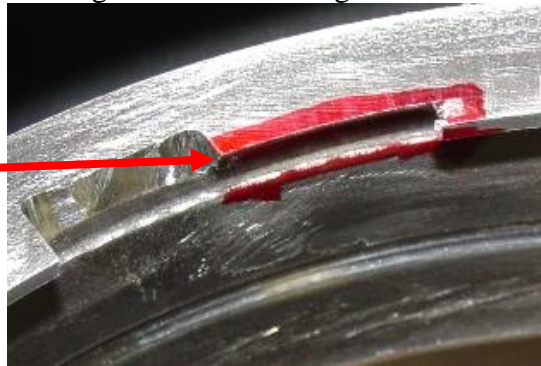
Photos 3 & 4

2.4 The Diffuser Case #3 Bearing Anti Rotation Slots exhibited heavy fretting wear with missing material (Ref. Photo 3, 4 & 5).

2.4.1 The fretting wear exhibited in the #3 Bearing slot area has been noted in other PW308C model units.

Diffuser Case #3 Bearing Bore

#3 Bearing Anti Rotation Slot
Fretting wear with missing material

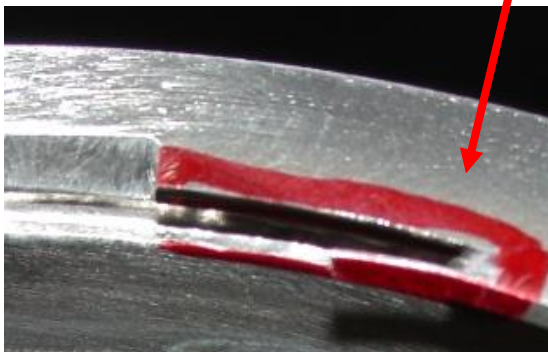
#3 Bearing Anti Rotation Slot
Fretting wear with missing material

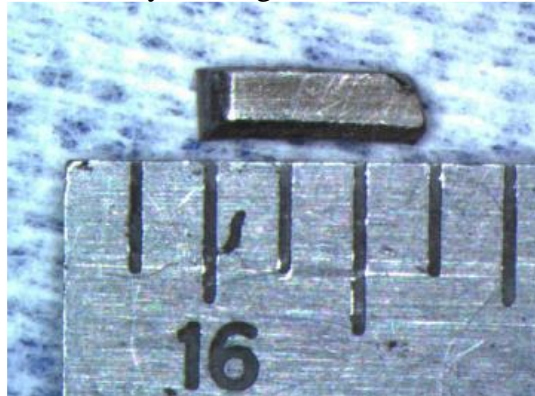
2.4.1.2 Photo 6 is from Pratt & Whitney preliminary assessment in Montreal, Canada.

2.4.2 The foreign material found in the main oil pump assembly by Pratt & Whitney in photo 6 was also tested by Pratt & Whitney and confirmed to be of the same material components as used in the material to manufacture the Diffuser Case Assembly.

Material found in the Oil Pump Assy. during
disassembly investigation

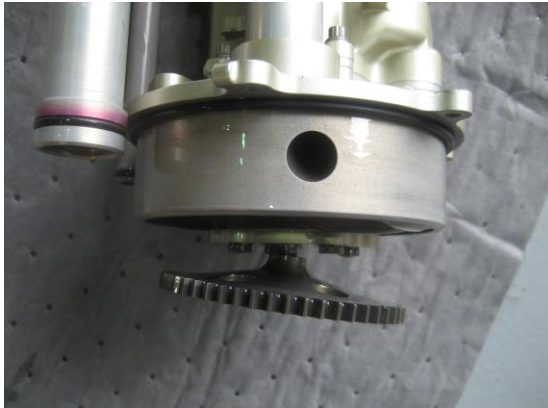
3.1 The Main Oil Pump Drive Gear exhibited distortion to the perpendicular alignment on its mounting shaft (Ref. Photo 7).

Oil Pump Drive Gear
Drive Gear Alignment on pump main shaft

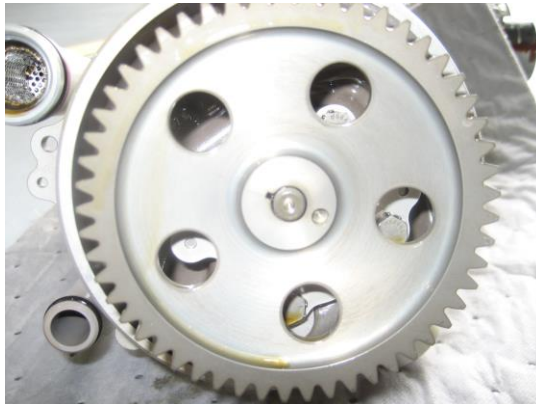
3.1.1 The retaining nut and tab washer were liberated from the pump shaft (Ref. Photo 8, 9 & 10).

Drive Gear retaining nut liberated from shaft

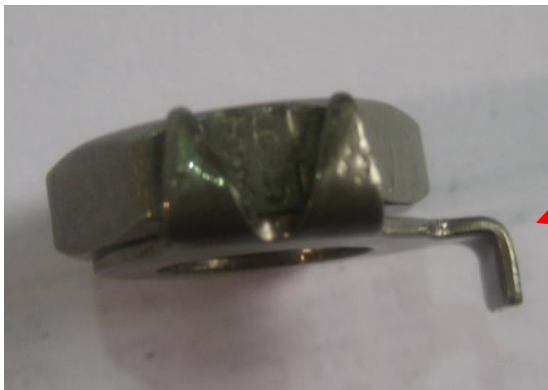
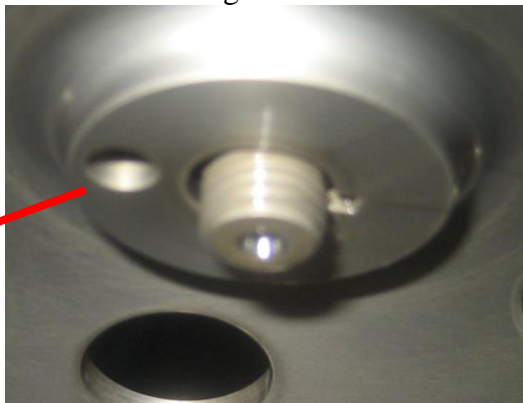
Photos 9 & 10

Oil Pump Drive Gear retaining nut
Locking tab washer still installed

Oil Pump Drive Gear
Lock tab retaining slot

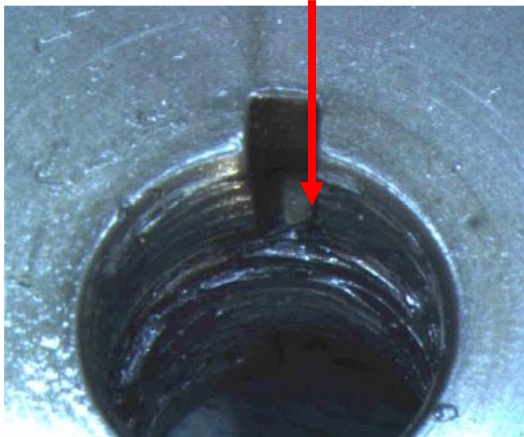
3.1.2 The gear bore was deformed and scored (Ref. Photo 11).

Oil Pump Drive Gear
Shaft bore deformed and scored

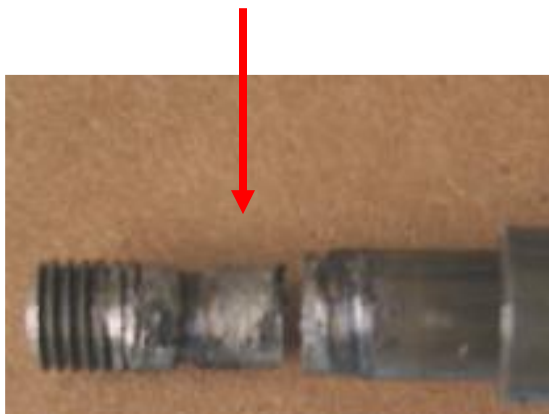
3.1.3 The pump shaft was deformed and fractured (Ref. Photo 12).

Oil Pump Main Shaft
Deformed and fractured

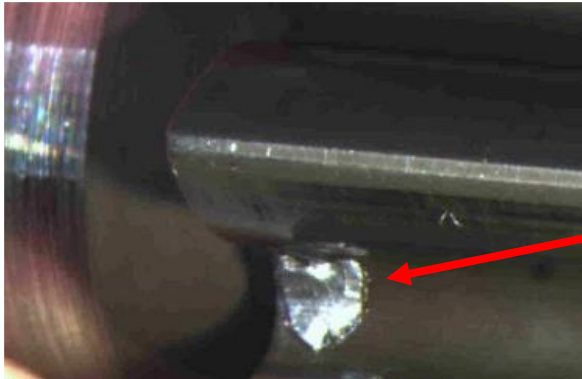
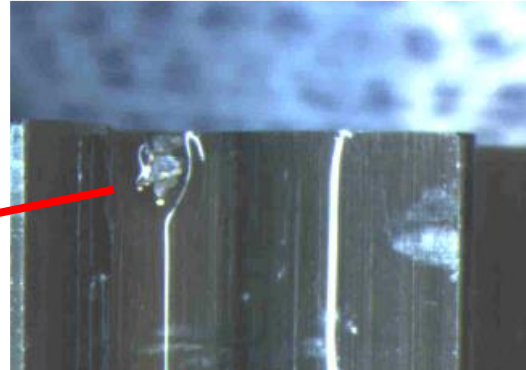
Photos 13 & 14

- 3.1.4 The Main Oil Pump Elements exhibited impact damage Ref. Photo 13 & 14).
- 3.1.5 The Main Oil Pump Housing exhibited heavy scoring in gear bore (Ref. Photo 15).
 - 3.1.5.1 Foreign Debris was found in the pump housing (Ref. Photo 16).
 - 3.1.5.2 Foreign Debris measurements (Ref. Photo 17 & 18).
 - 3.1.5.2.1 Length: 0.1983”
 - 3.1.5.2.2 Front Width: 0.04235”
 - 3.1.5.2.3 Rear Width: 0.06298”
 - 3.1.5.2.4 Depth: Not received

Main Pressure Pump Elements
Displayed foreign impact damage

Main Pressure Mating Pump Elements
Corresponding damage on mating surfaces

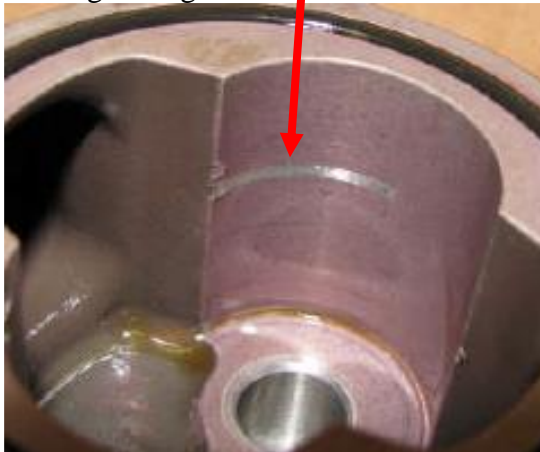
Main Pressure Pump Housing
Scoring damage noted

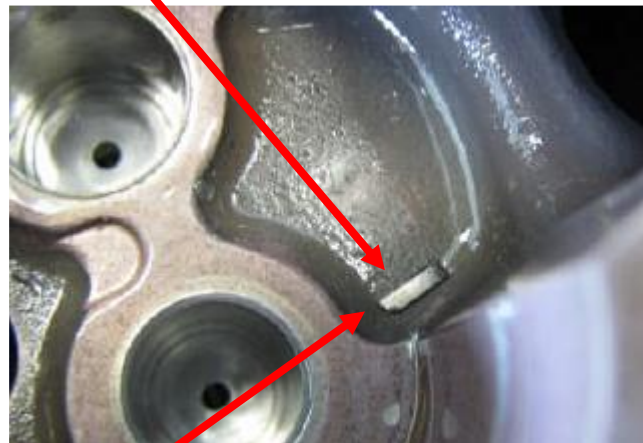
Main Pressure Pump Housing
Foreign Debris discovered in housing

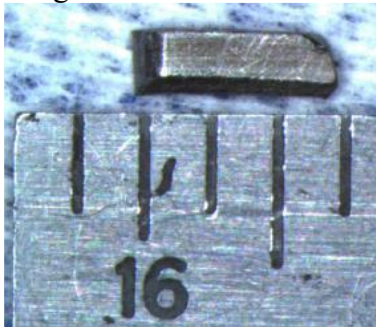
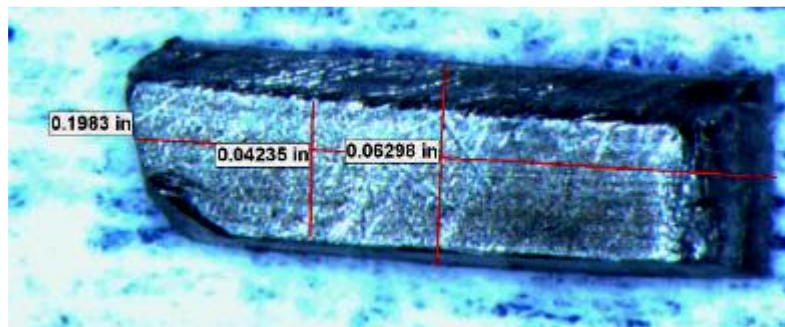
Photos 17 & 18

Debris found in Main Oil Pressure Pump
Length: 0.1983”

Front Width: 0.04235”

Rear Width: 0.06298”

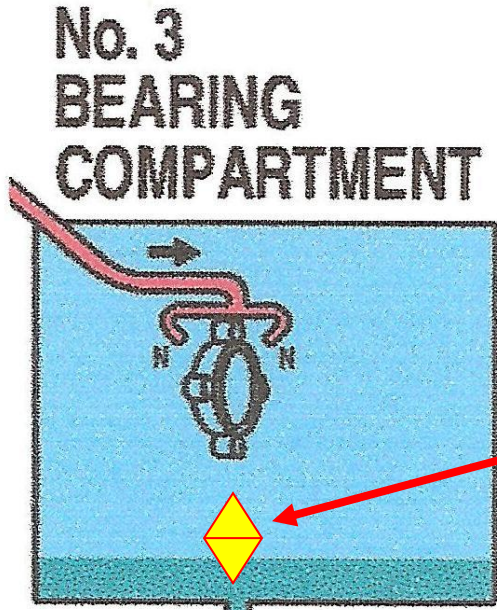
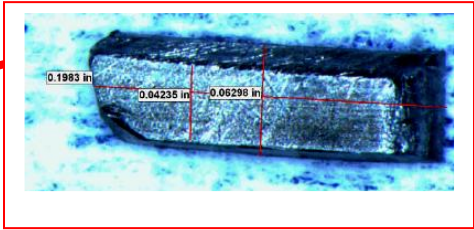
Photo 19

- 4.1 The most likely root cause for the Main Oil Pump failure (Ref. Photos 19 through 24).
 - 4.1.1 Fretting wear in Diffusers Case Anti Rotation Slots resulted in liberated material (Debris).
 - 4.1.2 The Debris followed the #3 bearing scavenged oil.
 - 4.1.3 The Debris bypassed the #3 bearing scavenge pump elements through the ‘Ball Type Anti-Flooding Valve’.
 - 4.1.3.1 Note: A last chance screen with the same P/N as the Main Oil Pump screen is also noted for the scavenge oil system. Although the manual diagrams only indicate that #1 & #2 scavenge pump elements are actually screened and a separate screen is used for the accessory gearbox scavenged oil. (See 4.1.5)
 - 4.1.4 The Debris was scavenged into oil tank.
 - 4.1.5 The Debris flowed through main oil pump screen.
 - 4.1.6 The Debris entered into “Main Oil Pump Elements” creating internal damage and pump failure.

Debris from Diffuser Case Liberated and entered into the scavenge oil system

Reference as Debris

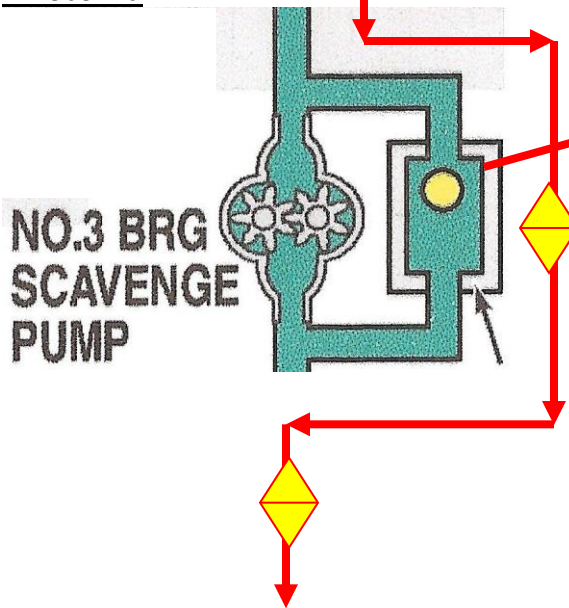
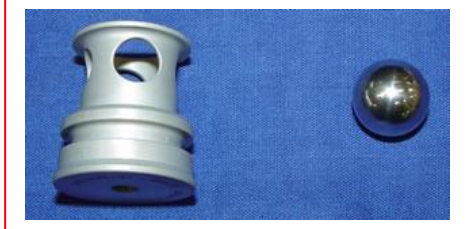
Photo 20

#3 Brg. Scavenge Oil

Ball Type Anti Flooding Valve

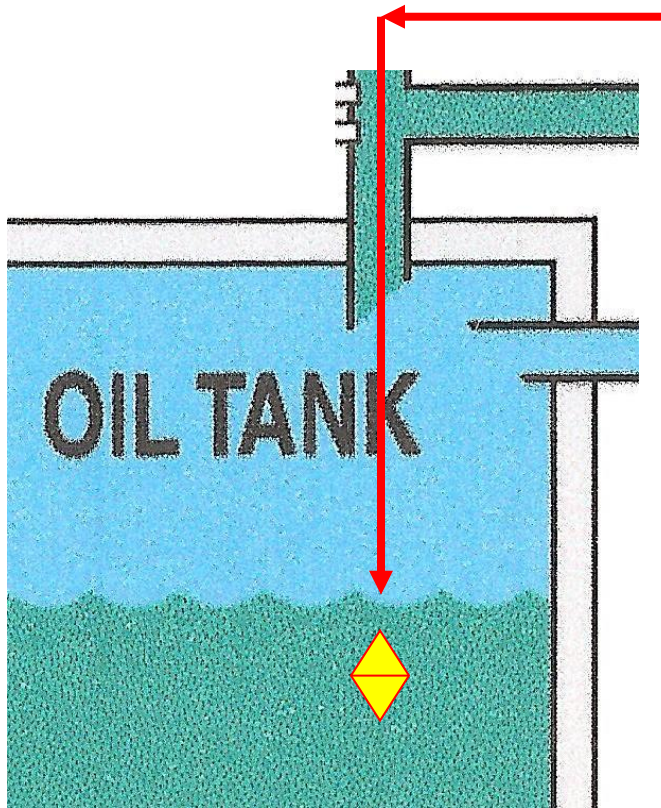
Photo 21

Debris flows into Oil Tank

Breather Air

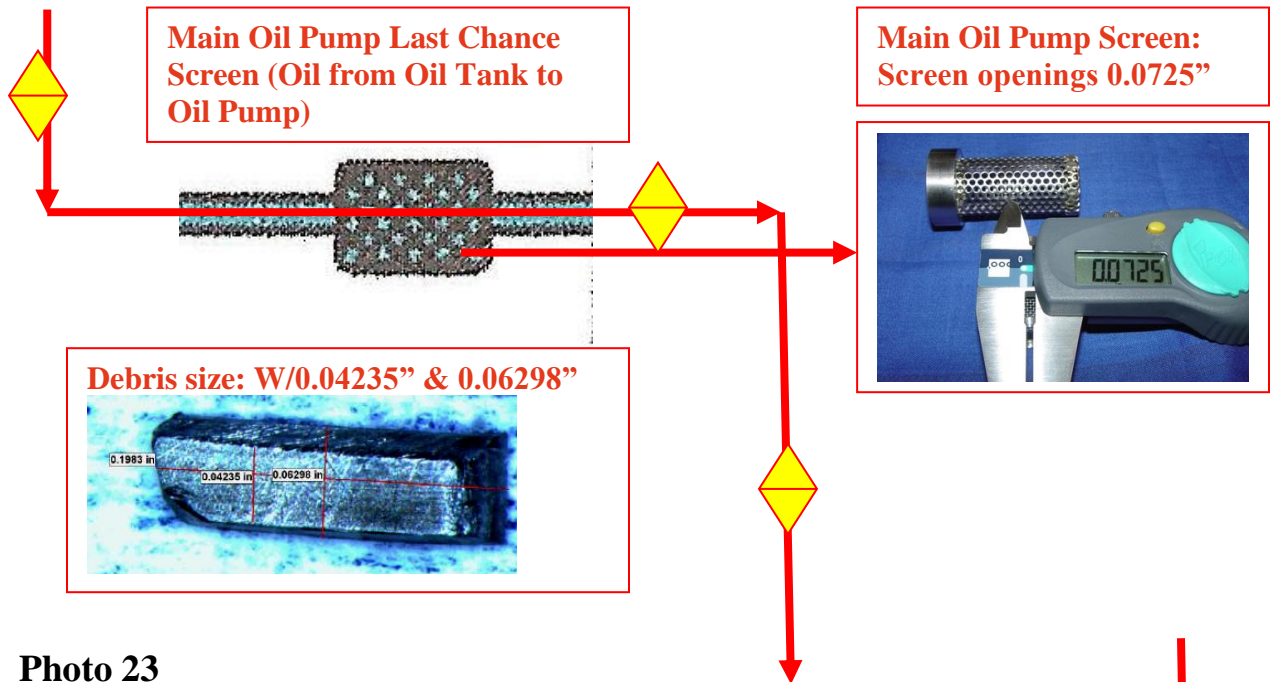
Photo 22

Main Oil Pump Last Chance Screen (Oil from Oil Tank to Oil Pump)

Main Oil Pump Screen: Screen openings 0.0725"

Debris size: W/0.04235" & 0.06298"

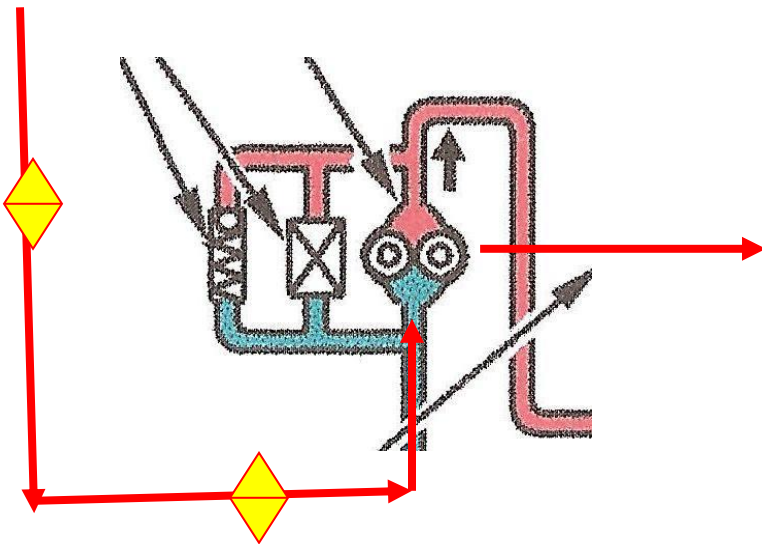
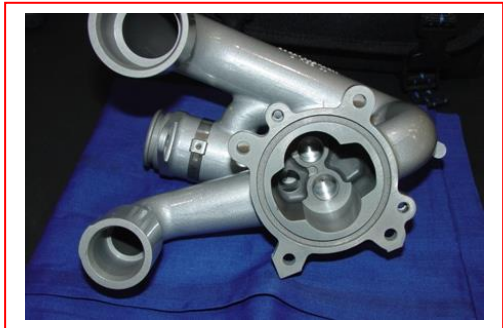
Photo 24

Main Oil Pump Assembly
