**Report ID:** 12907082100980  
**Report Date:** 7/9/2021  
**Client or Representative:** Gray Home Inspections  
**Location Address:** 8507 Billet Pl Oak Ridge, NC 27310  
**Sample Collected by:** Collected and delivered by independent home inspector  
**Sample Analysis by:** JED, GAP  
**Sample Results:**

# Sample Inspection Report Summary

**Gray Home Inspections, LLC**

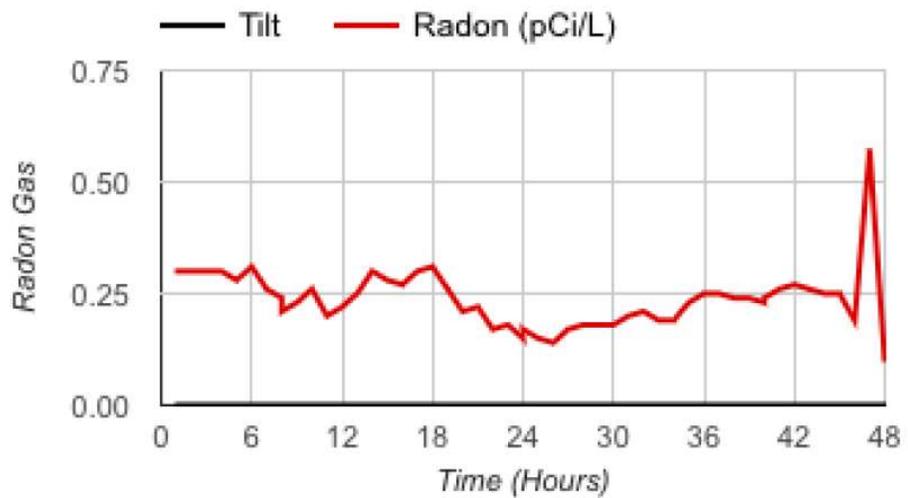
Radon Test Results

Below EPA Recommended Level of 4.0 pCi/L

**AVG Radon Gas Level: 0.2 pCi/L**

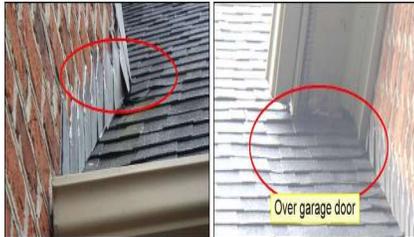
1.1 Item 1 (Picture)

The flashing is loose and needs repair. Flashing that has pulled away from surface can allow water to enter through the opening. Have roof flashing evaluated and repaired by certified roofing technician.

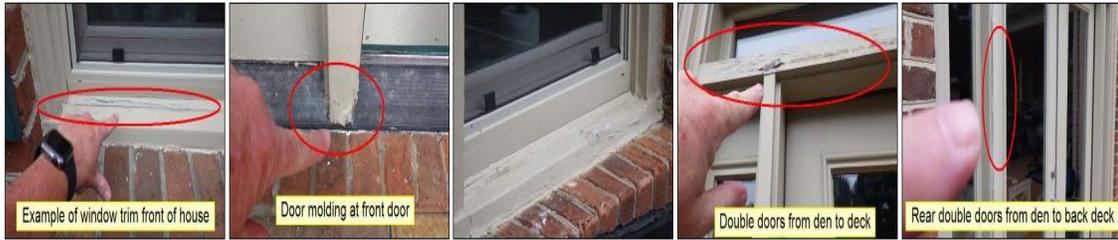
2.2

The exterior of the windows and doors are in very good working order. The wood trim is peeling paint at most windows and doors. Further deterioration may occur if not repaired. I recommend a qualified contractor inspect and repair as needed.

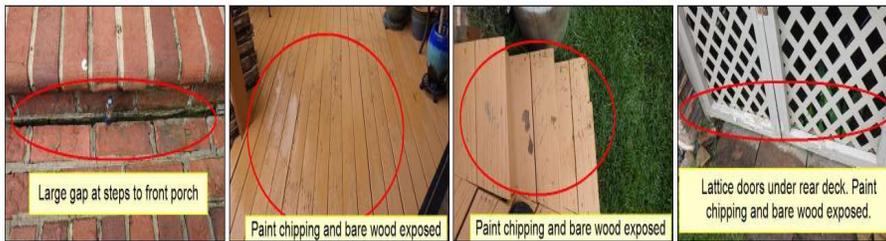
2.3

The deck needs cleaning with a "Deck wash" and seal with a waterproof sealant. Chipping paint will need to be removed before applying sealant. Also, do the underside of deck if accessible. No immediate signs of wood rot damage. Continued exposure to the weather will cause wood to deteriorate.

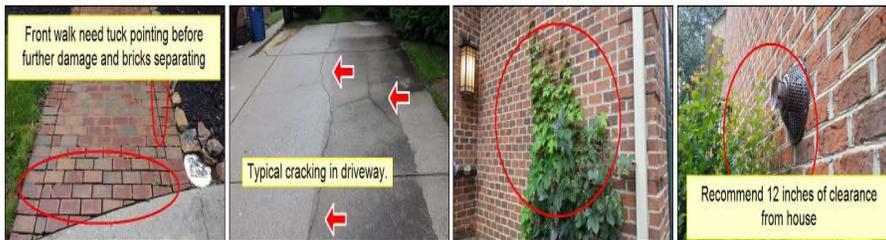
2.4

Brick walkway at front of house needs mortar repair or tuck pointing. Recommend repair by qualified brick mason. Driveway cracking appears to be typical and should be monitored for future damage or widening of cracks to become trip hazards.

Vegetation can cause damage to brick siding. Recommend keeping vegetation at least 12 inches from house.
