January 2023

Nave Ceiling Plaster Condition Assessment Saint Ninian Cathedral Antigonish, Nova Scotia

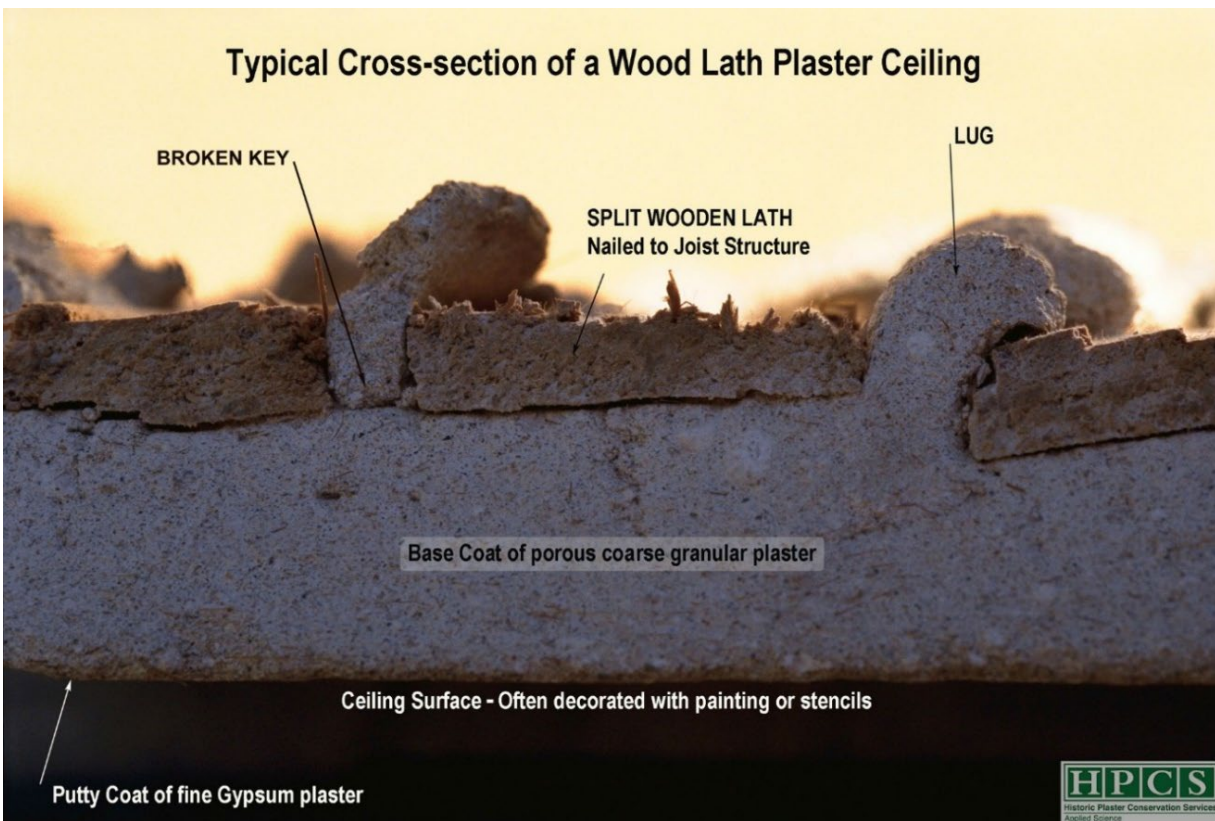
Figure 1: A visual inspection of this plaster would not reveal the broken key that is no longer supporting its share of the ceiling load. Without conducting the right testing the failed key will go unnoticed.

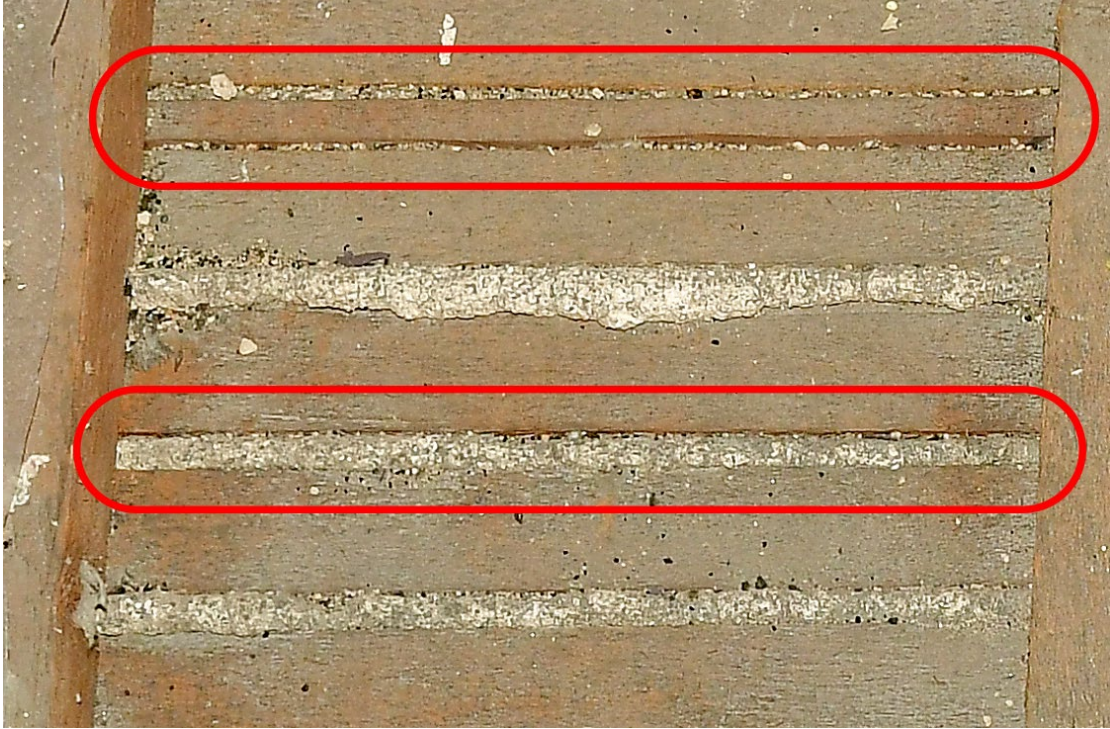
If laths are too closely spaced or if plaster squeeze through during construction was insufficient, the result is a non-viable lug and key. These lugs and keys do not provide support for the plaster.

Figure 2: Non-viable keys. In the uppermost red circle, the lath spacing is too narrow for a functioning key. In the lower red circle, there was not enough squeeze-through to form a functioning lug.

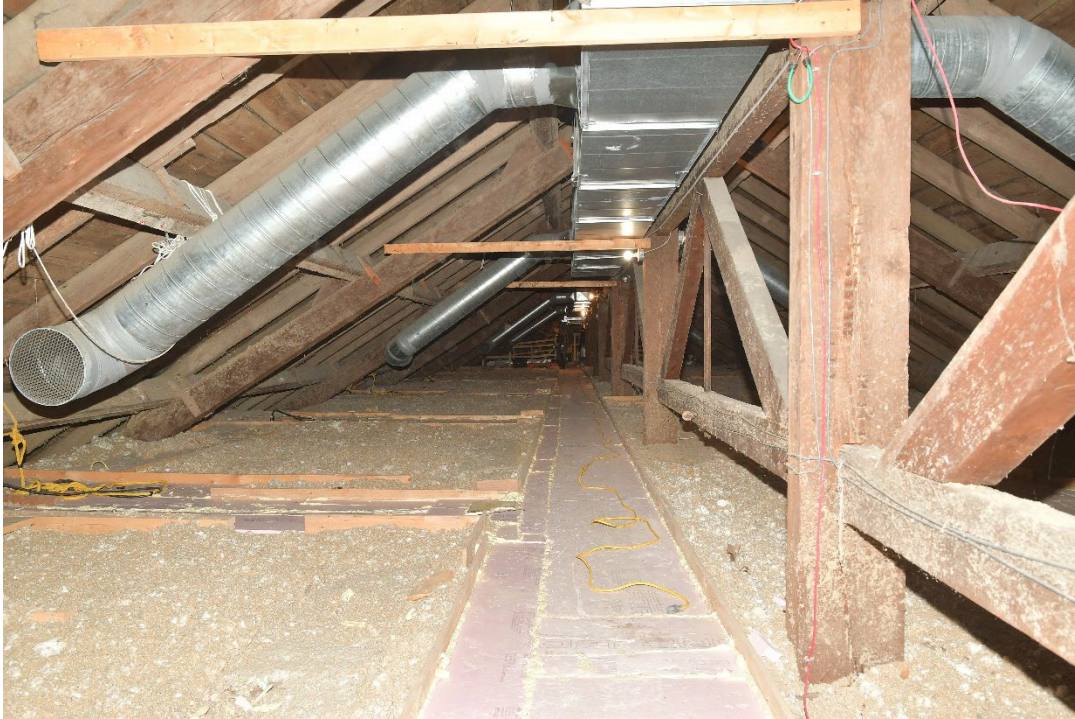
Figure 3: Attic conditions. Generally clean and well-kept. Mechanical systems are out of the way, and the catwalk is stable and secure.

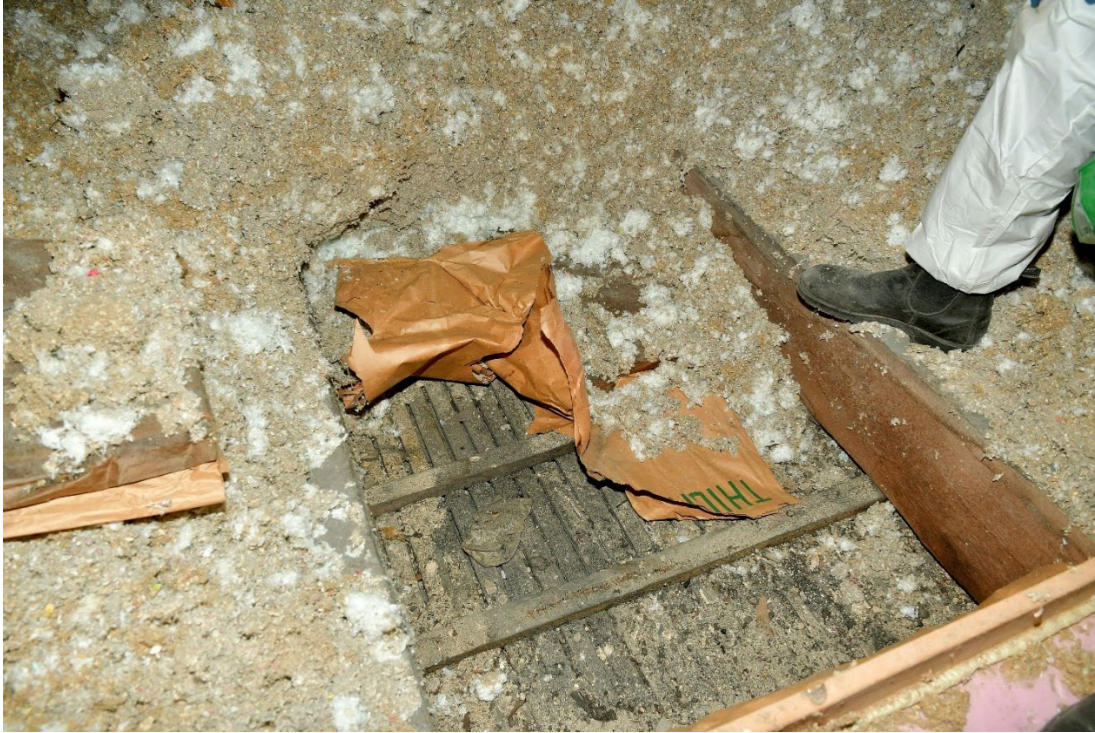
Figure 4: A partially cleared inspection location. The loose fill cellulose insulation covers a layer of rock-wool paper backed batts (removed in this image). The loose fill covers the top of the joists. Strapping runs perpendicular to the joists and is at roughly 30cm intervals. Note the near total lack of keys at this location even before testing (Location 3).

3. The plaster has almost no support keys remaining. The plaster is pulling away from the lath by as much as ten millimetres. There are stains and discolouration on the plaster from past exposure to water. **This area poses a potential safety risk.** See Figure 4 and Figure 10

In this case it will be necessary to install a temporary support system for very delicate areas of the ceiling where there is very high key loss. For example, the plaster is in such poor condition at test location 3 and 11 that it must be supported before it is consolidated. There are most certainly other areas that will also require support. HPCS has developed a specialized tool for gently supporting fragile plaster called Micro-Jacks™. Micro-Jacks are small screw jacks that work with standard tube and clamp scaffolding to provide gentle and highly adjustable support for decorated plaster ceilings while stabilization work is performed. Installation is simple and the jacks can be removed within a couple days of the consolidation treatment. The jacks have non-abrasive contact pads and can be dialed in to provide the minimum required support, or even re-align deflecting plaster if the conditions allow. The supported ceiling area is still fully visible for monitoring during treatment. Areas with more than 50% key loss should be supported prior to consolidation treatment.

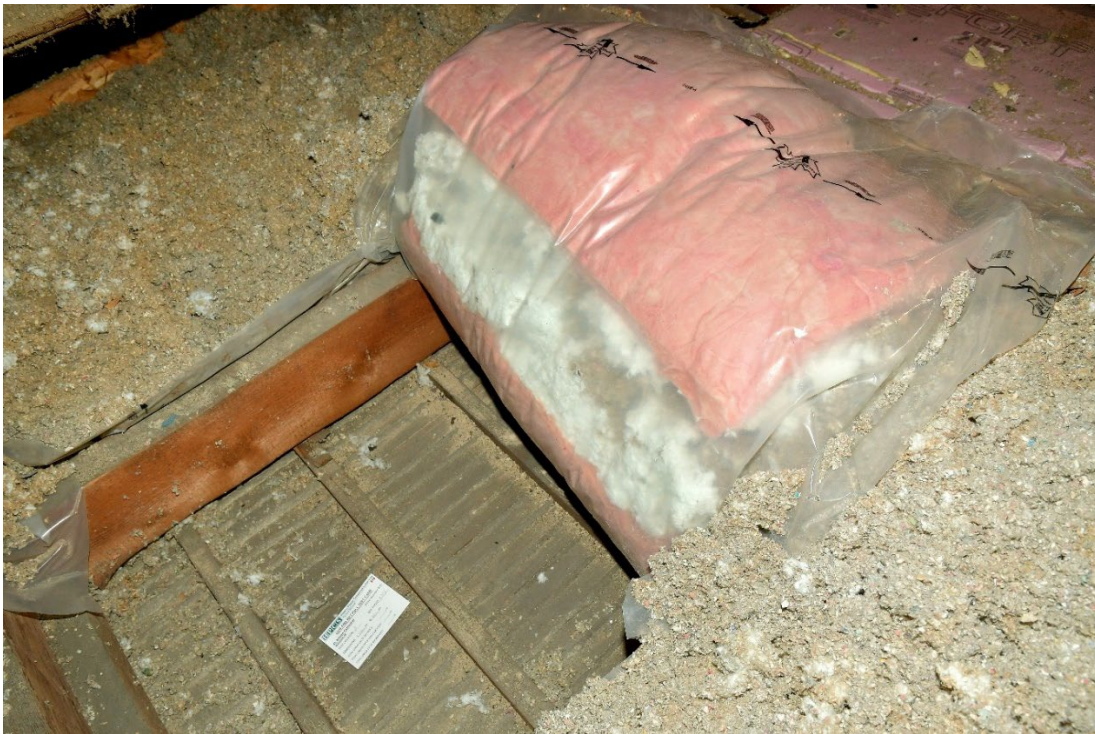
Figure 5: Newer insulation and a poly barrier were found at two of the test locations. The new insulation is hidden under the loose fill insulation so its extent is unknown.

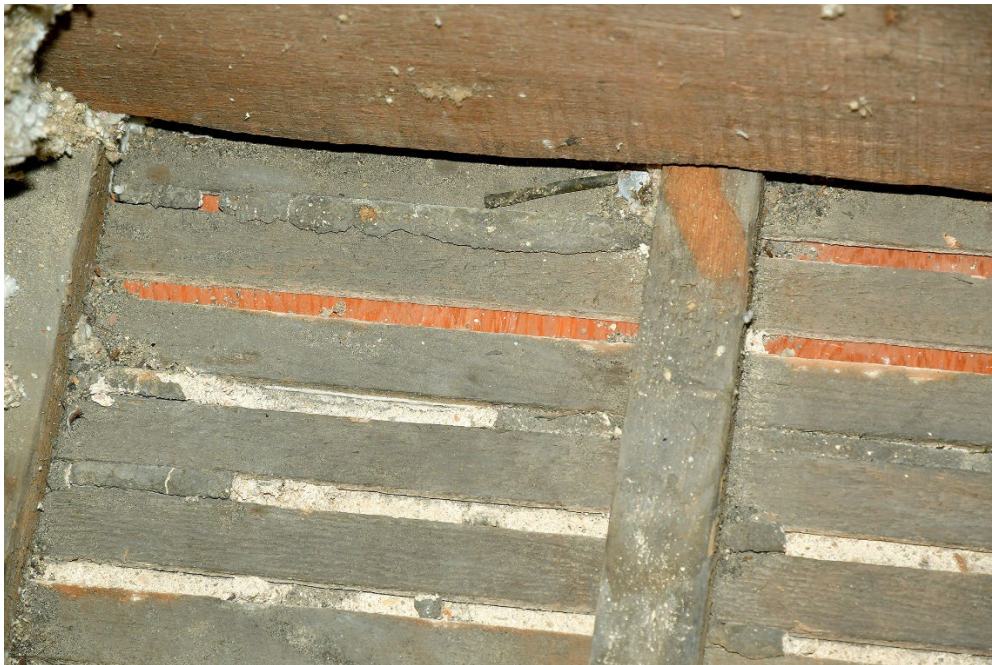
We discovered many piecemeal plaster repairs of varying quality. At test location #2 we found a portion of the ceiling that has been repaired with plywood. Presumably the plaster in this area was failing (or fell) and the area was patched with a plywood panel and filled over with some sort of patching compound.

Figure 6: Plywood can be seen through the lath spacing at this location. The plywood is flush against the lath. The plaster near the plywood is in poor condition.

2. The plaster is badly compromised. There are stains and discolouration on the plaster from past exposure to water. Previous repairs at the edge of the location made with drywall compound and, oddly, plywood. See Figure 8 and Figure 6.

As noted above, we found many old repairs of varying quality, and we know there are many more based on a visual inspection of the ceiling from floor level. Some of the old repairs should be carefully cut out and replaced, while others won't require any attention. The course of action for each repair will depend on its current stability, expected long-term stability, and the materials used for the repair. At this time the amount of work cannot be accurately quantified.

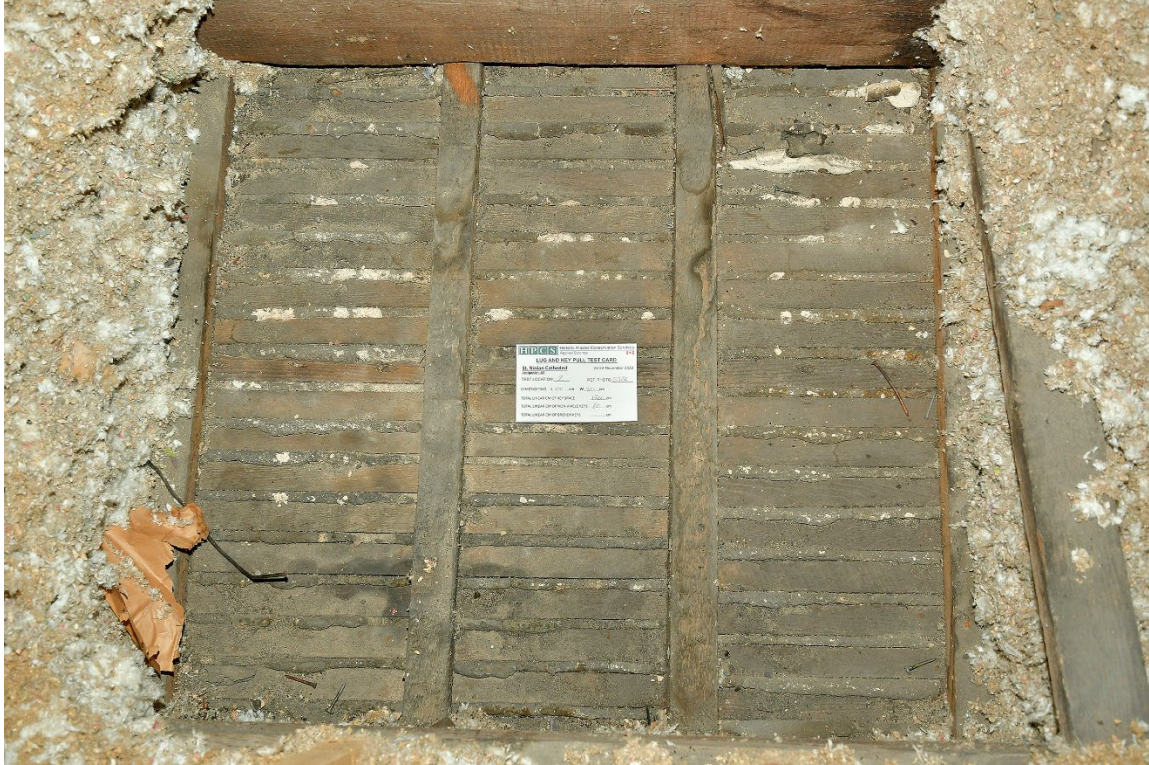
Figure 8: A test location after the insulation was removed and the area vacuumed. (Location 2).

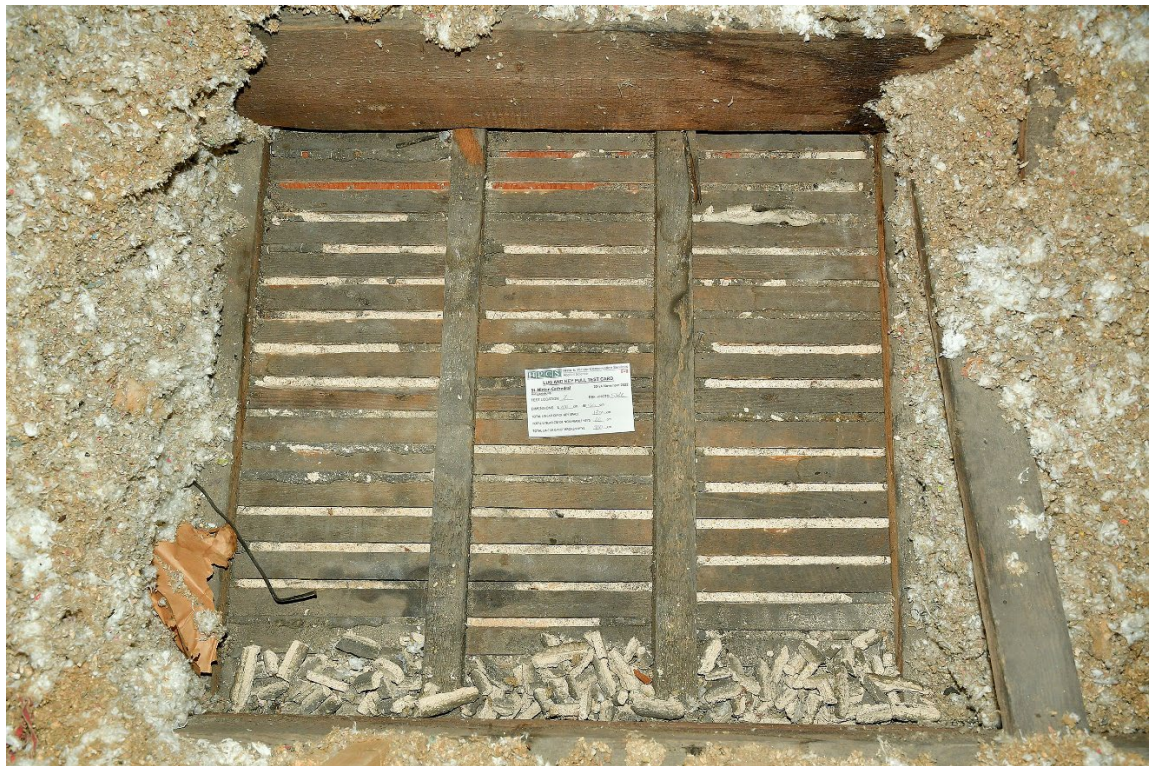
Figure 9: The same location as in Figure 8 after keys were tested.

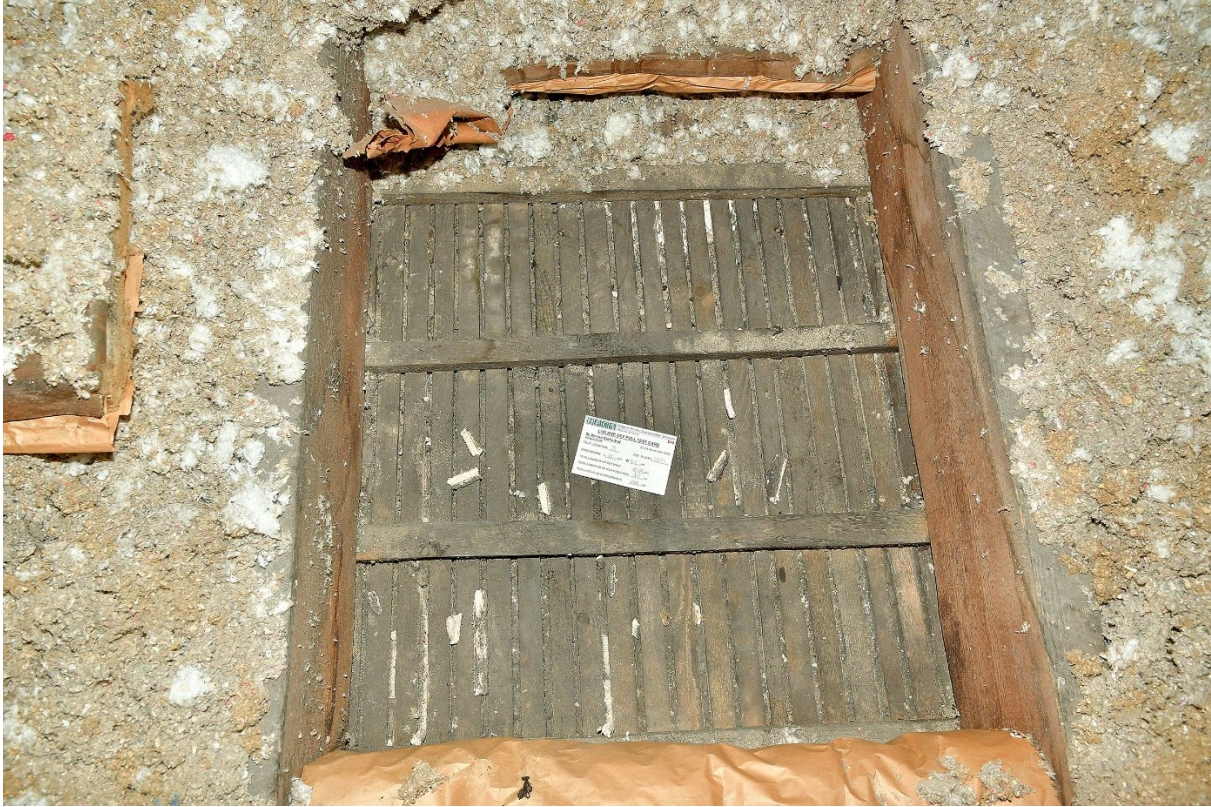
Figure 10: Near total key lost. Signs of water damage are clearly visible in the form of staining on wood (joists, strapping, and lath), and desiccated mold. There were many non-viable keys at this location, but it was difficult to count them as the plaster was sagging away from the lath enough to make it hard to distinguish old broken keys from non-viable.

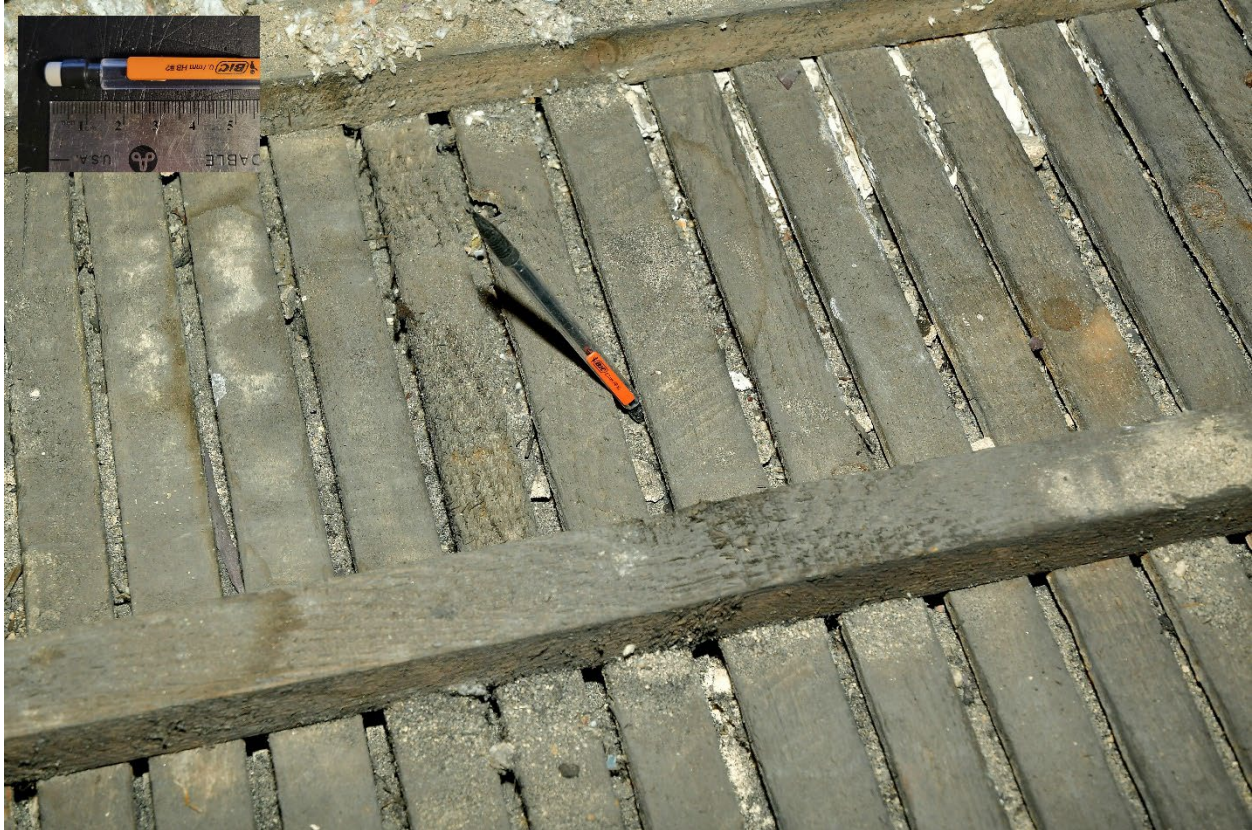
10. Moderate key loss. Some staining from past moisture. No obvious sign of past interventions.
11. The plaster has almost no support keys remaining. The plaster is pulling away from the lath by as much as ten millimetres. There are stains and discolouration on the plaster from past exposure to water. **This area poses a potential safety risk.** See Figure 11

Figure 11. Plaster sagging away from the lath at test location 11. A similar condition was found at Location 2 and 3.

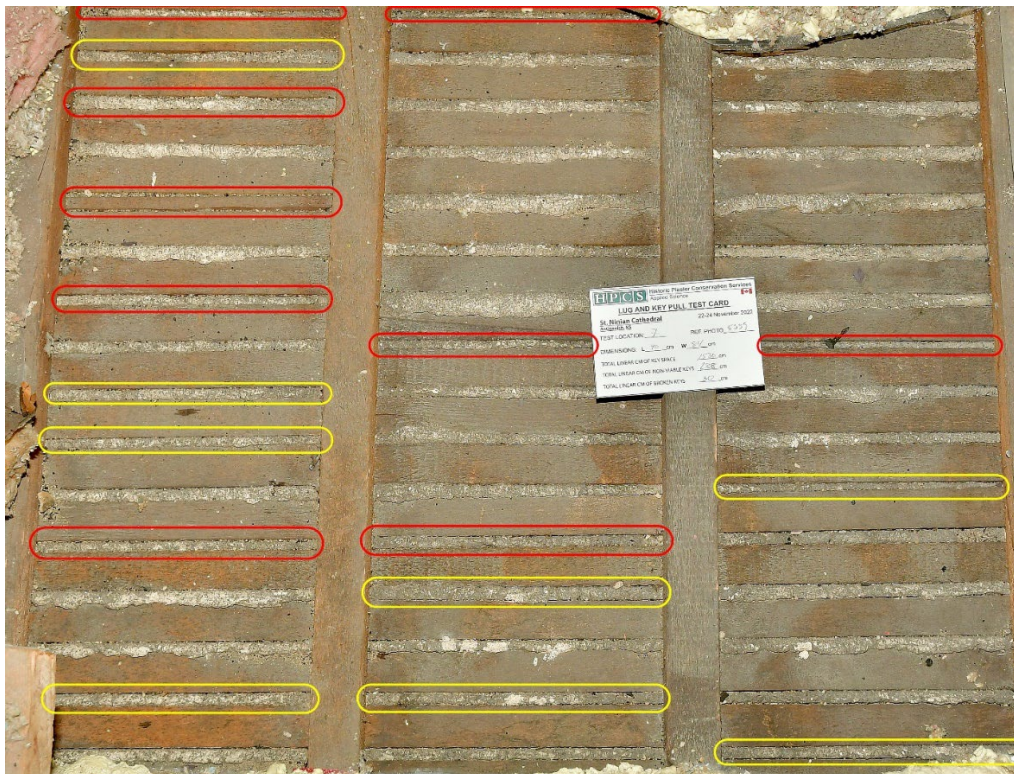
We found a higher-than-average percentage of non-viable lugs and keys in several of the test areas. The non-viable keys we found were mostly the result of inadequate extrusion through the lath spaces resulting in lugs that don't 'hook' the laths, rather than inadequate lath spacing. We found a few instances where the plaster is pulling away from the lath due to heavy key loss and the non-viable keys just slipped through the lath spacing without breaking. The data indicates that inadequate key formation is not a cause for failure, however our observations of the locations where plaster is detaching from the lath tell that non-viable keys could be exacerbating failure by other causes.

Figure 12: This is Test Location 7. Non-viable keys are circled in red. Substandard keys that are almost non-viable are circled in yellow. Almost 20% of the total potential keys in this area are non-viable and an additional ~15% are substandard.

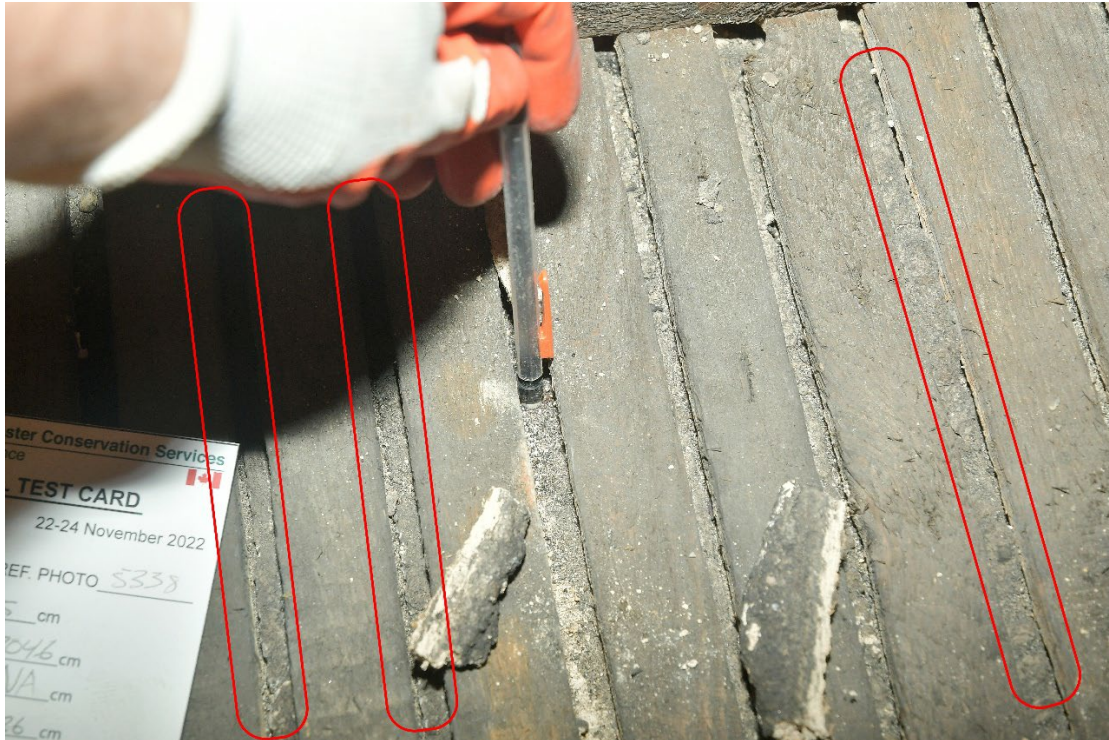
Figure 13: An area where the plaster is separating from the lath. Non-viable keys that have slipped through the lath spacing are circled in red. These keys did not break. (Three keys not circled were properly formed but had broken.)
