Oilheating

February 2003

Causes of soot damage to residential structures

By John Certuse P.E.

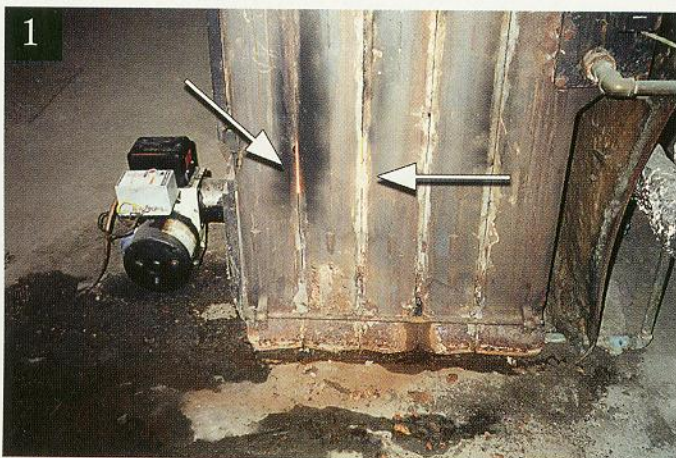
Photo 1: These boiler sections are leaking products of combustion into the structure. The rope packing between the sections has deteriorated, allowing slow entry of soot products into the structure directly from the appliance.

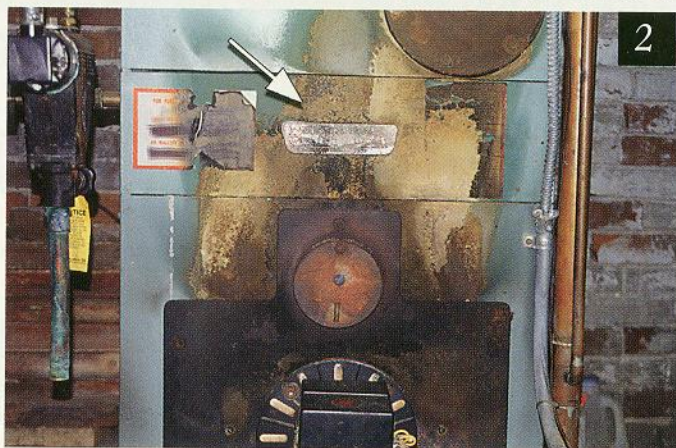
Photo 2: Poor cleaning and poor draft caused the plugged firesides of this boiler. Products of combustion cannot pass through the appliance and are forced back out into the structure. This is known as backpressure.

Soot damage to homes is also commonly encountered by service technicians as a result of a plugged boiler or furnace heat exchanger. This can result in a reversal in flow direction, causing the appliance to "leak" large amounts of combustion products from openings such as combustion chamber observation doors and gasket areas on the firesides of the appliance.

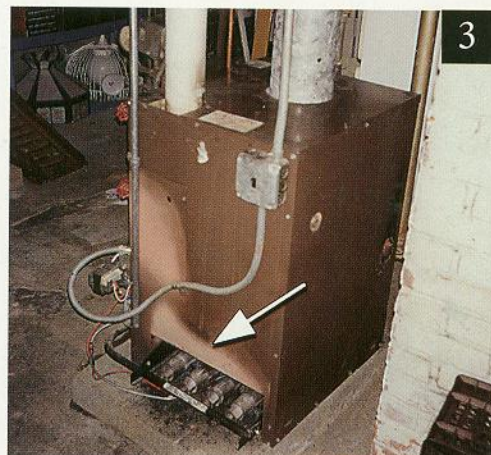
Photo 3: A poor draft can also cause products of combustion to reverse flow and enter the structure. Again, products of combustion cannot pass through the appliance and are pushed back out into the structure. This is called rollout in gas fired appliances.

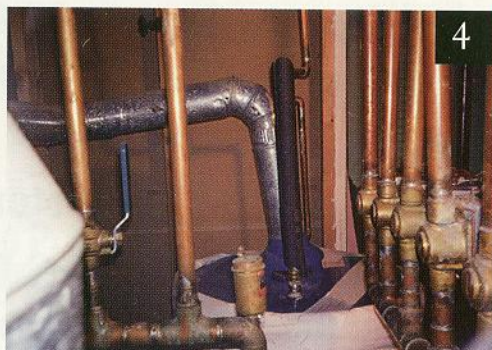
Photo 4: Stovepipe pitch should be upward towards the chimney at a slope of 1/4 inch per horizontal foot—not as shown here. Upon the burner's shutting down, emissions in the piping may re-enter the structure.

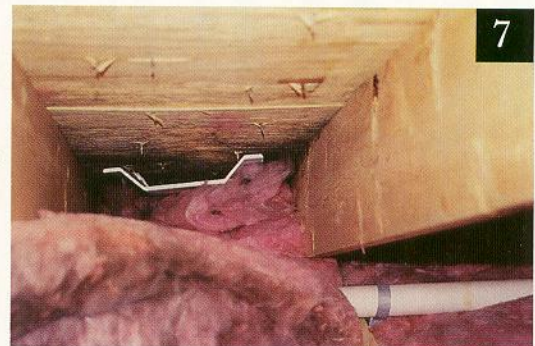
Photo 7: Soot-soiled insulation is seen at vent location in attic.

bustion does not enter the structure from the appliance directly. However, accumulations in the structure occur at a steady and ongoing rate, as shown in photos 7 and 8.

Deposits of soot or soot-like markings in areas far away from where the combustion appliance is located indicate a path of air flow into the structure, bringing these particles into the home. This condition is caused by *Depressurization Induced Combustion Re-Entry*.

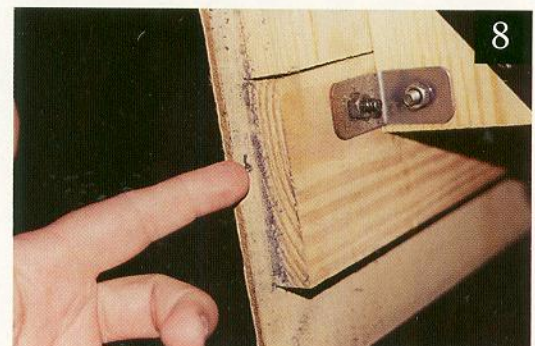
8

Photo 8: Attic stairwell doorjamb coated with soot

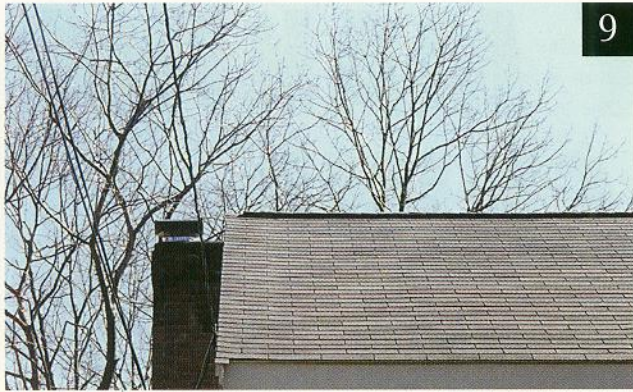
Photo 9: This chimney is below the peak of the structure. Discharge of gases should be at least two feet above the structure (see text) to prevent their re-entering the building.

These guidelines recommend that discharge gases be discharged above the eddy zone, and if possible, above the wake zone, which is generally two feet above the peak of a structure. Photo 9 shows an arrangement that would be inappropriate under these guidelines.

Direct venting of appliances may not be possible in all locations due to the distinct characteristics each home has for wind flow patterns. Poor chimney height or placement will also cause the emissions to mix with infiltrating air. NFPA 211 directs the vertical termination heights above structures to keep emission plumes flowing free of structures.

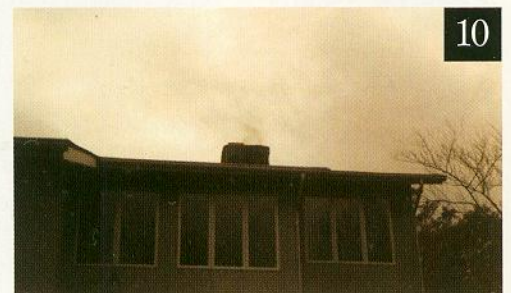
Photo 10: Malfunctioning burner's smoke lies closer to the house structure due to decreased stack effect. ©ISE

This failure causes heavier products of combustion, which cannot exit the chimney with the same velocity and hence distance themselves from the house as quickly as those from a properly firing burner. The force a chimney develops is known as the **Stack Effect**.

Annual tuning and combustion performance tests of the burner will verify correct firing conditions.
