# Property Inspection Report

**123 Elm Street, Houston, TX 12345**  
**Inspection prepared for: John Smith**  
**Date of Inspection: 7/27/2022 Time: 10am**  
**Age of Home: 2022 Size: 4,098 Sqft.**  
**Weather: Partly Cloudy**

**PROPERTY INSPECTION REPORT FORM**

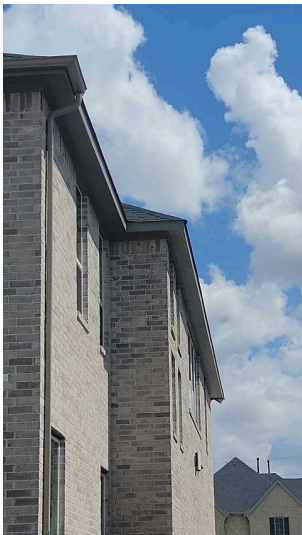
• I observed the home was lacking gutters in certain sections I am recommending having them installed to help prevent water runoff during heavy rain from accumulating next to the structure. This was noted on the sides of the home.

*I observed the home was lacking gutters in certain sections I am recommending having them installed to help prevent water runoff during heavy rain from accumulating next to the structure. This was noted on the sides of the home.*

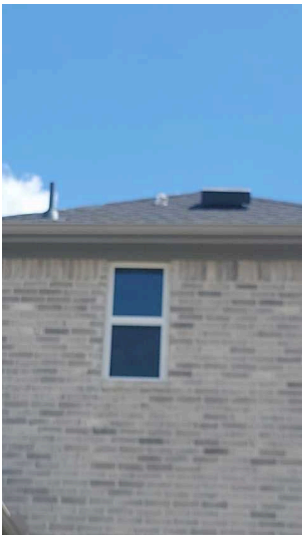
• I observed an inappropriate vent material protruding through the roof at the time of the inspection. This incorrect vent material was noted on the right side of the roof when facing the home from the backyard near a static vent.

*I observed an inappropriate vent material protruding through the roof at the time of the inspection. This incorrect vent material was noted on the right side of the roof when facing the home from the backyard near a static vent.*

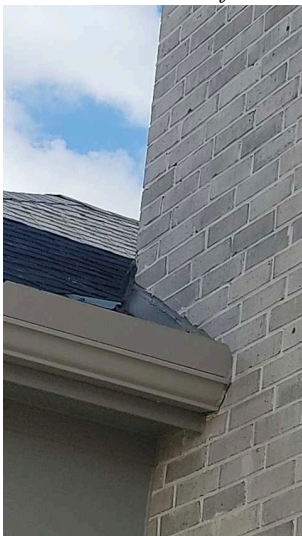
• I observed kickout flashing to be lacking or needs to be extended further out. The kickout flashing details observed at the lower bottom edge of the roof line interface and the sidewall that continues past the edge of the roof should be extended if installed. Kickout flashing is installed to prevent water runoff from entering behind the exterior wall covering. The lack of a proper kickout flashing will allow water to penetrate at these points. This will also help to prevent discoloration of exterior walls at the bottom of the roof/wall intersection and direct water into the gutters. This was noted over the back porch at the side wall extending past the edge of the roof.

*I observed kickout flashing to be lacking or needs to be extended further out. The kickout flashing details observed at the lower bottom edge of the roof line interface and the sidewall that continues past the edge of the roof should be extended if installed. Kickout flashing is installed to prevent water runoff from entering behind the exterior wall covering. The lack of a proper kickout flashing will allow water to penetrate at these points. This will also help to prevent discoloration of exterior walls at the bottom of the roof/wall intersection and direct water into the gutters. This was noted over the back porch at the side wall extending past the edge of the roof.*

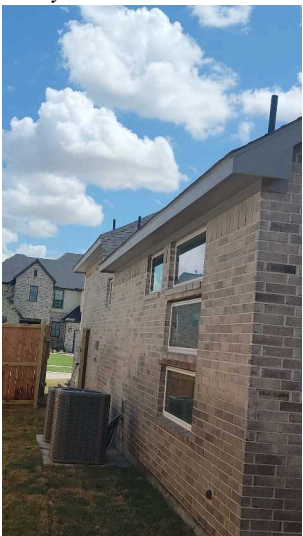
• I recommend gutters be added where the eaves of the roof are discharging water during heavy rains to protect electrical equipment.

*I recommend gutters be added where the eaves of the roof are discharging water during heavy rains to protect electrical equipment.*

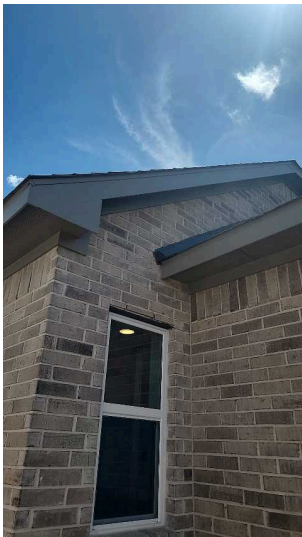
*This missing kickout flashing was noted over the master bathroom.*

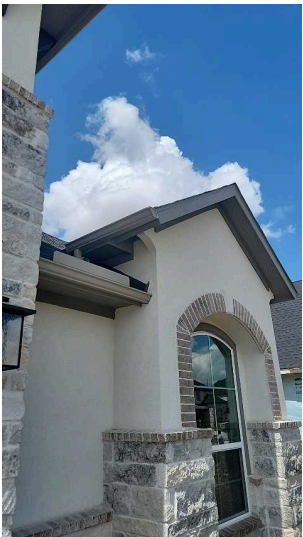
*This missing kickout flashing was noted to the right of the front door when facing the property from the street.*

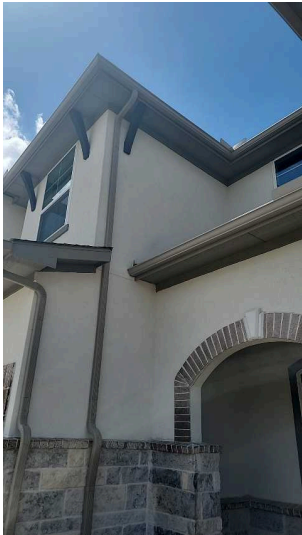
*This missing kickout flashing was noted between the garage and the front door.*

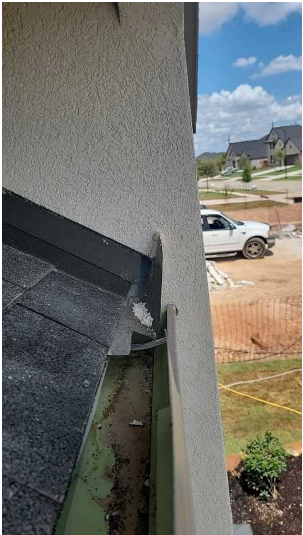
• I observed an open or exposed penetration in the roof line at the time of the inspection.

*I observed an open or exposed penetration in the roof line at the time of the inspection. This was noted to the right of the front door when facing the property from the street. I recommend this open penetration is sealed to not allow water to get back behind the stucco veneer and cause damage behind the wall cavity.*

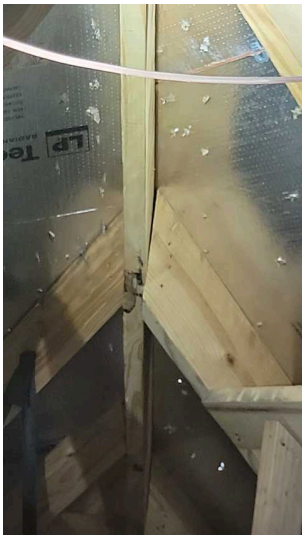
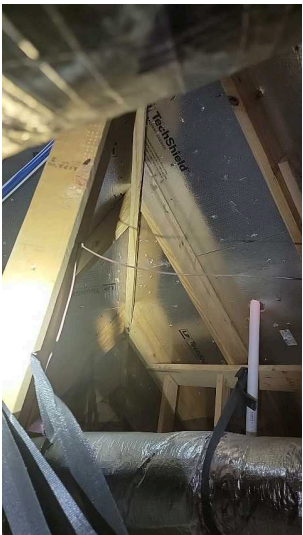
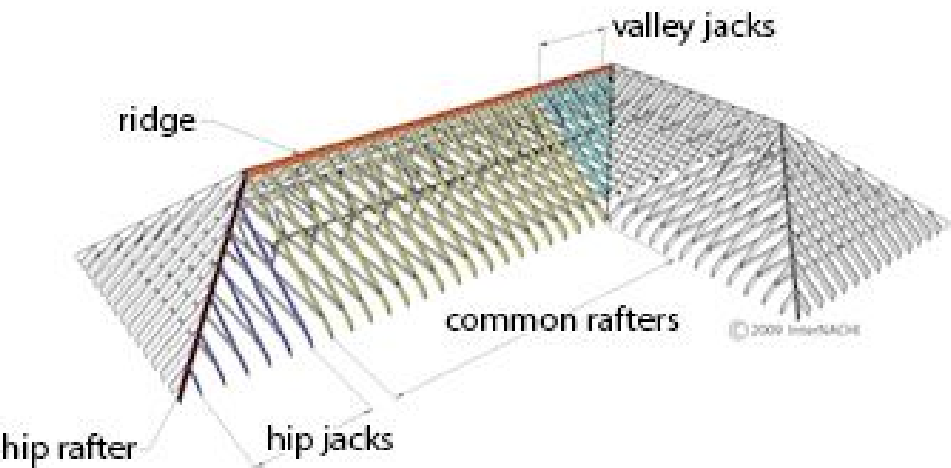
• I observed the roof rafter was not connected properly to the hip rafter at the time of the inspection. I recommend it is attached correctly. This was noted at a jack rafter connection to the hip rafter near the back right corner of the house in the attic space when facing the home from the street near a plumbing vent just off the attic walkway.

*I observed the roof rafter was not connected properly to the hip rafter at the time of the inspection. I recommend it is attached correctly. This was noted at a jack rafter connection to the hip rafter near the back right corner of the house in the attic space when facing the home from the street near a plumbing vent just off the attic walkway.*

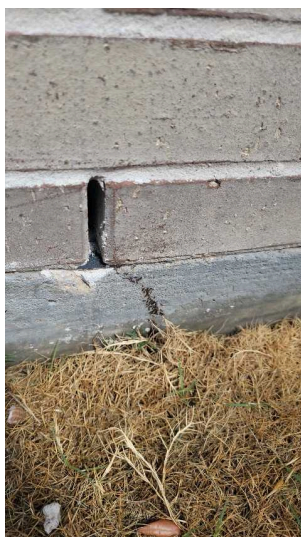
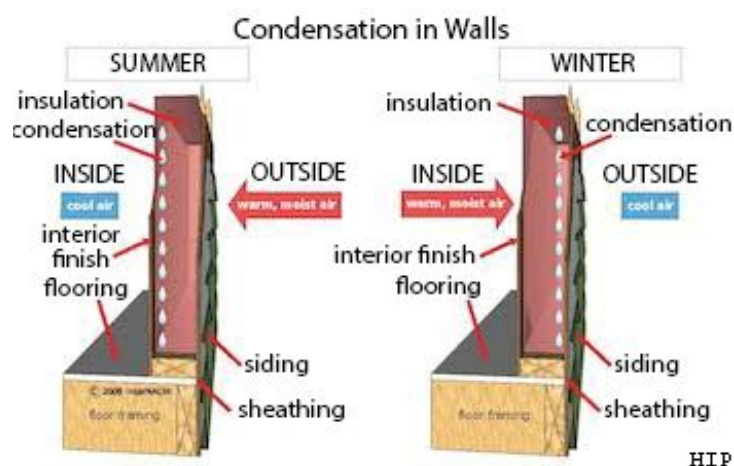
• I observed an ant trail at the time of the inspection. I recommend pest control to remedy the area to prevent further deterioration. This was noted on the side of the house between the main electrical shutoff panel and the fence gate.

I observed an ant trail at the time of the inspection. I recommend pest control to remedy the area to prevent further deterioration. This was noted on the side of the house between the main electrical shutoff panel and the fence gate.

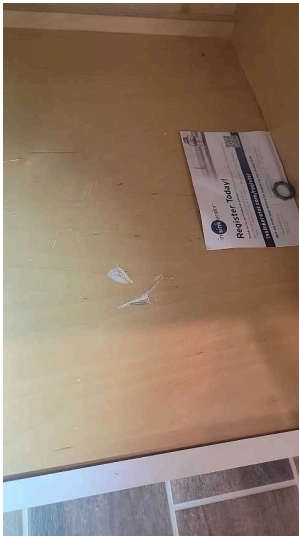
- **Client information:** I observed some damage to the interior finish at the time of the inspection on new construction. This was noted under the kitchen sink at multiple locations.

*Client information: I observed some damage to the interior finish at the time of the inspection on new construction. This was noted under the kitchen sink at multiple locations.*

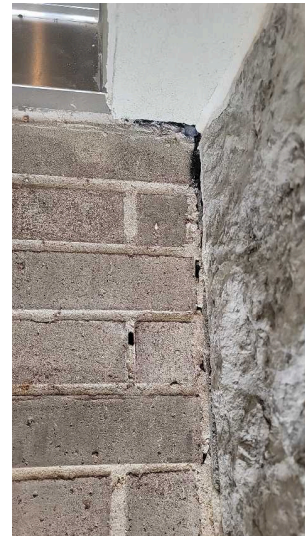
- I observed brick grout was missing at the time of the inspection. I recommend it is sealed appropriately to prevent deterioration and pest intrusion. This was noted near the front door entrance.

*I observed brick grout was missing at the time of the inspection. I recommend it is sealed appropriately to prevent deterioration and pest intrusion. This was noted near the front door entrance.*

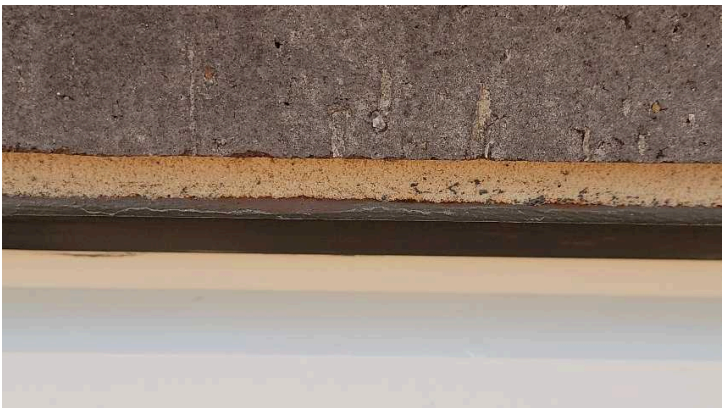
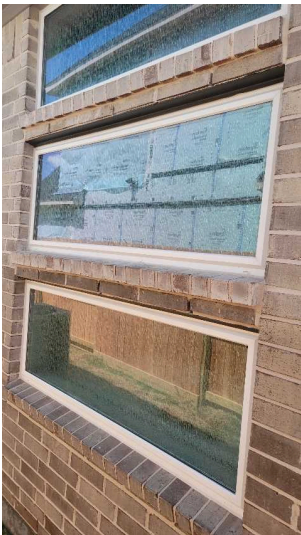
- REPAIR ITEM: The lintels above the exterior windows were beginning to show signs of rusting. Eventually the rust will result in expansion and cause the mortar and/or brick to crack. I recommend cleaning off the rust, sealing with a rust resistant paint, and sealing the brick/mortar cracks with hydraulic cement. Lintels are additional supporting structures, which are found above doors, windows and headers. They are essentially load-bearing structures made from timber, steel, concrete or other types of stone. They can also be decorative: however, they must support any heavy loads above the door, header or window.

These window lintels were noted behind the master bathtub.

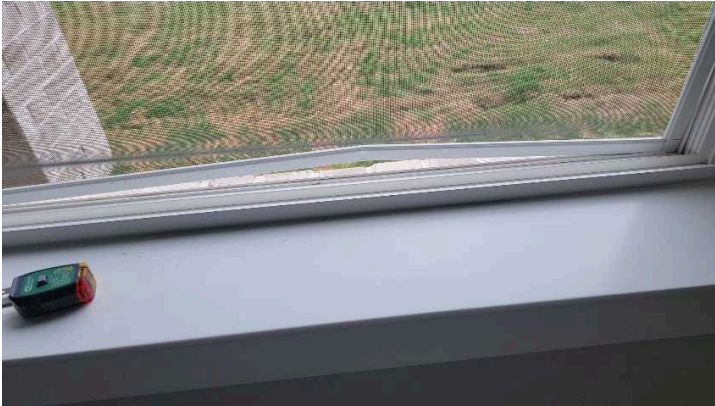
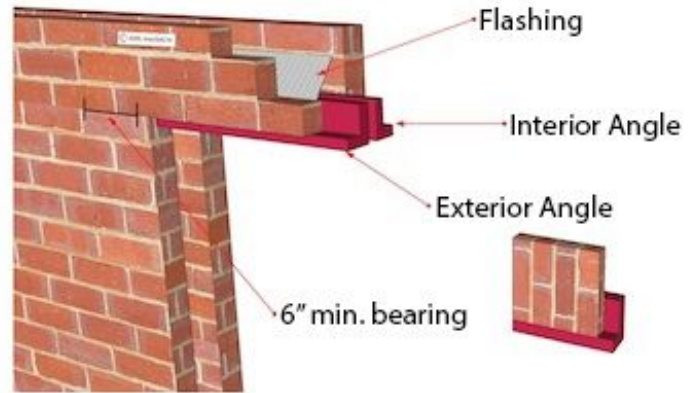
- I observed the window screen was damaged and/ or torn at the time of the inspection.

*I observed the window screen was damaged and/ or torn at the time of the inspection. This was noted on the left window in the master bedroom when walking in from the kitchen.*

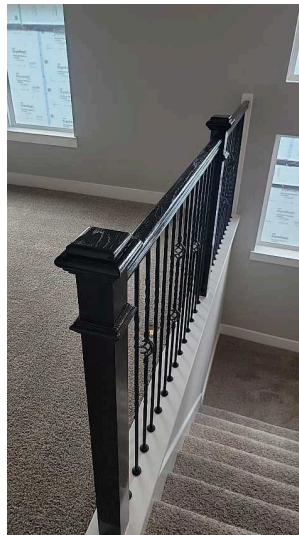
- I observed a loose newel/newel post at the time of the inspection. A newel, also called newel-post, is an upright post rising at the foot of a stairway at its landings or at its top. These posts usually serve as anchors for handrails. Often the stringboards, which cover and connect the ends of the steps, are framed into the newels. This was noted at the top of the staircase at the guardrail.

*I observed a loose newel/newel post at the time of the inspection. A newel, also called newel-post, is an upright post rising at the foot of a stairway at its landings or at its top. These posts usually serve as anchors for handrails. Often the stringboards, which cover and connect the ends of the steps, are framed into the newels. This was noted at the top of the staircase at the guardrail.*

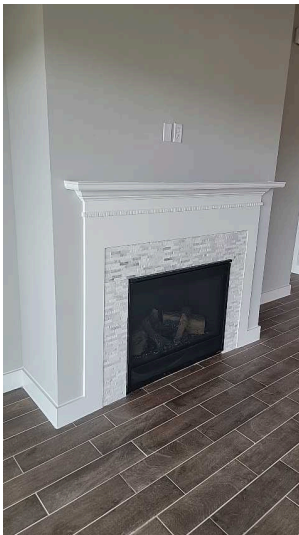
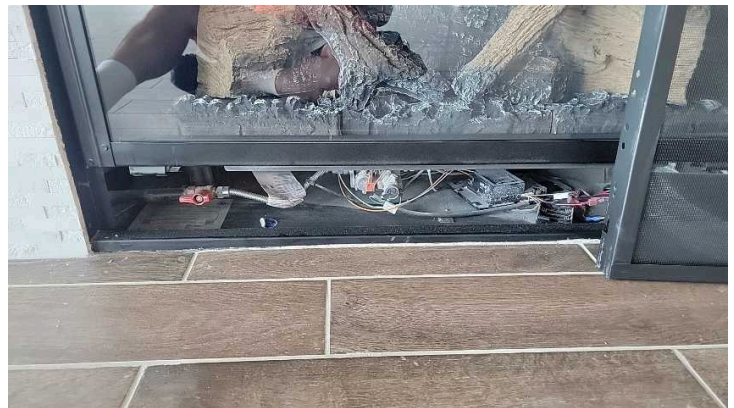
- **I was not able to locate a gas shutoff valve on the outside of the housing within 6 feet of the gas fireplace.**

*I was not able to locate a gas shutoff valve on the outside of the housing within 6 feet of the gas fireplace.*

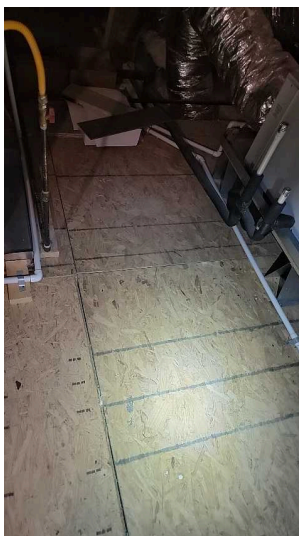
- I observed damaged and/ or missing insulation at the secondary drain line in the attic. Condensate drain lines contain water that can be cooler than the ambient temperature in your attic, the pipe can sweat or accumulate condensation.

*I observed damaged and/ or missing insulation at the secondary drain line in the attic. Condensate drain lines contain water that can be cooler than the ambient temperature in your attic, the pipe can sweat or accumulate condensation. This was noted at all three drain lines.*

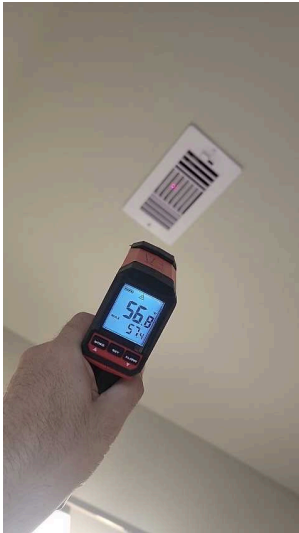
*I observed there is an insufficient temperature difference at some registers when ducts were in use. It is recommended that an HVAC technician further evaluate the system as needed. When testing the system you should have a 15 to 20 degree temperature difference between the return grille and the supply register. This was noted in the upstairs living room and both bathrooms to the right of the staircase.*

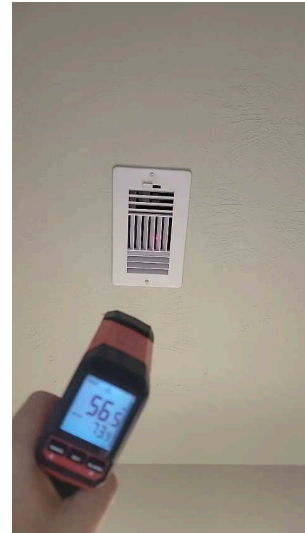
*I observed there is an insufficient temperature difference at some registers when ducts were in use. It is recommended that an HVAC technician further evaluate the system as needed. When testing the system you should have a 15 to 20 degree temperature difference between the return grille and the supply register. This was noted in the upstairs front right bedroom closet to the right of the staircase.*

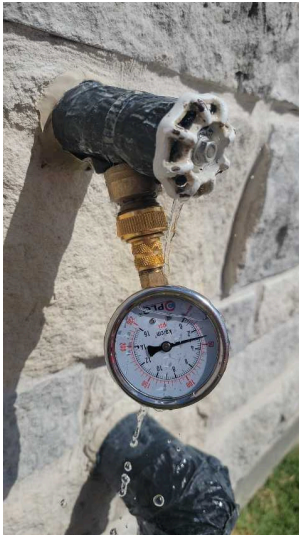
*I observed a leak at an exterior plumbing fixture when in use. This was noted at the gate valve hose bibb on the side of the house near the garage.*

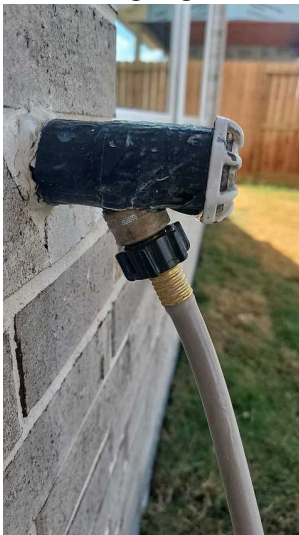
*I observed a leak at an exterior plumbing fixture when in use. This was noted at the hose bibb in the backyard.*

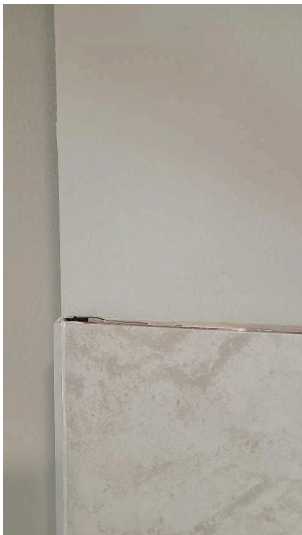
*I recommend sealing between the shower tile and wall assembly. This was noted at the inside corner shower/wall intersection of the front upstairs secondary bathroom from the right of the staircase that includes the bathtub.*

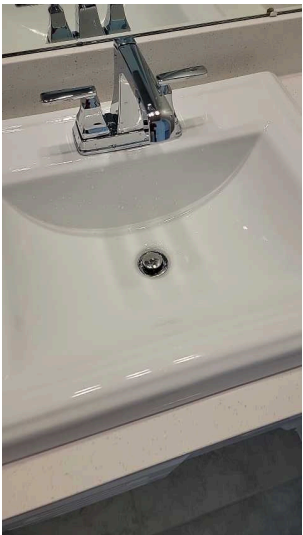
*I observed the water was not responding to cold at a plumbing fixture. This was noted in the front downstairs bathroom in the secondary bedroom. There was no water coming out of the cold water side of the fixture.*

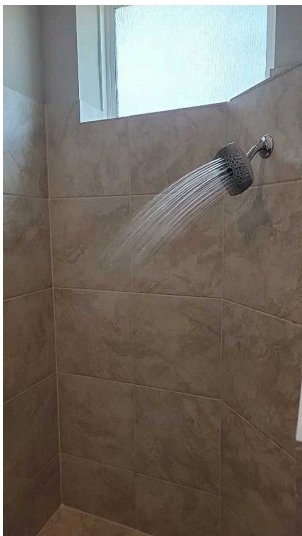
*I observed the water pressure was low at the shower at the time of the inspection. This was noted in the front downstairs bathroom in the secondary bedroom.*

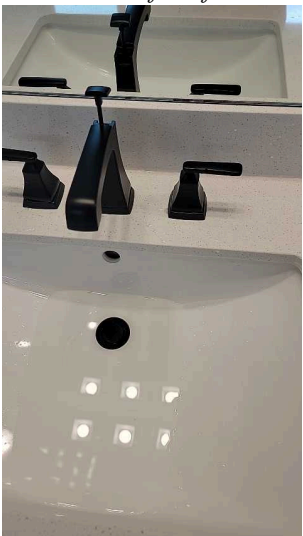
*I observed the water was not responding to cold at a plumbing fixture. There was no water coming out of the cold water side of the fixture at the left sink in the master bathroom.*

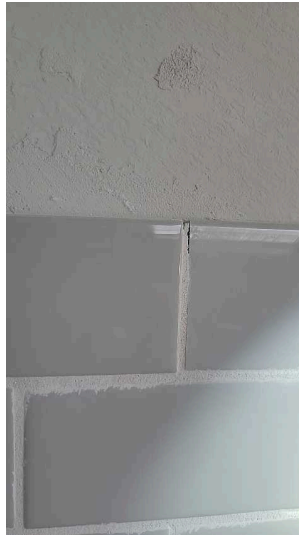
*I observed missing grout at the shower enclosure I recommend it is sealed correctly to prevent moisture intrusion behind the wall cavity. This was noted on the inside corner of the shower assembly that is over the shower bench.*

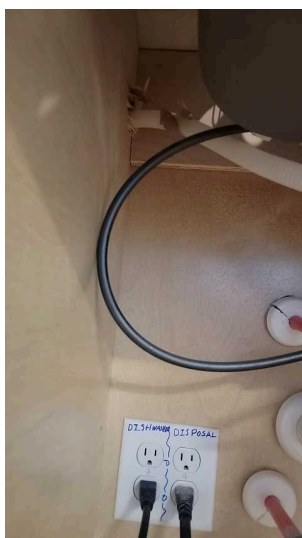
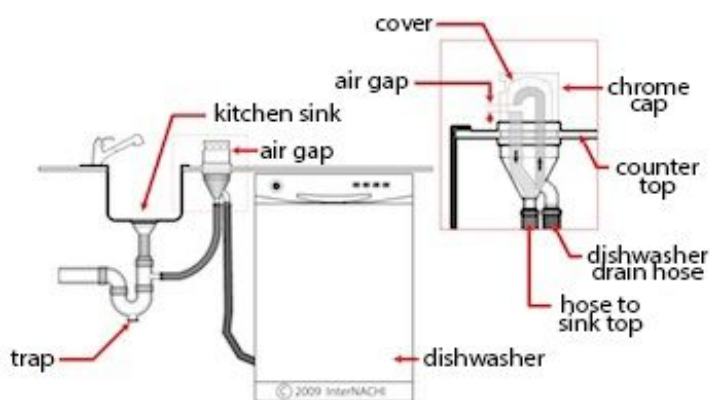
Dishwasher Air Gap

*REPAIR ITEM: I observed there was no air gap or "high loop" present on the dishwasher drain hose. An air gap or "high loop" prevents backflow of water into the dishwasher from the sink and/or water siphoning out of the dishwasher during operation. I recommend repair by a licensed plumber.*

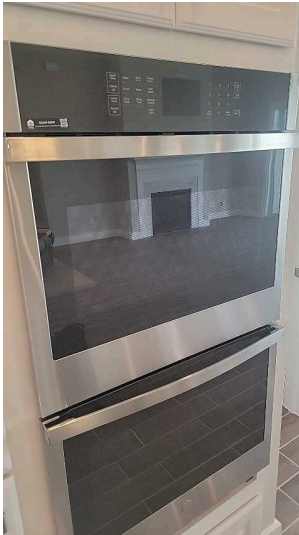
*I observed there was no power at the oven(s) at the time of the inspection.*

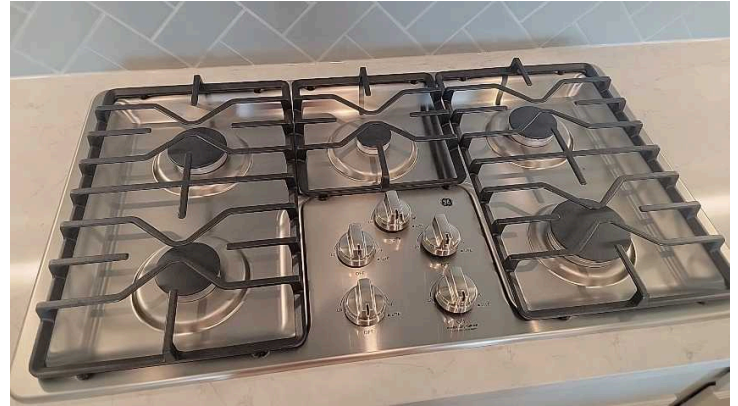
*I observed the gas range was inoperative at the time of the inspection.*

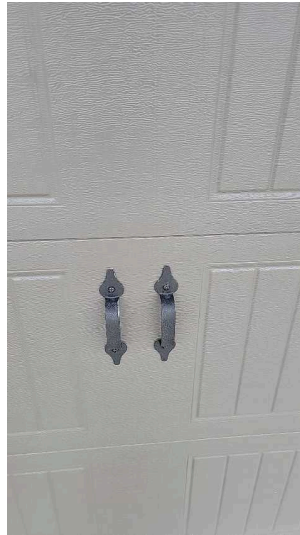
- I observed loose exterior garage door handles at the time of the inspection.

*I observed loose exterior garage door handles at the time of the inspection.*
