# Property Inspection Report

**123 Elm Street, Houston, TX 12345**  
**Inspection prepared for: John Smith**  
**Date of Inspection: 4/25/2022 Time: 10 am**  
**Age of Home: 2022 Size: 4,098 Sqft.**  
**Weather: partly cloudy**

**PROPERTY INSPECTION REPORT FORM**

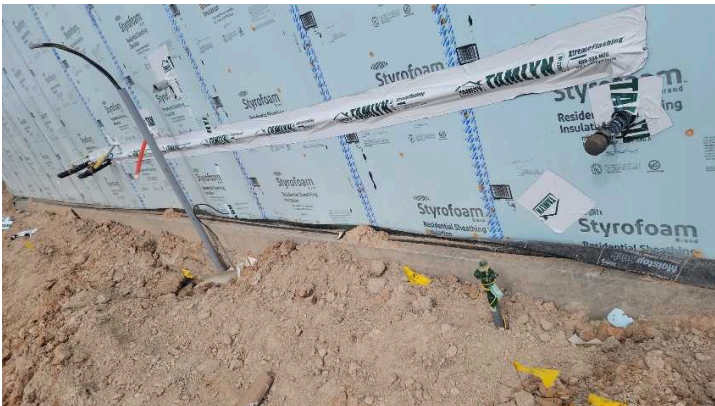
- I observed the masonry or stone veneer flashing/vapor barrier was not set in place at the ledge and/or corners of the foundation wall. If this is not present the brick or stone veneer will adhere to the concrete causing it to expand due to heat and can result in corner pops.

*This was noted along the left side of the property when facing the home from the street.*

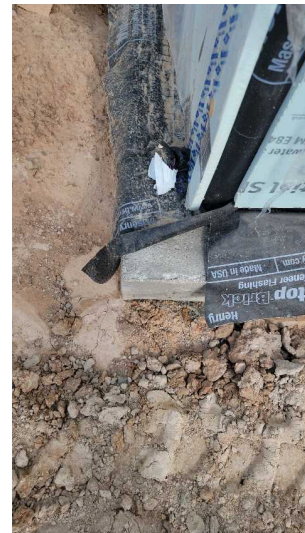
- I observed the masonry or stone veneer flashing/vapor barrier was torn at the time of the inspection. If this is not present the brick or stone veneer will adhere to the concrete causing it to expand due to heat and can result in corner pops.

*This was noted throughout the perimeter of the home.*

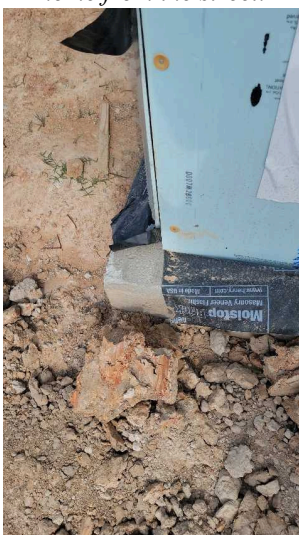
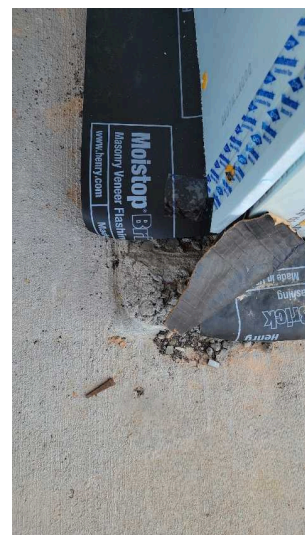
*This was noted throughout the perimeter of the foundation wall.*

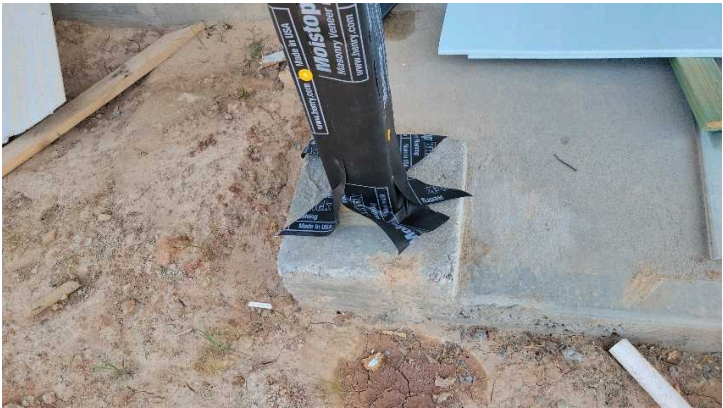
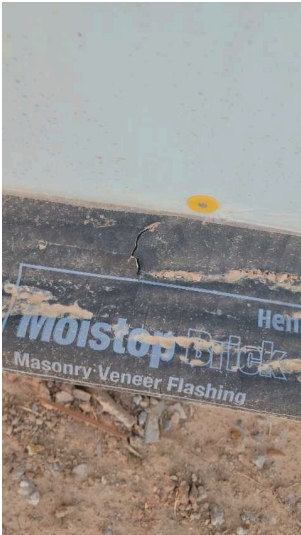
I observed the masonry or stone veneer flashing/vapor barrier was torn at the time of the inspection. If this is not present the brick or stone veneer will adhere to the concrete causing it to expand due to heat and can result in corner pops. This was noted at both columns.

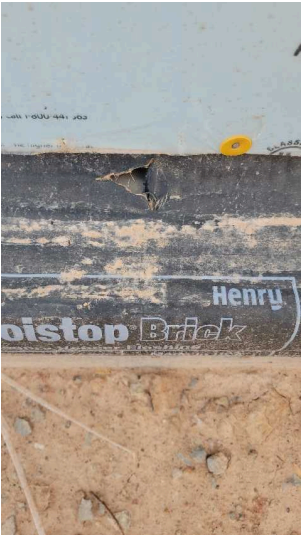
I observed the masonry or stone veneer flashing/vapor barrier was torn at the time of the inspection. If this is not present the brick or stone veneer will adhere to the concrete causing it to expand due to heat and can result in corner pops.

*This was noted throughout the perimeter of the home.*

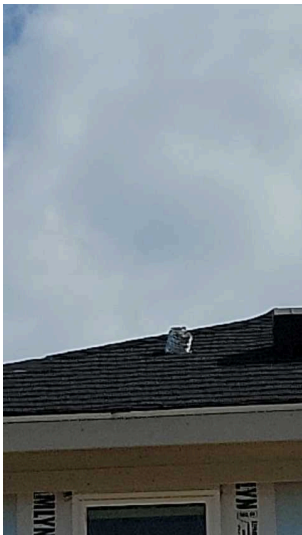
I observed an inappropriate vent material protruding through the roof at the time of the inspection.

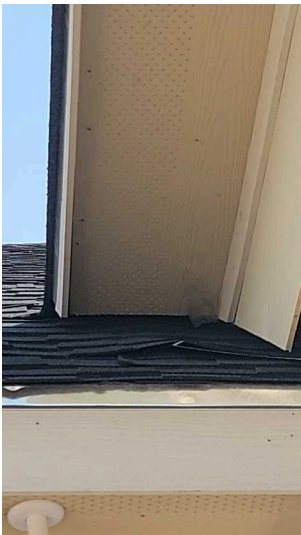
I observed flashing needed to be reset on the roof covering material at the time of the inspection. This was noted on the left side of the back porch over the AC secondary condensate lines.

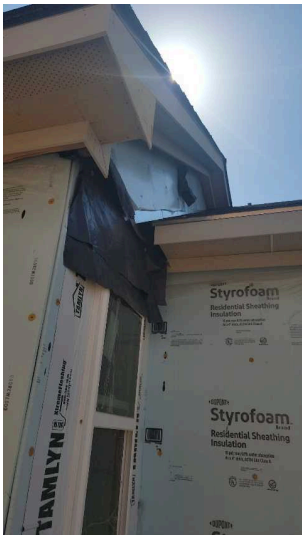
I observed kickout flashing to be lacking or needs to be extended further out. The kickout flashing details observed at the lower bottom edge of the roof line interface and the sidewall that continues past the edge of the roof should be extended if installed. Kickout flashing is installed to prevent water runoff from entering behind the exterior wall covering. The lack of a proper kickout flashing will allow water to penetrate at these points. This will also help to prevent discoloration of exterior walls at the bottom of the roof/wall intersection and direct water into the gutters. This was noted on the left side of the home when facing the property from the backyard.

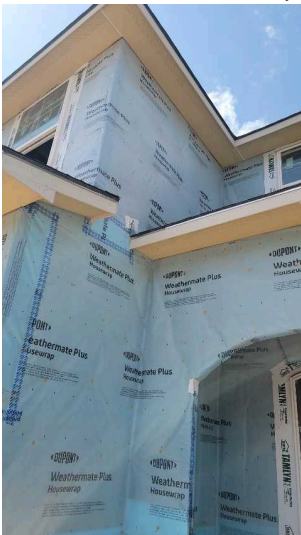
This was area lacking kickout flashing was noted over the front porch.

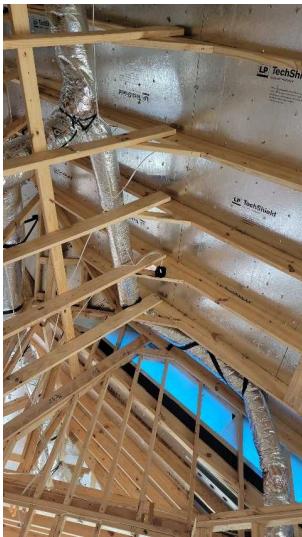
*I observed the purlin was not flush with the rafter at the time of the inspection. A purlin is a horizontal structural member in a roof that supports a rafter. This was noted at multiple purlins in the back right corner when walking in through the front door.*

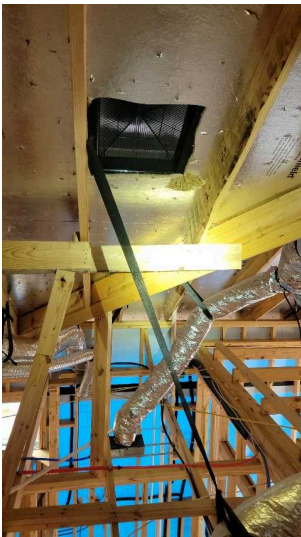
*I observed damaged radiant barrier at the time of the inspection. This was noted in the attic space over the right of the home when facing the property from the street.*

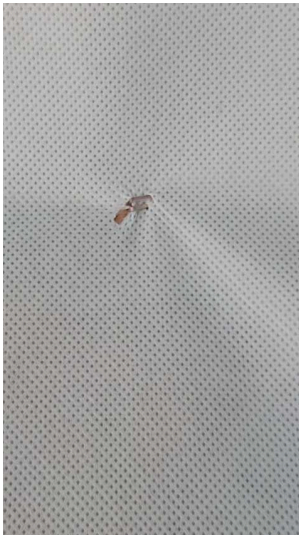
- I observed a tear or puncture in the Housewrap at the time of the inspection I recommend it is taped over as this can potentially reduce its effectiveness.

*This was noted to the left of the garage entrance on the housewrap.*

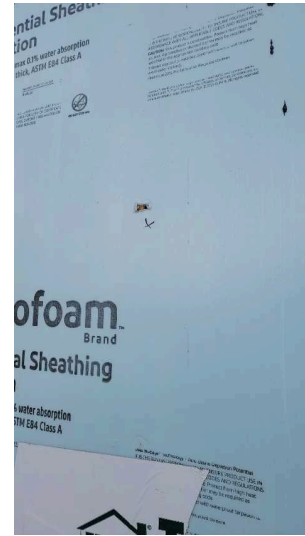
*I observed a fastener was driven through the housewrap at the time of the inspection. I recommend it is sealed with flashing tape as holes, tears and other types of damage can potentially reduce its effectiveness. This was noted on the left side of the home above where the electrical connection point and meter will be.*

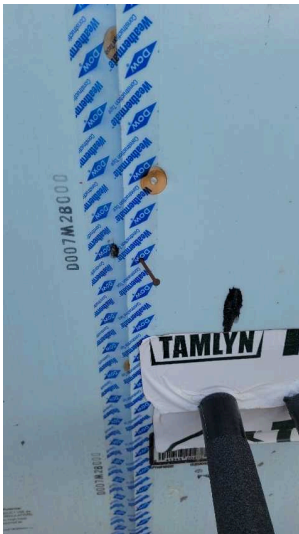
*I observed a gap in the exterior structural sheathing I recommend it is sealed appropriately. This was noted on the left side of the home when facing the property from the street.*

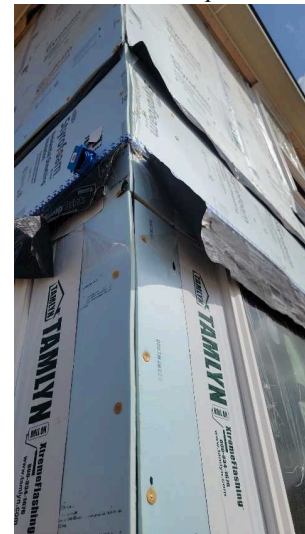
*I observed a gap in the exterior structural sheathing I recommend it is sealed appropriately. This was noted near the back right corner of the property when facing the home from the backyard.*

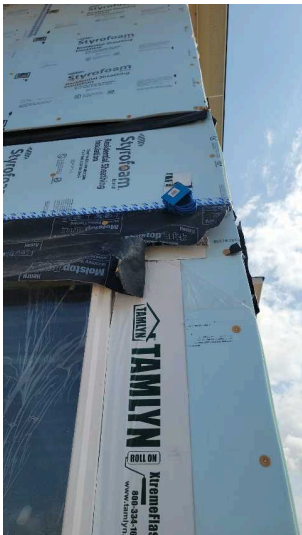
I observed tore masonry veneer flashing. This was noted over the back right window in the backyard on the right side.

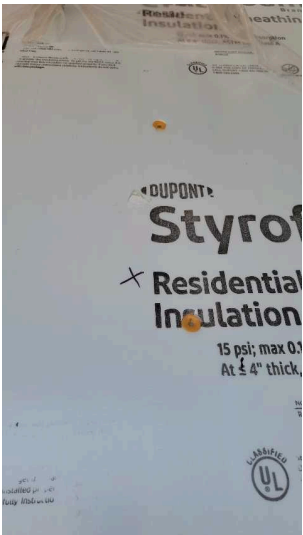
This was noted in the backyard near the back entrance.

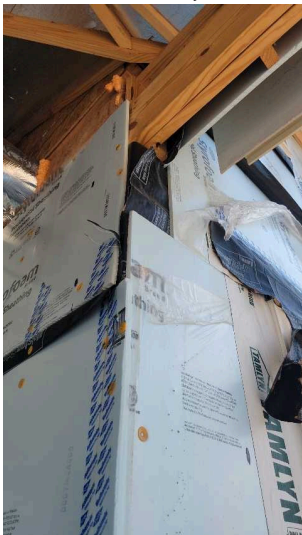
I observed a section of the exterior wall to be missing structural sheathing at the time of the inspection. This was noted to the right of the back porch.

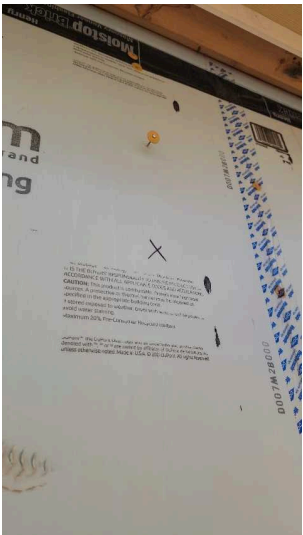
I observed a loose fastener in the structural sheathing of the exterior wall. This was noted on the left side of the house when facing the property from the backyard.

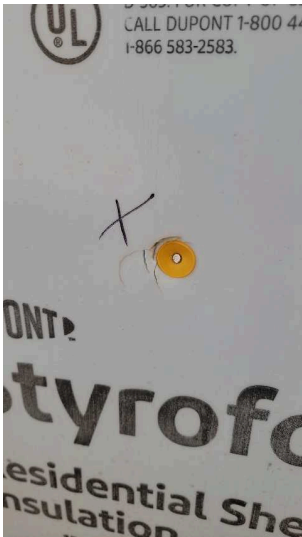
*This was noted on the left side of the house when facing the property from the backyard.*

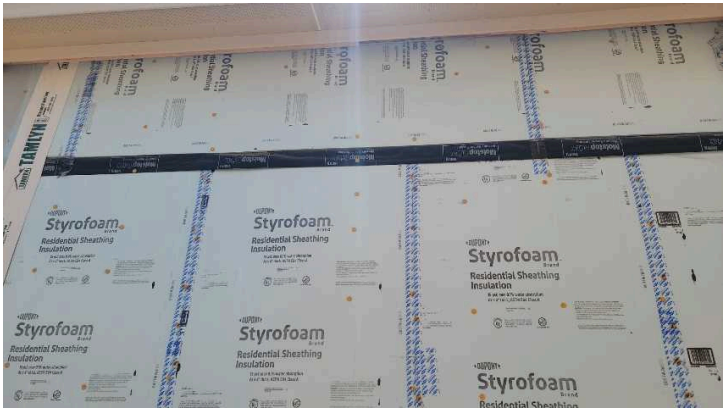
*I observed the sheathing insulation was not butted up so that the top section is not flush with the lower level and creating a potential area for water leach down into the wall. This was noted on the right of the front of the home when facing the house from the street.*

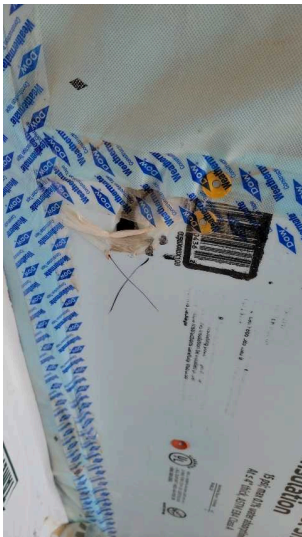
*This was noted near the front door on the right.*

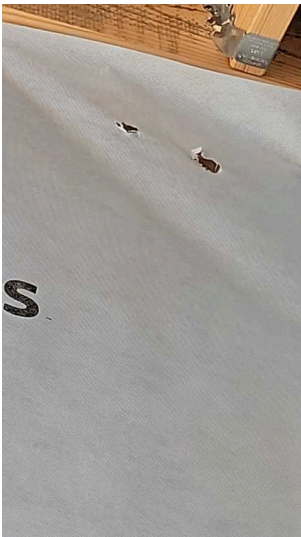
*This was noted on the top left near the front door area.*

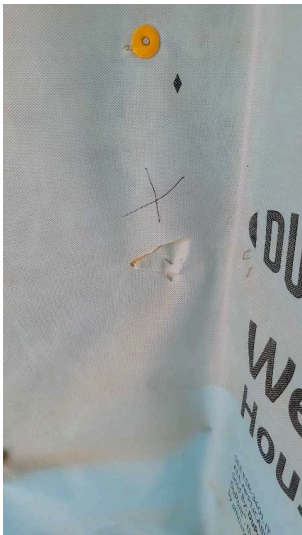
*This was noted next to the window in the front porch area.*

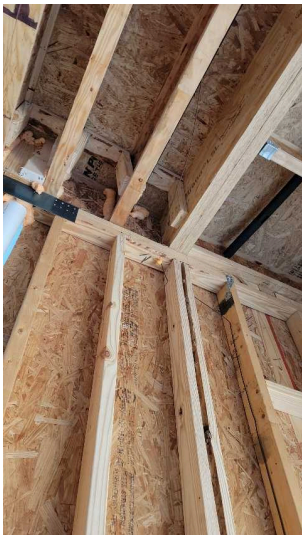
*I observed missing fire caulk at the time of the inspection. This was noted in the garage in the stud bay above the double top plate.*

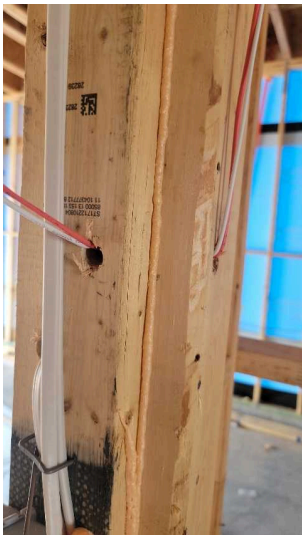
*This was noted in the laundry room on the wall near the garage entrance.*

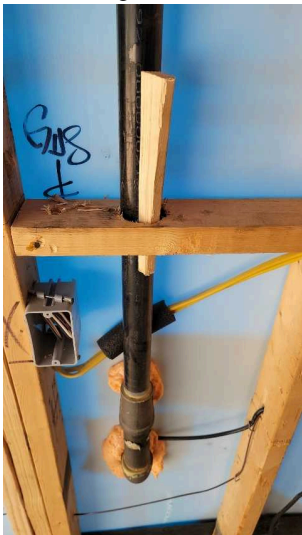
*This missing nail plate was noted in the garage on the exterior wall.*

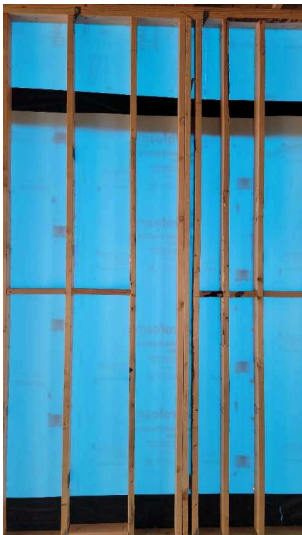
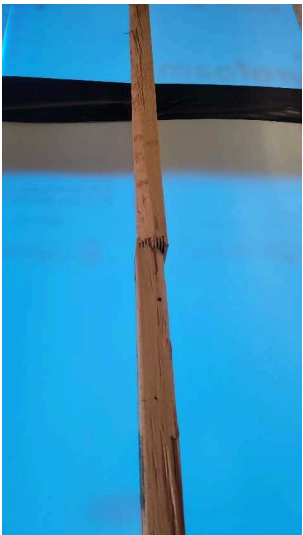
I observed missing fire blocking at the time of the inspection. This was noted in the interior wall of the garage.

This was noted in the garage area on the exterior wall near the electrical panel.

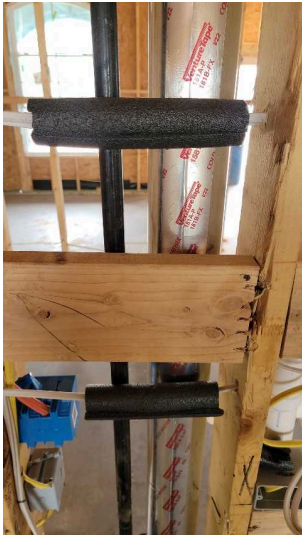
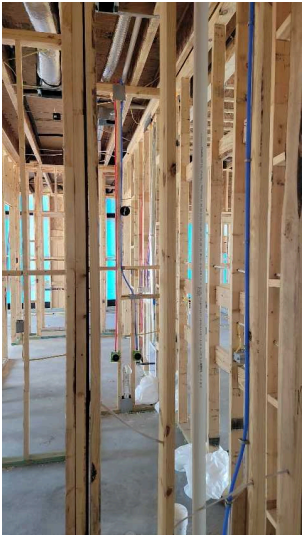
I observed a missing nail plate at the blocking for the cabinetry at the time of the inspection. A nail protection plate helps prevent nails from piercing pipes and electrical lines after the drywall is installed and the finish trim is being applied. Nail protection plates are typically installed over utilities that pass through framing members. The blocking used for cabinetry fasteners tend to be longer than the standard 1 1/4 inch drywall screws which has the potential to cause damage behind it. This was noted in the kitchen opposite the laundry room.

I observed missing fire blocking at the time of the inspection This was noted in the front hallway to the left when you walk in the front door.

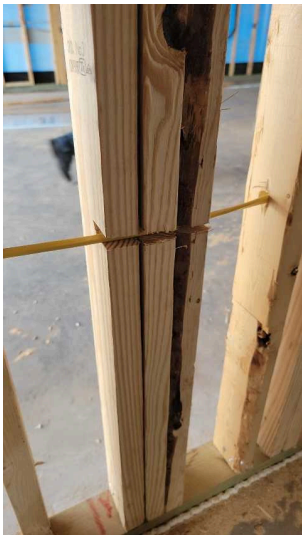
*These missing nail plates were noted in the front room next to the garage.*

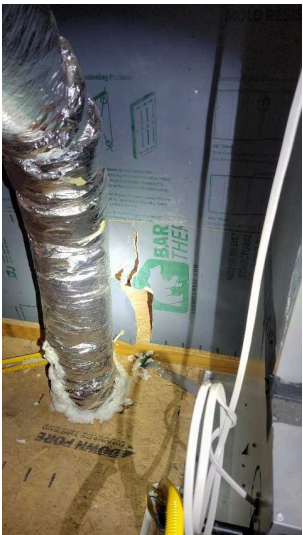
*This was noted in the attic space.*

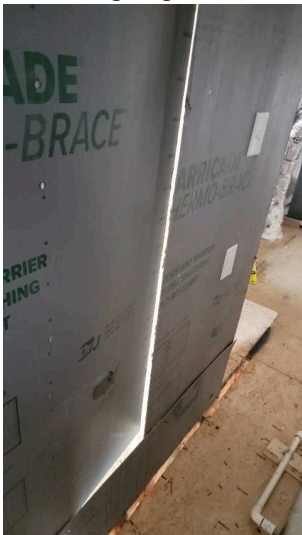
*I observed the structural sheathing needed to be refastened. This was noted in the attic space.*

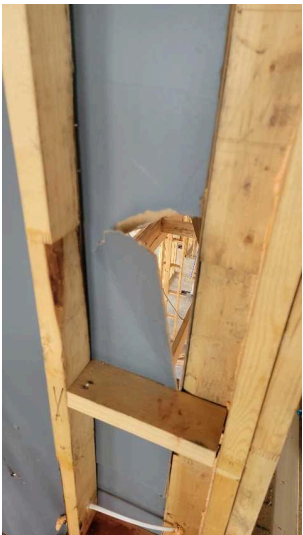
*I observed a tear or puncture in the structural sheathing. This was noted in the upstairs wall in front of the top of the staircase.*

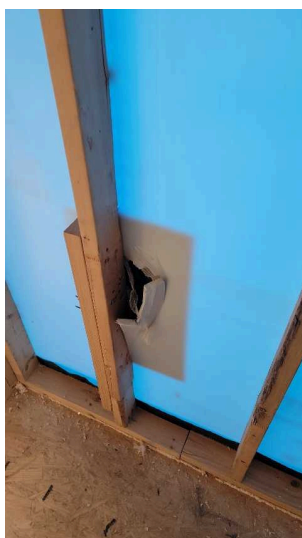
*This was noted in the upstairs closet, on the top right corner when facing the home from the backyard.*

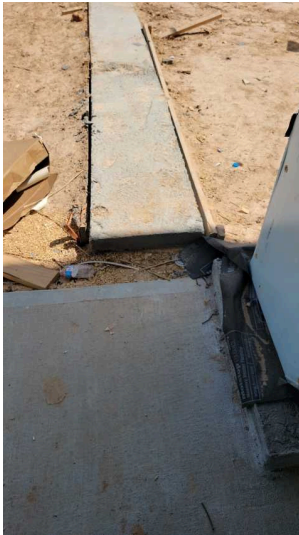
*I observed the sidewalk leading to the front porch was not flush at the time of the inspection.*

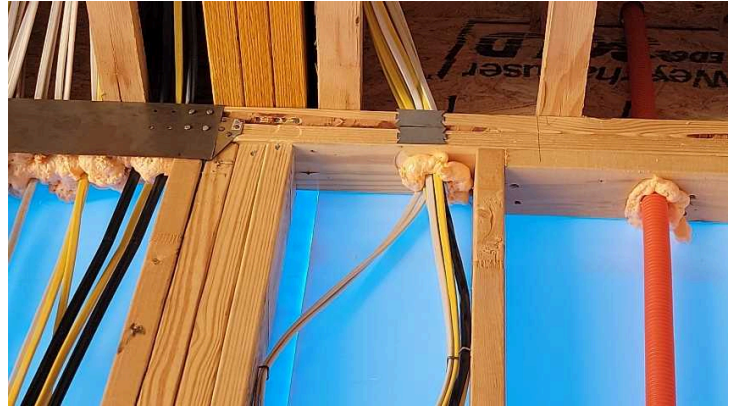
*I observed the lack of a larger nail protection plate at a top or bottom of a wall. A larger nail plate should extend 2 inches past where the electrical or plumbing is penetrating a wood member to avoid potential damage during the drywall installation. This was noted on the exterior wall of the garage.*

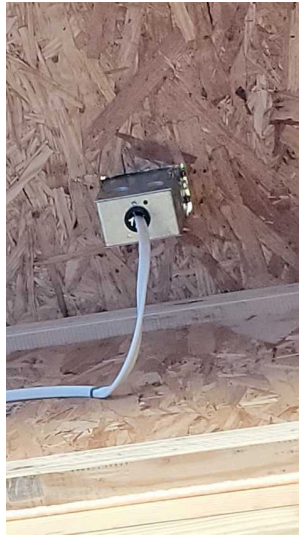
*I observed missing fire caulk at the time of the inspection. This was noted in the garage near the staircase on the ceiling.*

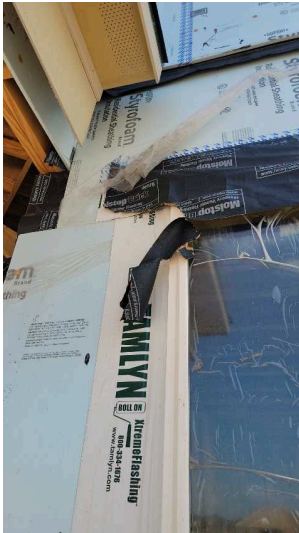
*I observed tore masonry veneer flashing. This was noted over the back right window in the backyard on the left side.*

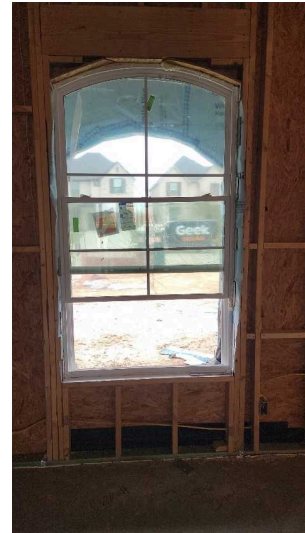
*I observed the window was inoperative at the time of the inspection. This was noted in the front room overlooking the front porch.*

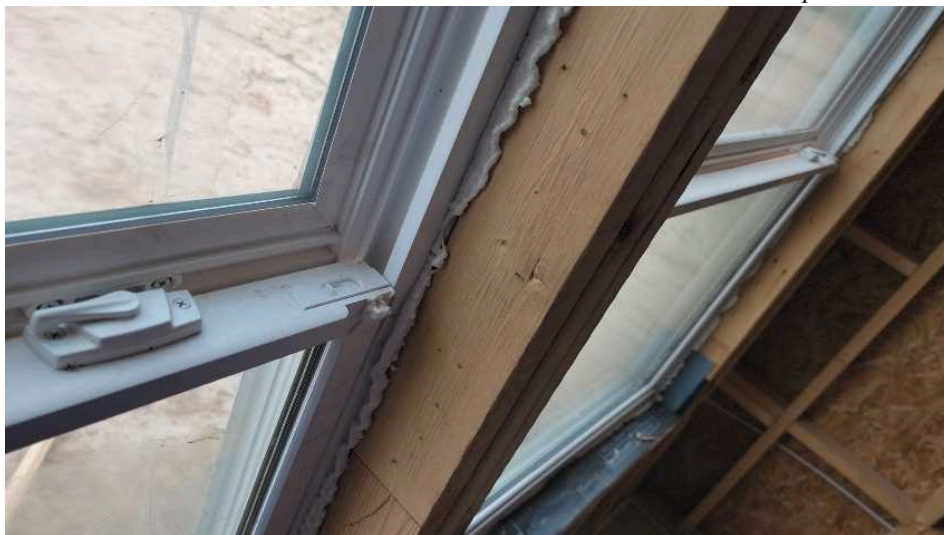
*These windows were noted in the far back right room facing the backyard when walking in from the front entrance.*

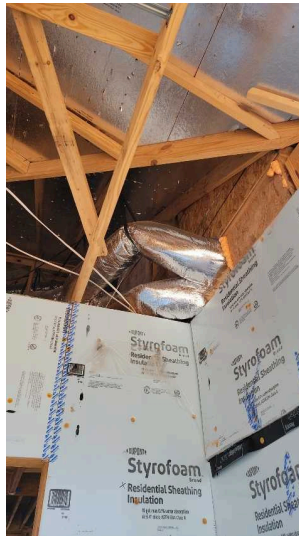
*I observed the ductwork in the attic to be sagging and/ or kinked (crimped) and not supported at 4' spacing as recommended. I recommend all ducts are open to allow for proper airflow therefore not restricting the efficiency of the system. This was noted over the back porch area to the right when facing the home from the backyard.*

It is recommended that a licensed HVAC technician further evaluate the ducting and vents, and make all necessary repairs/replacements.

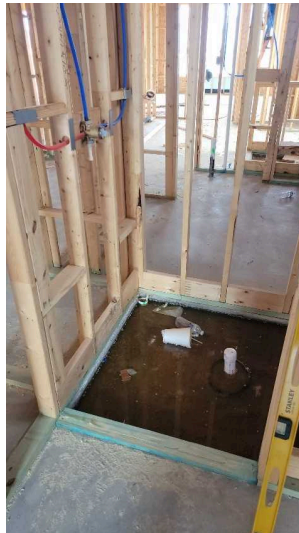
*I observed the shower liners to be inaccessible throughout the home due to water leak tests at the time of the inspection.*
