At the Repair Bench – Icom IC-3210 – July 2023

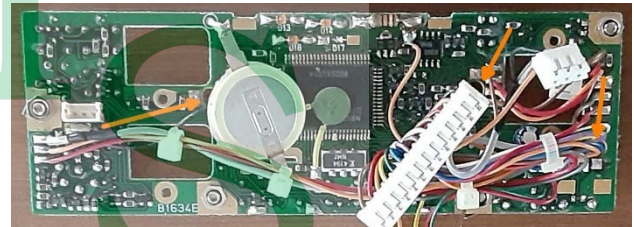
Figure 4 - Logic PCB with lamp holes indicated

The backlight problem was one that was to be expected with a radio of the age of this particular unit. The front panel on this model is backlit by a set of three T-1 12VDC incandescent lamps that are soldered in place on the front panel printed circuit board (PCB), called the *logic board* by Icom. Each of these lamps is covered with a yellow plastic boot (Figure 2) that provides the desired color to the illumination provided. The lamps sit down into holes in the PCB (Figure 3 & Figure 4) and have their wire leads soldered to pads on

the PCB. The PCB holes index with recesses in the front panel carrier housing, directing the provided light into the rear area of the panel. All three of the lamps were burned out.

Once the PCB is stripped down as far as is possible, removal of the lamps was a simple matter of heating their soldered lead connections and lifting the lamps out of their holes. I then cleaned the excess solder off the pads using a soldering iron and some flux-impregnated braided solder wick.

As mentioned above, I had decided to use LED's instead of the OEM incandescent type of lamps for the replacements. I chose cool white LED's in the 3mm (T-1) size, and I paired each LED with a 1k Ω resistor for current-limiting purposes. I removed the yellow plastic boots from the original lamps and installed them onto the LED's. I then placed the LED's in the lamp holes of the PCB, soldering the cathode leads to the appropriate pads. Next, I added a resistor to each of the LED anode leads, and then soldered the opposite end of the resistors to the appropriate PCB pads. Application of 12VDC from a power supply to the PCB showed that all three LED's worked perfectly. It was time to move on to the other problem that the radio's owner had reported.

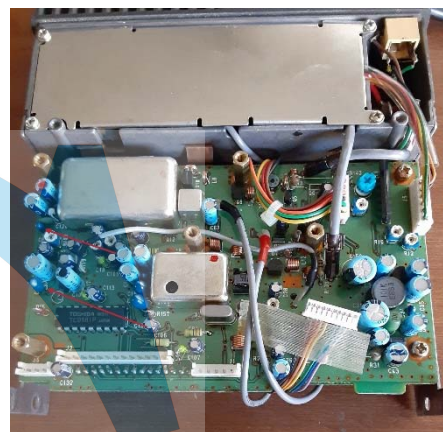
Figure 6 - Locations of failed capacitors

the main PCB are known to fail together with this switch. What happens is that two tantalum capacitors, C87 (0.22 μ F/35V) and C97 (4.7 μ F/35V) (Figure 5) have a tendency to fail with high leakage, causing the UHF phase-locked loop circuit to lose phase lock. The user causes the switch damage by repeatedly working the switch, often aggressively, in an attempt to get the radio to lock onto the UHF band. This action causes the switch to become fatigued internally, leading to the switch failure found on this unit. As a result, the switch merited replacement, as did the two tantalum capacitors. On testing of the removed

capacitors, they both had extremely high DC leakage values, and had ESR readings of 14.6 Ω for C97 and 9.3 Ω for C87.
