Yaesu G-5500 Rotator Controller Repair

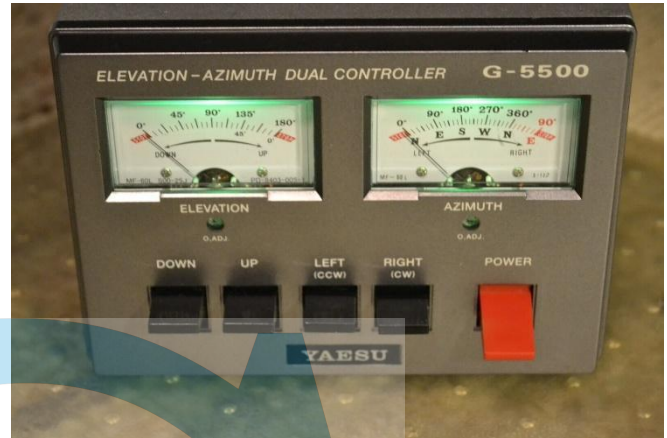
Back at the end of September, we had a rather strange occurrence at the GCARC Clubhouse. One of our members was at the Satellite station and found that the AZ-EL rotator was inoperative. The controller for this rotator is the Yaesu G-5500 model as shown in Figure 1. A little bit of rudimentary troubleshooting led to the discovery that the power inlet fuse, a 2-ampere Type 3AG 1/4" x 1-1/4" glass fuse, had gone open. He attempted to replace the fuse, and ended up getting a shock and also blowing the new fuse as well. As that was the only spare fuse of that type on hand at the Clubhouse, I came back the next day prepared with a few of the correct fuses with me. At a first glance, we (**Frank Romeo N3PUU** and I) found that the motor output wires on the back of the controller, especially for the Azimuth output, were loose and had been shorting to each other and to the controller chassis. We made the decision to change the "wire under screw head" arrangement that existed to a more orderly system of wire terminals designed to be secured under screw heads. I installed a full set of such terminals on both the azimuth and the elevation (which also turned out to have loose leads) wire lead sets. Thinking that I may have corrected the problem. I installed a new fuse and plugged the unit in. On plugging it in however, the fuse blew again immediately.

Figure 1 -- Yaesu G-5500 controller

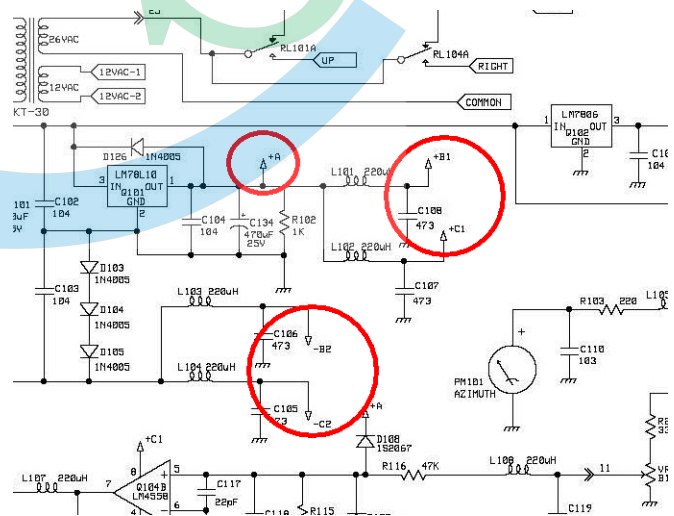
This controller has several operating voltages in its circuitry, identified on the schematic as +A, +B1, +C1, -B2, and -C2 (see Figure 4). While none of these voltages are clearly identified on the schematic as to amplitude, it is clear that +A is +10VDC as it is directly at the output of the LM78L10 voltage regulator. The other positive voltages, which are simply highly-filtered +10VDC sources, are derived from that +10VDC source, while the negative voltages are derived from a diode stack. A quick look at the schematic shows that the two negative voltages are simply produced via three series diode drops of approximately 0.7V each, giving us roughly a negative 2-volt potential there. The two negative supplies are filtered and each is used for one of the two 4558 op-amps, supplying -2.0VDC to the negative rails of the op-amps. Taken together with the filtered +10VDC

Figure 4 - Controller operating voltage sources

I replaced both of the voltage regulator IC's and the two 470 μ F capacitors on the board, and this restored full operation of the controller *when supplied by my bench power supply*, with the exception of the panel meter lamps, one of which was still burned out. My next job was to replace both of the panel meter lamps, going by the philosophy that they were of the same age and therefore the second one was likely to fail soon as well. That was a simple and straight-forward parts replacement job.

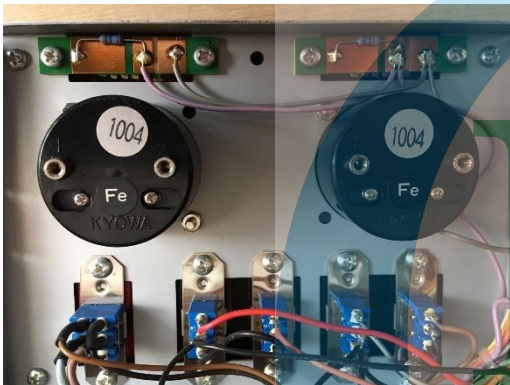
Figure 5 - Front panel rear view

The original panel lamps were of an axial or tubular design (Figure 5), having one wire lead coming out of each end of the tubular envelope. The lamps were supplied directly from the 12VAC secondary winding, and each lamp had a 47-ohm current limiting resistor wired in series with the lamp. I chose a T-1 type lamp with radial wire leads as the replacement, selecting a 14-volt 0.91-watt lamp for the replacement units. I could have converted these lamps over to LED's by adding a rectifying diode to each of the

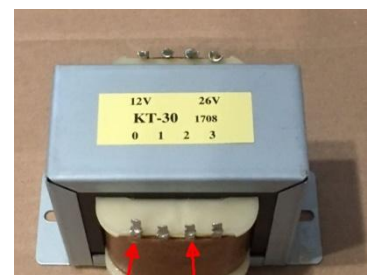
The power transformer has three windings, a single (effective) primary and two secondaries, as already described. Figure 7 illustrates the power transformer used in this controller, with the terminals of the primary winding that are used in the 117VAC version indicated by the red arrows. In general terms, the higher a voltage to be expressed across a transformer winding will be, the higher that winding resistance will usually be. In the case of the Yaesu transformer in this controller, what I found initially was 0.8 Ω across the primary winding, and 0.1 Ω across the 12VAC secondary with 0.00 Ω across the 26VAC secondary. These readings

Figure 7 - Power transformer

were low enough that they were basically unreliable, so I decided to measure them again using my Ascel $\text{Æ}20218$ milli-ohmmeter. In this test, I measured 0.674Ω across the primary winding, 0.385Ω across the 12VAC secondary winding, and 0.128Ω across the 26VAC secondary winding. These readings, while quite accurate due to the nature of the Ascel $\text{Æ}20218$, reveal a bit of a problem. Following the conventional “higher voltage, higher resistance” logic, the 26VAC winding should have had more resistance than does the 12VAC winding. In addition, I believed that the primary winding resistance was considerably lower than it should properly have been. In theory, it should have been the greatest of the three resistances. I resolved to measure the winding resistances of the new transformer when it arrived, using the milli-ohmmeter.

A quick glance at the table will show that the only winding of the original transformer that has a resistance measurement anywhere near that of the new (factory replacement) transformer is the 12VAC output secondary winding. In this table, those connections displayed in **bold** typeface are the connections that are used in this controller model. The values that are shown in **red** type are the failed values, while the **green** values are the acceptable values. Of course, *all* of the values in the “Replacement” column are acceptable values, as they are the values of the new transformer.

It is unusual for multiple windings to develop short circuits simultaneously *unless, of course, the failure of one winding was the direct cause of the failure of the other winding*. I believe that a cascade failure of that type is exactly what happened here.

Remember that one of the original findings was that the motor power leads were shorting at the back of the controller. I suspect that this short circuit caused excessive current draw through the 26VAC secondary winding, which in turn caused excessive current draw in the primary. I believe that it was the heat caused by this excess current that led to the failure of the transformer

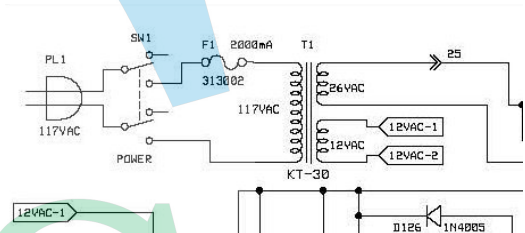
Figure 11 - Power inlet circuit

The power inlet of this controller switches both the line and the neutral wires, using a DPDT paddle switch as the power switch (see Figure 11). The circuit has the power cord line side connected to the common on one half of the DPDT power switch. From the switched terminal of that side of the switch, the circuit goes to the fuse. From the fuse, the circuit goes through the primary of the power transformer. Coming out of the transformer primary, the circuit goes back to the switched terminal of the second side of the DPDT power switch. From there, the common on that side of the switch is connected to the power cord neutral. What I found was that while one pole of the DPDT paddle switch was switching, the other pole was not, and that pole was shorted (closed) to the active circuit. It was the fused (line) side that was shorted, meaning that even when switched "OFF", line current was available at the fuse and then at the transformer. To make things worse, the switch did not even switch that one pole each and every

time the paddle was moved, giving a hit or miss action to the switch. The result was that even when the switch lever was in the was “OFF” position, sometimes the circuit was actually “ON”, which accounts for the fuse blowing as soon as I plugged the controller in with the switch “OFF”.

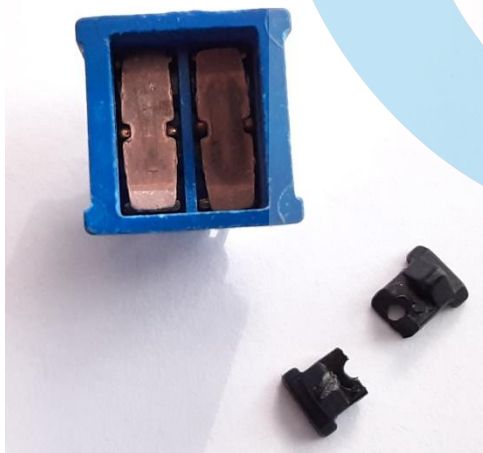
Figure 12 - Switch body and broken operating bar

Being a curious cuss, I disassembled the paddle switch by prying open the retaining tabs that secure the switch body to its upper-half operating mechanism. Inside this switch, there are two teeter-totter contact bars that are supposed to rock back and forth between the opposite ends of the switch when the switch is operated. The single paddle lever is connected to a short toggle shaft, which is inserted into a plastic operating bar, which in turn slides along the teeter-totter contacts as the switch paddle is moved, thus rocking the contacts (see Figure 11). This plastic bar was broken into two pieces, and one side of the switch had the teeter-totter contact bar welded to the output terminal.

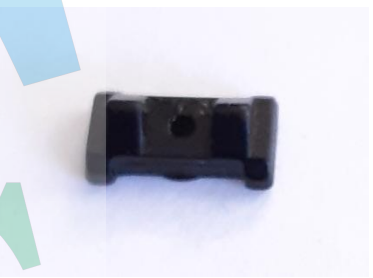
Figure 13 - Repaired operating bar

I was able to free up the teeter-totter contact bar by exerting a little bit of force on it, breaking the tiny weld. I then used some cyanoacrylate cement to glue the two pieces of the operating bar back together (Figure 13). Finally, I was able to re-assemble the switch, crimping the tabs back into place. Voilà! The switch worked as it should, with proper snap action as the paddle was moved. However, knowing that the switch was on borrowed time, I went ahead and ordered the replacement switch from Yaesu so that I would have it if and when the switch failed again.
