# Icom IC-756 VFO Encoder Repair

It seems like certain repair types run in groups. This is the third IC-756-series radio (Figure 1) that I have had on the bench in the past two months, and this one was another case of a failed VFO encoder. The symptoms that the owner reported to me were that there was no response on the display when she rotated the VFO knob in one direction, and a skipping response when rotating the VFO knob in the opposite direction. These are some of the typical indications of a failed encoder.

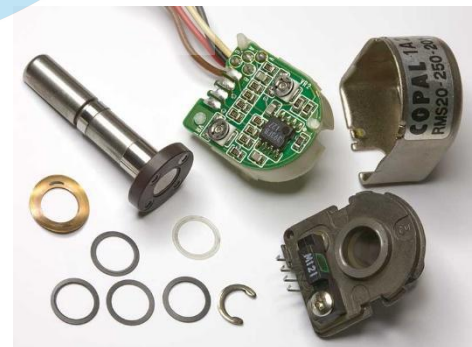
Figure 3 - Encoder fully disassembled

For now, let's take a closer look at the encoder. This encoder, shown fully disassembled in Figure 3 and unlike many that are found in amateur radio applications, is magnetic rather than optical. Physically, there is a wheel that is mounted to the shaft and therefore rotates with the shaft. This wheel consists of a

Unfortunately, there is another failure mode for these encoders. The circumstance can exist whereby the encoder produces a single pulse train in its “normal” condition, but if the shaft is held outward or away from the body of the encoder, it will produce both pulse trains. The user indication of this condition is the fact that when turned normally, the VFO seems to “skip” or jump in steps rather than varying smoothly. However, if the VFO knob is pulled outward while it is turned, the VFO adjustment seems to vary normally. I have seen this failure mode a few times, and the solution in every case is to replace the encoder *unless you have a source of proper shim washers*. I believe that in these cases, the cause is the disintegration of one or more shim washers that start out life on the shaft of the encoder, between the magnet wheel and the body of the encoder. In every case with this type of encoder failure, it has been accompanied by a fine black powder emanating from the encoder, coming out along the shaft. These shim washers can be seen in the photo of the disassembled encoder presented earlier.

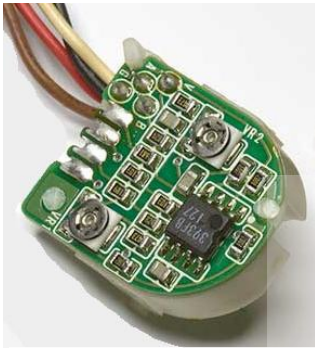
Figure 4 - Encoder PCB

The processing circuitry is comprised of an LM393 dual comparator IC, a pair of potentiometers, and several resistors and capacitors. While the LM393 is primarily responsible for the square or digital shaping of the pulse train, the pulse widths of the two separate pulse trains generated must be equal (or *balanced*) in order for the pulse trains to be meaningful and reliable. This balance between the independent spontaneous widths of the two pulse trains is adjusted via the twin potentiometers on the circuit board, with each potentiometer affecting one of the two pulse trains.

There are four wires attached to the PCB (Figure 4), as well as the four leads from the Hall-effect sensor body. The wires are as follows:

The LM393 comparator IC used in this encoder is in the SOIC-8 package, a surface-mount type measuring a mere 4mm x 6mm body size. It is best removed using some solder wick to pull most of the solder out, and then using a dental pick and the soldering iron to heat and gently lift the chip at the same time, one side at a time. Be careful not to overheat the PCB or to pull traces off the board, because at that point, the encoder must be replaced. Work slowly and carefully, using limited heat, and you should be successful.

Once the IC has been removed, clean the pads with the solder wick, and then clean the PCB with some 99.9% IPA. Lightly tin the pads, and then apply an abundance of liquid flux to the area. Place the new IC onto the pads and heat its leads enough to bond them to the tinned pads. Touch up the soldering of the leads as necessary. Clean up the excess flux with some 99.9% IPA, and then you are ready to adjust the pulse train balance.

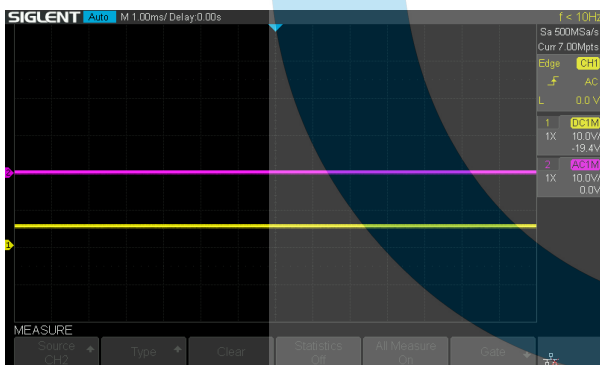
Figure 5 - No pulse train outputs

1. No output traces at all:
  - a. power supply inoperative;
  - b. misconnected encoder;
  - c. open circuit(s) on PCB; or
  - d. failed comparator IC.
2. Two flat traces (no pulses) (Figure 5):
  - a. failed Hall-effect sensor;
  - b. badly imbalanced encoder; or
  - c. failed comparator IC.
3. One flat trace and one pulse train (Figure 6):
  - a. failed Hall-effect sensor;
  - b. imbalanced encoder; or
  - c. failed comparator IC.
4. Two pulse trains with one pulse train having a greater amplitude:
  - a. imbalanced encoder.

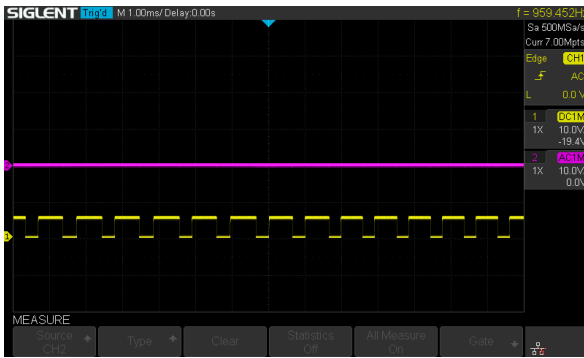
Figure 6 - Single pulse train

With a helper, it is possible to adjust the potentiometer(s) while the encoder is turning. Be sure to turn the encoder at a relatively slow rate, but fast enough to produce a consistent pulse train. If no pulse train at all can be developed, or if only a single pulse train can be produced, it is most likely time for a replacement of the comparator IC.

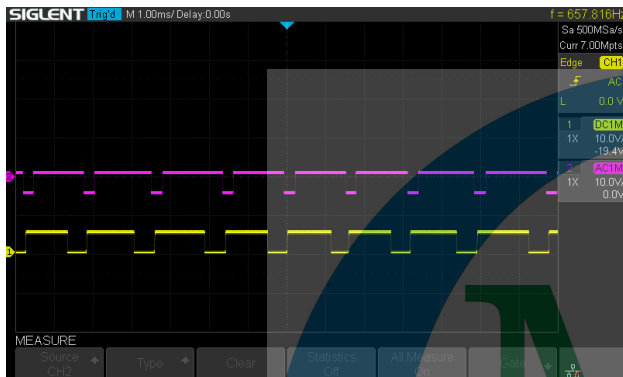
Figure 8 – Imbalanced pulse trains

5. Two pulse trains with unequal pulse widths (Figure 8):
  - a. imbalanced encoder.
6. Two pulse trains of equal heights and widths (Figure 9):
  - a. normal indication of a properly working encoder.

If, while testing the encoder with the oscilloscope, any imbalance in the pulse trains or missing pulse trains are noted, attempt to adjust the potentiometers before condemning the comparator IC. Each potentiometer controls the pulse formation on one of the two outputs. When adjusting the potentiometers, adjust in very small increments, as it is easy to turn right through the active portion of the range. These potentiometers are full-rotation devices without limit stops in their design, so they can be adjusted continually in one

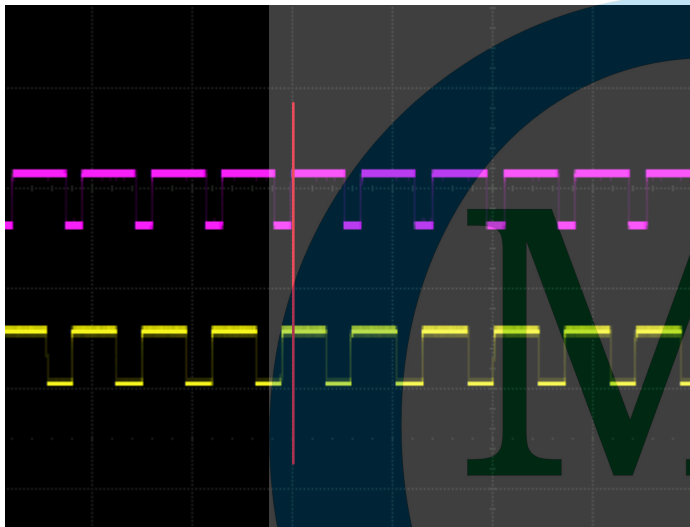
Figure 10 - Phasing indicated by red line on photo

Set up the encoder in the test configuration again, and then adjust the potentiometers for a pair of balanced pulse trains. When properly adjusted, the pulse trains will have equal amplitudes and the pulse widths will be equal between the pulse trains. Note however that the pulses will be out of phase with each other, as illustrated in Figure 10. If you reverse the rotation direction, the phase difference should reverse, swapping the leading and lagging status between the pulse trains.
