At the Repair Bench – Heathkit® HD-1234 – July 2022

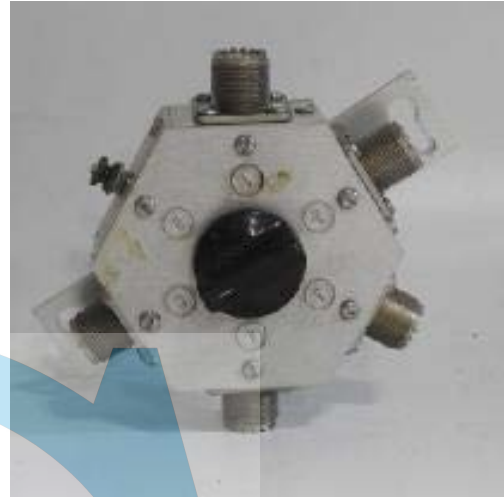
This unit has a six-position switch mechanism which connects each of the four live connectors to a common connector in turn as the switch is rotated. The device is of a hexagonal shape, with a standard SO-239 connector on each of five of the sides, and a ground post on the sixth side. The way the unit is designed, when a given position is selected, all of the other positions' connectors are grounded. The connectors are labeled "1" through "4", "C", and "G". The internal switching mechanism has no physical stop, which means that it can be rotated a full 360° if so desired.

The complaint was that positions "3" and "4" were defunct, with no connection to the common connector or to ground when selected. At first, it seemed like a straight-forward open circuit problem, such as a broken solder joint at each of the non-working connectors. Close examination, however, showed that all of the solder joints were intact. On the off chance that there were hidden defects there, I went ahead and reflowed the solder on all of the connectors, but to no avail. The problem still existed.
