At the Repair Bench – MFJ-259 SWR Analyzer – February 2023

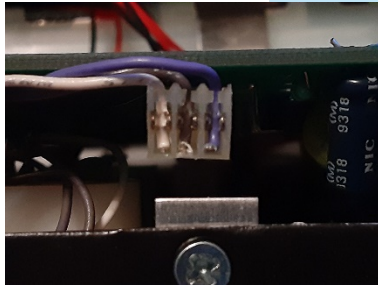
Figure 1 - Meter plug

Diving in “under the hood”, so to speak, I quickly found some cracked solder joints on the unit’s main printed circuit board. There are two meters on the front panel of this unit. One is the SWR meter, and the other is a resistance meter. These two meters are connected to the main PCB via a three-wire harness with a 90° plug at its end (Figure 1). The plug connects to a three-pin right-angle pin header on the PCB.

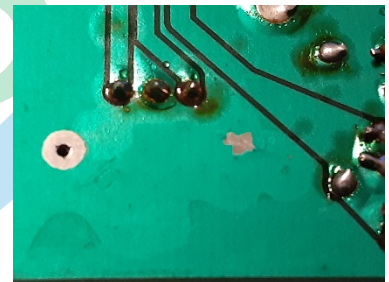
Figure 2 - Cracked solder joints

It was this header that had the cracked solder joints (Figure 2). A simple fix – I simply reflowed the solder on those pins and the meters worked as intended. However, I did not stop there.

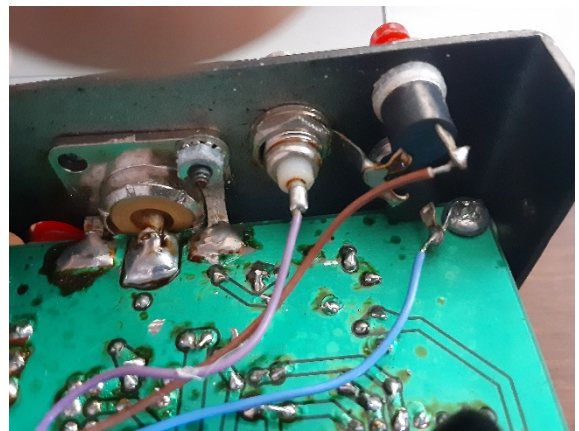
239, when the main PCB is in place, sits about an eighth of an inch above the PCB. That gap is simply filled with solder at the factory. Each of the two mounting screws used for the SO-239 has a solder lug installed under its nut. The lugs are then bent over to reach the main PCB and are soldered to pads on the PCB. These solder lugs also do not quite reach the board surface, and so their gaps are also solder-filled in production (Figure 3). Large solder bridges of this type are prone to cracking with time, a condition with which I was not happy. I therefore decided to correct this as well.

Figure 3 - Factory treatment

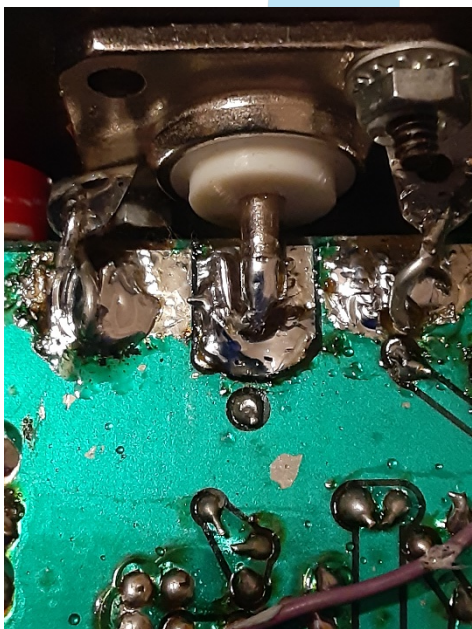
Figure 4 -SO-239 as repaired

I installed the new SO-239 to the enclosure. Then, I went over the main and display PCB's carefully, touching up any solder joints that looked the least bit suspicious. I then installed the main PCB to the enclosure, and I added lengths of bus wire between the mainboard solder pads and the SO-239 center pin and also at the solder lugs on its mounting screws (Figure 4). Next, I installed the BNC jack and the two pushbutton switches, wiring them up to the main PCB as they were originally. I added some bus wire to connect the grounded sides of the pushbutton switches to the BNC jack ground lug to make it a more comfortable fit. Now for the moment of truth.

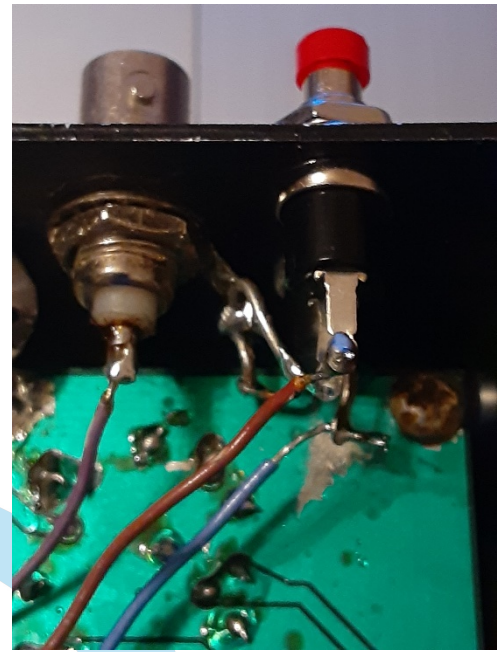
Another poor manufacturing technique, in my view, was the manner in which the BNC jack and the pushbutton switches were connected. The two pushbutton switches are normally-open switches that, when pressed, connect their respective circuits to ground. The way that MFJ chose to implement this was to bend one solder lug of each switch over and solder them to the solder lug under the nut on the BNC jack (also shown in Figure 3). It was a stretch at best, and it put undue stress on the bodies of the pushbutton switches. As it turned out, when I removed these switches, I found that the bodies of both switches were cracked. Solution? Two new switches... which turned out to be an adventure in and of itself.

Figure 5 - Pushbutton switches as repaired

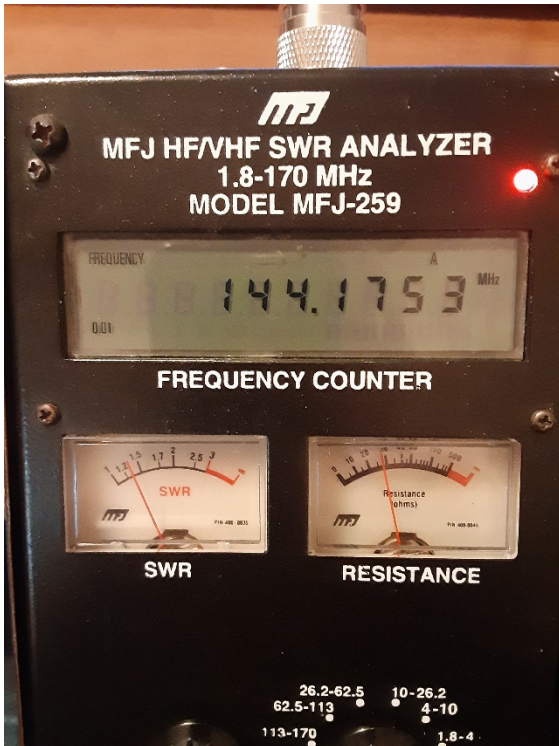
Figure 6 - Working unit

Swapping out that switch for another (verified NO) switch from my stock solved the problem (Figure 6).
