# At the Repair Bench – Conar 231 Tuned Signal Tracer – April 2024

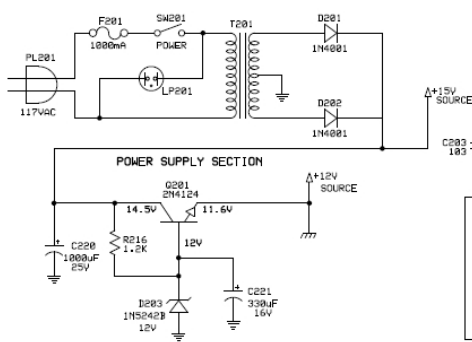
Figure 3 - Power supply section

This model is powered by 117VAC line current into a step-down transformer with a center-tapped secondary, which then produces two operating voltages, a +15VDC source and a +12VDC source (Figure 3). The +15VDC is taken directly off the rectified and filtered output of the power transformer, while the +12VDC output is tapped off the full wave rectifier and regulated down to twelve volts via a 2N2124 transistor and a 1N5242B 12V Zener diode. The +15VDC source is filtered by capacitor C220, a 1000µF/25V axial aluminum electrolytic capacitor, and the +12VDC source is further filtered by capacitor C221, a 330µF/16V

On power-up, the +15VDC supply was found to be varying from about +6VDC up to about +19VDC, most likely as a result of heavy ripple imposed upon the source. The only possible cause of this ripple was the 1000µF filter capacitor C220. At the same time, the +12VDC supply was found to be dead. As a starting point, I removed and tested capacitor C220 and also C221 (the 330µF filter for the +12VDC source). The 1000µF capacitor turned out to be *extremely* leaky, while the 330µF capacitor was shorted. I replaced these two capacitors and went back to my testing routine. Now the +15VDC source was as it should have been, but the +12VDC supply was still dead. Voltage measurements at the 2N4124 pass transistor Q201 showed that the transistor was shorted, as was the 1N5242B 12V Zener diode. Replacement of both of these components restored the +12VDC source to proper operation.

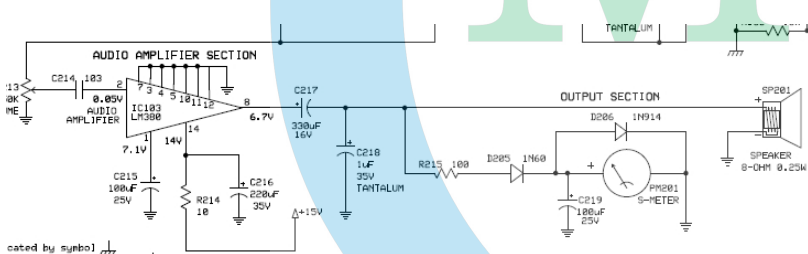
Figure 4 - Audio amplifier and output section

At this point, I thought that I had the problems solved, but it turned out that there was still another problem. In testing the operation of the signal tracer, I found that there was no audio from the speaker at all, and no activity at all on the front panel signal strength meter. It was

I fired up my signal generator and set it for a 1kHz sine wave output at about a half of a volt amplitude. I then injected that signal at the input of the LM380 audio amplifier, IC103 (Figure 4). There was no signal throughput to the speaker at this point. I checked all of the IC voltage readings and they were all right on the money, where they were supposed to be. That led me to the most likely culprit being C218, a 1µF/35V tantalum capacitor in a shunt position across the speaker. I removed and tested that capacitor and found it to be shorted. Replacement of the tantalum capacitor restored the audio operation to normal.

With three failed polarized capacitors in this unit so far, and considering the age of the unit and therefore its capacitors, I elected to go proactive and replace the remaining polarized capacitors, which included a pair of 100µF/25V axial electrolytics, a second 330µF/16V radial electrolytic, and a single 220µF/35V radial electrolytic. It was good repair practice to replace all of these capacitors based upon the rate of failure already seen and the overall age of the parts involved.
