At the Repair Bench – Plasma Lamp – November 2023

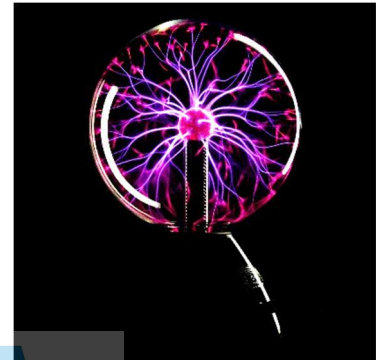
Figure 1 - Operating plasma lamp

Don't get me wrong. The repair itself was relatively easy. It is just that this item is so far removed from my usual type of repair that I found it to be intriguing. The item was a plasma lamp (Figure 1), and it had just up and quit working.

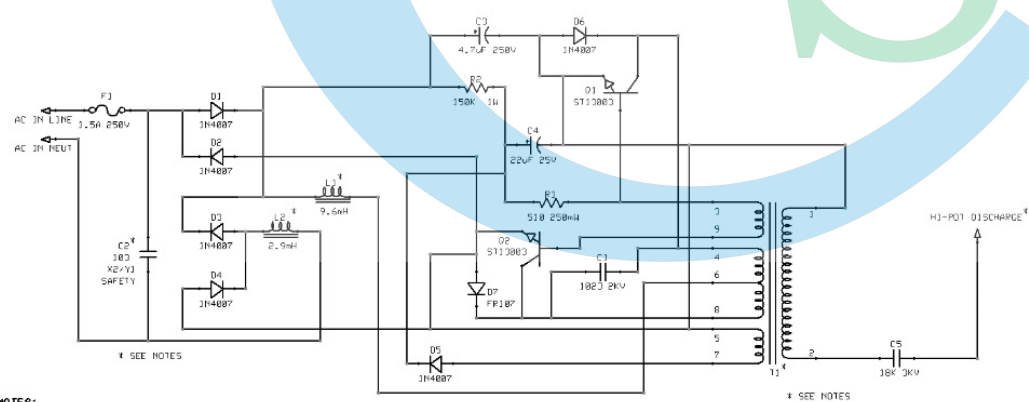
Figure 2- Derived unit schematic

circuit and put down into a schematic diagram what I was seeing. I typically use *ExpressSchematic* (part of the *ExpressPCB* package) to draw my schematics, and I did so here. The circuit (see Figure 2) basically consisted of a full wave rectifier for the incoming AC, an

oscillator, a chopper or switching transistor, and a multi-section transformer. The transformer has a winding that is part of the oscillator circuit, but largely serves as a flyback transformer to produce the high potential output needed to drive the plasma stream.

The plastic cover that I mentioned earlier is the housing of the transformer, and the diode that had melted a groove into the housing was one of the full wave rectifier set. There are two transistors used, one for the oscillator itself, and the other for the high-frequency switching necessary to create the pulse train input for the transformer. Testing revealed that the oscillator transistor had failed, and the switching transistor was severely past its “best by” date. While this transistor did operate, it was extremely below peak frequency and its *hFE* or *beta* tested out to be a mere 2.5 instead of the normal 200-plus value of a serviceable transistor.

Further testing showed that the diodes used in the unit, seven in all, were all also below spec in performance, although they were still operational. The biggest problem was that one of the diodes, an FR107 fast-recovery type, was not fast at all, having recovery time measured in the 875mS realm instead of the 500nS that it should have been. Voltage drops on the diodes in the full-wave rectifier proved to be quite variable, with one as low as 350mV and another as high as 935mV. The norm is around 535mV for these 1N4007 diodes.

Also indicative of high heat levels in this unit was the condition of the 4.7 μ F 250V aluminum electrolytic capacitor. This capacitor was quite leaky, acting more like a resistor than a capacitor. The equivalent series resistance (ESR) measured out at just under 5 Ω . It should have been down near zero ohms. The transformer, as near as I could tell using an ohmmeter and LRC meter, seemed to be in serviceable condition, as were the resistors, the 18pF 3kV ceramic capacitor and the 1.5A fuse.

Repairs to this unit, then, included replacement of all of the diodes with like types (1N4007 x 6 and FR107 x 1), replacement of both ST13003 transistors, replacement of the 4.7 μ 250V and the 22 μ 25V electrolytic capacitors, and installation of the new 0.001 μ F 2kV film capacitor.
