At the Repair Bench – Icom ID-4100A Shutdown – March 2023

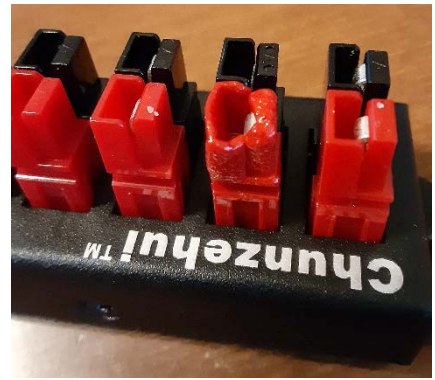
I went to the Powerpole® distribution block and carefully examined both it and the power cords connected to it. Much to my surprise, I found that the port to which my 2-meter radio was connected looked melted, very slightly on the black connector shell, but quite heavily on the red shell (Figure 3). This melting had occurred on both the cable end (Figure 4) and the distribution block port. I disconnected the cable from that port and got another surprise. Inside the red shell of the cable, the contact was not all the way out to the end of the connector shell as it should have been. Instead, it was pushed back a little bit, enough to cause the connection made when the plug bodies

Figure 4 - Melted block port

were joined to be somewhat less than optimal. Apparently, this connection would occasionally open, usually when heavier current was drawn during transmission. The heat caused by the resistance formed there is what melted the connector bodies.

The fix for the cable was simple. Cut off the melted connector and crimp on a new pair of Powerpole® connectors. I keep the Powerpole® parts on hand, so that was no problem. The repair to the distribution block was not quite as simple.

exposing the inside of the unit. Inside, there was a small printed circuit board (Figure 5) having bus bars along its outer edges to help handle the rated current of the unit. Each of the Powerpole® shells was installed to a blade-type contact that is soldered into the PCB. I fooled around with trying to release the contact from the body and to slide the body off, but that was going nowhere fast. Ultimately, I decided to try a more direct approach. I took a pair of pliers and simply crushed the melted red connector body, causing it to separate from its contact a bit. Then it was just a matter of using pliers to grip and wiggle it off the contact, sort of like pulling a tooth (Figure 6). After that, all that was left was the job of

forcing a new connector body down in place of the melted one. The black connector body was intact, so I was able to leave that one alone.

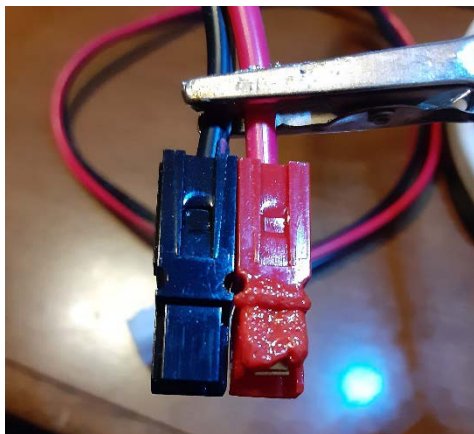
Figure 3 - Melted cable end

This particular cable was an ebay.com buy that I picked up before I got my Powerpole® assembly kit in house. I needed a power pigtail for the mobile-type radios, so I bought a couple of inexpensive ones on the auction site. My guess is that the actual contact was never fully inserted into the connector body far enough to lock into place. It simply pushed away from its mating contact, maintaining a light touch with its mate, but opening up under load. This caused

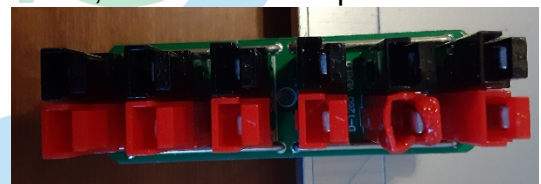
Figure 5 - PCB with bus bars

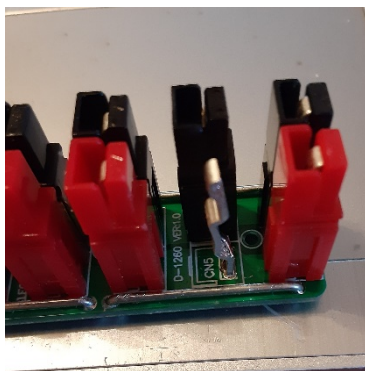
Figure 6 - Connector shell removed

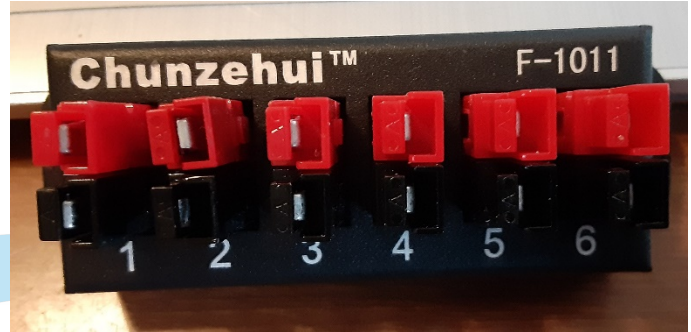
Figure 7 - Repaired distribution block

After the connector shell was replaced, reassembly of the distribution block was the reverse of the disassembly procedure. The only tricky part was reinstalling the three miniature truss-head machine screws that secure the PCB to the lower enclosure half, as they are buried down between the Powerpole® shells.

With the distribution block repaired and reassembled (*Figure 7*), it was time to put it back into service, which I did. The new connectors on the power cable, properly assembled this time, worked as they should, and the problem of the dead radio has not occurred since the repairs.
