Triple A Inspections
(502) 555-1234

Home Inspection Report

123 Example St

Prepared For: Demo Dan
Inspected On Mon, Oct 4, 2021 at 9:00 AM

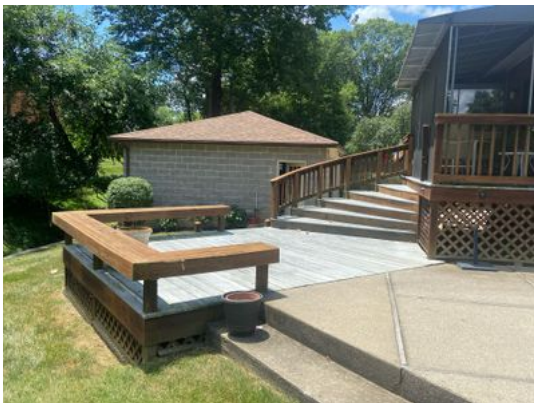
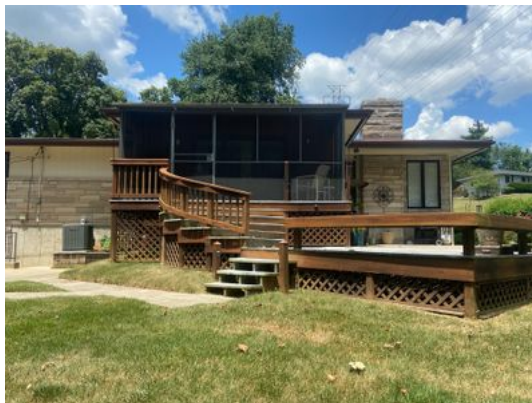
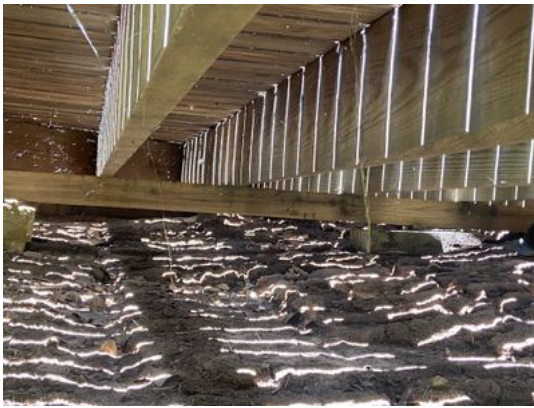
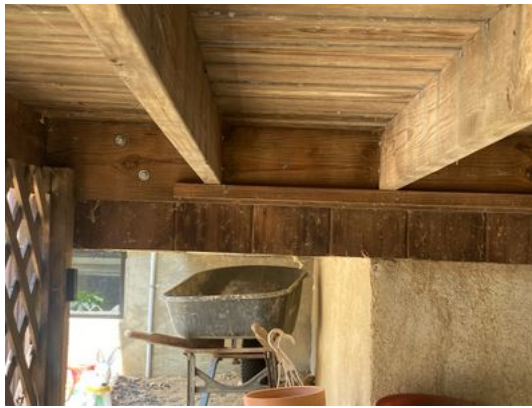
Comment 1 Information

Deck has been well maintained and is acceptable condition.

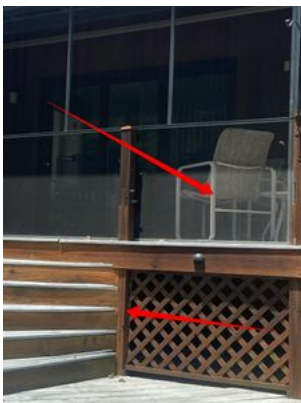
Comment 2
Safety Concern

Guardrail missing on step winders and upper deck. Install appropriate protection to prevent falls.

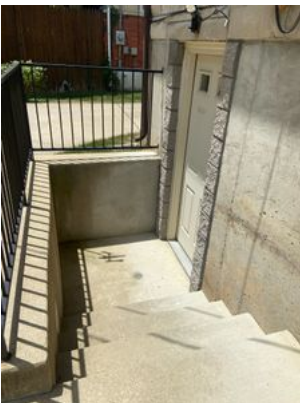
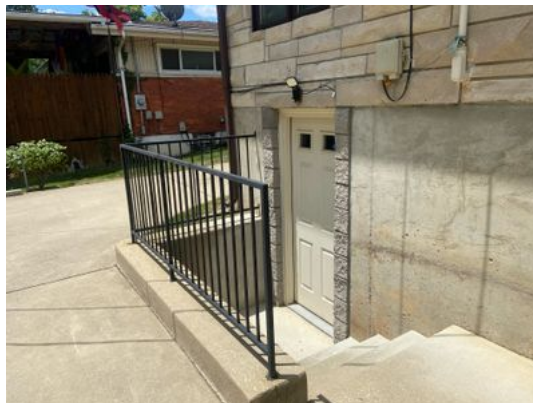
Comment 3

Handrail missing at basement exterior entry. Install for safety.

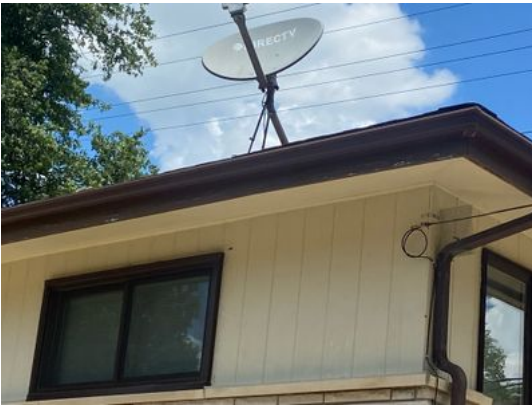
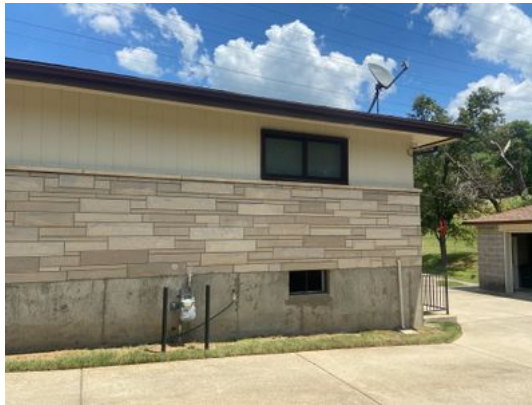
Comment 5

Exterior wood trim has peeling paint and possible minor wood damage. Repair, prep and paint to prevent wood from rotting.

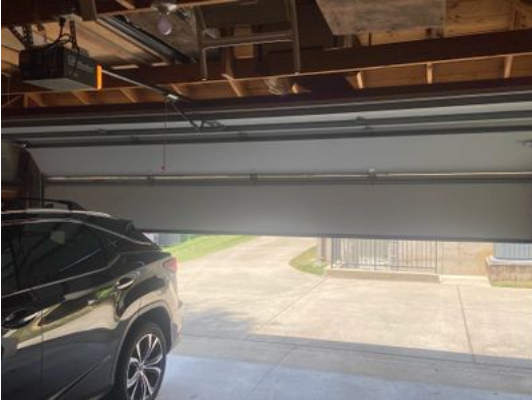
Comment 6 Information

Vehicle door and opener operates as expected.

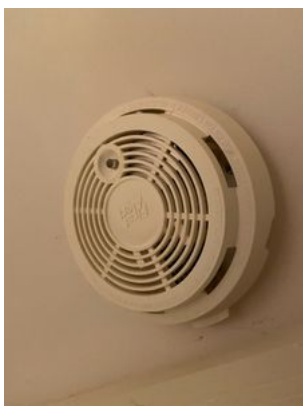
Comment 8

Smoke detectors are 9 volt type. Replace with 10 year lithium type or hard wired smoke detectors on each occupied level.

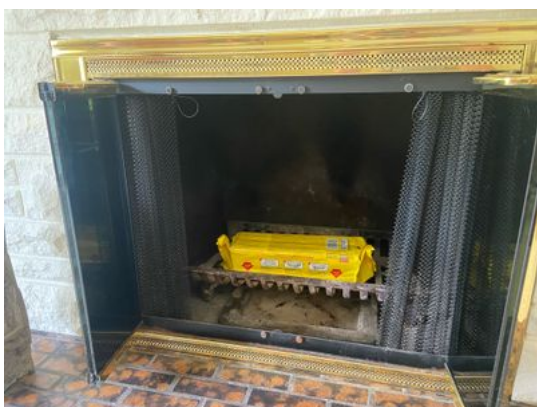
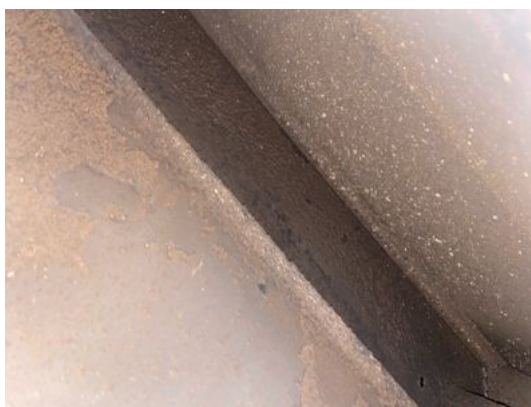
Comment 15

Fireplace flue appears very dirty. Have cleaned by chimney sweep before use for safety.

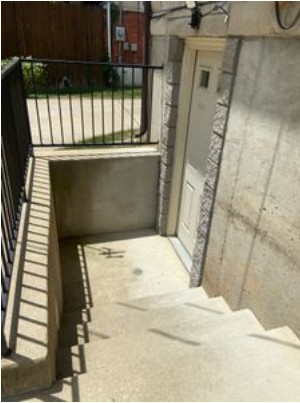
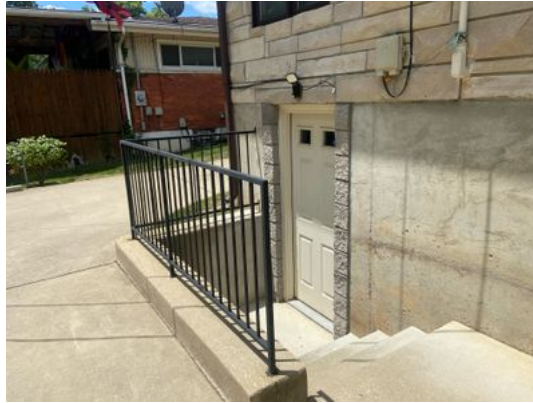
Exterior: Railings

Handrail missing at basement exterior entry. Install for safety.

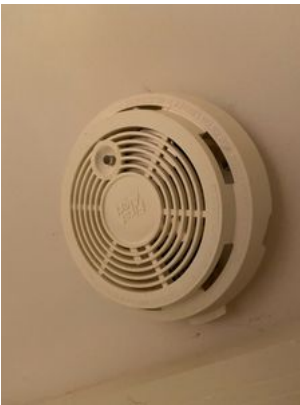
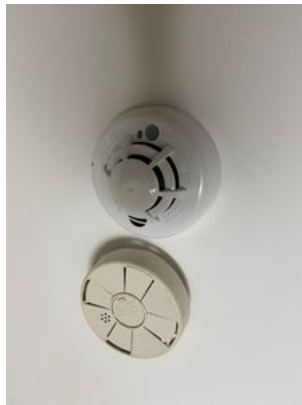
Electrical

Smoke detectors are 9 volt type. Replace with 10 year lithium type or hard wired smoke detectors on each occupied level.

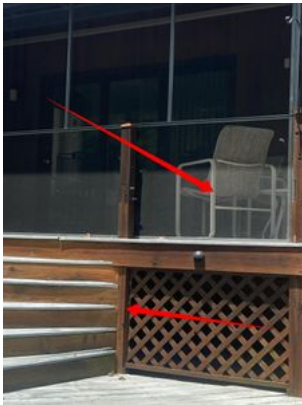
Site

Guardrail missing on step winders and upper deck. Install appropriate protection to prevent falls.

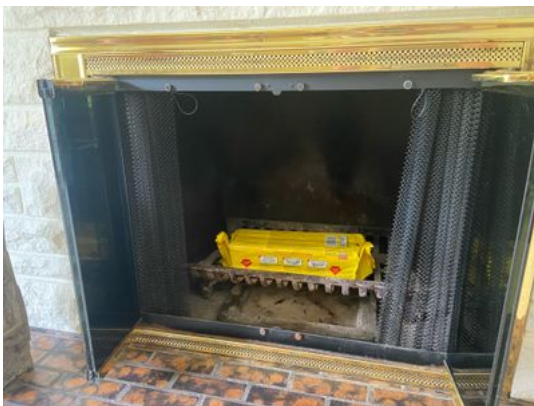
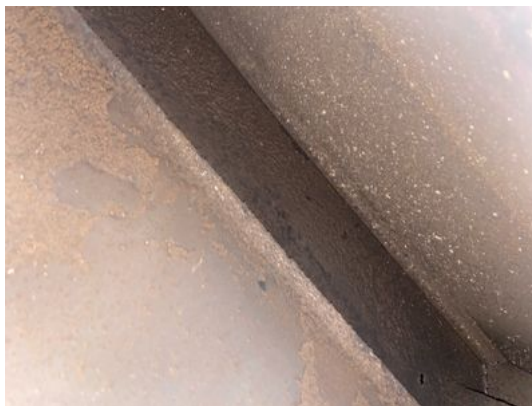
Interior: Fireplace

Fireplace flue appears very dirty. Have cleaned by chimney sweep before use for safety.

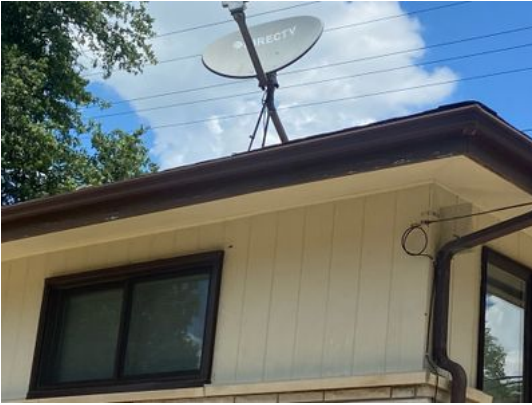
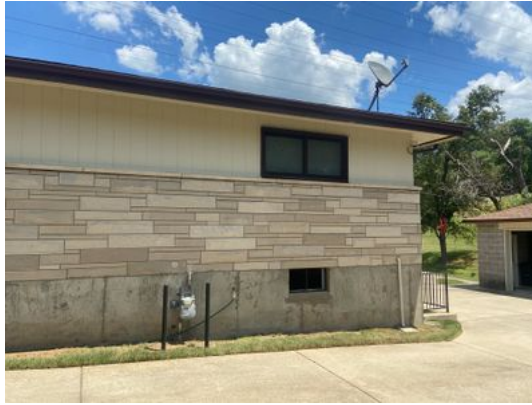
Exterior wood trim has peeling paint and possible minor wood damage. Repair, prep and paint to prevent wood from rotting.

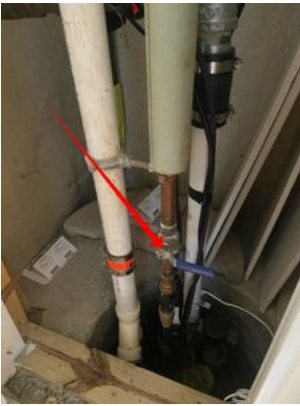
Plumbing

Water driven backup sump pump at rear right sump is not functioning. Repair or replace by licensed plumber.
