# LILLY HOME INSPECTIONS

## INSPECTION REPORT

CLIENT(S) NAME(S):	Clients N/A,e	AGE OF HOUSE:	~ 30 years
JOB ADDRESS:	Any Road	SQUARE FEET:	~ 2115 ft2
CITY & STATE:	Any town	HOUSE FACES:	Northeast
INSPECTION DATE & TIME:	Inspection Date	REALTOR:	Your realtor
WEATHER CONDITIONS:	Hopefully Sunny	TEMPERATURE:	~ 78 degrees
DWELLING CONDITION:	Unoccupied	ATTENDEES:	Inspector & Client
INSPECTED BY:	Randy Lilly	INSP. END TIME:	Anytime
Inspector's Signature:

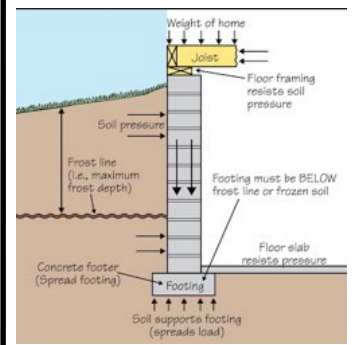
Foundation Type:	Footing and block foundation	
Floor Structure Type:	Crawl space and slab on grade	
Wall Structure Type:	Block foundation walls and wood framed walls	
Foundation Moderate Items:	1. Some foundation mortar finish had hairline cracks at the joints that needs to be repaired.

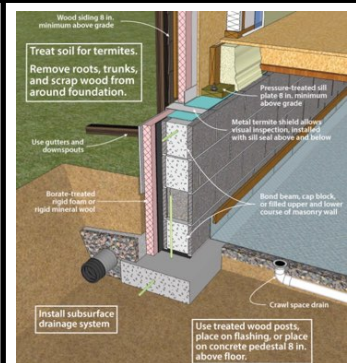
Crawl Space Moderate Items	1. Strap up all wires better in this area. 2. All supply piping in this area needs to be properly insulated to protect against freezing.
----------------------------	---

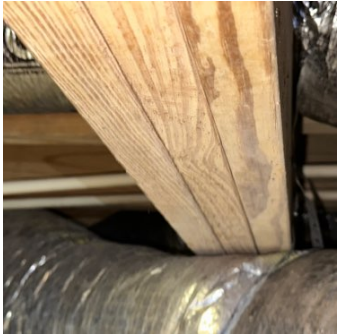
<p>3. Observed what appeared to be a microbial fungi growth substance on the floor system which is recommended to be addressed by a licensed company.</p>

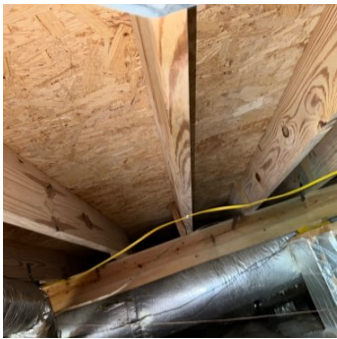
<p>4. Recommend insulating the floor system to current standards.</p>

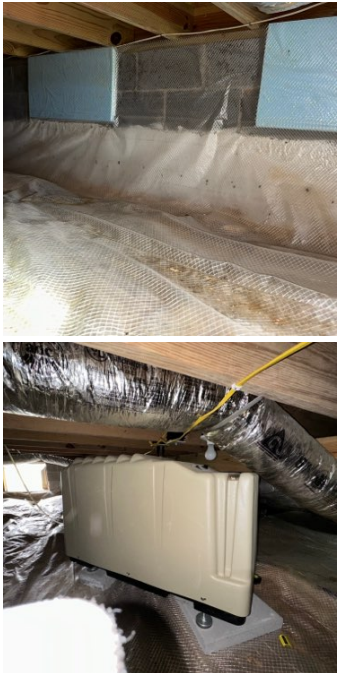
<p>How Crawl Space is Inspected:</p>	<p>Physically</p>	
<p>Crawl Space Noted Items:</p>	<p>1. Crawl space - the crawl space weatherstrip observed to be turned into an unvented crawl space with an air handler unit installed. This needs to be evaluated and repaired by a licensed company. See the summary section. The unit will need to be routinely maintained.</p>

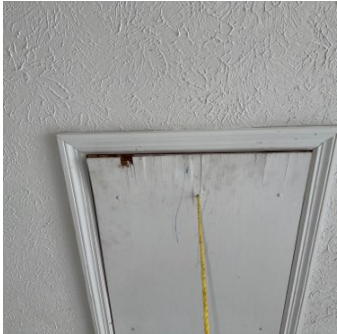
Attic Moderate Items:	1. The attic door had a chip out of the edge.

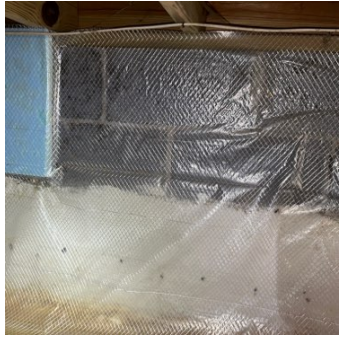
2. Crawl space - the crawl space was turned into an unvented space with an air handler. The walls of the foundation should have been insulated per unvented crawl space guidelines. This needs to be evaluated and repaired by a licensed company.

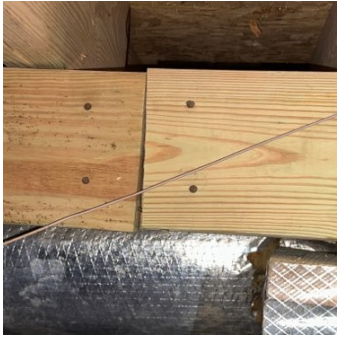
<p>3. Crawl space floor system - the piers should have full span shims across the tops of the piers that are of solid wood or metal. The beam splices should bear on the piers or be properly supported. Observed what appeared to be too large of span in between piers. Observed crushed shims at the tops of the piers. This needs to be evaluated and repaired by a licensed contractor.</p>

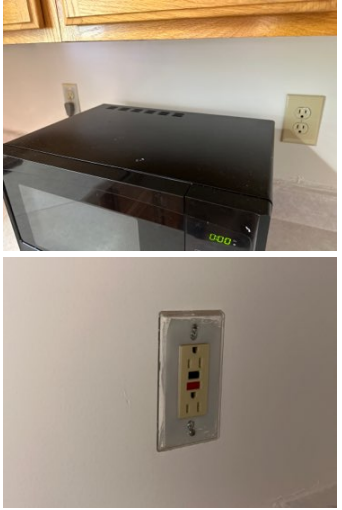
<p><b>SERIOUS ITEMS:</b></p>	<p><b>1. Kitchen Electrical - the two outlets around the microwave must be GFCI protected and were not when tested. Both GFCI outlets had open grounds and need to be repaired. This needs to be evaluated and repaired by a licensed electrician.</b></p>

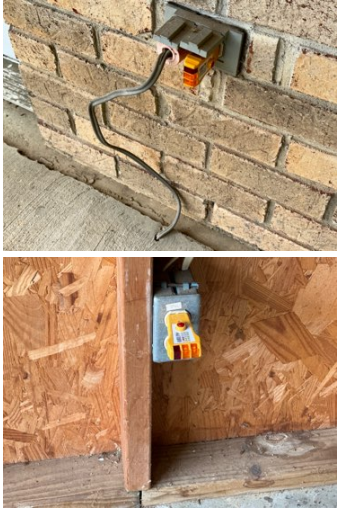
<p><b>2. Outside Building - observed illegal wiring that plugged into the exterior outlet. The outlet(s) in this area need to be GFCI protected and should be repaired by a licensed electrical contractor.</b></p>

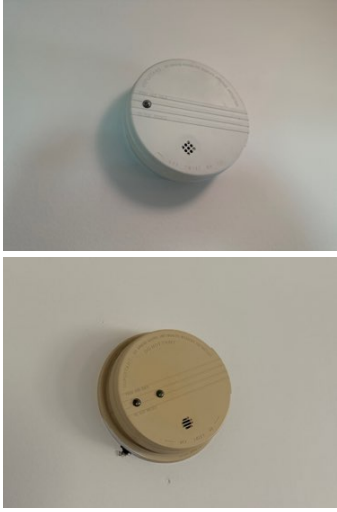
<p>5. Smoke detectors - The average lifespan of a smoke detector is approximately 10 years and the smoke detectors in the house appeared to be older and recommend that they be replaced by a licensed electrician.</p>

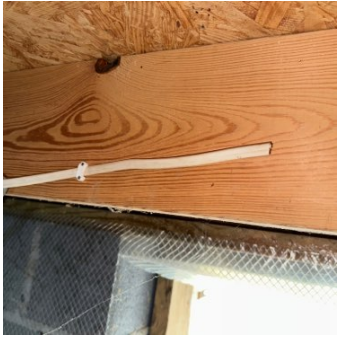
<p>7. Crawl Space - Observed a bare wire electrical violation that needs put into a junction box with a coverplate for fire safety. This issue needs repaired by a licensed electrician. This was located near the entrance on the ceiling. All crawl space electrical needs gone over by the electrician.</p>
