AMAC Inspection Services, LLC

Chuck Taylor 14 Lakewood Ave Lakewood, OH 44147

Property Information: 1560 Lakewood Ave Lakewood , OH 44147

Date: 3/16/2021 Time:Morning Weather Conditions:Sunny Present at time of inspection:Buyer's Agent, Current Occupants

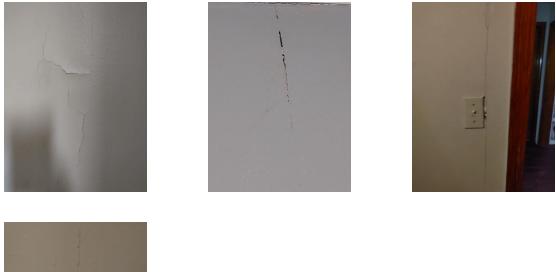
.There are cracks or holes in the walls.

There are cracks within the walls however this is normal for the age of the home.

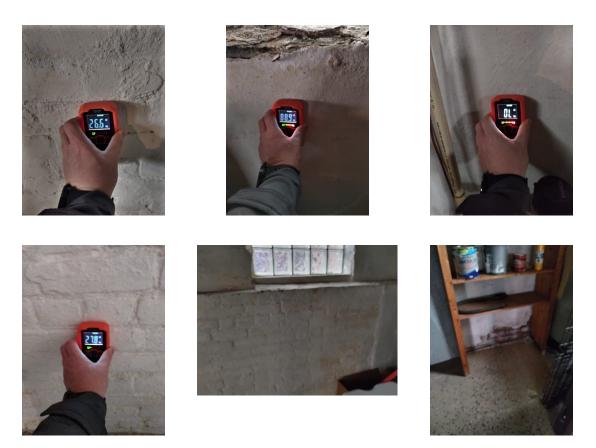
High moisture readings on three of four walls. There is pealing paint, efflorescence and concrete skim coat pealing on the wall. The front wall shows the most signs of water damage. The wall is directly below the porch where there is not a correct connection for the down spout. Recommend further evaluation.
