Inspection Report

Sample Report

544 West Emerald
Street
Willard, OH 44890

**Wednesday
June 22, 2022**

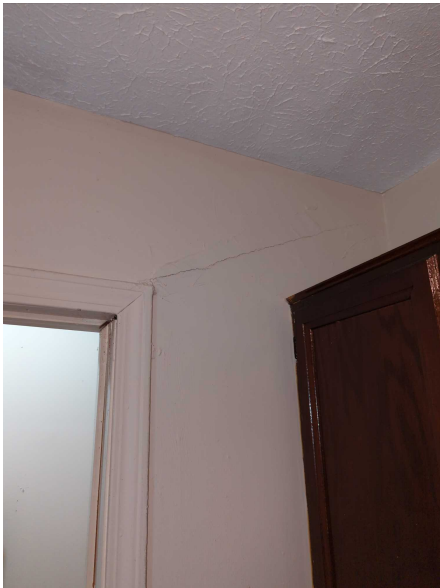
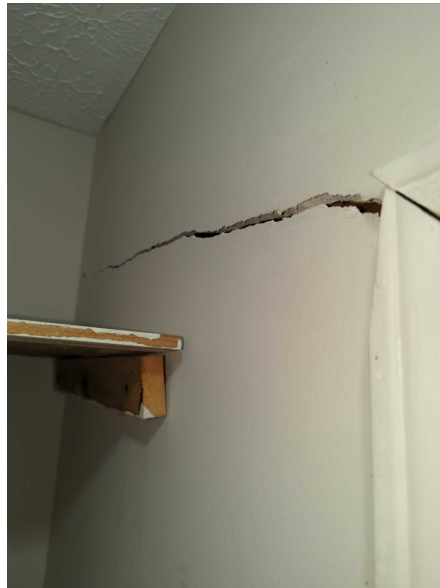
REPA **EVAL** **2:** The wall and ceiling surfaces appear to be properly installed and in good condition except in the kitchen. We recommend repair in that area to restore function and appearance.

Based on the size of the crack this could be a structural issue. We would recommend further evaluation

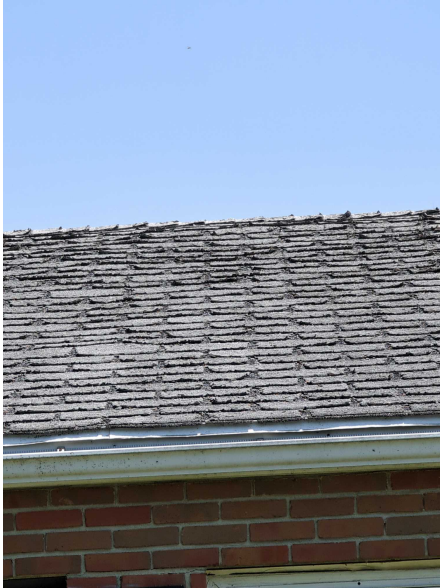
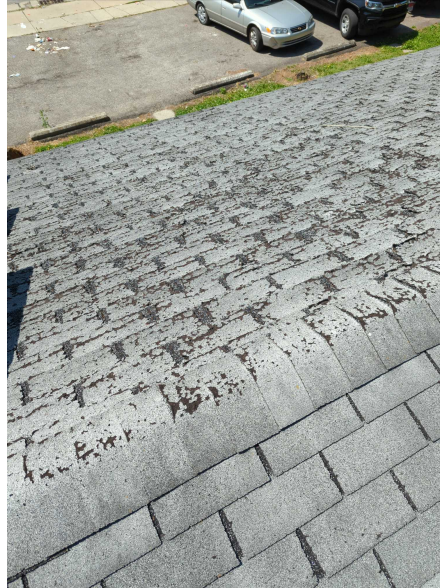
Unit 2

REPA 5: The shingles are damaged and deteriorated.

Unit 2's roof should be replaced.

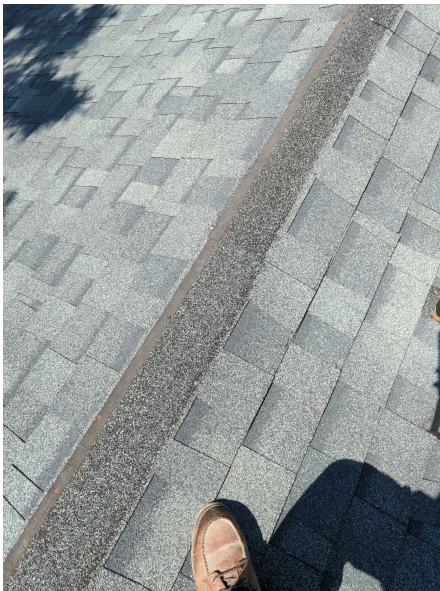
REPA 6: There are a significant number of loose and missing shingles on the ridge and throughout the field.

Unit 1, 2 and 3 are missing a ridge vent. Unit 3 peak shingles are missing.

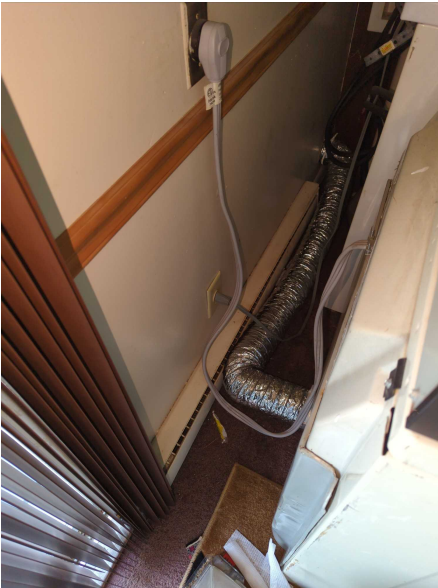
Unit 2 and 3

REPA 10: The structure was built after 1971 and should have GFCI outlets in this location. We would recommend upgrading the current outlets to GFCI outlets.

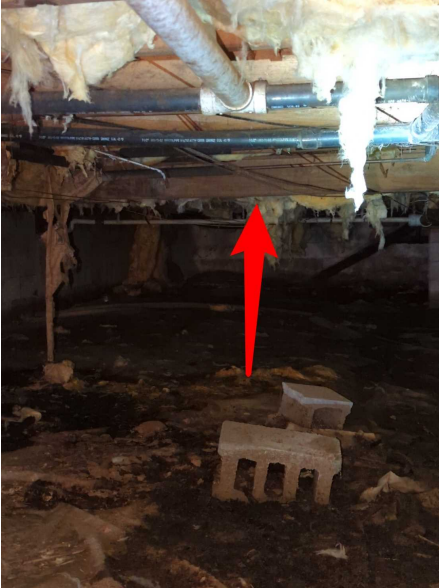
REPA 12: The joists are sagging under the under unit 2. This is a relatively recent installation indicating improper design and/or workmanship. We recommend that additional support be installed in accordance with present standards.

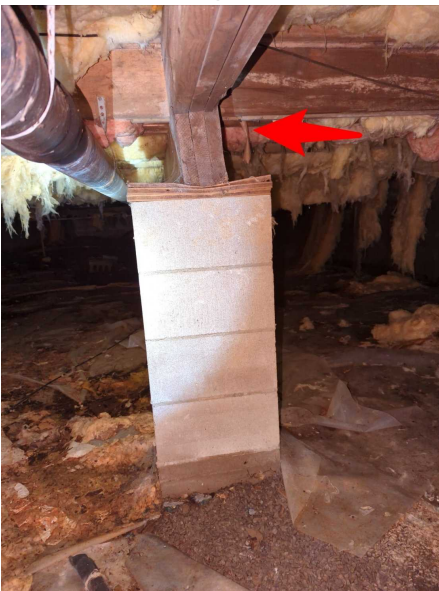
REPA 13: A pier under the unit 2 has moved significantly since original installation and full support in this area is now compromised. We recommend that this pier be reinstalled.

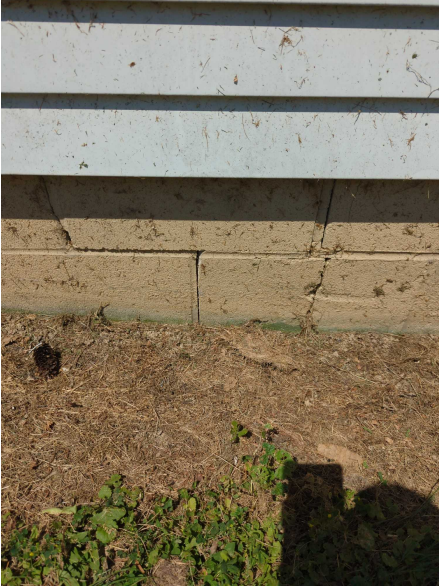
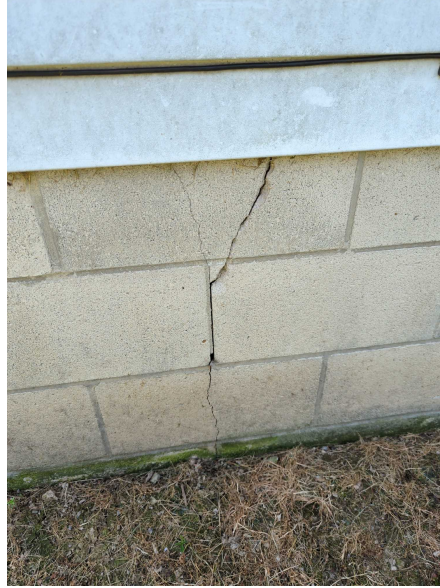
EVAL 14: Hairline and/or small cracks, within normal tolerances, are visible. This type of cracking is often a result of shrinkage of materials and/or minor settlement and usually does not affect the strength of the foundation.

We recommend applying an exterior grade sealant to all cracks. This will help protect the structural integrity of the home.

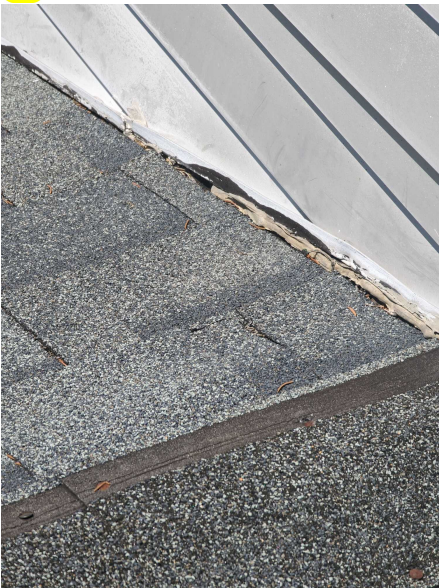
Unit 3

EVAL 15: Sections of flashings are missing. We recommend they be installed to prevent leakage.

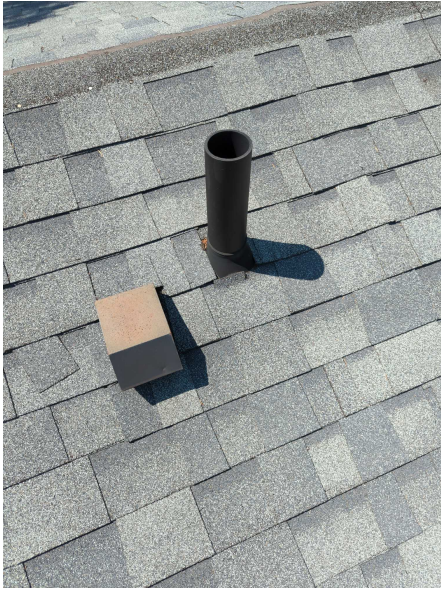
Unit 3

EVAL 16: Flashings are incorrectly installed and do not fully serve their intended purpose. We recommend repair or replacement to prevent leakage.

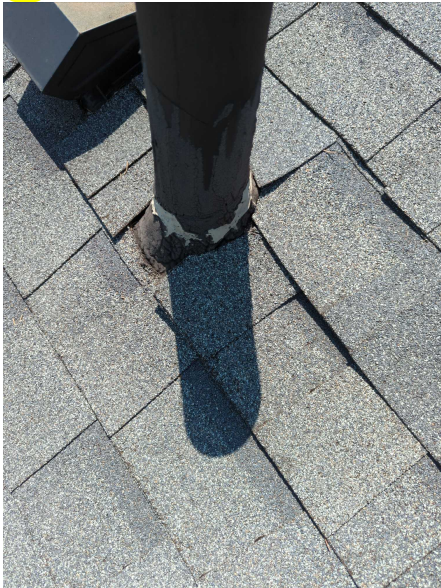
All units

EVAL 17: The rubber boot is damaged and should be replaced. This will allow water to enter the structure

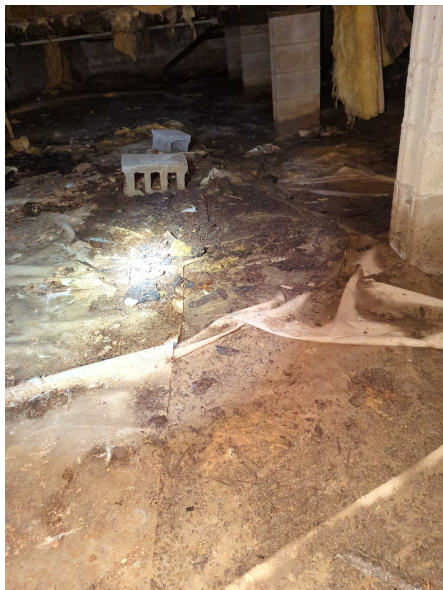
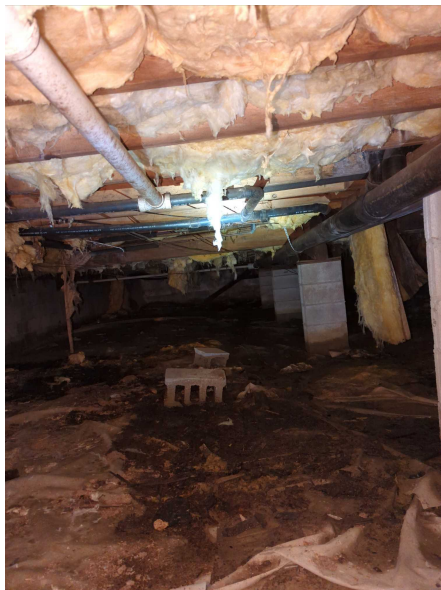
EVAL 20: There is surface deterioration and leakage at the exposed and accessible piping. We recommend that these lines be repaired or replaced.

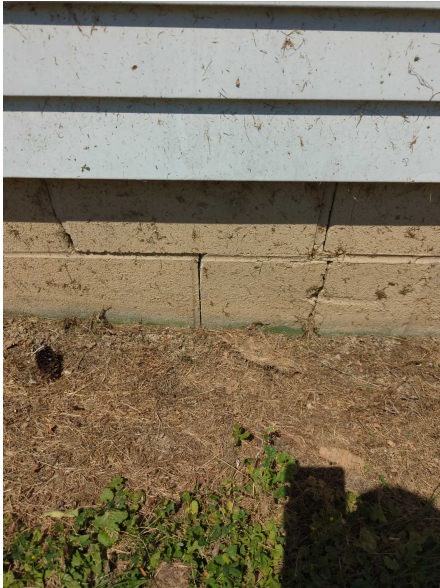
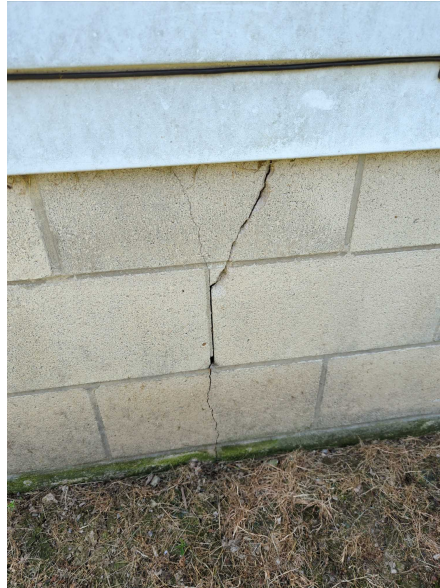
EVAL Hairline and/or small cracks, within normal tolerances, are visible. This type of cracking is often a result of shrinkage of materials and/or minor settlement and usually does not affect the strength of the foundation.

We recommend applying an exterior grade sealant to all cracks. This will help protect the structural integrity of the home.

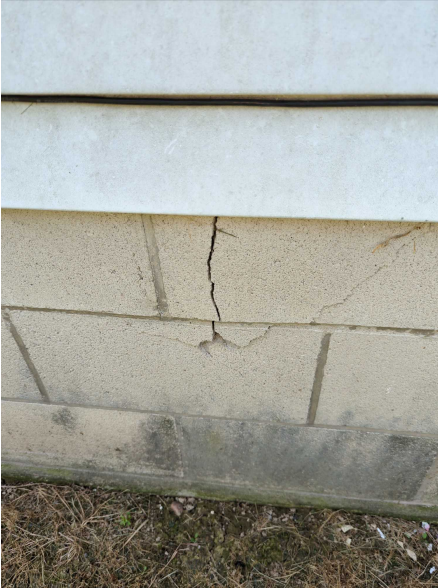
Unit 3

There are small and/or moderate cracks visible. We observed no related conditions suggesting the need for immediate repairs. However all crack should be sealed with an appropriate exterior grade sealant the prevent further deterioration. We recommend these cracks be sealed and monitored. If ongoing movement is observed, further review would then be recommended.

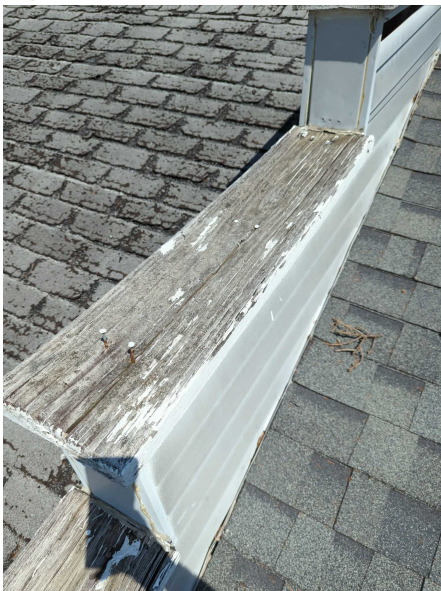
The trim at the separation point between unit 2 and 3 is deteriorated. We recommend it be repaired or replaced.

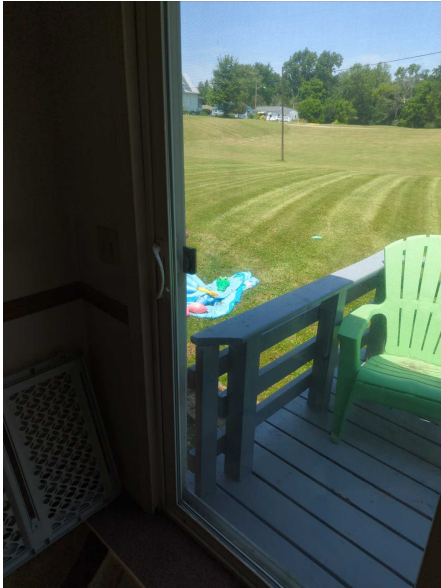
Screen door unit 3

The exterior doors appear to be properly installed and generally in serviceable condition, with exceptions noted below.

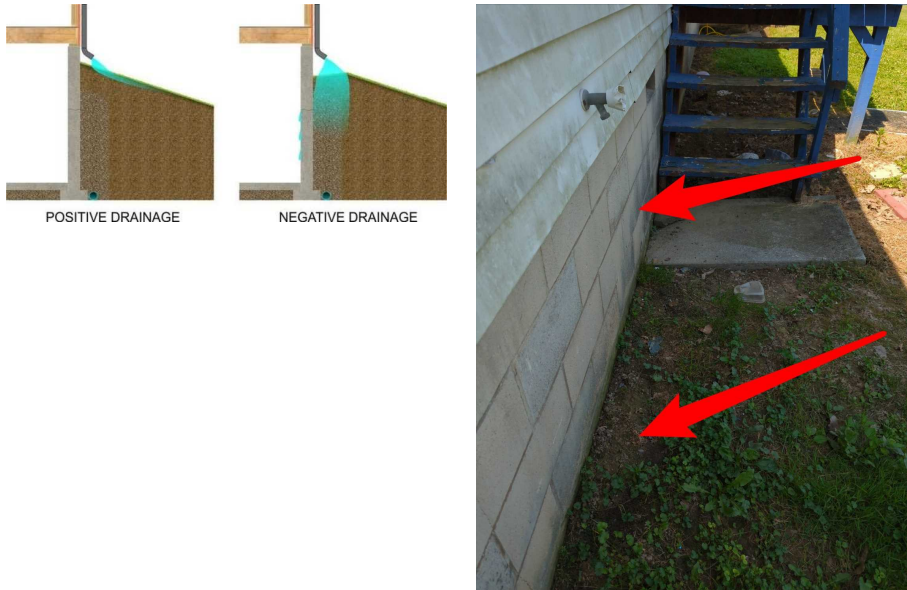
UPG Grading is sloped toward the structure in some areas. Low spots and negative grading promote water accumulation near the building, leading to foundation problems. Regrading to a minimum of 1 inch rise for every 6 feet of land, would help ensure that surface water flows away from the structure.

The photo is representative of the entire rear of the structure.

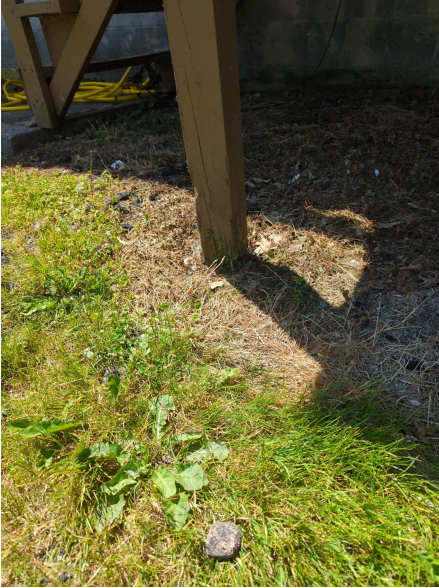
UPG There is earth-to-wood contact at the bottoms of some deck support posts. This condition is conducive to infestation of wood-destroying pests/organisms. We recommend that all earth-to-wood contacts be broken and any damaged materials be replaced.

This photo was representative of all three decks.

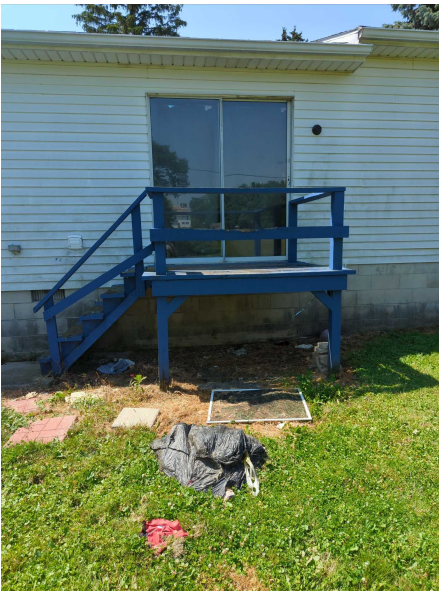
UPG At unit 1 and 2, the railing construction is deficient by present standards. Modifications to eliminate hazards, especially for children, are recommended as an upgrade. The local building authority can supply minimum present standards.

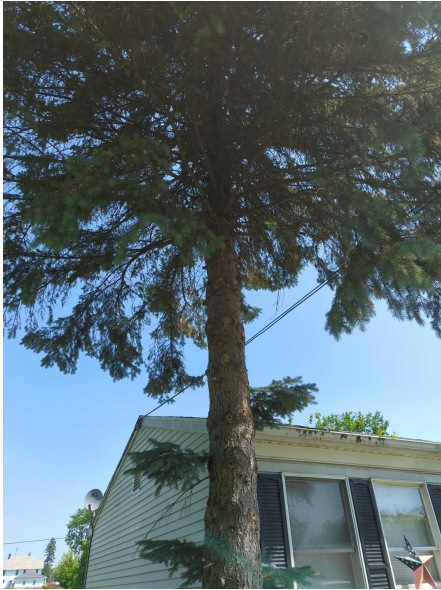
We recommend the trees overhanging the roof be trimmed to prevent damage of the roofing surface, and allow free flow of roof runoff.

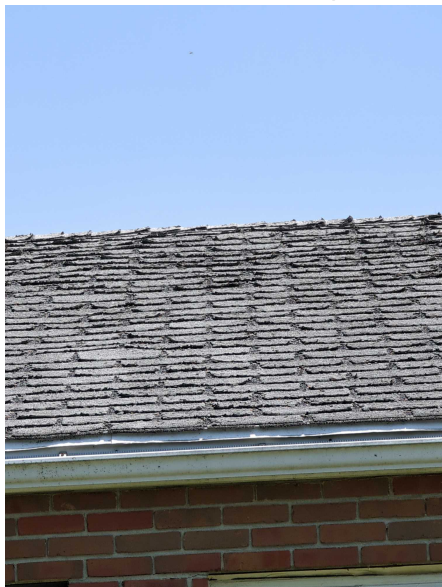
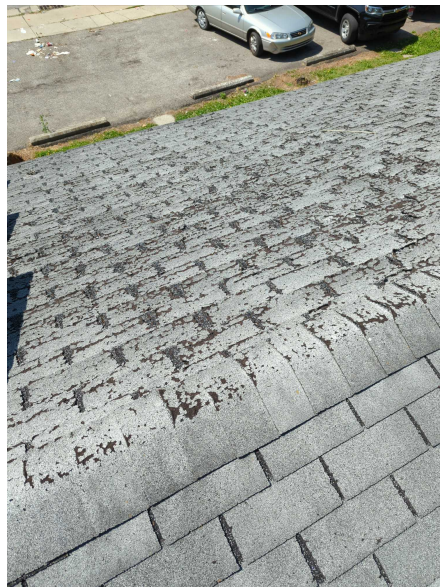
Unit 2

The shingles are damaged and deteriorated.

Unit 2's roof should be replaced.

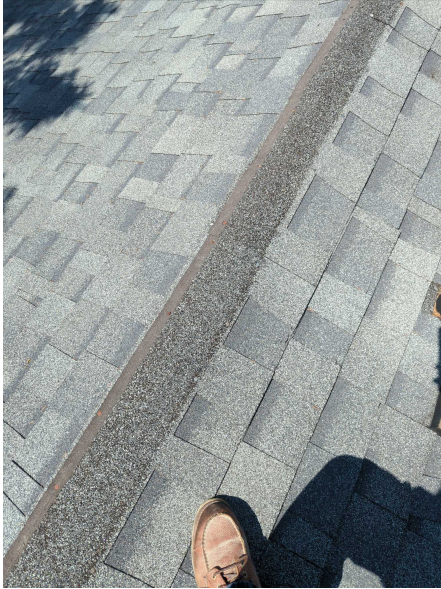
There are a significant number of loose and missing shingles on the ridge and throughout the field.

Unit 1,2 and 3 are missing a ridge vent. Unit 3 peak shingles are missing.

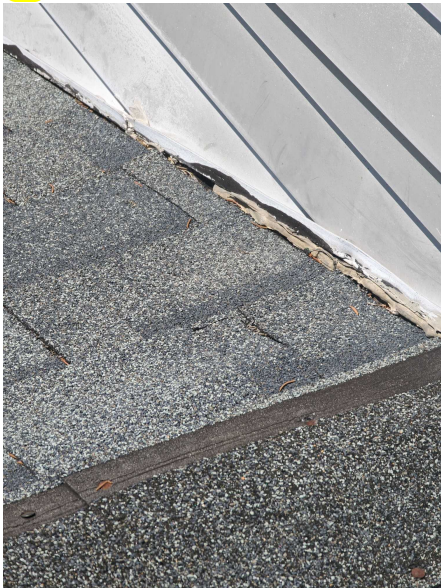
Unit 3

Sections of flashings are missing. We recommend they be installed to prevent leakage.

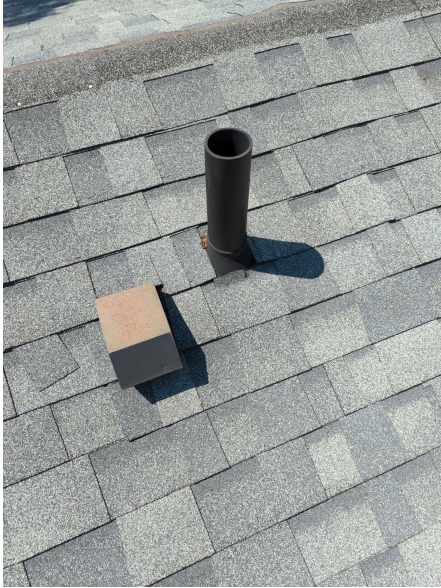
Unit 3

EVAL Flashings are incorrectly installed and do not fully serve their intended purpose. We recommend repair or replacement to prevent leakage.

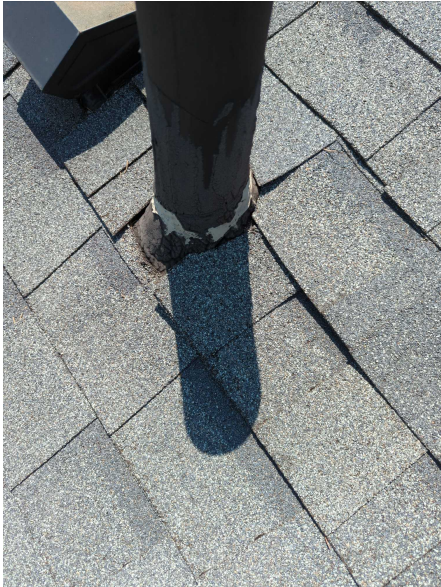
All units

EVAL The rubber boot is damaged and should be replaced. This will allow water to enter the structure

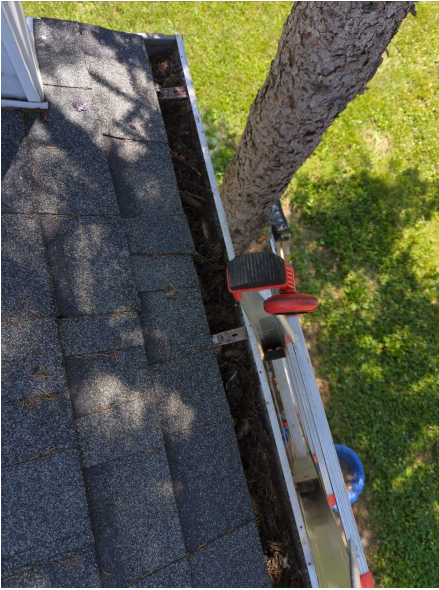
Debris was present in the gutters, which limited our visual inspection. We recommend all debris be removed to ensure proper drainage. The condition of the gutters can be better assessed at that time.

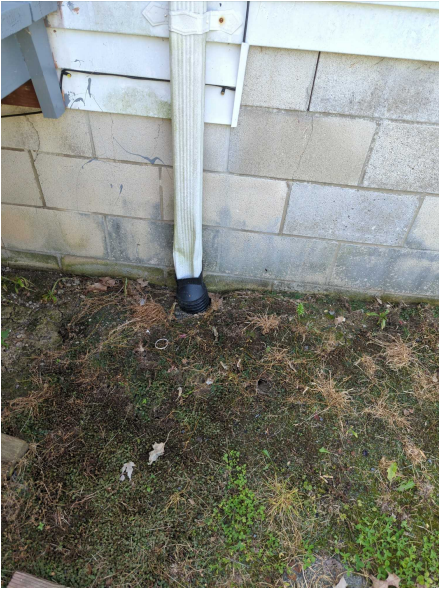
The downspout at the rear unit 3 has been damaged. Replacement is recommended.

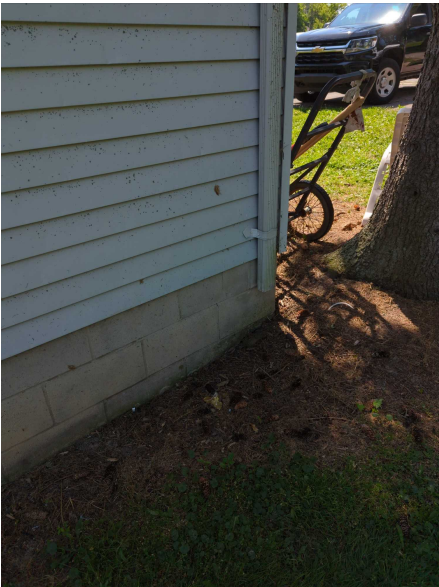
Unit 1

Runoff water from the roof discharges next to the house. We recommend the downspouts be routed sufficiently away from the structure to prevent puddling, pooling, and saturation of the soil around the building.

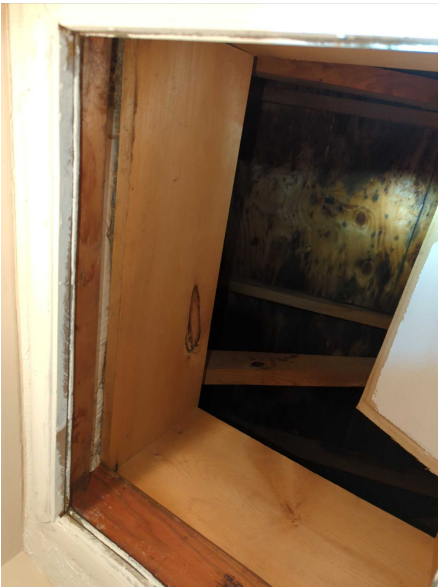
The sheathing has staining and discoloration which could be consistent with an organic material. Would recommend having this cleaned / mitigated. There is no structural damage based on the view that we were able to see.

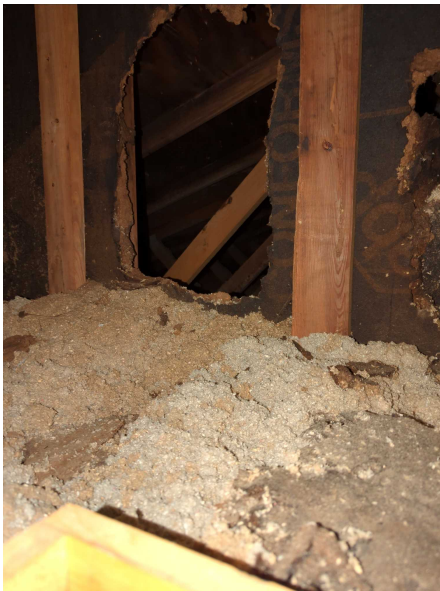
Rodents have been active in the attic in the past. It is possible there is no current infestation. We recommend that bait or traps be set and monitored. The advice and services of a licensed exterminator would be recommended if problems persist.

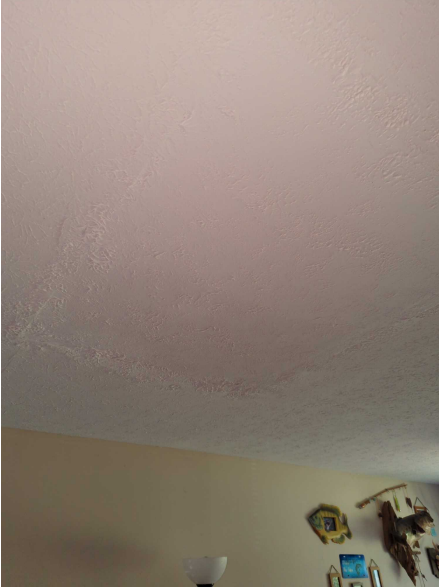
The wall and ceiling surfaces appear to be properly installed and in good condition except in the living room. We recommend repair in that area to restore function and appearance.

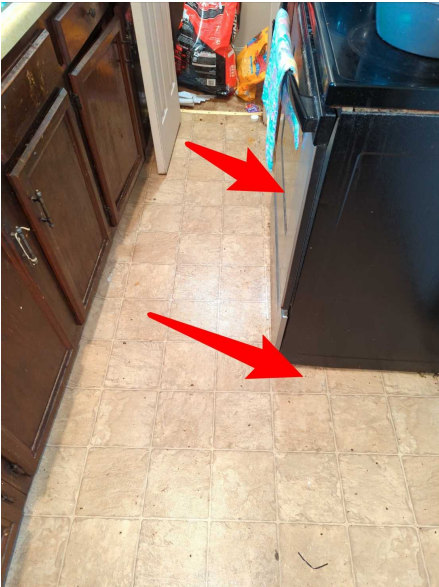
The interior floors are sloped in some areas. Individual perception and sensitivity to floor sloping varies greatly.

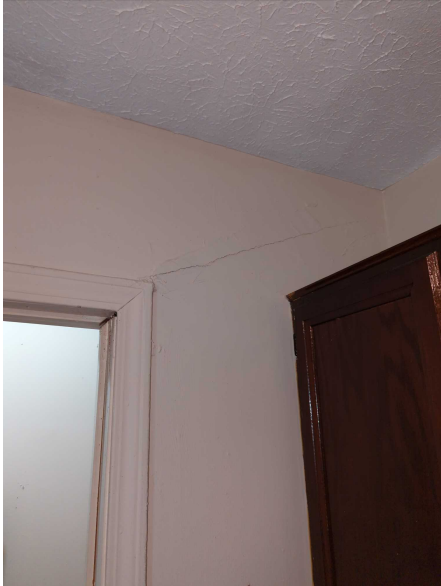
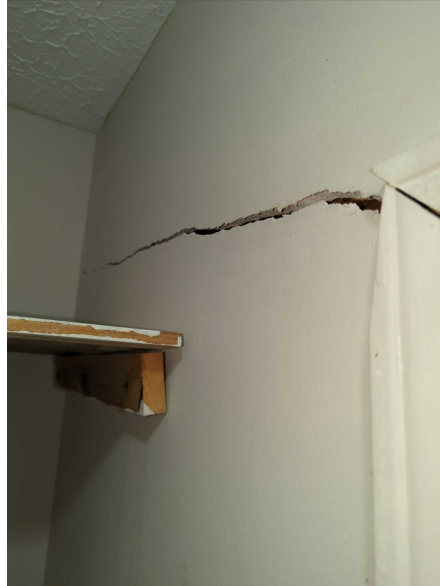
The wall and ceiling surfaces appear to be properly installed and in good condition except in the kitchen. We recommend repair in that area to restore function and appearance.

Based on the size of the crack this could be a structural issue. We would recommend further evaluation

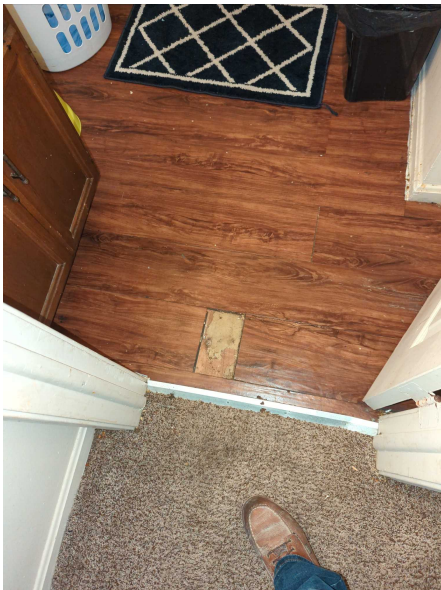
Bathroom floor

The floors have a good appearance and are in serviceable condition, with exceptions noted below.

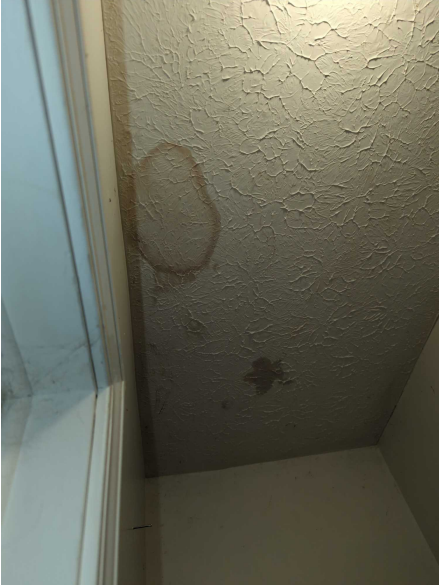
Conducted a moisture reading in all levels were within standard. This must be from the past water event.

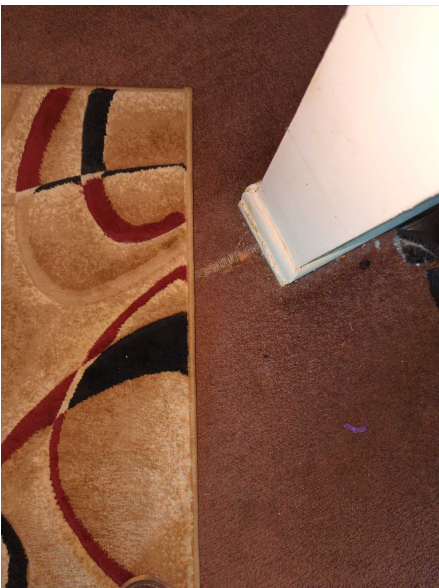
Torn seam in unit.

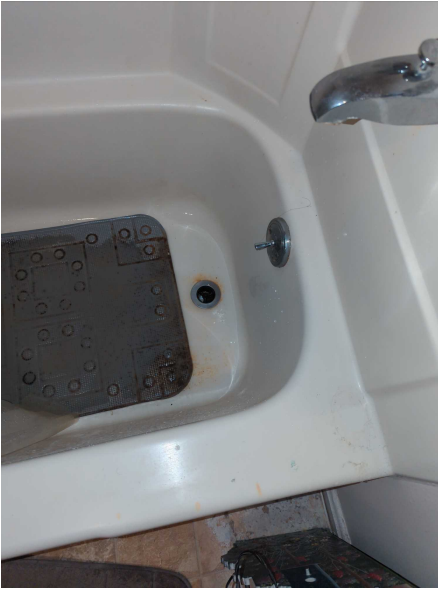
The drain is slow. We recommend the trap be cleaned of grease, hair, sludge, etc. and if this does not correct the problem, we recommend the line be 'snaked' by a professional sewer cleaning service.

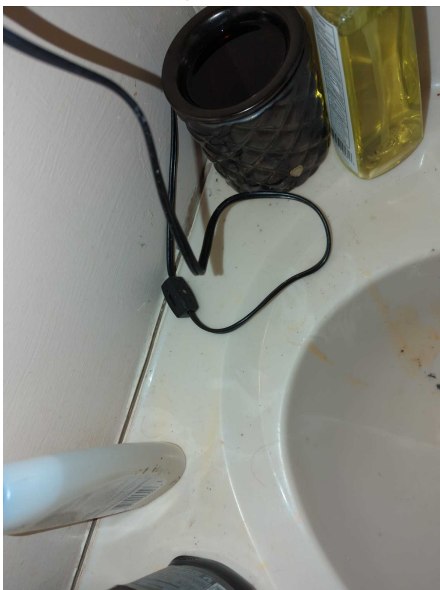
Not secure

The countertop has been installed in a substandard manner. We recommend it be reinstalled properly.

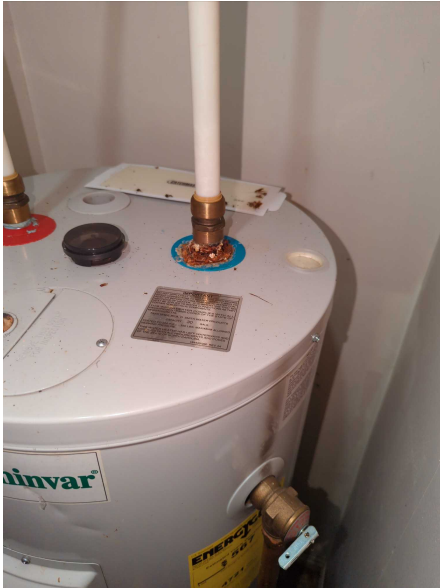
The water connections are heavily corroded and show signs of previous leakage. We recommend replacement.

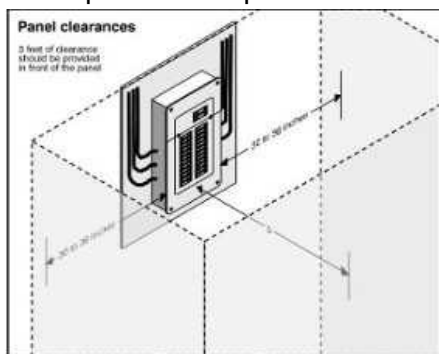
Panel clearance information

The service panel is obstructed and was inaccessible at the time of inspection. We recommend the wiring in the panel be inspected when the obstruction is removed.

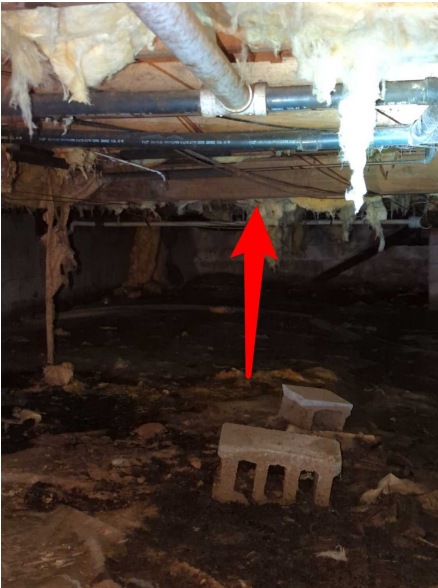
REPA The joists are sagging under the under unit 2. This is a relatively recent installation indicating improper design and/or workmanship. We recommend that additional support be installed in accordance with present standards.

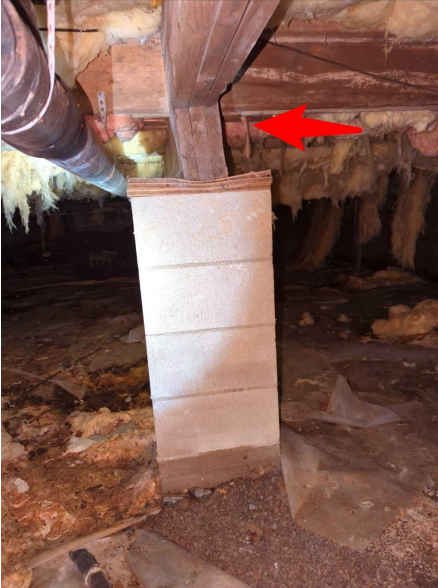
REPA A pier under the unit 2 has moved significantly since original installation and full support in this area is now compromised. We recommend that this pier be reinstalled.

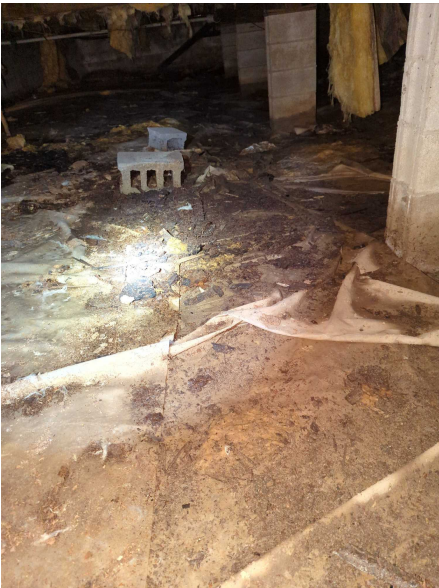
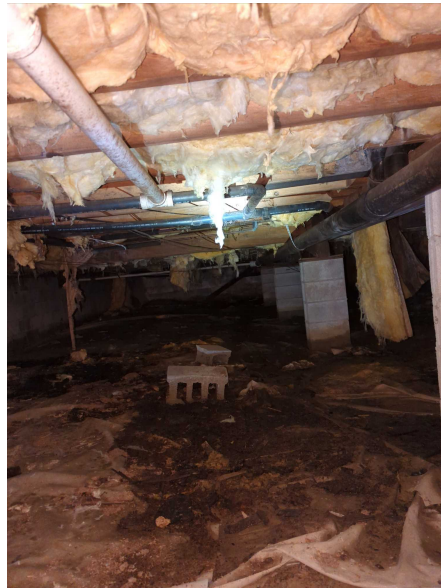
EVAL There is surface deterioration and leakage at the exposed and accessible piping. We recommend that these lines be repaired or replaced.
