ADA Architectural Barriers Summary List

APPENDIX I

ADA Architectural Barrier Photographs

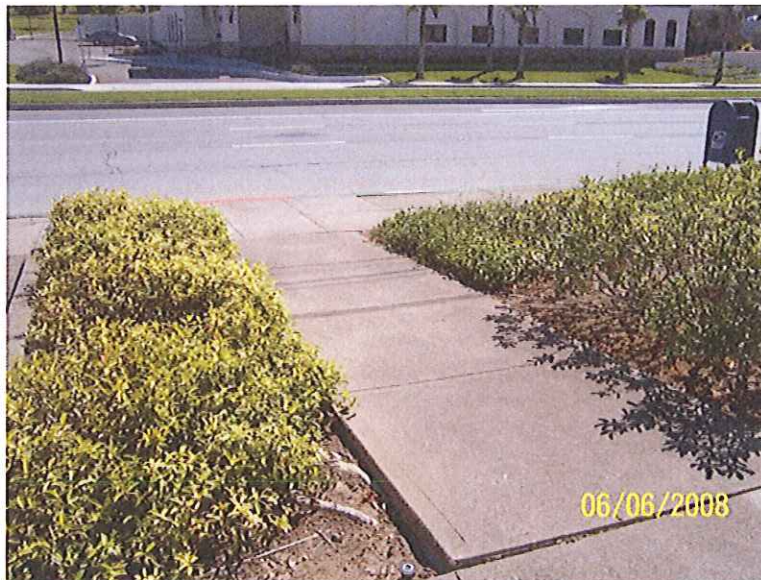
Locations	Observation	Recommended Corrections/Modifications	Urgency Criteria	Additional Information/References	Finalized Action
Location	Problem Identified	Recommended Solution	L = Low, M = Med, H = High	Photo # Est. Cost \$	Est. Correction Date. Date Corrected
Public Works/ Planning/ Bldg. Dept. Annex (1188-90 <i>El Camino Real</i> )	Handrail for the accessible ramp at front of building is 32" high.	Provide code-compliant handrails (between 34" - 36" in height, including wheel guides, and graspable surface 1 1/4" - 1 1/2" dia)	H	PWB1,3 \$5,000	FY2012-13
	Route of travel from sidewalk to entrance of building has changes in surface level.	Provide beveled paving (slope no greater than 1:2) where changes in level exceed 1/2".	M	PWB2 \$4,500	FY2012-13
	Route of travel from sidewalk to entrance of building exceeds 5% slope.	Remove and replace concrete sidewalk. Provide route of travel that is compliant and does not exceed 5% longitudinal slope and 2% cross-slope.	M	PWB4 \$5,500	FY2012-13

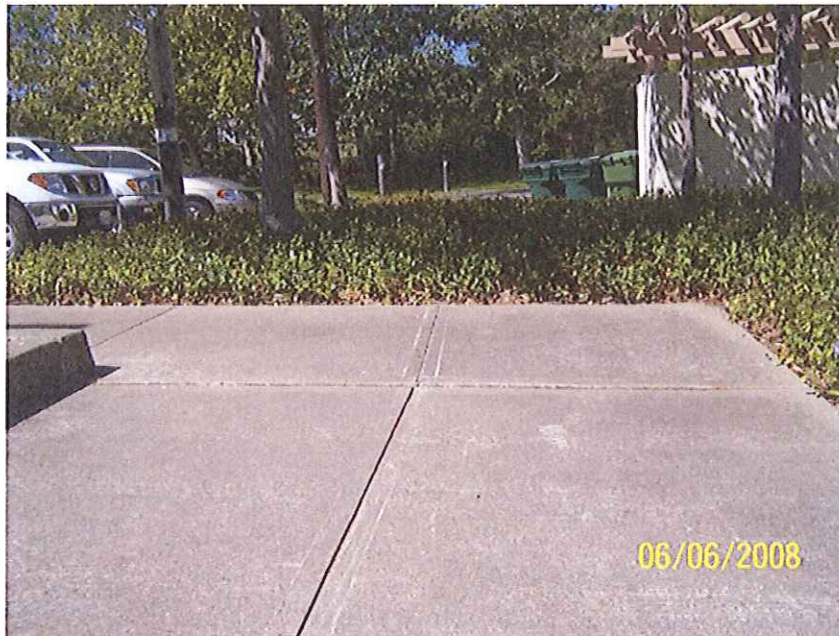
**PWB8**

Locations	Observation		Recommended Corrections/Modifications	Urgency Criteria	Additional Information/References	Est. Cost \$	Finalized Action	Date Corrected
Senior Housing/ Creskide Villas (1180 El Camino Real)	Curb ramp pavement at South parking lot is damaged and has no detectable warning.	4.29.2	Repair damaged pavement and provide truncated domes.	H	PWB5	\$4,500	FY2010-11	
Public Works/ Planning/ Bldg. Dept. Annex (1188-90 El Camino Real)	Accessible parking at South side of bldg. needs restriping, and geometric reconfiguration for van access. Signage and striping is incomplete.	4.6	Parking spot shall be designated as van accessible; reconfiguration will be necessary. International Symbol of Accessibility and striping shall be repainted. Phone number for retrieving tow away car shall be provided on sign. Access aisle shall read "No Parking".	H	PWB 6,7, 12	\$12,500  \$1,000	FY2011-12	
Public Works/ Planning/ Bldg. Dept. Annex (1188-90 El Camino Real)	Route of travel from west parking lot to the front of the building exceeds 5% slope.	4.3.7	Provide code-compliant route of travel including signage.	M	PWB 8	\$15,000	FY2012-13

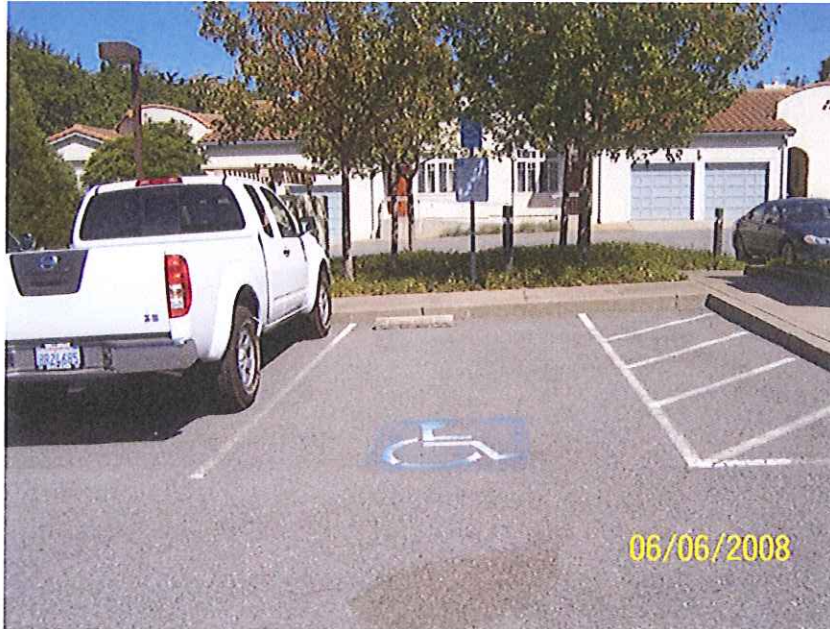
PWB9

Locations	Observations	Recommended Corrections/Modifications	Urgency Criteria	Additional Information/References	Est. Cost \$	Est. Correction Date.	Finalized Action Date Corrected
Public Works/ Planning/ Bldg. Dept. Annex	Accessible parking at West side of bldg. needs restriping.  Signage and striping is incomplete.	4.6  International Symbol of Accessibility and striping shall be repainted. Phone number for retrieving tow away car shall be provided on the sign. Access aisle shall read "No Parking". Updated "Parking Fine" sign shall be provided. Convert accessible space at North East area of lot to van accessible. Demo Pathway to widen access aisle	H	PWB 9	\$4,500	FY2011-12	
	Problem Identified	ADAAG Spec.  Recommended Solution	L = Low, M = Med, H = High	Photo #	Est. Cost \$	Est. Correction Date.	Date Corrected
	Curb ramp slope at West parking lot is 11% and has no detectable warning.	4.29.2  Reconfigure ramp slope and provide truncated dome per appropriate standards.  OR Remove existing accessible parking space. Convert accessible space at North East area of lot to van accessible. (closest direct route)	H	PWB 9,10, 11	\$3,500	FY2010-11

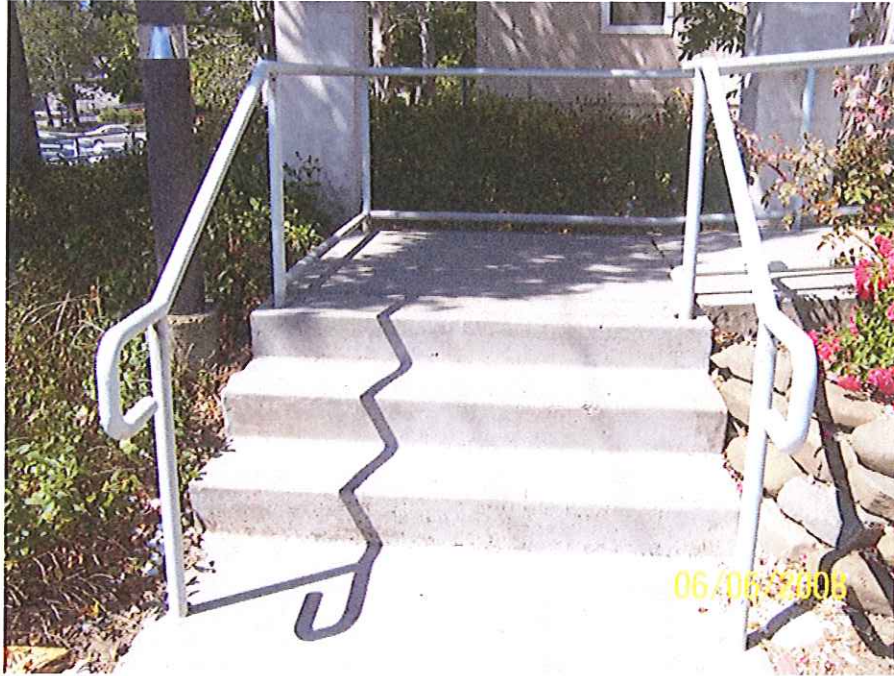
No detectable warnings on stairs at front entry.	Provide detectable warnings on stairs (painted stripes at each tread).	M	PWB13 \$1,000	FY2010-11

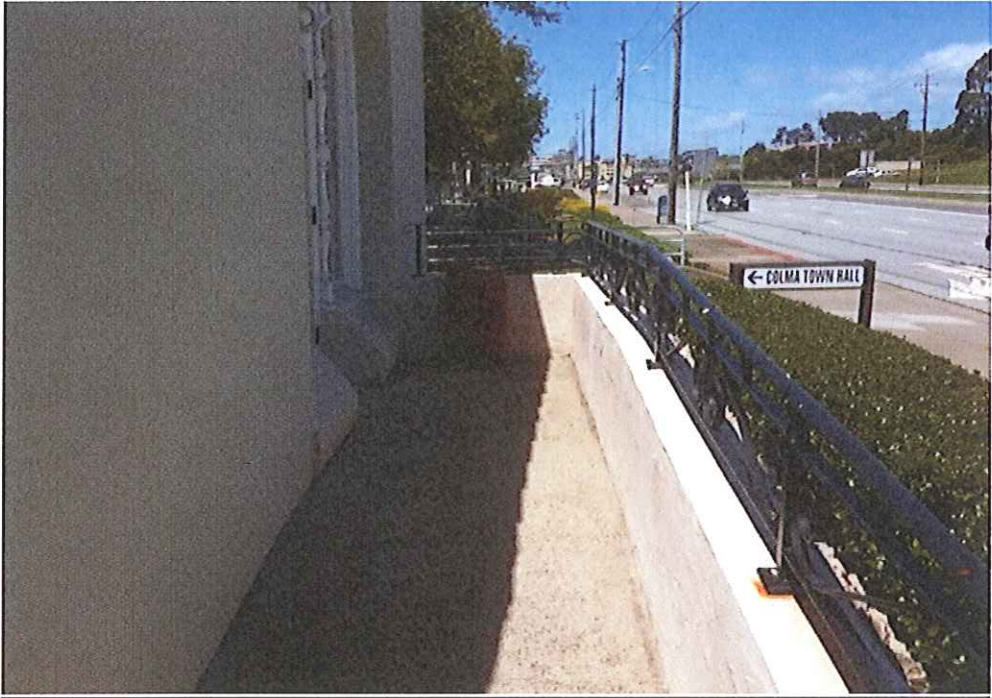
TH 1

Door to the Council Chambers has inadequate clearance	The ramp will need to be reconstructed to achieve required clearance. Door will need to be widened to get 32" min clear.	H	TH 1, 2	\$125,000	FY2012-13

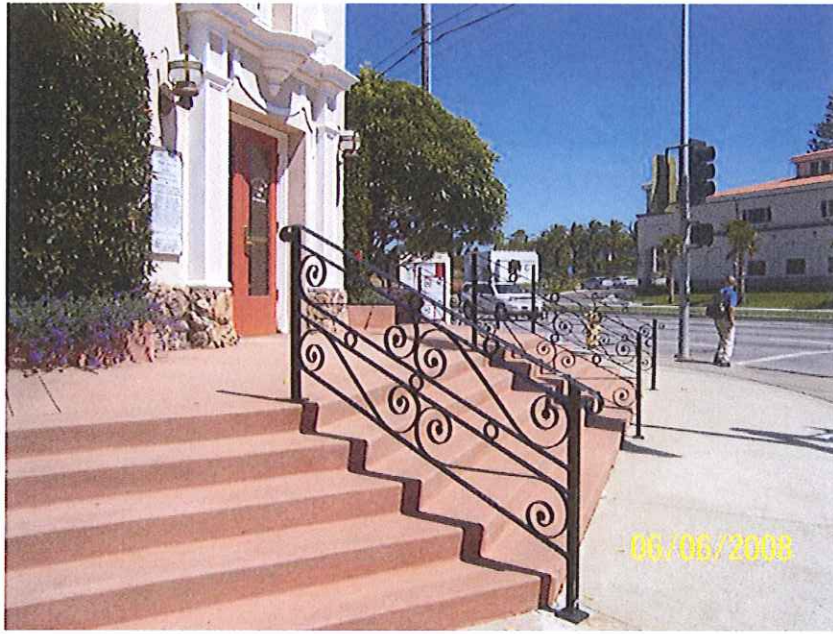
TH5

Locations	Observations	Recommended Corrections/Modifications	Urgency Criteria	Additional Information/References	Est. Cost \$	Finalized Action	Date Corrected
<p>Location</p>	<p>Problem Identified</p>	<p>Recommended Solution</p>	<p>L = Low, M = Med, H = High</p>	<p>Photo #</p>	<p>Est. Cost \$</p>	<p>Est. Correction Date.</p>	<p>Date Corrected</p>
<p>Town Hall (1198 El Camino Real)</p>	<p>Exist. handrails for the accessible ramp at the east entrance to council chamber are non compliant. Handrails are not provided on both sides of the ramp.</p>	<p>Provide fully compliant handrails per ADAAG 4.8.5.</p>	<p>H</p>	<p>TH3,4</p>	<p>\$5,500</p>	<p>FY2012-13</p>	
	<p>Exist. Handrails at the front entry stairway are non-compliant. No detectable warnings.</p>	<p>Provide handrails per ADAAG 4.9.4. and provide detectable warnings on stairs (painted stripes at each tread).</p>	<p>H</p>	<p>TH5</p>	<p>\$4,500</p>	<p>FY2012-13</p>

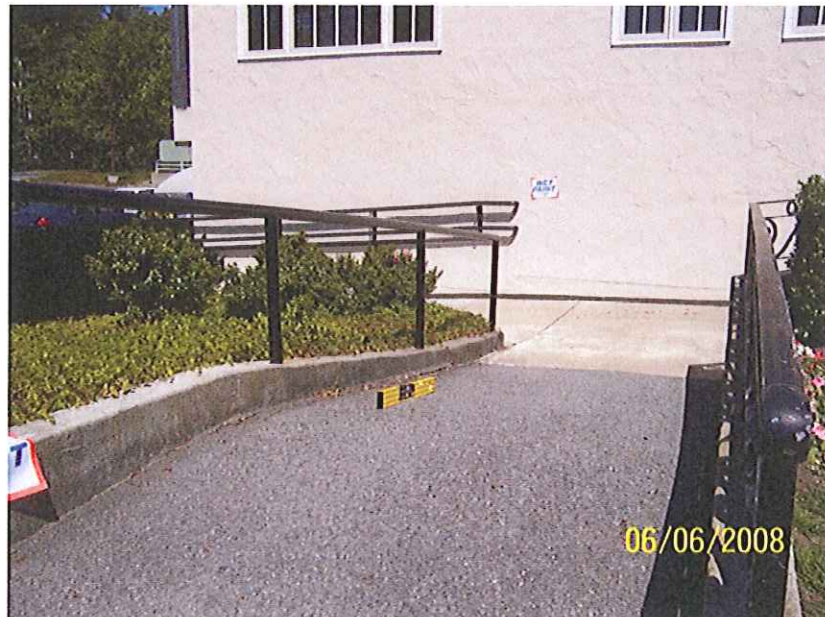
TH6

Locations	Observations	Recommended Corrections/Modifications	Urgency Criteria	Additional Information/References		Finalized Action	
			L = Low, M = Med, H = High	Photo #	Est. Cost \$	Est. Correction Date.	Date Corrected
Town Hall	<p>Force required to open entry doors to council chamber connecting to the corridor exceed 5 lbs (10 lbs.).</p>	<p>4.13.11 Provide push button or an equivalent mechanical solution. In the interim, provide a <i>doorbell for assistance</i> as an alternative solution. Reconfigure the swing of the door to require less than 5 lbs. of opening force. During business hours these doors will remain open.</p>	L	No Photo	\$4,500	FY2013-14	
	<p>ADAAG Spec.</p>						
	<p>Handrails for access ramp at Southwest end of building are non-compliant. One side is 32" high while the other is 42" high.</p>	<p>4.8.5 Provide code compliant handrails.</p>	H	TH8,9,10,11,19	\$6,500	FY2012-13	
	<p>In reference to ramp at Southwest end of bldg: intermediate landing is not level. Slope from Serramonte sidewalk down to intermediate landing is 14.8%.</p>	<p>4.8 Level existing landing and modify existing ramp to comply with a slope no greater than 8.33%.</p>	H	TH6,7	\$20,000	FY2012-13

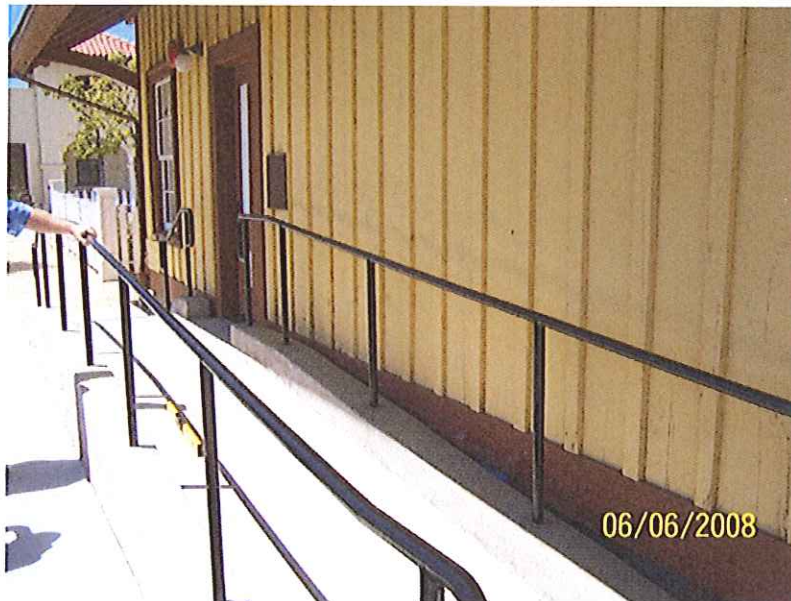
MSM 4

Locations	Observations	Recommended Corrections/Modifications	Urgency Criteria	Additional Information/References		Finalized Action	
				Photo #	Est. Cost \$	Est. Correction Date.	Date Corrected
Location Colma Museum Building 1500 Hillside Blvd	Problem Identified No detectable warning at curb ramp located at front entrance.	ADAAG Spec. Recommended Solution Provide truncated dome per appropriate standards.	L = Low, M = Med, H = High H	MSM1	\$2,000	FY2012-13	
	Signage and striping is incomplete.	4.6 Repair the striping and indicate tow truck information on the parking sign.	H	MSM2,3	\$500	FY2011-12	
	Exterior railroad station: * Handrail extensions are non compliant	4.8.5 4.8.2 Provide ADA compliant modifications	L	MSM4,5	\$1,500	FY2012-13

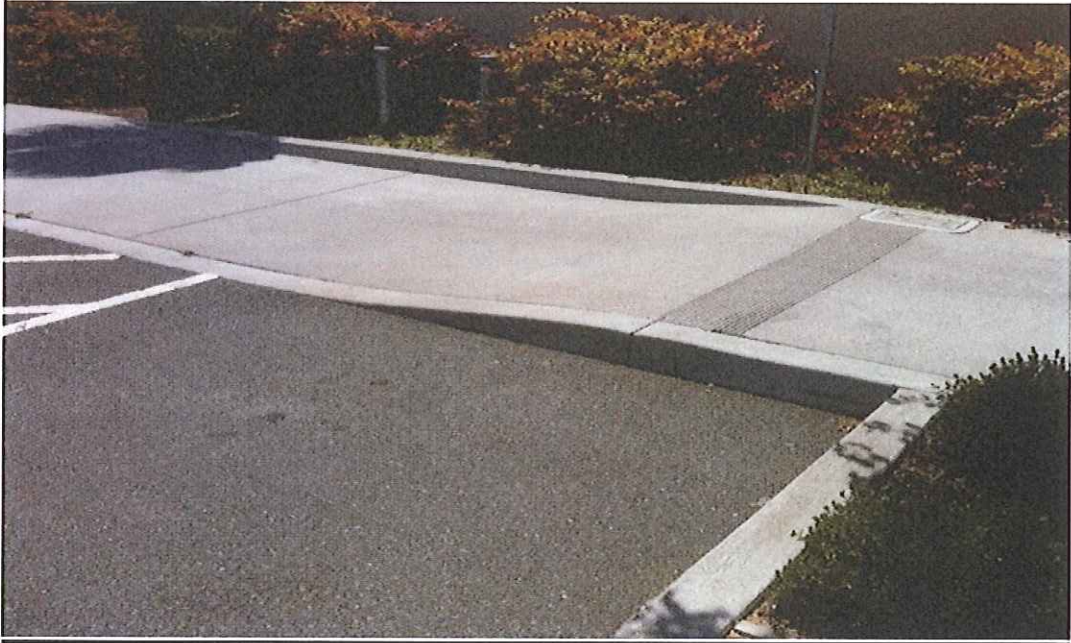
Locations	Observations	Recommended Corrections/Modifications	Urgency Criteria	Additional Information/References			Finalized Action	
			L = Low, M = Med, H = High	Photo #	Est. Cost \$	Est. Correction Date.	Date Corrected	
Community Center 1520 Hillside Blvd	Force required to open front entry doors exceeds 5 lbs.	4.13.11 Provided push button on front door Reconfigure the swing of the remaining doors to require less than 5 lbs. of opening force.	M	No Photo	\$5,500	N/A	Feb-09	
	Accessible Path of Travel at north side in unclear	4.3.2 Install signage directing individuals in wheelchair's to accessible entrance Place on north side entrance door to office area.	M	CCC 1	\$1,000	FY2012-13		
	Accessible ramp in parking lot is non compliant.	4.3.2 4.29.2 Correct when parking lot is scheduled for re-surfacing	H	CCC 2	\$3,500	FY2012-13
