## EXISTING CONDITIONS

This report is based on a December 19, 2017 site visit with Ivan G. Smith school facilities personnel, taking into consideration the various systems viewed and current system conditions described by them.

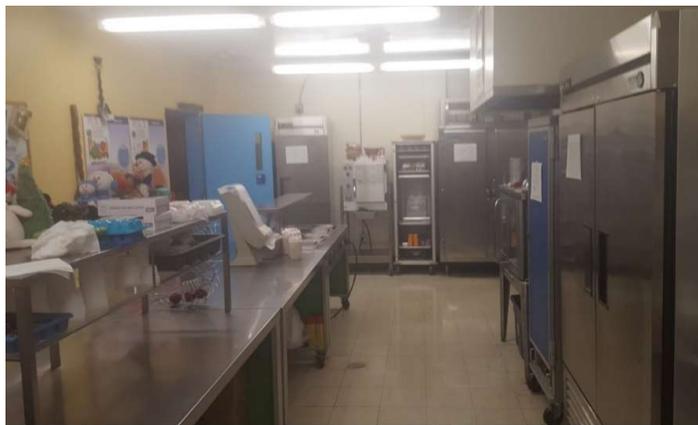
Kitchen

- 2) The three-compartment sink is not connected to a code required grease interceptor. Thus, any grease being drained from this unit discharges directly into the town's waste water system. This is a state plumbing code violation.
- 3) A dishwasher was not observed during this visit.
- 4) The kitchen does have two (2) floor drains within the center of the room. These drains are subject to grease as well but drain directly to the town's waste water system. This is also

state plumbing code violation.

- 5) Visual inspection outside of the building did not reveal the existence of an exterior grease trap. Existing conditions drawings do not indicate one either. It is fair to assume that the kitchen waste piping discharges directly to the town's waste water system without being treated.

- 3) Additional floor sinks and/or floor drains would be added to any new equipment design to ensure proper drainage throughout the kitchen.
- 4) A new three-compartment sink with new grease trap should be included per state code requirements.

- 5) A new dishwasher with accompanying grease trap should also be provided per state code requirements.
- 6) A new exterior grease trap, located underground, outside of the kitchen portion of the building will also need to be considered as part of any new design or renovation to the kitchen. Venting of this exterior grease trap should enter back into the school building and exit to the atmosphere above the roof.

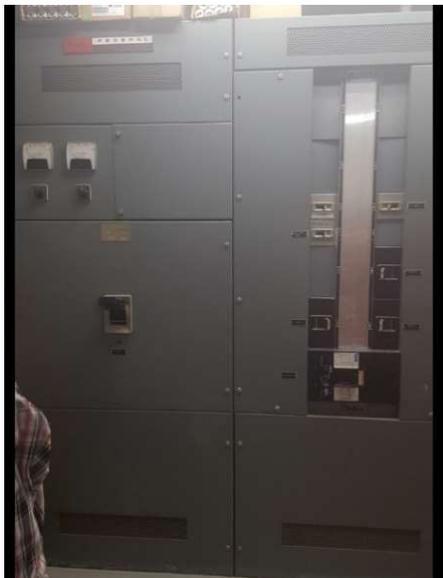
- 1) Utility primary feeders are extended overhead to a pole on Orrantia Circle where it drops and extends underground approximately 300' to a utility owned pad mounted transformer located behind the building. Secondary service conductors are extended underground from the transformer to a 2000A, 277/480V, 3 $\phi$ , 4w switchboard. Branch distribution panelboards are located throughout the building in electrical rooms and other storage closets. With the exception of a few panelboards, all equipment is original to the building and over 45 years old. The distribution equipment is manufactured by Federal Pacific, which is no longer in existence and so reconditioned or custom parts are required for repairs.

Federal Pacific switchboard

- 1) The existing electrical distribution system is over 45 years old. The manufacturer of the existing equipment is no longer in existence and so repairs are problematic. The entire system should be removed and replaced. The new system consists of a new 2000A, 277/480V, 3 $\phi$ , 4w switchboard with new underground secondary service conductors extended to the existing utility transformer in the back of the building. New electrical branch circuit panelboards will be provided in dedicated electrical rooms. Lighting loads, the elevator, large mechanical equipment and large kitchen electrical loads will be connected to 277/480V panelboards and all other loads will be connected to 120/208V panelboards.

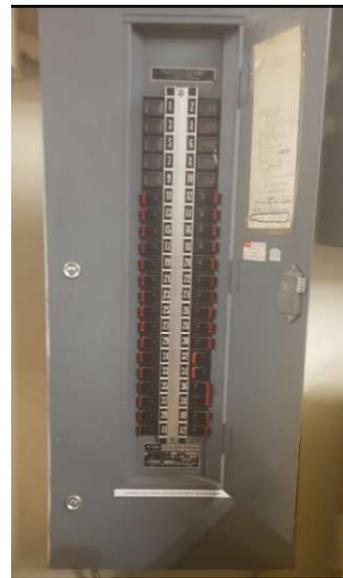
Typical Federal Pacific panelboard

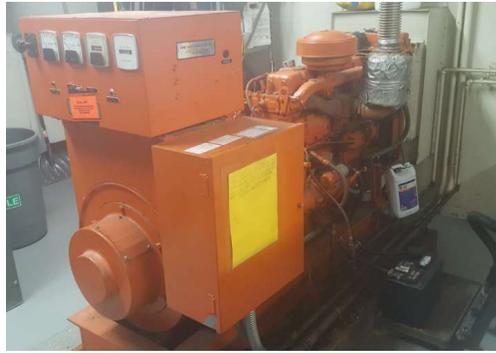
- 2) The building has a 50kW/62.5kVA, 277/480V, 3 $\phi$ , natural gas generator system and the generator and automatic transfer switch (ATS) are located in the main electric room. The generator has a single distribution panel and so life safety, such as emergency lighting, and optional standby loads are mixed on the same panel. The generator is reported to be operational but is original to the building and over 45 years old.

Generator in shared electrical room

- 2) The generator is reported to be operational but is original to the building and has reached the end of its useful life. Furthermore, the generator system does not meet current code requirements since it is not located in a 2hr rated, dedicated emergency electrical room and emergency lighting and optional loads are mixed on the same

panelboards. The entire system should be removed and replaced with a new diesel generator system with separate optional standby and emergency distribution feeders from the system. The exact size of the generator will depend on additional discussions with the Town of Danvers regarding desired auxiliary power needs, but the generator size is expected to be approximately 100kW. The generator will be pad mounted on the exterior of the building. A dedicated 2hr emergency electrical room will be provided for the emergency lighting panelboards and automatic transfer switch. The optional standby panel and ATS can be located in the main electrical room. It is expected that optional standby loads will include kitchen freezers/cooler, the building heating system, Tel/Data and communications systems, and security systems.

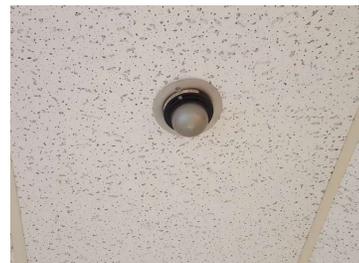
Old style heat detector

- 3) The existing fire alarm system is operational, but does not meet 780 CMR 907 building code requirements for voice evacuation. A new fire alarm and voice evacuation system is recommended. The new system would consist of an addressable voice evacuation fire alarm control panel, automatic smoke and heat detectors, manual pull stations, audible and visible alarm signals, elevator recall, connections to automatic fire suppression systems, and connection to the Fire Department. The new fire alarm system will report to the Fire Department through the existing master box.

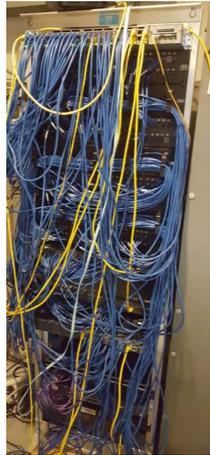
- 1) There are two main distribution racks for telephone and data cabling located in shared rooms with the electrical rooms. Category 5 cabling is utilized for both telephone and data cabling and cabling is run exposed above ceilings. Wireless access points are distributed throughout the building and classrooms in general have a single tel/data outlet at the teachers stations in the front of the classroom.

Typical IDF rack adjacent to panelboard  
in shared electrical room

- 1) The existing structured cabling system utilizes Category 5 cabling which is functional and even though existing standards use Category 6 cabling, Category 5 cabling is sufficient for most data needs. However, it is unlikely that any major renovation or upgrade to the building will result in utilizing existing cabling outlets and IDF locations. Furthermore, the existing number of telephone/data outlets is limited and restrictive. Lastly the IDF locations are shared with electrical rooms and storage rooms which are difficult to maintain and preclude additions of new cabling. A new structured cabling system is recommended for long term technology use.

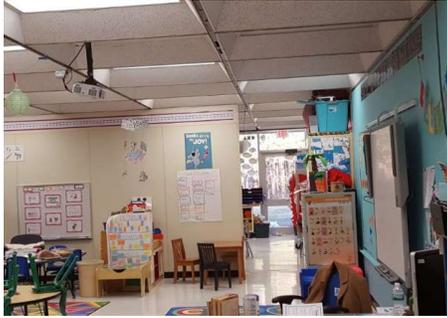
Ceiling mounted data projector with whiteboard

- 1) The existing classroom data projectors and imaging technologies are in operational condition and will continue to function for the foreseeable future. However, whether this technology meets the instructional needs and plans for the school is not known at this time. It is assumed that for long term planning, classrooms will need to be fitout with new teacher computers and imaging technologies. Additional technology needs will require further discussions with the school.

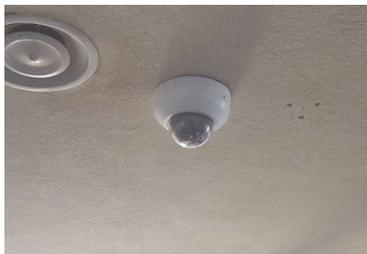
- 1) There are a small number (less than 6) of IP cameras in selected locations. Cameras are connected to the network and are displayed on a computer in the main office. It was not known if the system has video storage and if so system capacity. Furthermore, it was not known when the current system was installed, but it is assumed it was less than 10 years old.
- 2) There is not a door access or card reader system. Visitors arriving at the main entrance are required to announce their arrival through an intercom system connected to the main office and the main office remotely unlocks the main entrance door. A small intrusion detection system is present in the building. Magnetic door contacts were not observed in the exterior doors but motion detectors were found in the corridors and other locations. A keypad located in the facilities managers are enables and disables the system.

IP camera at entrance

- 1) The existing security systems are operational but are reaching the end of their useful life. Neither the intrusion detection system or CCTV system has expansion capability. New CCTV and intrusion detection systems should be provided. Furthermore, the building does not currently have a door access system. The recommended new system(s) should consists if the following:
  - a. Intrusion detection for the exterior doors via door contacts
  - b. Intrusion detection in all first floor and basement corridors via motion detectors
  - c. Card access control points for main entrance.
  - d. CCTV surveillance system via POE (Power Over Ethernet) cameras connected to a central digital video recorder system in the main telecoms room.

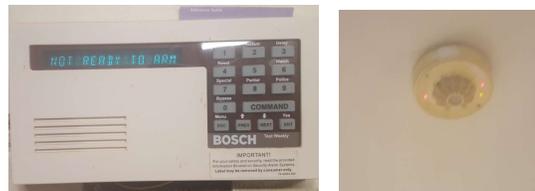
Intrusion detection keypad and motion detector
