# **Forest Lake Dam 2024 Inspection Report**

**Ela Township Highway Department  
23605 N. Echo Lake Road  
Lake Zurich, Illinois 60047**

Prepared by:  
Gewalt Hamilton Associates, Inc.  
625 Forest Edge Drive  
Vernon Hills, Illinois 60061  
Tel. (847) 478-9700  
Fax: (847) 478-9701

March 27, 2024

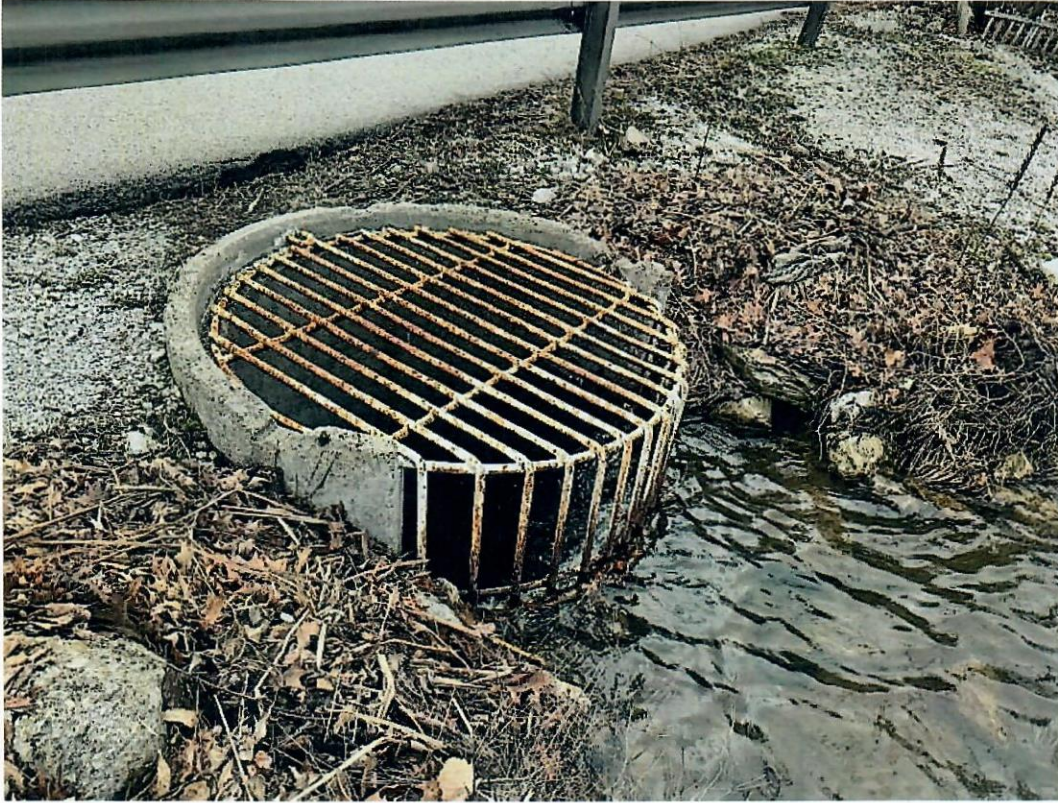
Drop Manhole Control Structure- 3/27/24

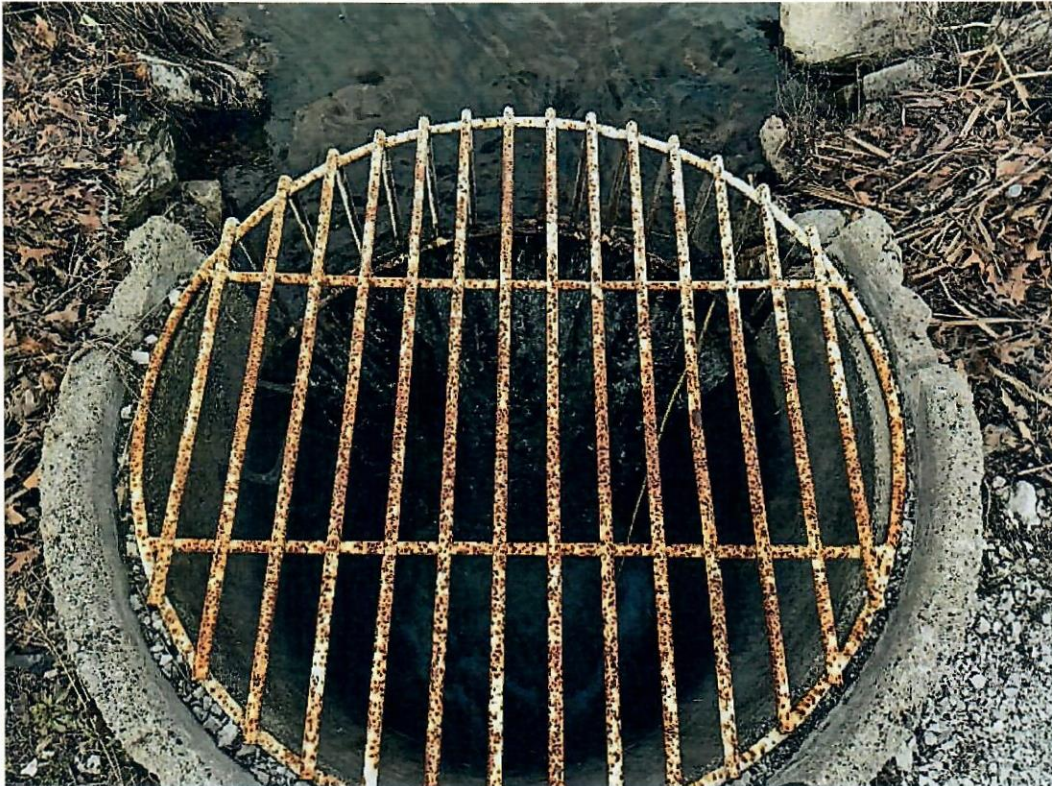
Control Structure- Water Level Approximately 5" Above Concrete Sill- 3/27/24

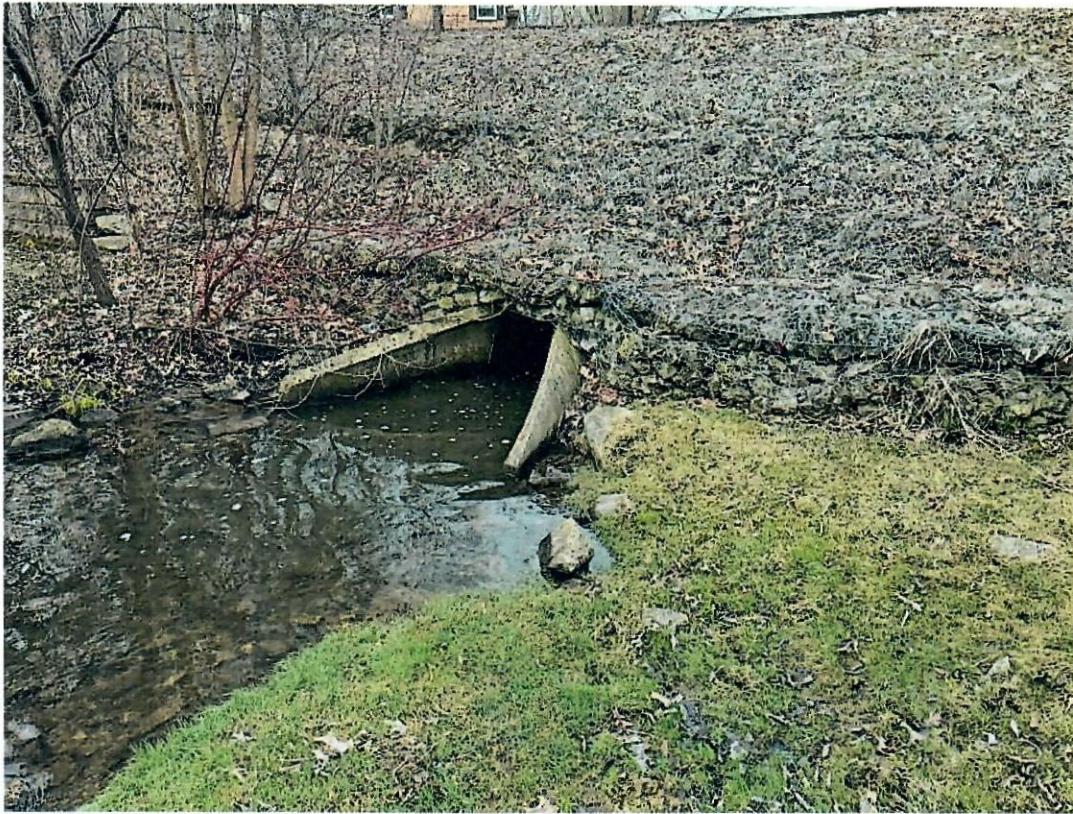
36" RCP Outlet Pipe- 3/27/24

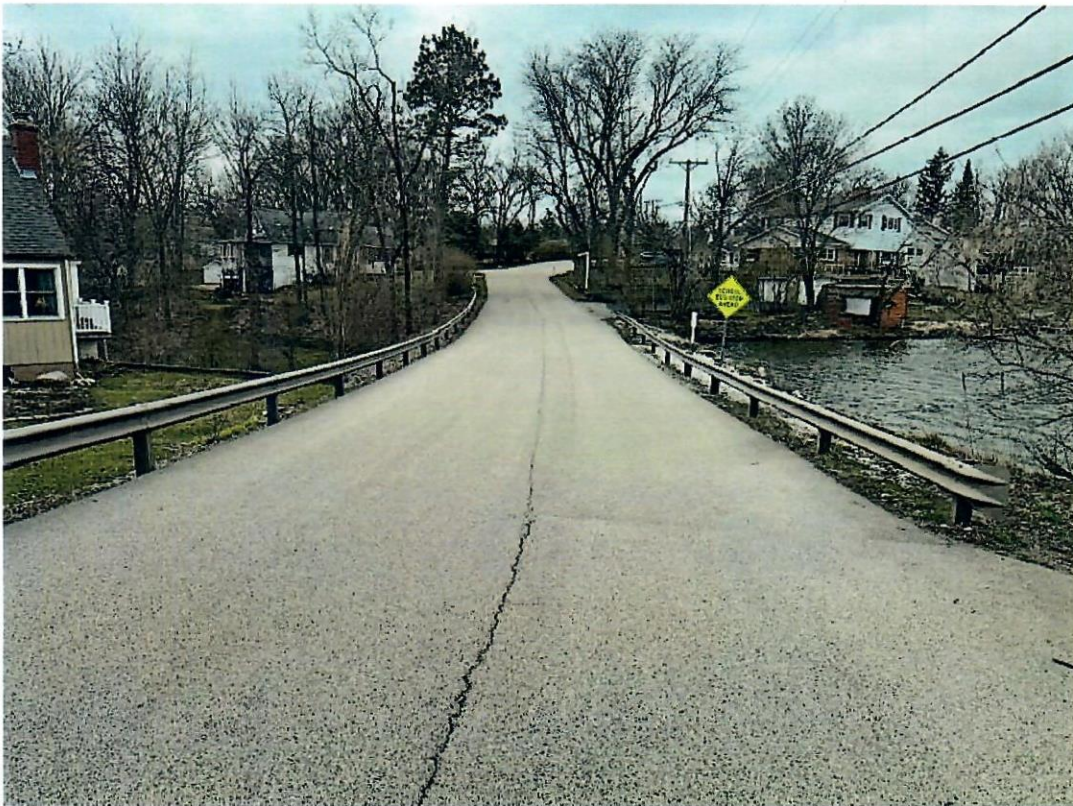
Lakeside Drive- 3/27/24 (Forest Lake on right side of road, outlet pipe on left side)
