Forest Lake Dam 2020 Inspection Report

**Ela Township Highway Department
23605 N. Echo Lake Road
Lake Zurich, Illinois 60047**

Prepared by:
Gewalt Hamilton Associates, Inc.
625 Forest Edge Drive
Vernon Hills, Illinois 60061
Tel. (847) 478-9700
Fax: (847) 478-9701

October 9, 2020

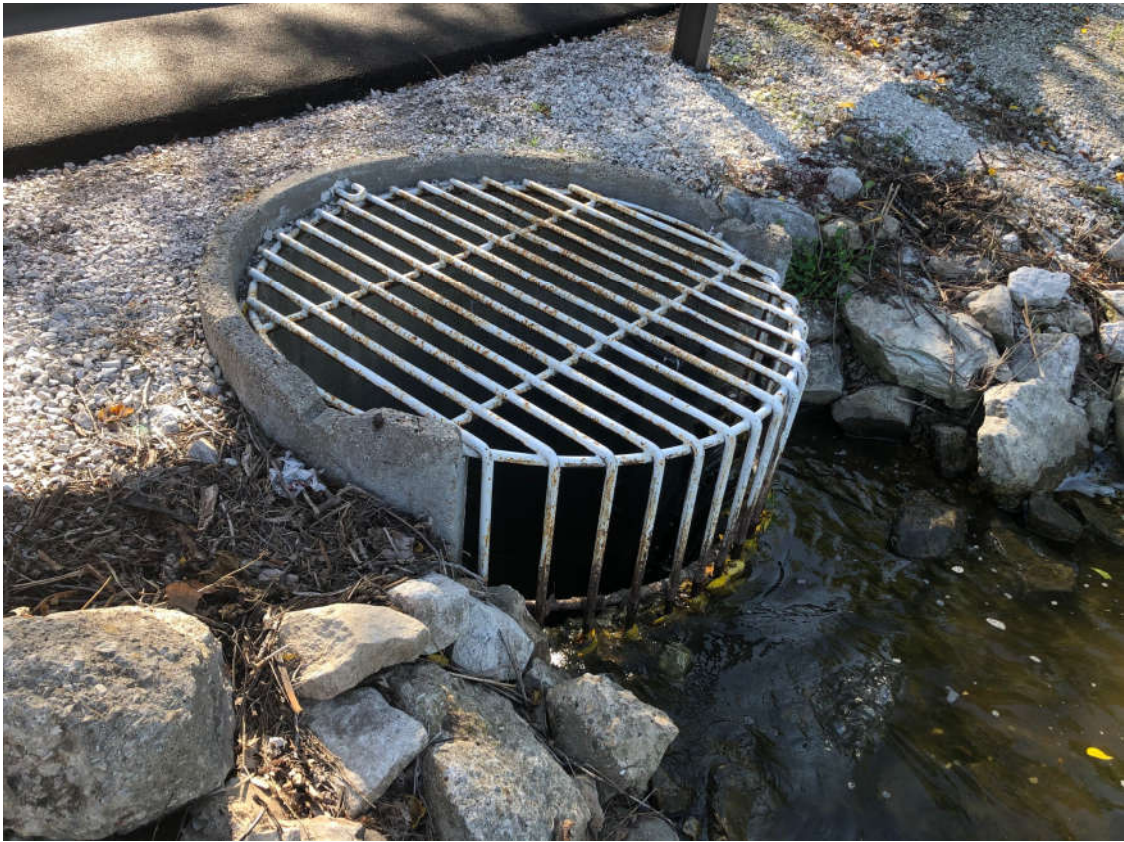
ITEM	CONDITION CODE	DEFICIENCIES	RECOMMENDED REMEDIAL MEASURES AND IMPLEMENTATION SCHEDULE
Erosion, Spalling, Cavitation	NE		
Structure to Embankment Junction	GC		
Drains	NA		
Seepage Around or Into Structure	OB	<i>Minor infiltration between bottom two sections of drop inlet; condition has not worsened since previous inspection.</i>	<i>Continued observation to ensure condition does not become worse.</i>
Surface Cracks	NE		
Structural Cracks	NE

Drop Manhole Control Structure- 9/30/20

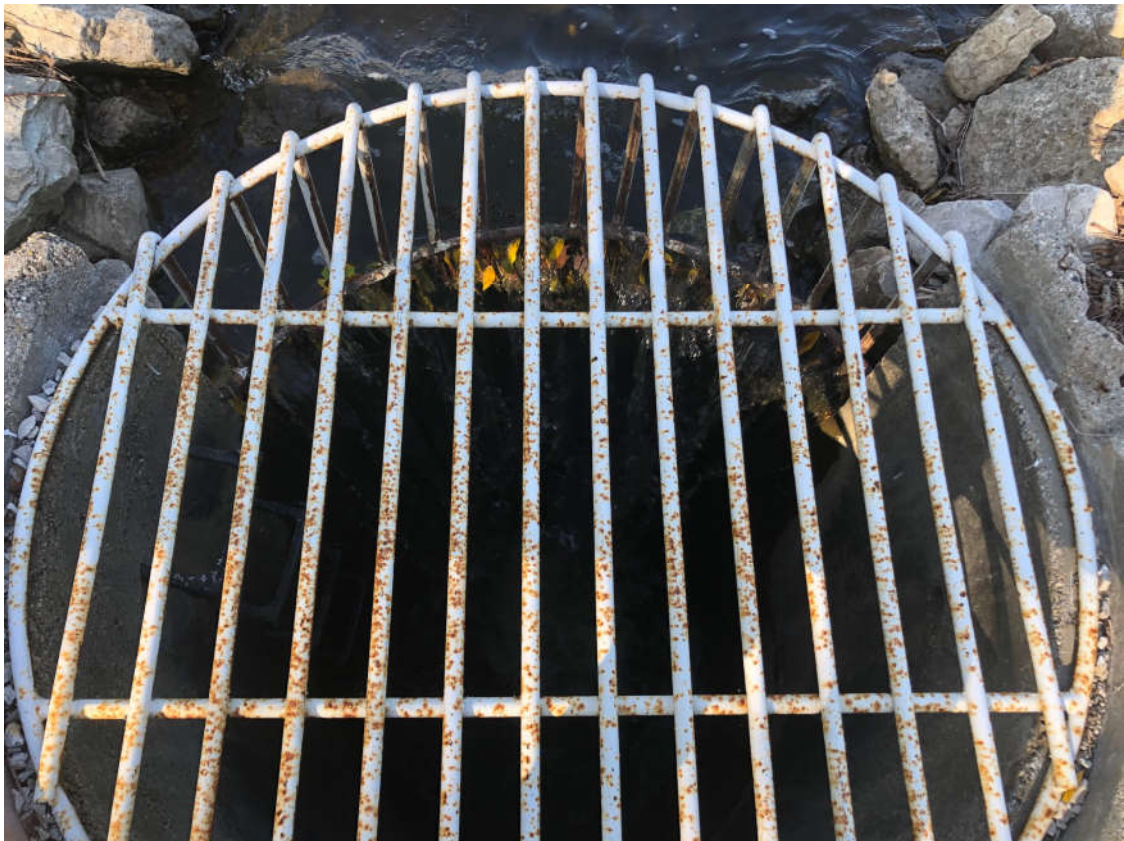
Control Structure- Water Level Approximately 1.5" Above Concrete Sill- 9/30/20

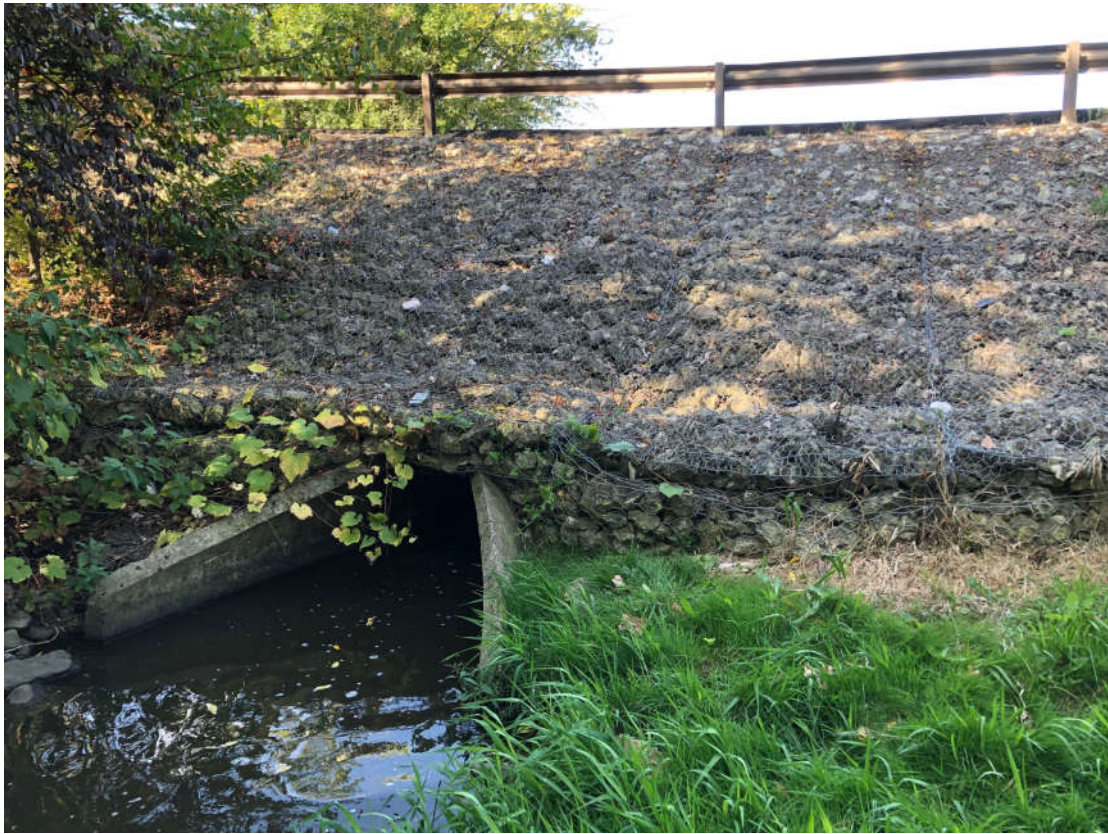
ITEM	CONDITION CODE	DEFICIENCIES	RECOMMENDED REMEDIAL MEASURES AND IMPLEMENTATION SCHEDULE
Erosion, Spalling, Cavitation	NE		
Joint Separation	OB	<i>Minor 0.16' gap at bottom of outlet pipe end section; not visible at time of inspection.</i>	<i>Continue to monitor.</i>
Seepage Around or Into Conduit	NE		
Surface Cracks	NE		
Structural Cracks	NE		
Trash Racks	NE		
Differential Settlement	NE		
Alignment	GC		
Other (Name)

36" RCP Outlet Pipe- 9/30/20

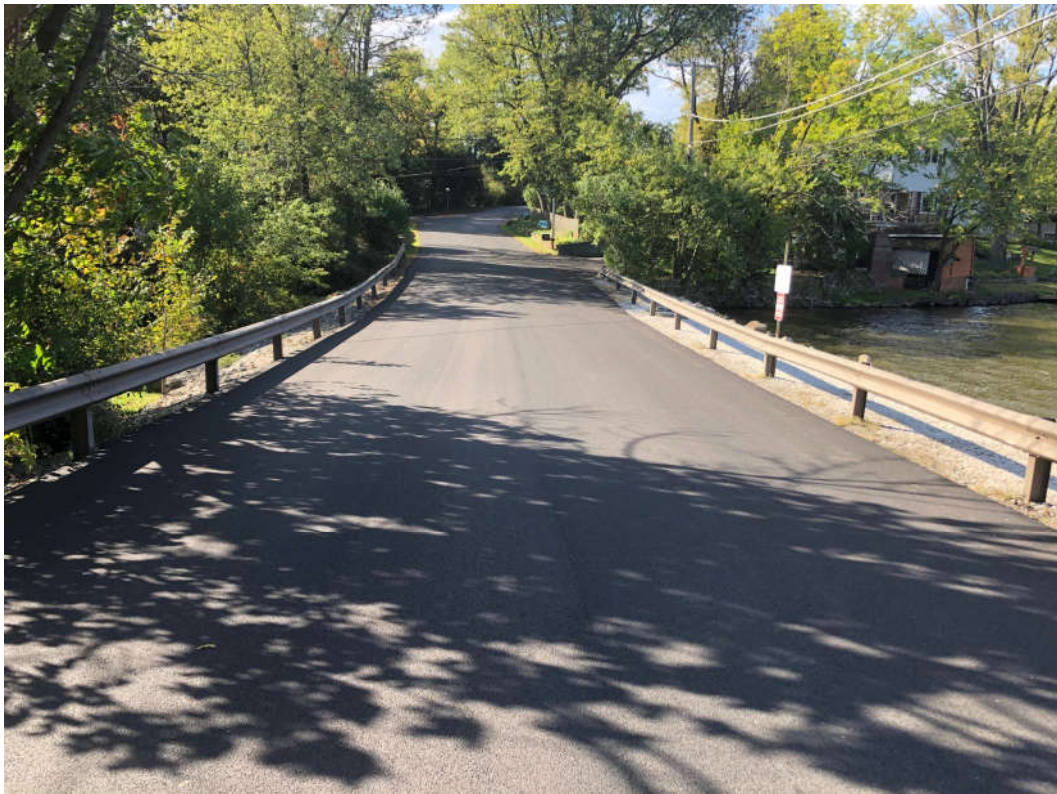
Roadway resurfaced September 2020.

Lakeside Drive- 9/30/20

(Forest Lake on right side of road, outlet pipe on left side;
HMA resurfacing completed September 2020)
