Forest Lake Dam 2021 Inspection Report

**Ela Township Highway Department
23605 N. Echo Lake Road
Lake Zurich, Illinois 60047**

Prepared by:
Gewalt Hamilton Associates, Inc.
625 Forest Edge Drive
Vernon Hills, Illinois 60061
Tel. (847) 478-9700
Fax: (847) 478-9701

December 6, 2021

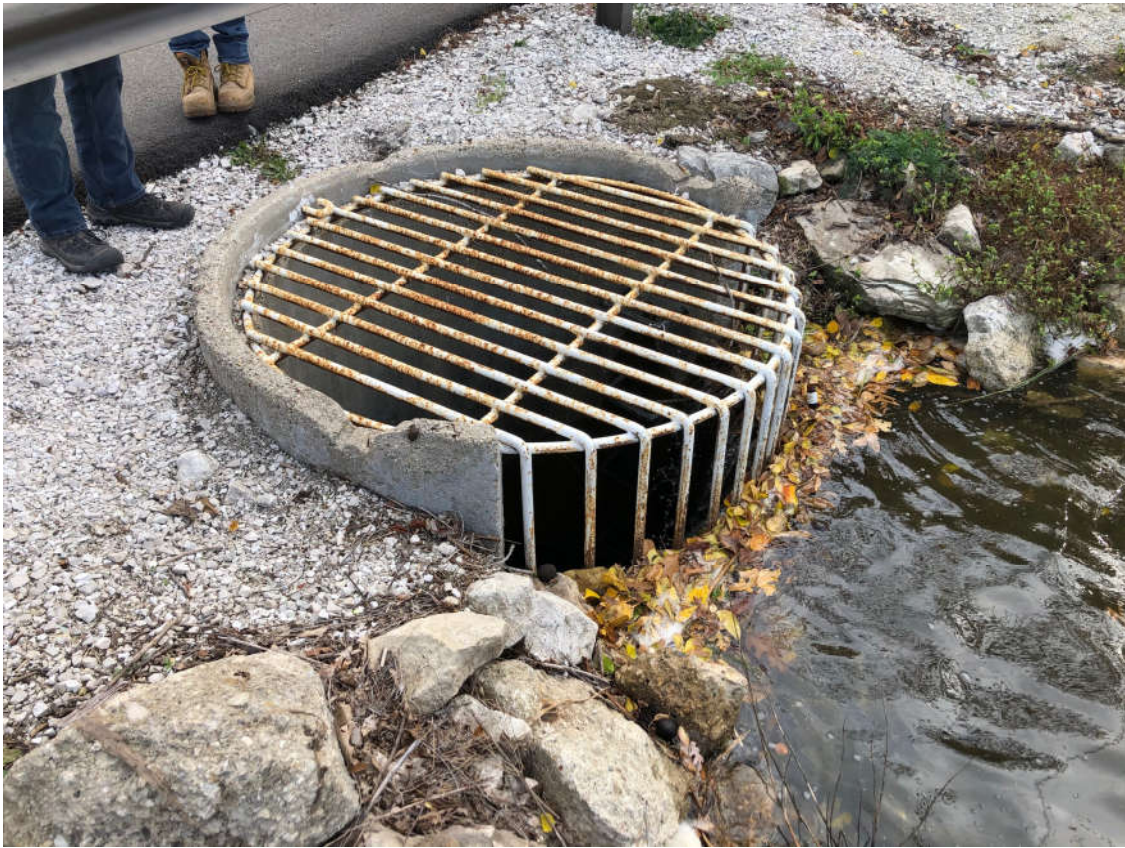
Drop Manhole Control Structure- 11/1/2021

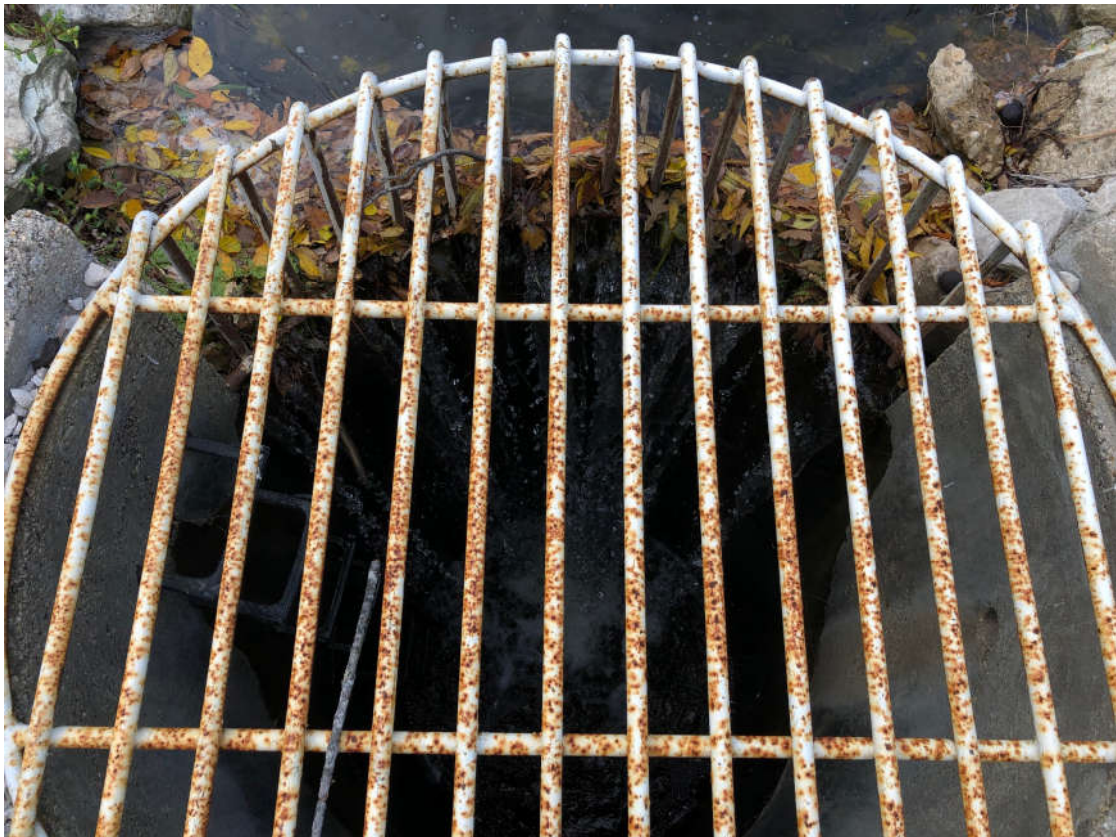
Control Structure- Water Level Approximately 10" Above Concrete Sill- 11/1/2021

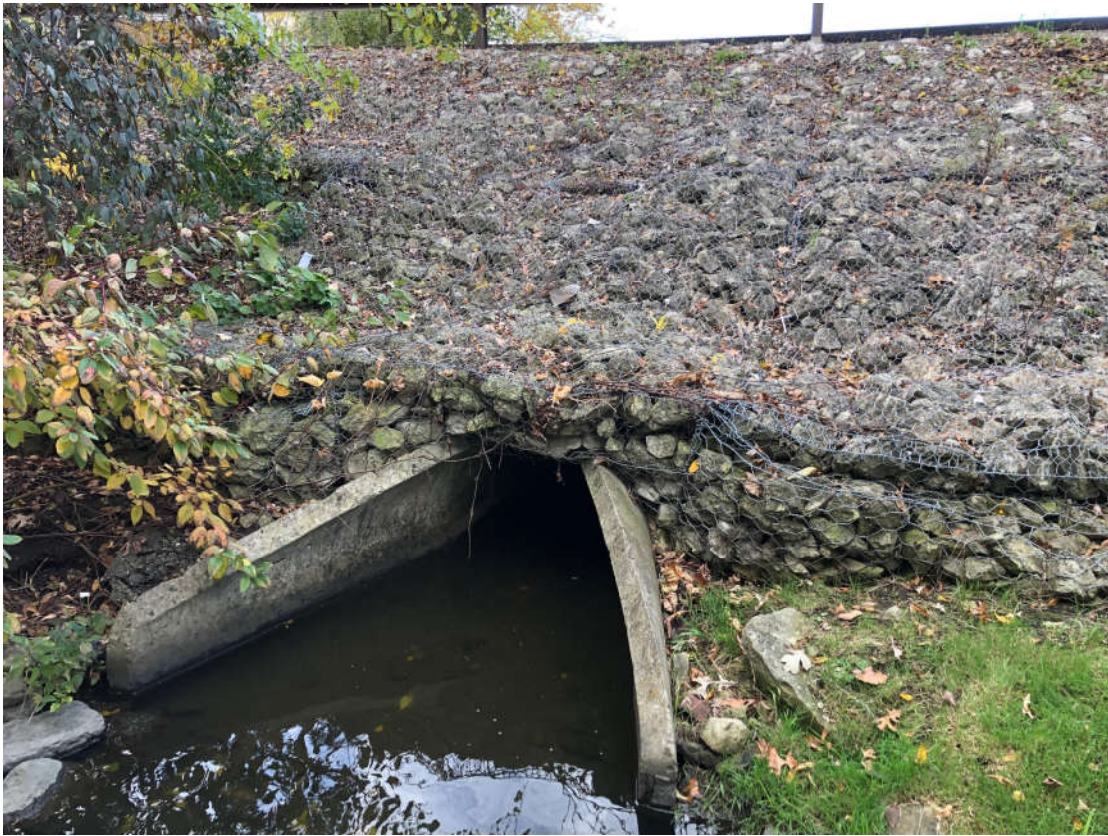
ITEM	CONDITION CODE	DEFICIENCIES	RECOMMENDED REMEDIAL MEASURES AND IMPLEMENTATION SCHEDULE
Erosion, Spalling, Cavitation	NE		
Joint Separation	IM	<i>Joints separating between pipe sections adjacent to drop inlet caused by concrete deterioration, creating small sinkhole.</i>	<i>Township is pursuing a repair of the pipe.</i>
Seepage Around or Into Conduit	NE		
Surface Cracks	NE		
Structural Cracks	NE		
Trash Racks	NE		
Differential Settlement	NE		
Alignment	GC		
Other (Name)

36" RCP Outlet Pipe- 11/1/2021
