FORESTRY PLAN - LOT 10
MARINDA HEIGHTS SUBDIVISION
APN: 001-150-12, 001-171-51, 001-251-31, 001-160-09
CITY OF FAIRFAX
Date: OCTOBER 2017

Scale: 1"=20'
SHEET
T-10

URBAN FORESTRY ASSOCIATES, INC.
(415) 454-4212 info@urbanforestryassociates.com
CALIFORNIA

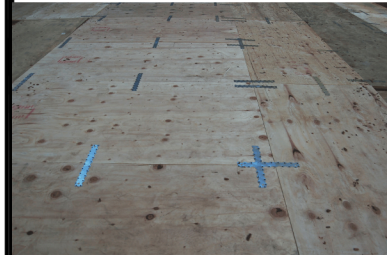
This area may be better suited to soil and trunk armoring as opposed to protection fencing to allow access to what is likely to be a high traffic area. See example photos below and report for specifications.
