FORESTRY PLAN - LOT 6
MARINDA HEIGHTS SUBDIVISION
 APN: 001-150-12, 001-171-51, 001-251-31, 001-160-09

CITY OF FAIRFAX

DATE: OCTOBER 2017

SHEET
T-6

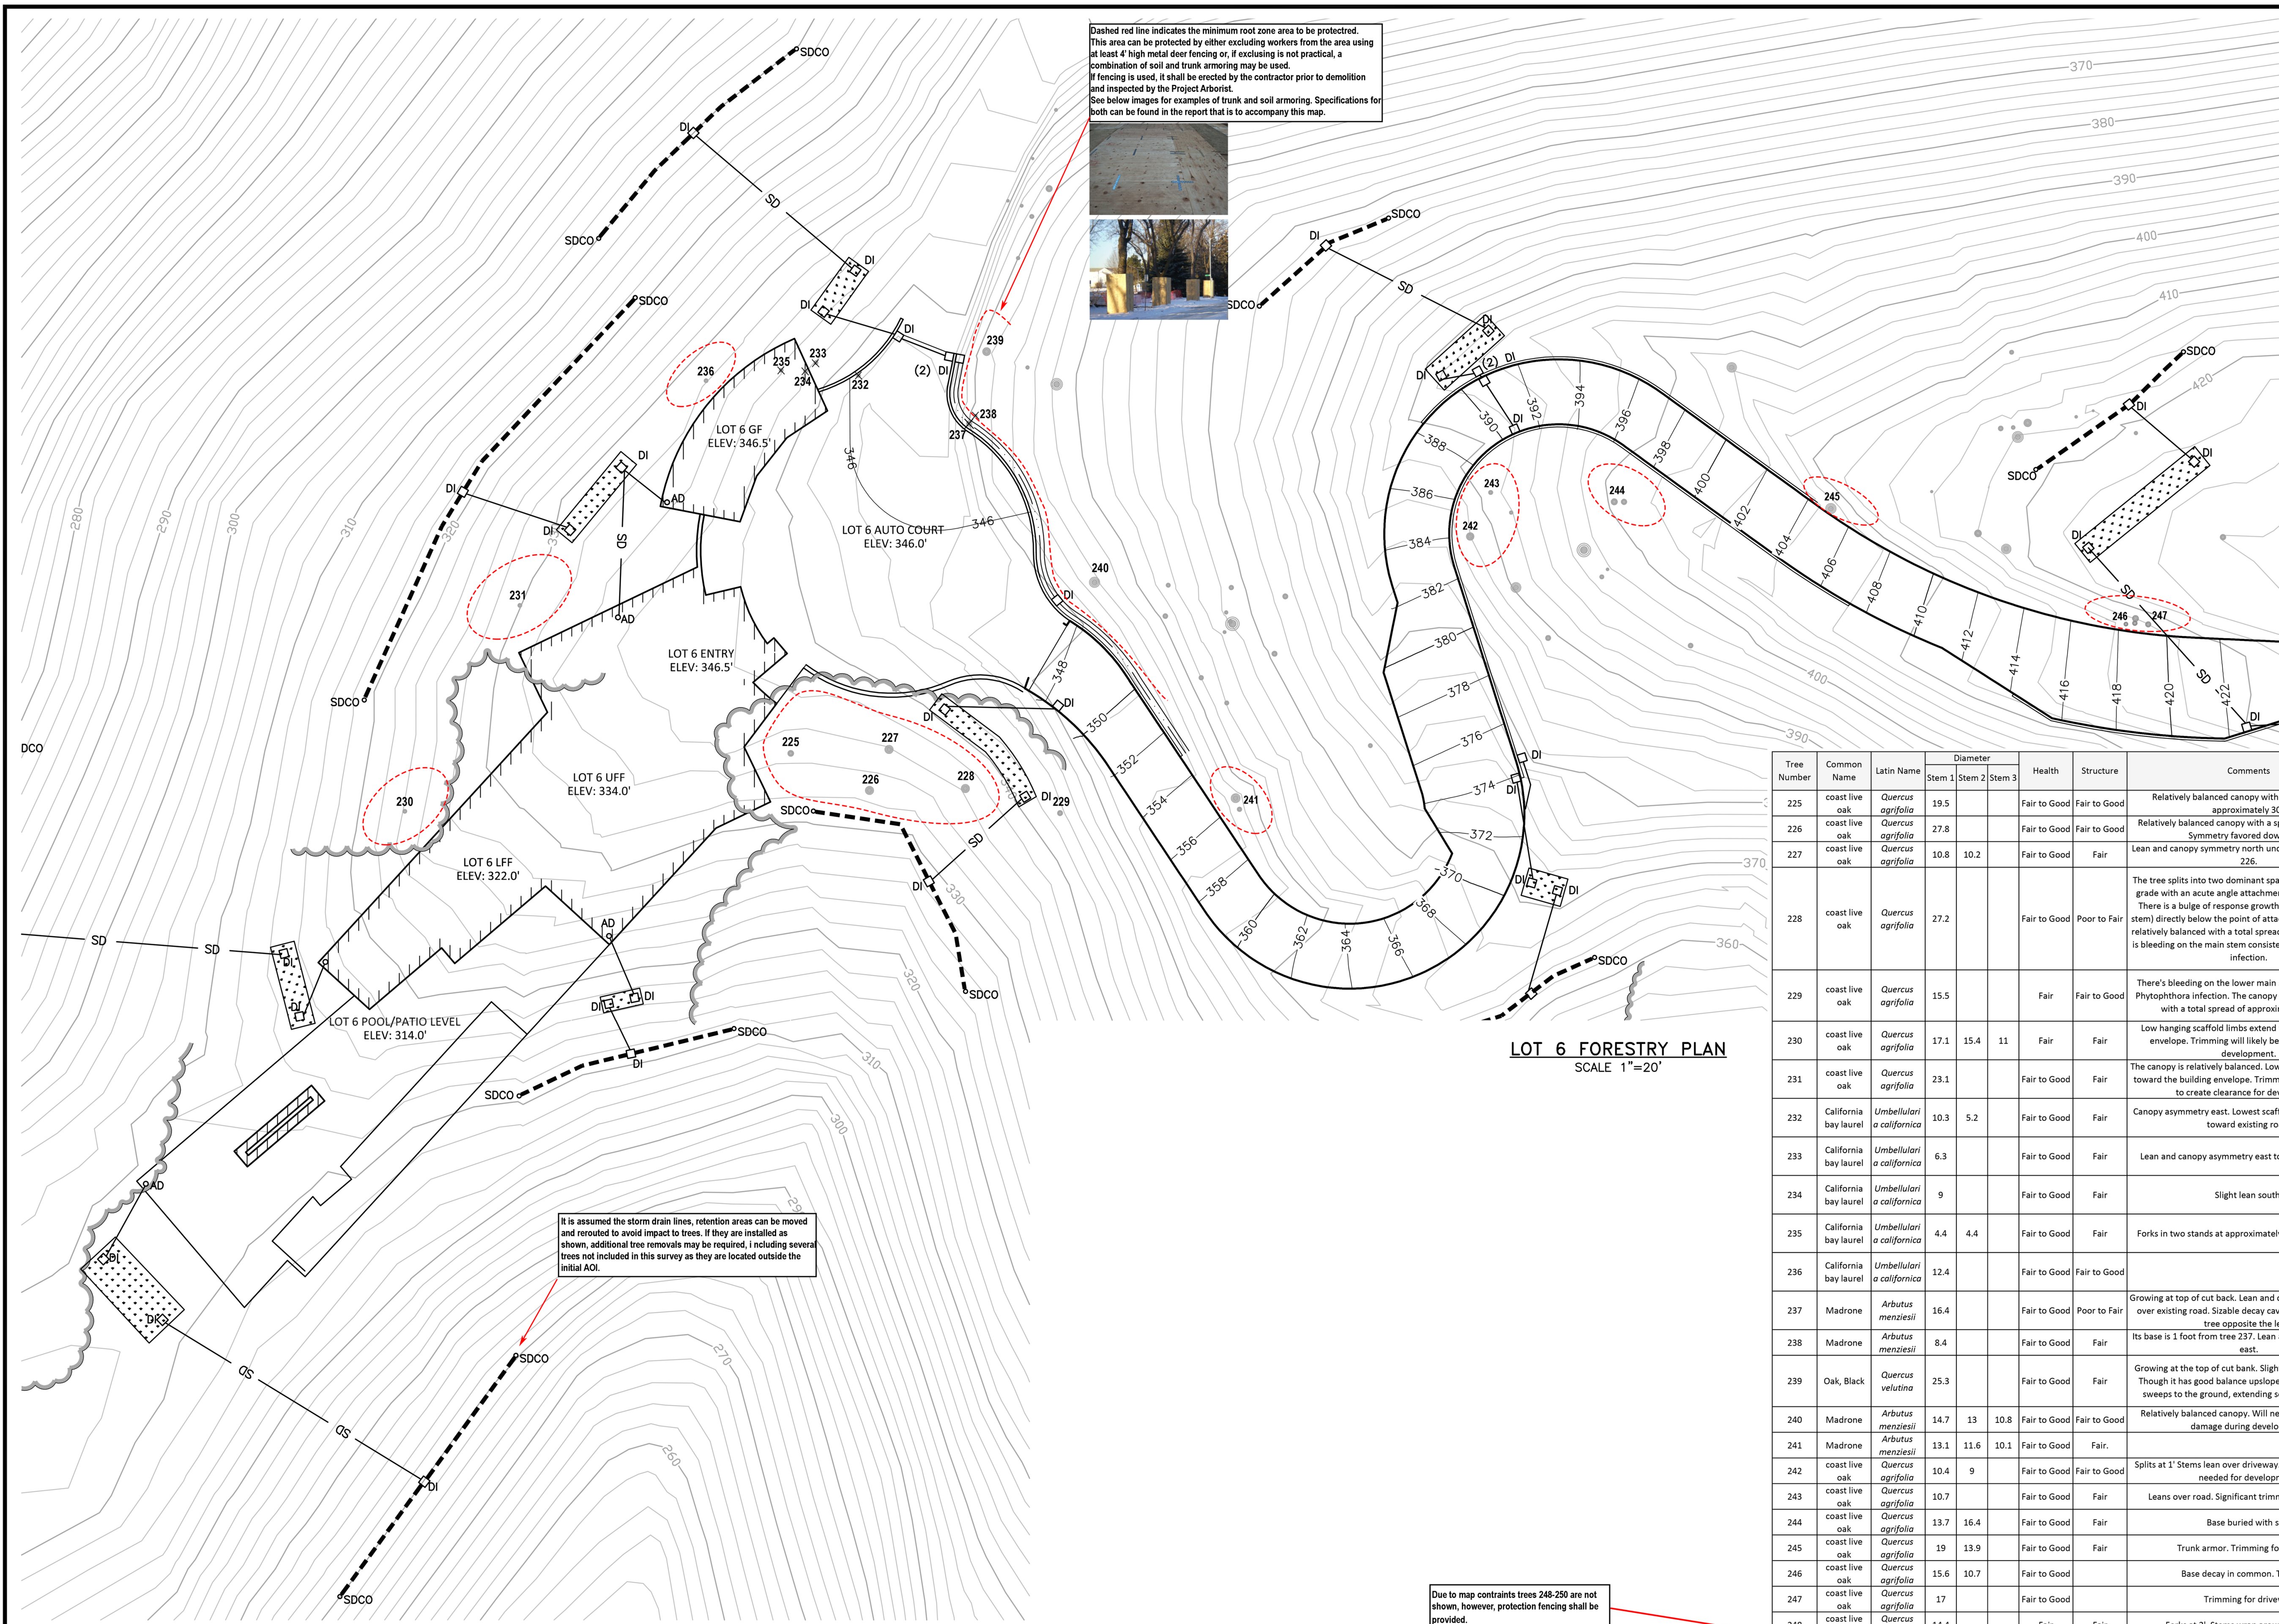
LOT 6 FORESTRY PLAN
SCALE 1"=20'

It is assumed the storm drain lines, retention areas can be moved and rerouted to avoid impact to trees. If they are installed as shown, additional tree removals may be required, including several trees not included in this survey as they are located outside the initial ADI.

Due to map constraints trees 248-250 are not shown, however, protection fencing shall be provided.

Tree Number	Common Name	Latin Name	Diameter			Health	Structure	Comments	Removal
			Stem 1	Stem 2	Stem 3				
225	coast live oak	<i>Quercus agrifolia</i>	19.5			Fair to Good	Fair to Good	Relatively balanced canopy with a total spread of approximately 30'.	
226	coast live oak	<i>Quercus agrifolia</i>	27.8			Fair to Good	Fair to Good	Relatively balanced canopy with a spread of approx. 40'. Symmetry favored downslope.	
227	coast live oak	<i>Quercus agrifolia</i>	10.8	10.2		Fair to Good	Fair	Lean and canopy symmetry north under the canopy of Tree 226.	
228	coast live oak	<i>Quercus agrifolia</i>	27.2			Fair to Good	Poor to Fair	The tree splits into two dominant spars at approx. 4' above grade with an acute angle attachment and included bark. There is a bulge of response growth (on both side of the stem) directly below the point of attachment. The canopy is relatively balanced with a total spread of approx. 45'. There is bleeding on the main stem consistent with Phytophthora infection.

229	coast live oak	<i>Quercus agrifolia</i>	15.5			Fair	Fair to Good	There's bleeding on the lower main stem consistent with Phytophthora infection. The canopy is relatively balanced with a total spread of approximately 25 feet.	
230	coast live oak	<i>Quercus agrifolia</i>	17.1	15.4	11	Fair	Fair	Low hanging scaffold limbs extend toward the building envelope. Trimming will likely be necessary during development.	
231	coast live oak	<i>Quercus agrifolia</i>	23.1			Fair to Good	Fair	The canopy is relatively balanced. Low scaffold limbs extend toward the building envelope. Trimming may be necessary to create clearance for development.	
232	California bay laurel	<i>Umbellularia californica</i>	10.3	5.2		Fair to Good	Fair	Canopy asymmetry east. Lowest scaffold limb extends east toward existing road.	X
233	California bay laurel	<i>Umbellularia californica</i>	6.3			Fair to Good	Fair	Lean and canopy asymmetry east toward existing road.	X

234	California bay laurel	<i>Umbellularia californica</i>	9			Fair to Good	Fair	Slight lean south.	X
235	California bay laurel	<i>Umbellularia californica</i>	4.4	4.4		Fair to Good	Fair	Forks in two stands at approximately 3 feet above grade.	X
236	California bay laurel	<i>Umbellularia californica</i>	12.4			Fair to Good	Fair to Good		
237	Madrone	<i>Arbutus menziesii</i>	16.4			Fair to Good	Poor to Fair	Growing at top of cut bank. Lean and canopy symmetry west over existing road. Sizeable decay cavity in the base of the tree opposite the lean.	
238	Madrone	<i>Arbutus menziesii</i>	8.4			Fair to Good	Fair	Its base is 1 foot from tree 237. Lean and canopy symmetry east.	
239	Oak, Black	<i>Quercus velutina</i>	25.3			Fair to Good	Fair	Growing at the top of cut bank. Slightly undercut on bank. Though it has good balance upslope. A 16' scaffold limb sweeps to the ground, extending south over cut bank.

240	Madrone	<i>Arbutus menziesii</i>	14.7	13	10.8	Fair to Good	Fair to Good	Relatively balanced canopy. Will need pruning to avoid damage during development.	
241	Madrone	<i>Arbutus menziesii</i>	13.1	11.6	10.1	Fair to Good	Fair		
242	coast live oak	<i>Quercus agrifolia</i>	10.4	9		Fair to Good	Fair to Good	Splits at 1' stems lean over driveway. Significant trimming needed for development.	
243	coast live oak	<i>Quercus agrifolia</i>	10.7			Fair to Good	Fair	Leans over road. Significant trimming for driveway.	
244	coast live oak	<i>Quercus agrifolia</i>	13.7	16.4		Fair to Good	Fair	Base buried with soil.	
245	coast live oak	<i>Quercus agrifolia</i>	19	13.9		Fair to Good	Fair	Trunk armor. Trimming for driveway	
246	coast live oak	<i>Quercus agrifolia</i>	15.6	10.7		Fair to Good		Base decay in common. Trim ming	
247	coast live oak	<i>Quercus agrifolia</i>	17			Fair to Good		Trimming for driveway	
248	coast live oak	<i>Quercus agrifolia</i>	14.4			Fair	Fair	Forks at 2'. Stems wrap around each other

249	coast live oak	<i>Quercus agrifolia</i>	19.4	14.2		Fair	Fair	Top of driveway. Base buried. Trimming	
250	coast live oak	<i>Quercus agrifolia</i>	5.1			Fair to Poor	Fair	Bleeding on main stem consistent with Phytophthora infection.	
Total Removals									4

Dashed red line indicates the minimum root zone area to be protected. This area can be protected by either excluding workers from the area using at least 4' high metal deer fencing or, if excluding is not practical, a combination of soil and trunk armoring may be used. If fencing is used, it shall be erected by the contractor prior to demolition and inspected by the Project Arborist. See below images for examples of trunk and soil armoring. Specifications for both can be found in the report that is to accompany this map.
