APP.	NO.	DATE	REVISION	SHEET
	1			
	2			
	3			
	4			
FORESTRY PLAN - LOT 8				
MARINDA HEIGHTS SUBDIVISION				
APN: 001-150-12, 001-171-51, 001-251-31, 001-160-09				
CITY OF FAIRFAX				
OCTOBER 2017				
T-8

URBAN FORESTRY ASSOCIATES, INC.
18100 22nd Street Suite 100, San Rafael, CA 94903
(415) 452-2222 or 415-452-2223

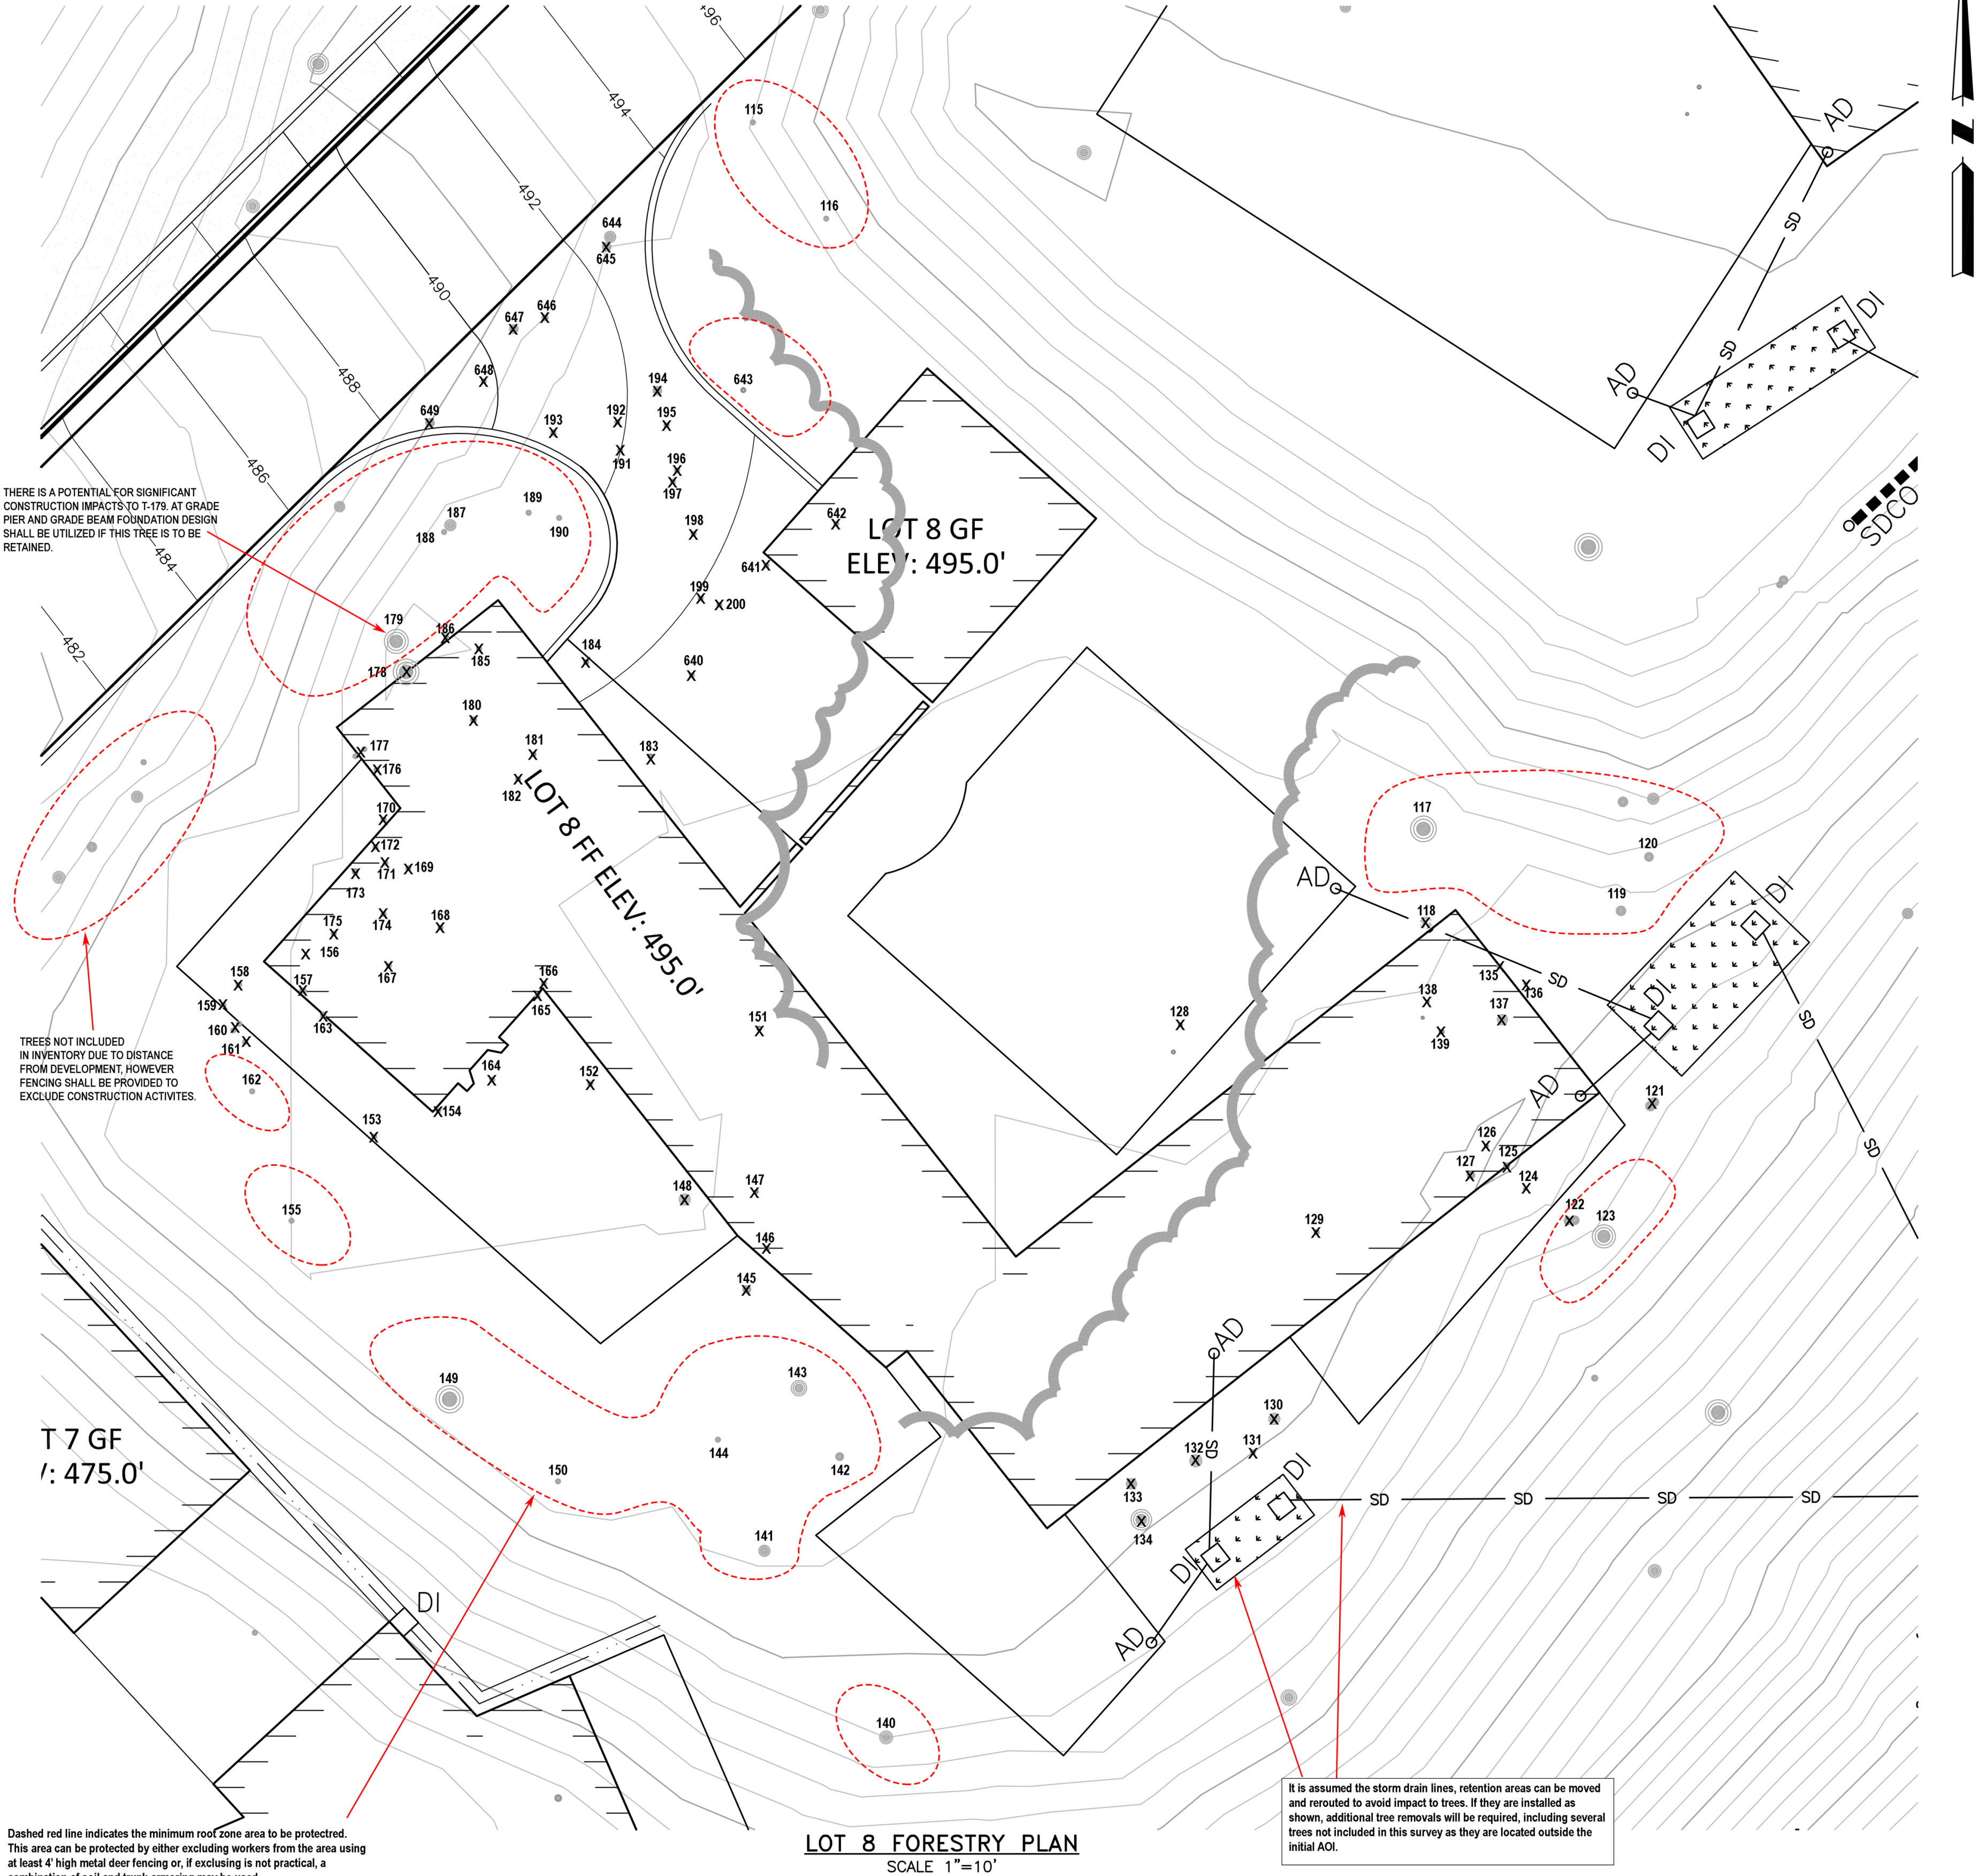
THERE IS A POTENTIAL FOR SIGNIFICANT CONSTRUCTION IMPACTS TO T-179 AT GRADE PIER AND GRADE BEAM FOUNDATION DESIGN SHALL BE UTILIZED IF THIS TREE IS TO BE RETAINED.

TREES NOT INCLUDED IN INVENTORY DUE TO DISTANCE FROM DEVELOPMENT, HOWEVER FENCING SHALL BE PROVIDED TO EXCLUDE CONSTRUCTION ACTIVITIES

Dashed red line indicates the minimum root zone area to be protected. This area can be protected by either excluding workers from the area using at least 4' high metal deer fencing or, if excluding is not practical, a combination of soil and trunk armoring may be used. If fencing is used, it shall be erected by the contractor prior to demolition and inspected by the Project Arborist. See below images for examples of trunk and soil armoring. Specifications for both can be found in the report that is to accompany this map.
