LOT 9 FORESTRY PLAN  
SCALE 1"=10'

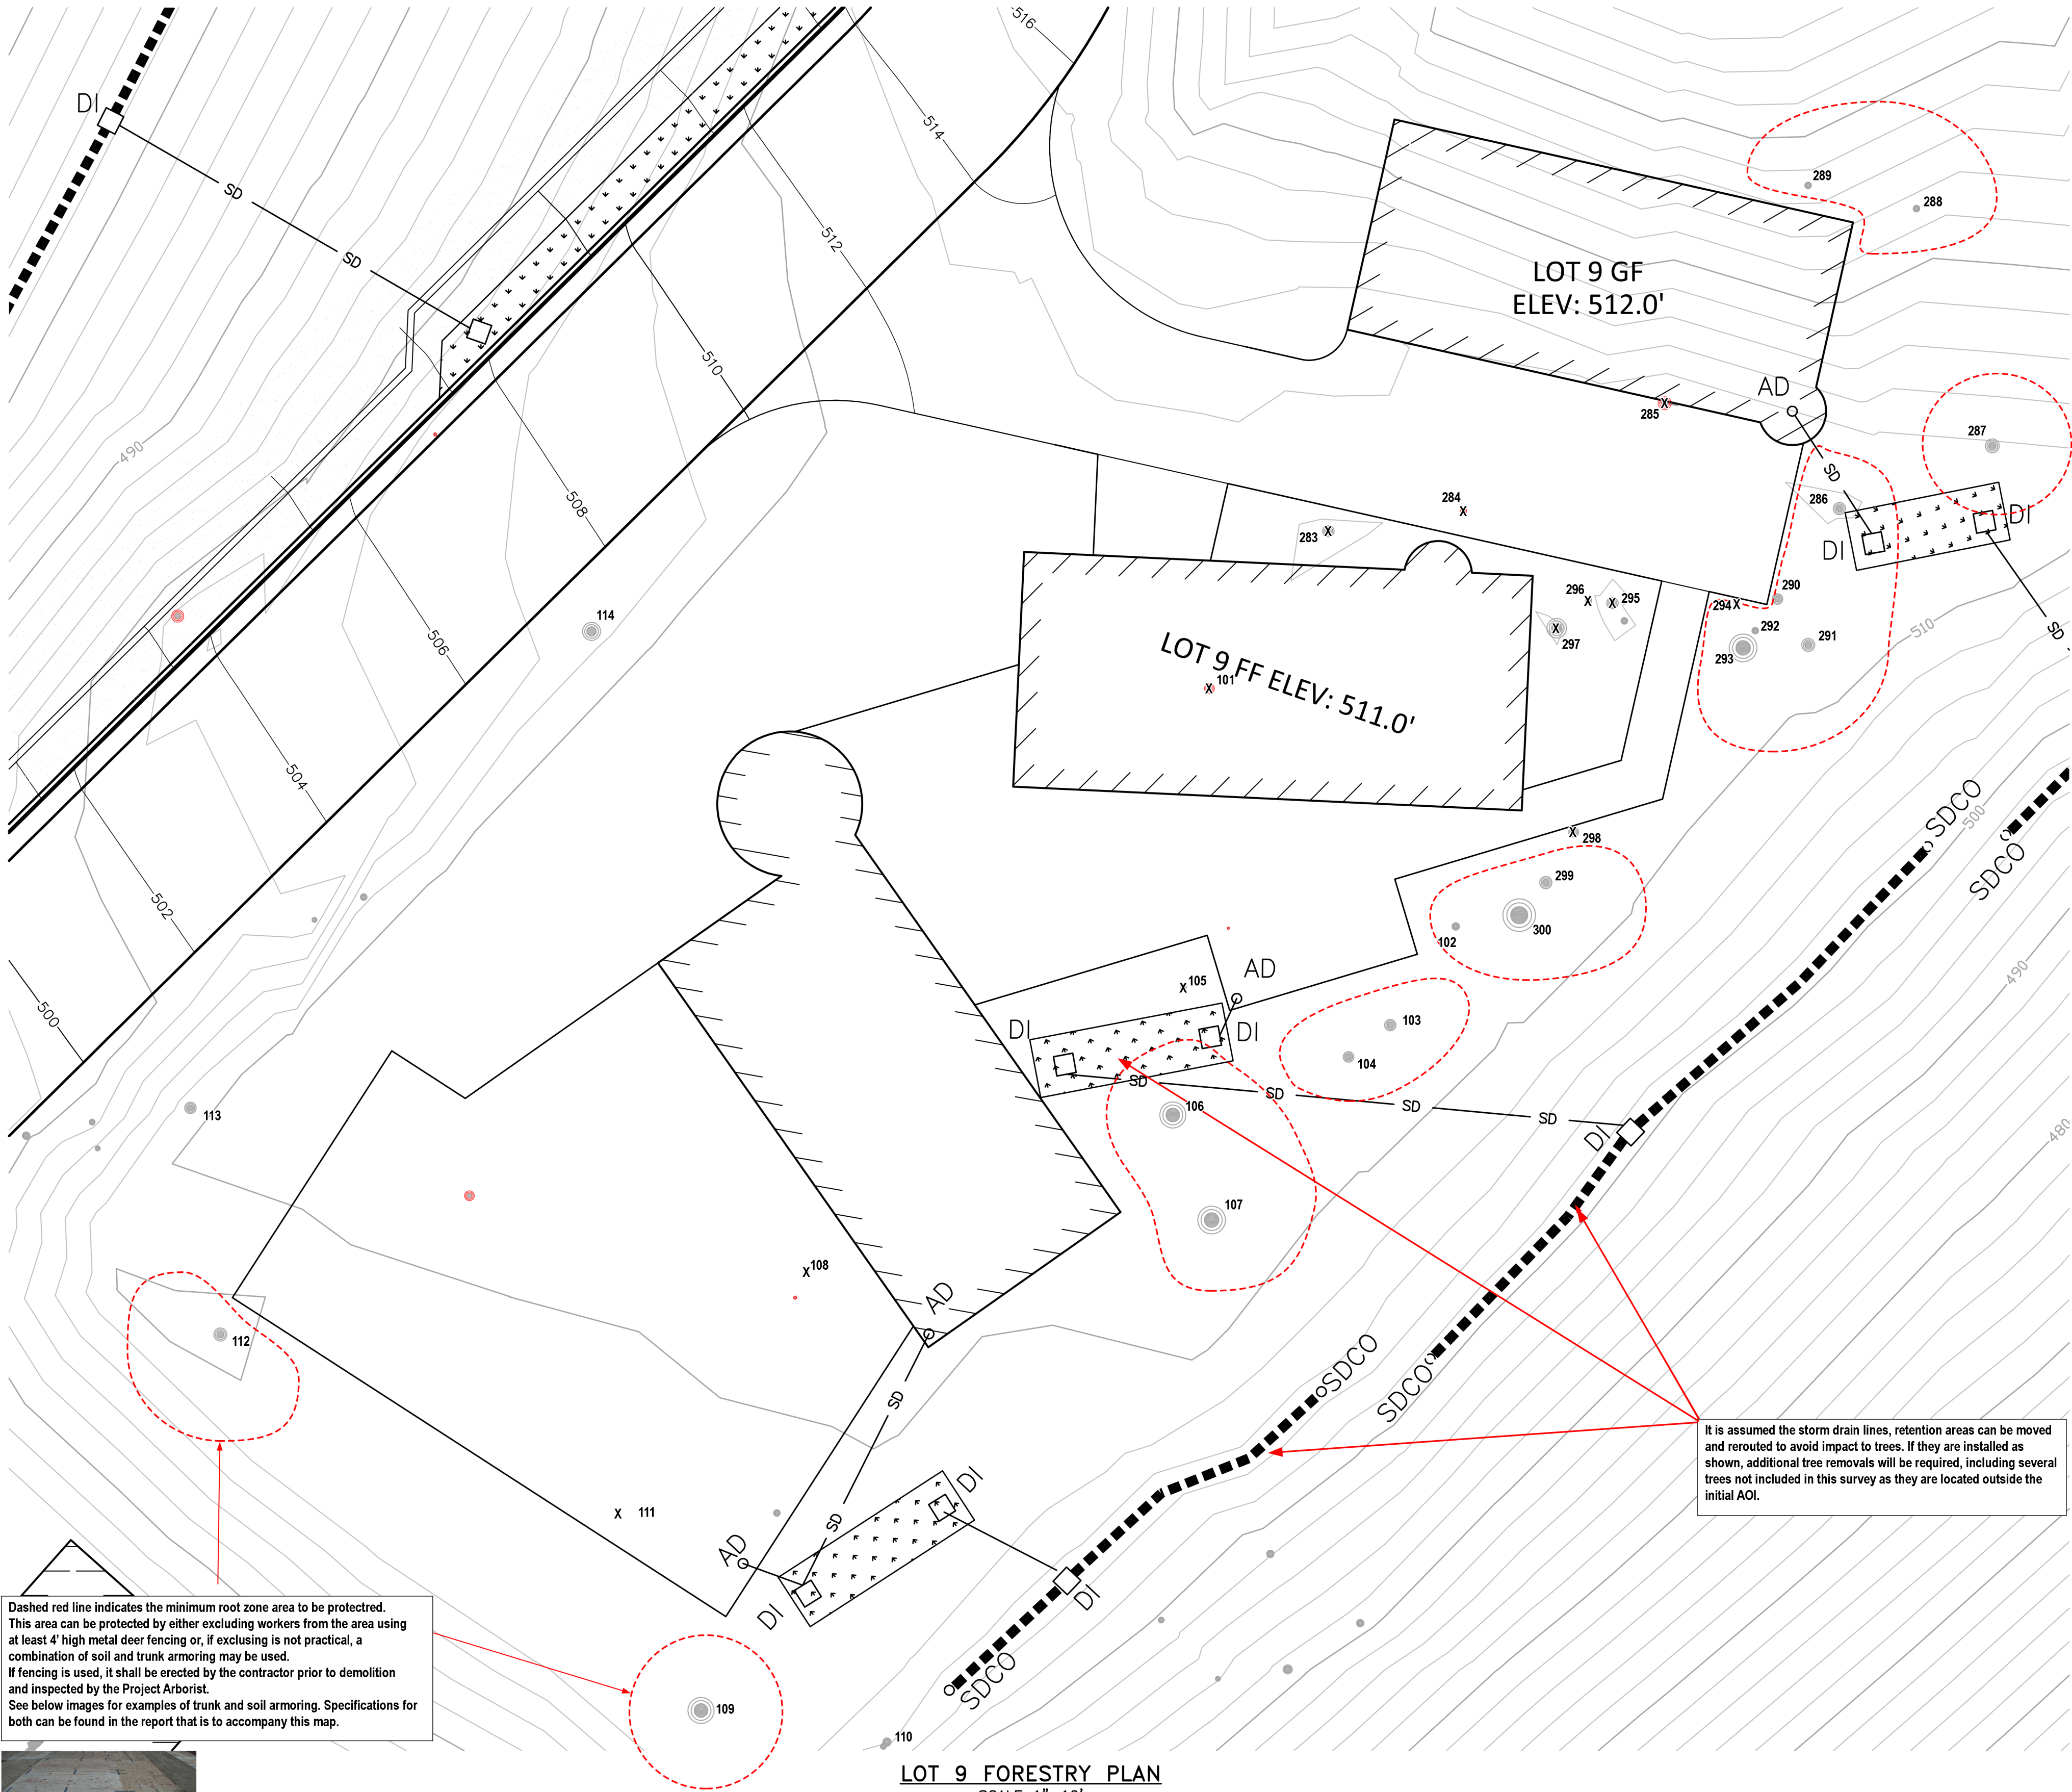
Tree Number	Common Name	Latin Name	Diameter			Health	Structure	Comments	Removal
			Stem 1	Stem 2	Stem 3				
101	Madrone	<i>Arbutus menziesii</i>	5.6	4.3	3.4	Fair	Fair	The canopy is sparsely foliated.	X
102	Madrone	<i>Arbutus menziesii</i>	8.8			Fair to Good	Poor to Fair	There is a long decay column on the northwest face of the tree base from grade extending to approximately 15' above grade.	
103	Madrone	<i>Arbutus menziesii</i>	15.2			Fair	Fair	There is scattered small diameter deadwood throughout the canopy.	
104	Madrone	<i>Arbutus menziesii</i>	12.9			Fair to Good	Fair	There is a moderately sized decay column in the tree base associated with an old fire wound. The canopy is relatively upright and balanced.	
105	coast live oak	<i>Quercus agrifolia</i>	7			Fair to Good	Fair	Canopy symmetry west.	X
106	Madrone	<i>Arbutus menziesii</i>	10.2	8.8	5.9	Fair to Good	Fair to Good	The smallest scaffold limb extends west toward building envelope.

107	coast live oak	<i>Quercus agrifolia</i>	17.8	10.5		Fair to Good	Fair to Good	Moderate sycamore borer activity on lower main stem. The canopy is relatively balanced with a total spread of approximately 30 feet	
108	coast live oak	<i>Quercus agrifolia</i>	5.8			Fair to Good	Fair		X
109	Madrone	<i>Arbutus menziesii</i>	12.3	11.1	9.3	Fair to Good	Fair to Good	A total of six stems with a relatively common attachment near grade.	
110	coast live oak	<i>Quercus agrifolia</i>	8.2	3.1		Fair to Good	Good	Attractive canopy architecture.	
111	Madrone	<i>Arbutus menziesii</i>	7.8			Poor	Poor	Fallen tree. Nearly dead.	X
112	Madrone	<i>Arbutus menziesii</i>	9.9	8	5.7	Fair to Good	Fair to Good	Attractive canopy architecture.	
113	Madrone	<i>Arbutus menziesii</i>	6.8	4.5	3.5	Fair	Fair	Shrubby form. Abundance of small diameter deadwood throughout canopy.	
114	Madrone	<i>Arbutus menziesii</i>	20.9	11.1		Fair to Good	Fair	Moderate dieback of eastern canopy quadrant.

283	coast live oak	<i>Quercus agrifolia</i>	6.8	5.8	5	Fair to Good	Fair	Common attachment of stems at grade.	X
284	coast live oak	<i>Quercus agrifolia</i>	8.5	2.4		Fair to Good	Fair	Subordinate stem arises from on the main stem near grade. Slight lean west.	X
285	coast live oak	<i>Quercus agrifolia</i>	8.6	5.7	5.2	Fair to Good	Fair	Common attachment of stems near grade.	X
286	coast live oak	<i>Quercus agrifolia</i>	14.1			Poor to Fair	Poor to Fair	Bleeding at 6' on main stem consistent with Phytophthora infection. Weak attachment of west most spar.	
287	coast live oak	<i>Quercus agrifolia</i>	14.3	8.4		Poor to Fair	Fair	At least two areas of bleeding on main stem consistent with Phytophthora infection.	
288	coast live oak	<i>Quercus agrifolia</i>	13.8	7.8		Fair to Good	Fair	Lean and canopy symmetry south. The southern half of the canopy extends at least 15' horizontally.	
289	coast live oak	<i>Quercus agrifolia</i>	6.4	4.8		Fair to Good	Fair	Common attachment of stems at grade. Slight lean and canopy symmetry south.

290	coast live oak	<i>Quercus agrifolia</i>	13			Fair to Good	Fair	The tree splits into two stems at approximately 7 feet above grade. The south stem is dominant. There is an abundance of deadwood in the lower canopy.	
291	California bay laurel	<i>Umbellularia californica</i>	15.6			Fair	Poor to Fair	There is a column of decay in the main stem from grade extending to 7 feet above grade. Lean in canopy symmetry east.	
292	Madrone	<i>Arbutus menziesii</i>	13			Fair	Fair	There is a strip of necrotic cambium on the east face of the main stem extending up the dominant stem.	
293	coast live oak	<i>Quercus agrifolia</i>	16.4			Fair to Good	Fair	Moderate lean south.	
294	Madrone	<i>Arbutus menziesii</i>	4.2			Fair	Fair	Somewhat suppressed with leggy structure as a consequence. Leans west.	X
295	Madrone	<i>Arbutus menziesii</i>	7.9			Fair	Poor to Fair	There is a long decay column extending from grade up the main stem to approx. 8' above grade.	X

296	Madrone	<i>Arbutus menziesii</i>	6.7	5	4.5	Fair	Fair	Decay columns low on the tree likely related to fire. The smallest stem is dead.	X
297	Madrone	<i>Arbutus menziesii</i>	10	6.6	6.2	Fair to Good	Fair	Common attachment of stems near grade. Abundant amount of deadwood scattered throughout the canopy.	X
298	coast live oak	<i>Quercus agrifolia</i>	10.9			Fair	Fair	Lean and canopy symmetry east.	X
299	coast live oak	<i>Quercus agrifolia</i>	12.3	8.5		Fair to Good	Fair to Good		
300	California bay laurel	<i>Umbellularia californica</i>	12.5	12.4	10.1	Fair to Good	Fair	Poor attachment of two most upright stems. Removal is recommended, but not required.	
Total Removals									12

Dashed red line indicates the minimum root zone area to be protected. This area can be protected by either excluding workers from the area using at least 4' high metal deer fencing or, if excluding is not practical, a combination of soil and trunk armoring may be used. If fencing is used, it shall be erected by the contractor prior to demolition and inspected by the Project Arborist. See below images for examples of trunk and soil armoring. Specifications for both can be found in the report that is to accompany this map.
