URBAN FORESTRY ASSOCIATES, INC.

URBAN FORESTRY UPDATE OF 2013 TREE INSPECTION

*PARKADE: trees in the parking lot between Broadway Blvd. and
Sir Francis Drake Blvd. in downtown Fairfax*

The purpose of this study is an update for the Town of Fairfax of the 2013 inspection and report in light of the repaving project to begin on February 20th 2019 – **Updates Highlighted**

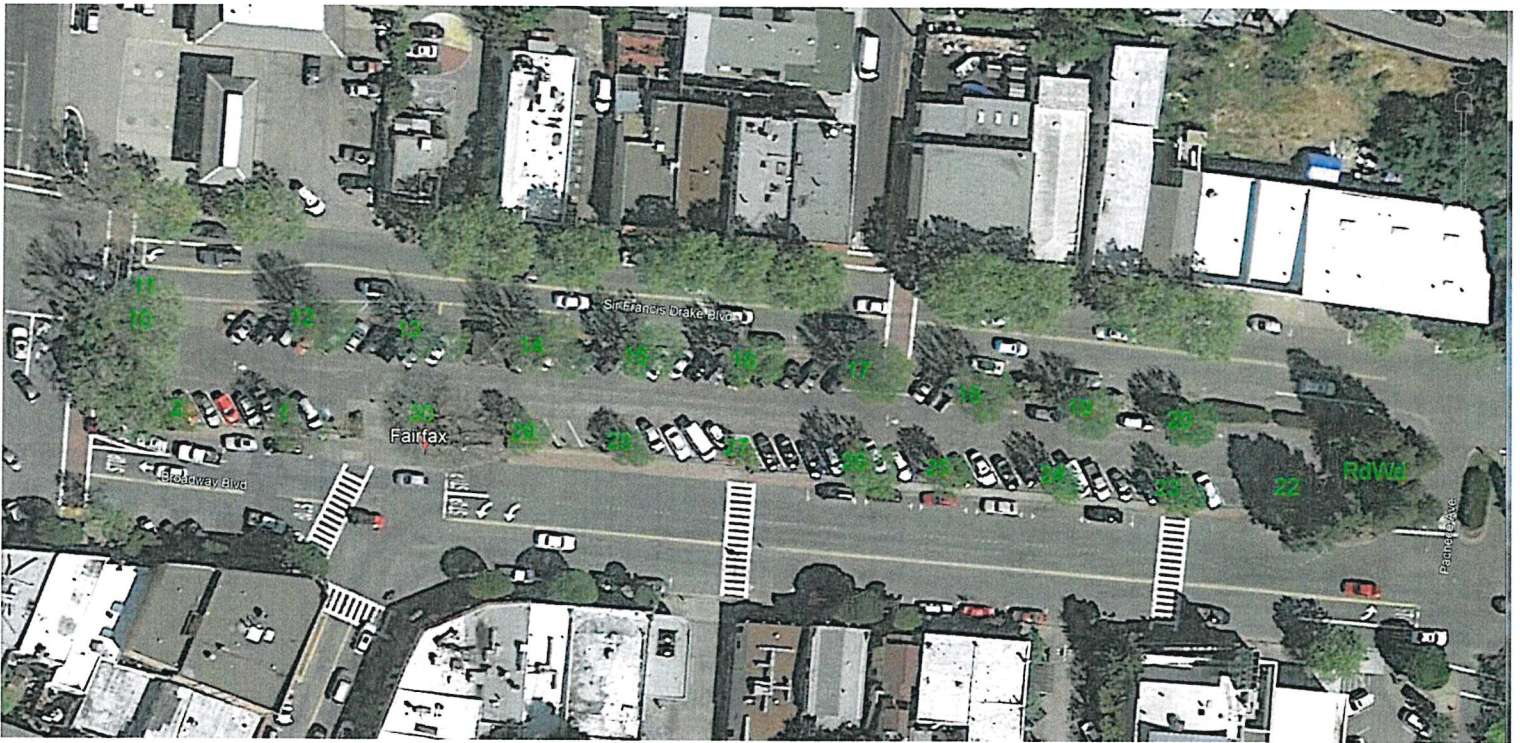
Tree Numbers of Trees to be Removed:

Recommended Removals: Trees # 1, 10, 16, 20, 22, 23, 27 & 29 (8 out of 30)
