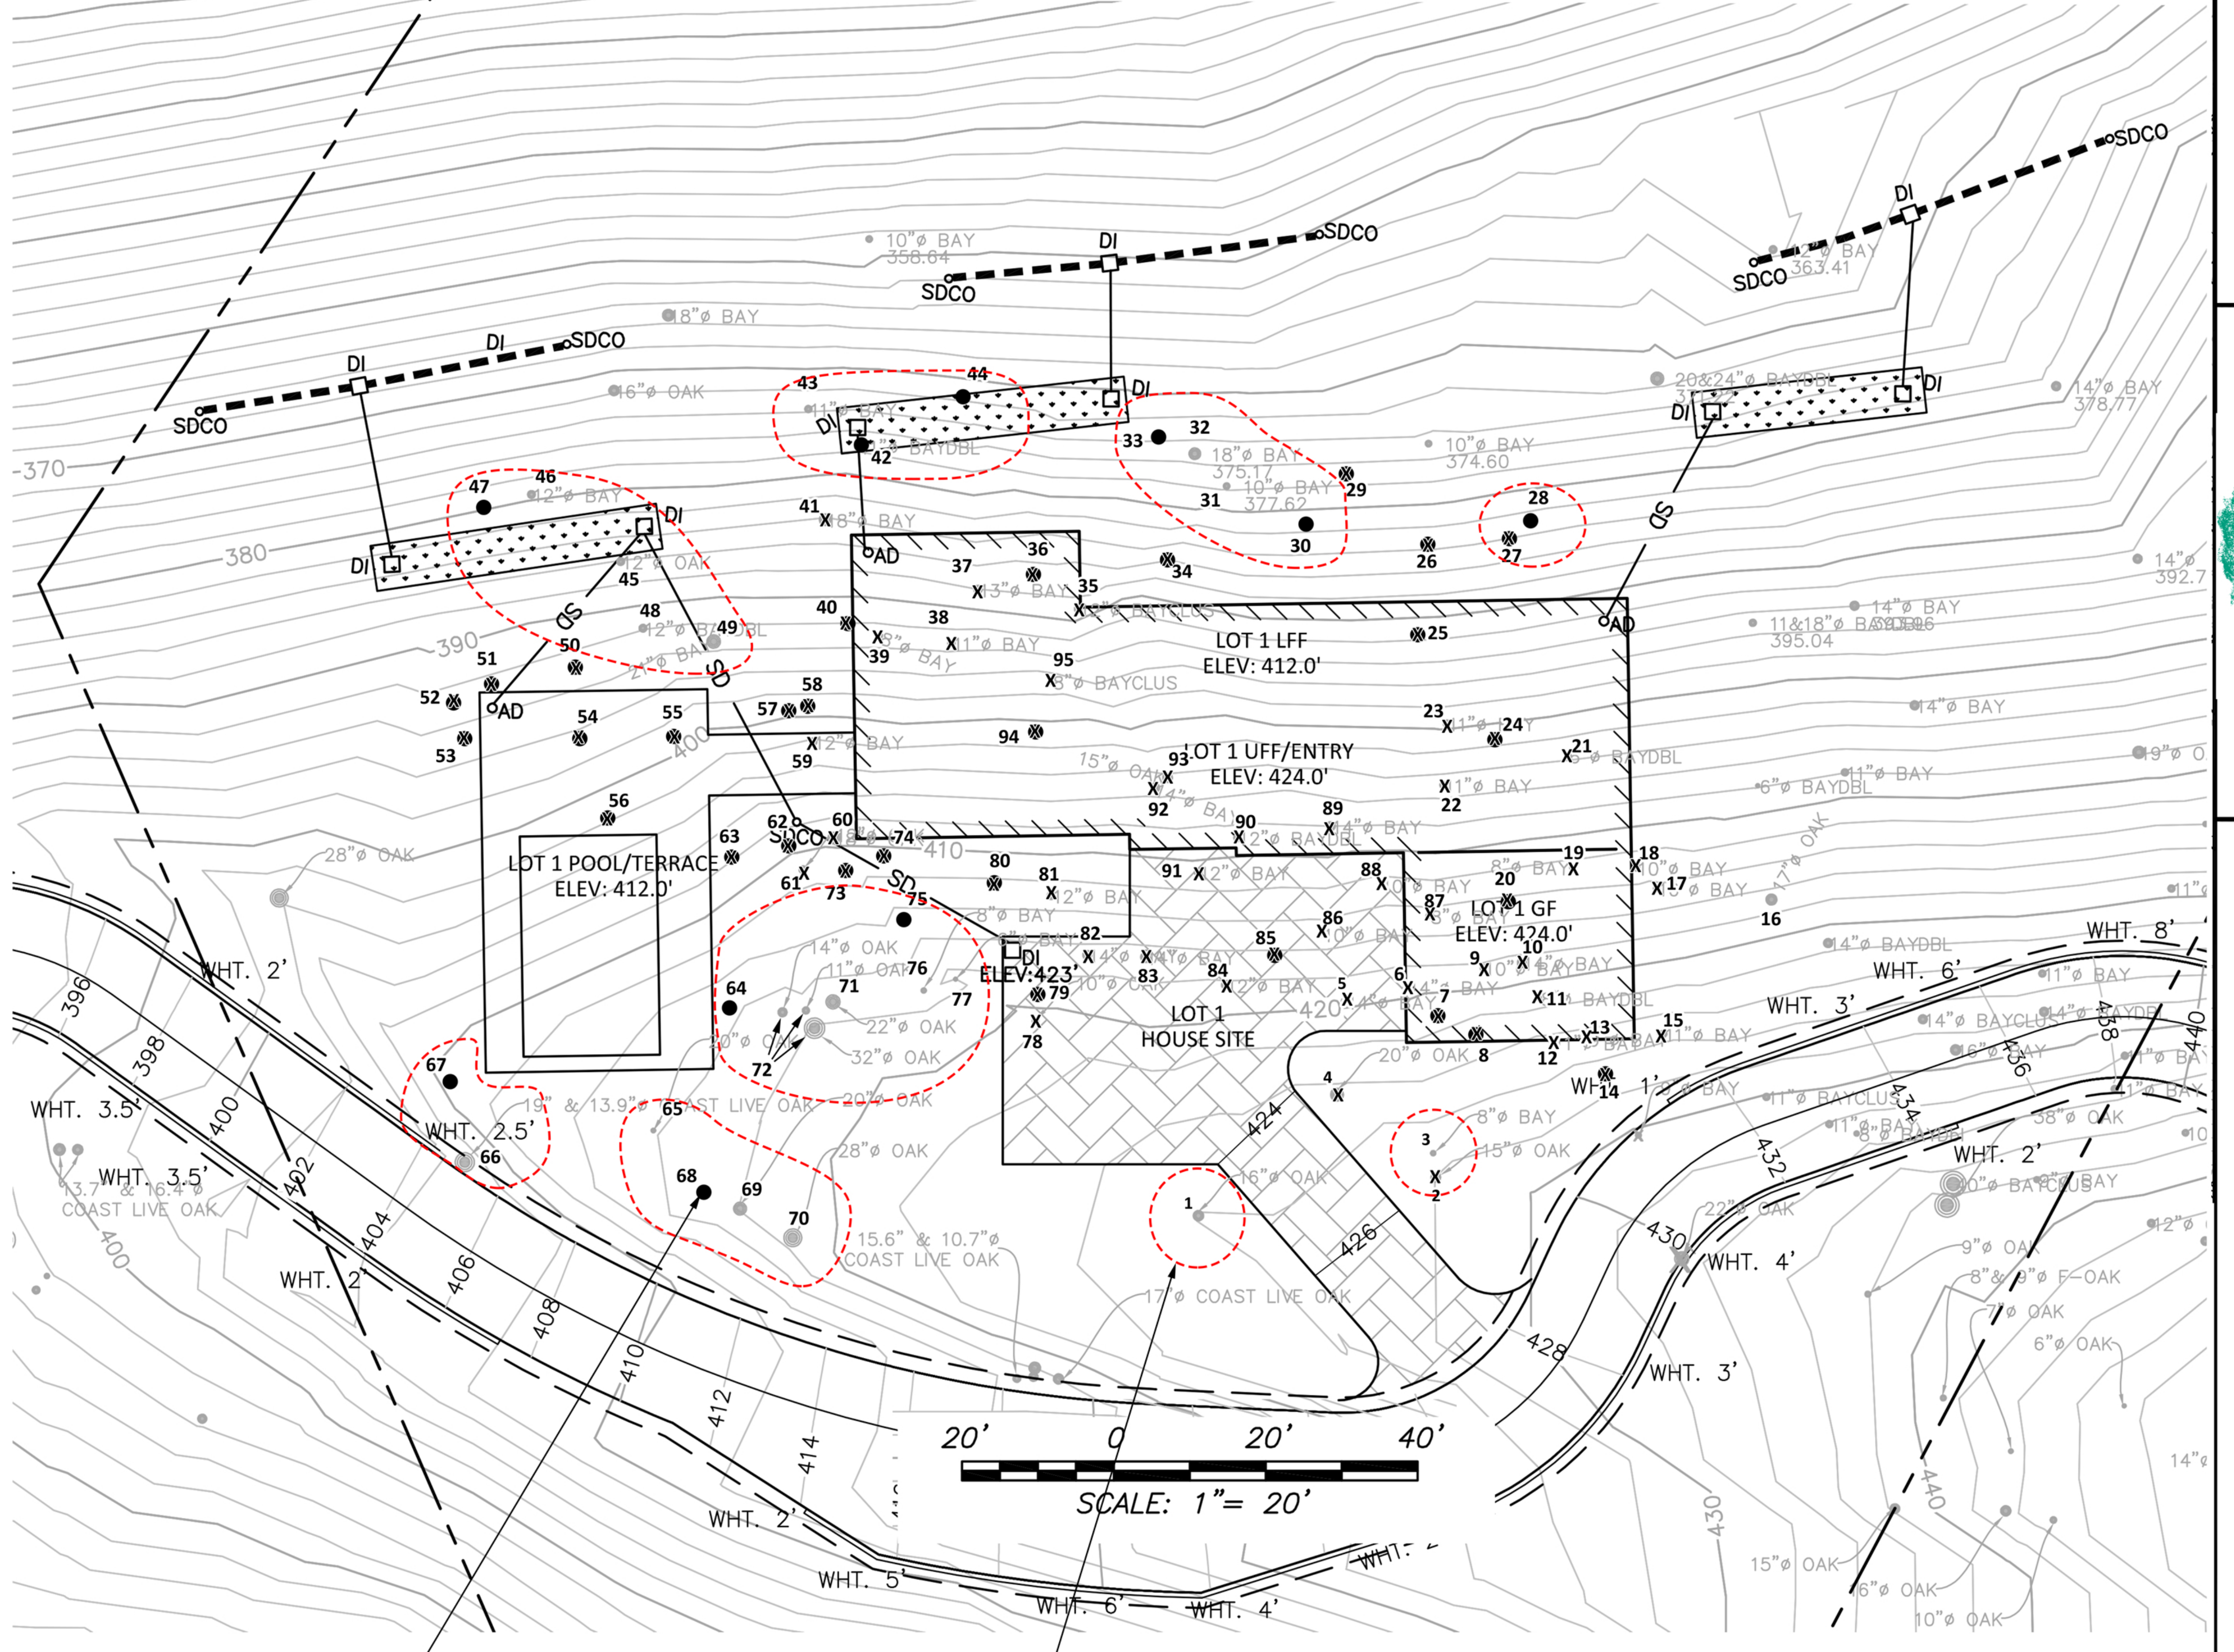
Trees shown with solid black dots were not located by the surveyor and so their locations on this map are approximate.

At least 4' high metal deer fence. Specifically not the orange plastic fencing found on most construction sites. Should be installed in such a manner that it can remain until landscape installation. If the location shown will not work with planned construction, it should be brought to the attention of the Arborist.
