TOWN OF FAIRFAX

STAFF REPORT

SUBJECT: Receive presentation on Redwood Tree Maintenance Plan (Plan) from the Town Arborist, discuss/consider the Plan, and direct staff as appropriate.

DRAFT REDWOOD TREE HEALTH, STABILITY MAINTENANCE PLAN for: *The Town of Fairfax, California*

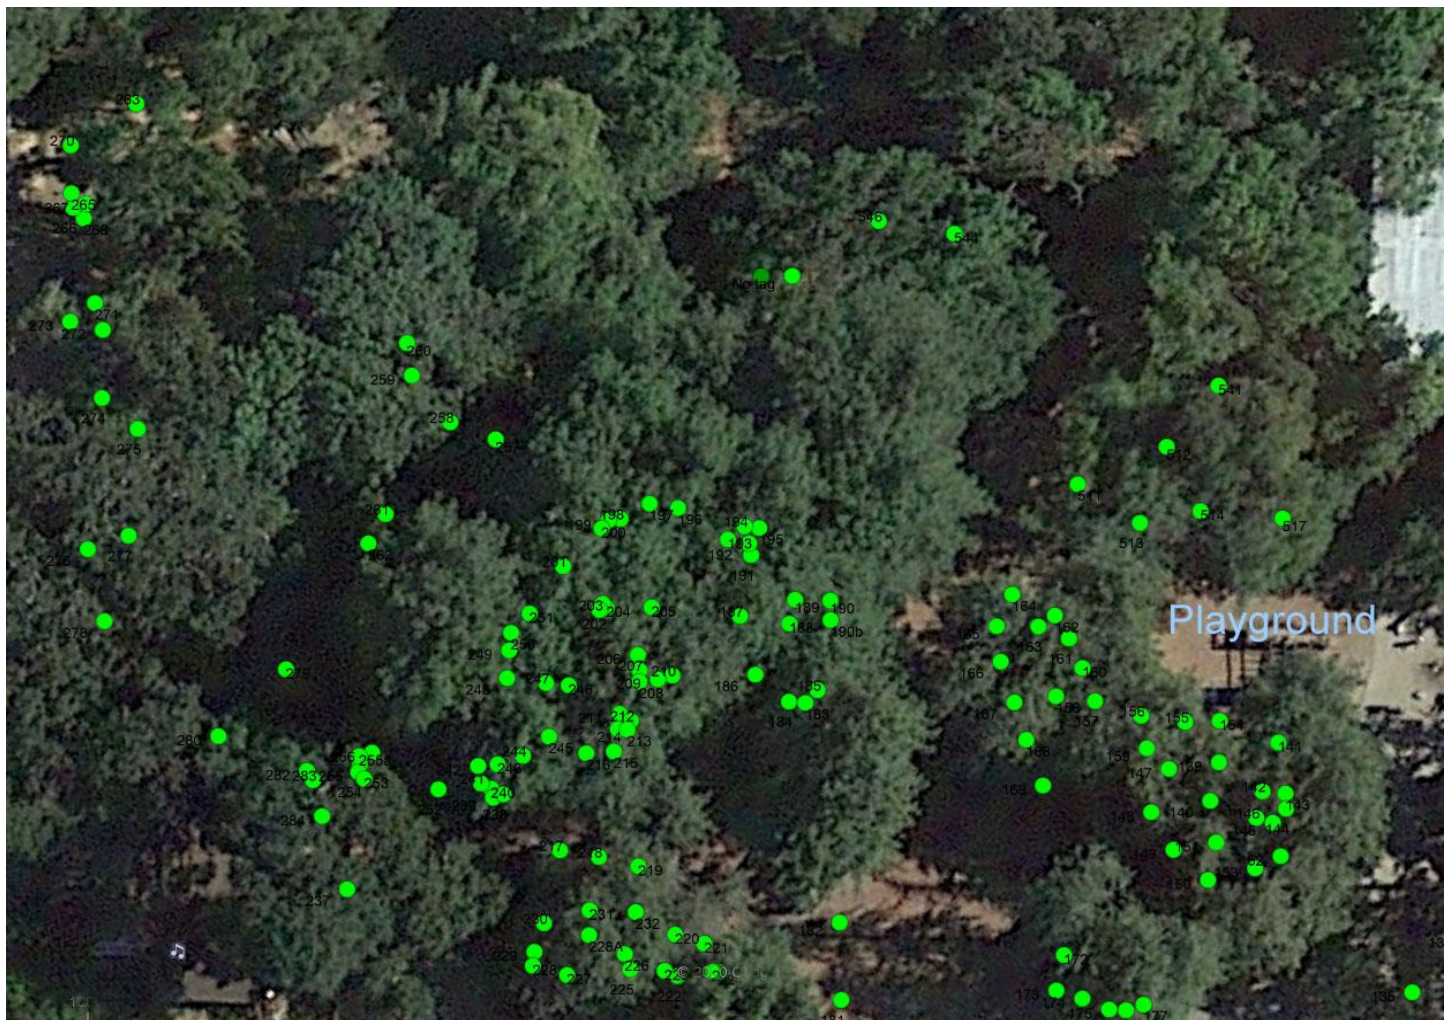
Figure 1 – Peri Park Redwood stand. Fairfax Creek runs along the more exposed areas at the top of the photo.

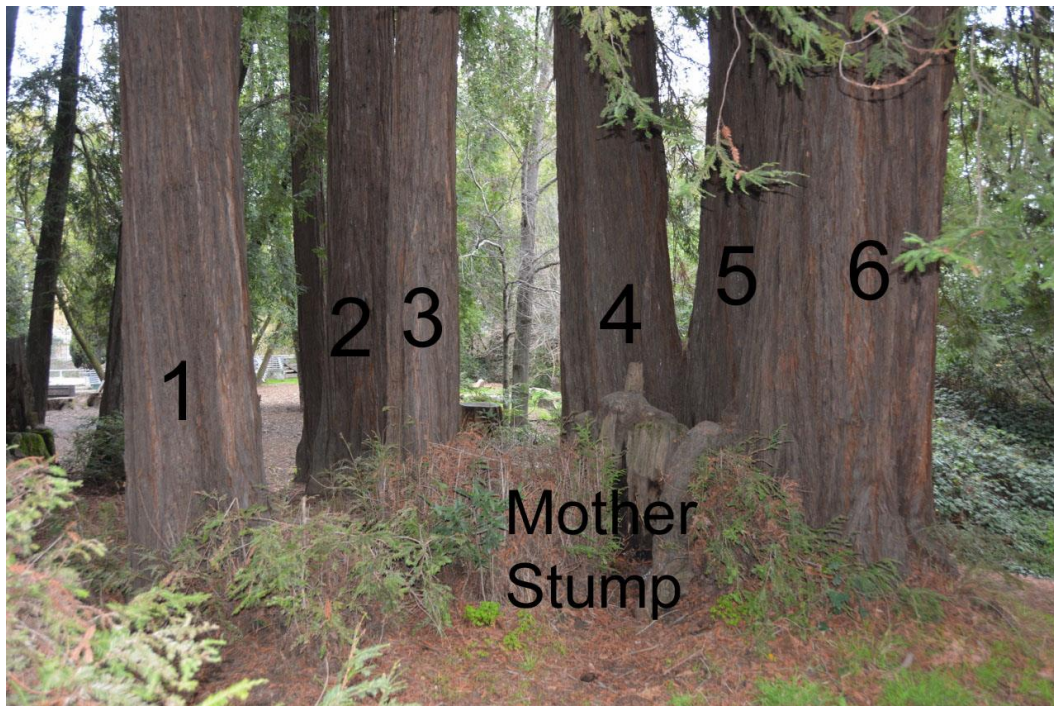
Figure 2 – As with any organism too many individuals per unit area leads to stress, poor vigor and poor health. Crowding also inhibits their response to abiotic (drought, freeze, etc.) and biotic (bacterial, fungal, & other pathogens, and insect pests).

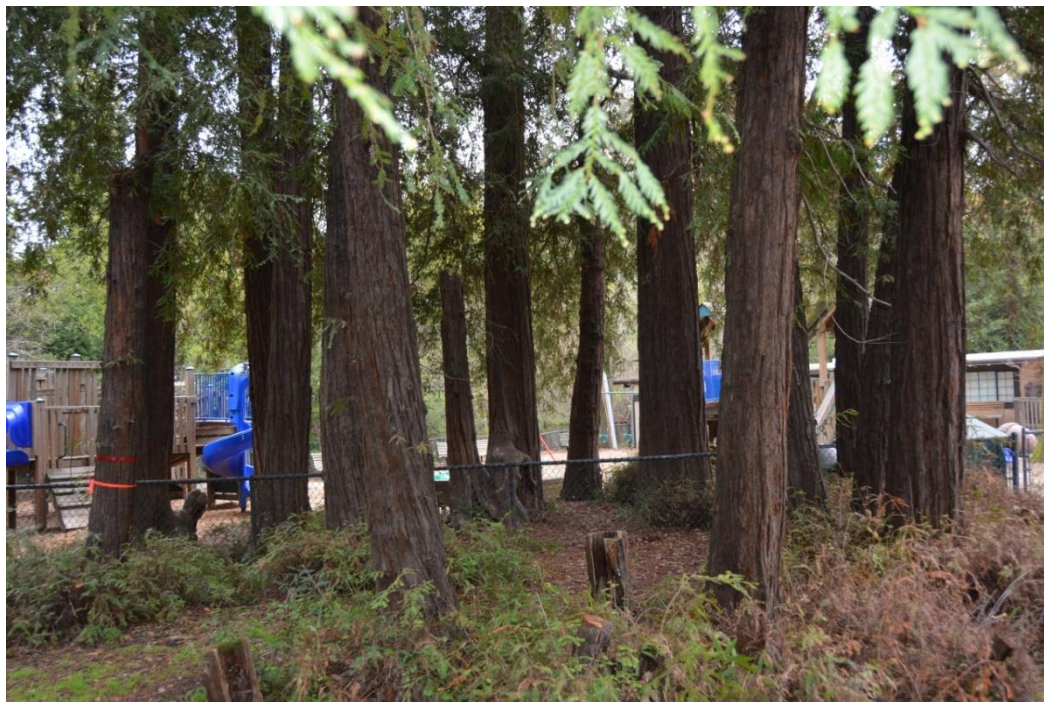
Figure 3 – The trees in this second growth, crowded group are largely stunted due to insufficient growing space and soil resources for the number of trees per unit area. Redwoods may have as many as 100 sprouts per stump after logging. Gradually the sprouts are thinned through natural competition for light, growing space and soil resources (water, minerals, and nutrients) (See also Figure 3b).

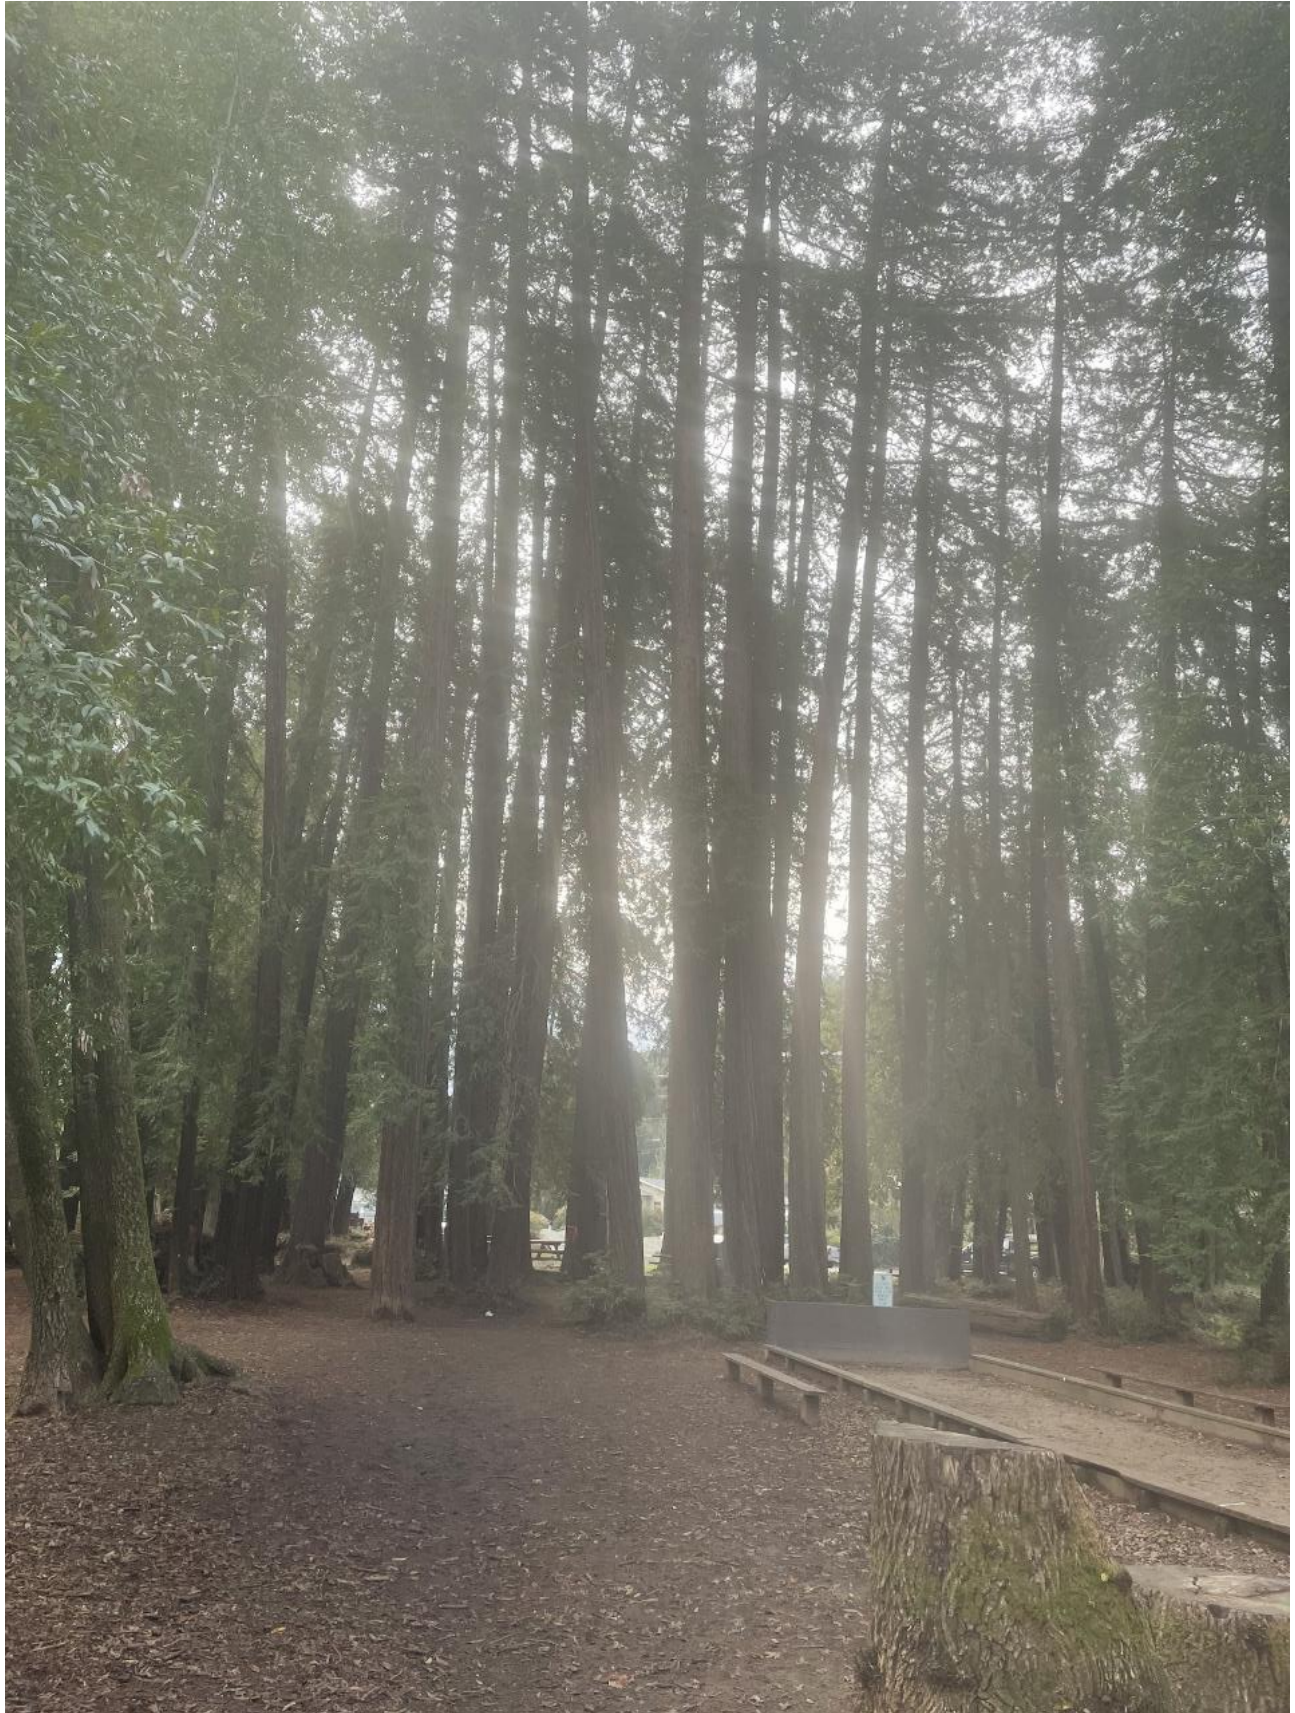
Figure 3b – While there are areas of the park that are quite open, the areas where the trees are located are very crowded. There is insufficient room for canopy growth and too much demand on limited soil volumes.

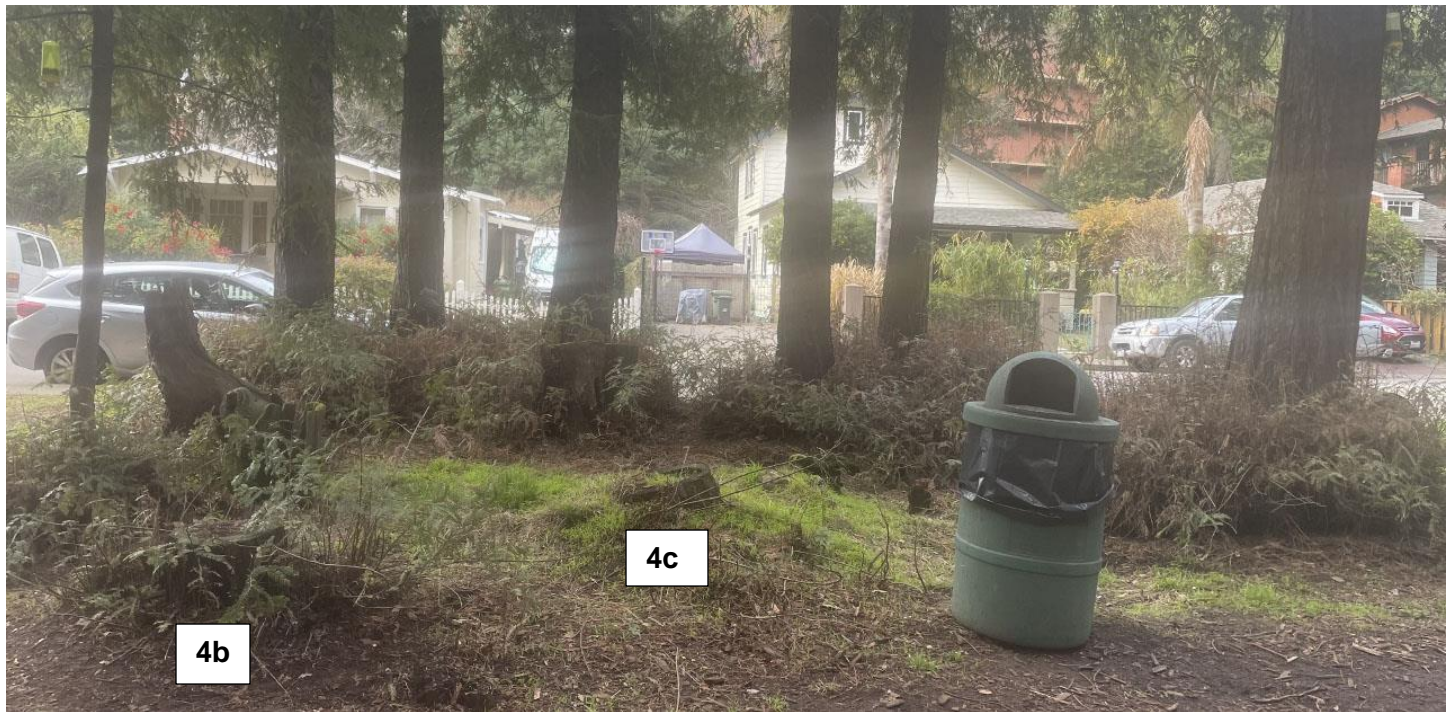
Figure 4 – This group has lost a number of trees due to extensive heart rot (brown cubicle rot).

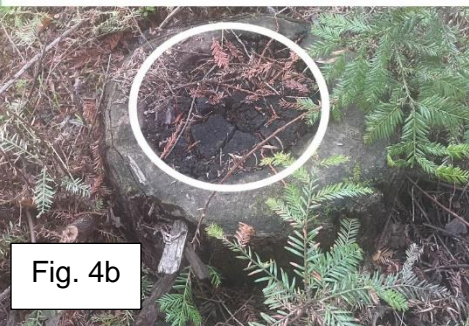
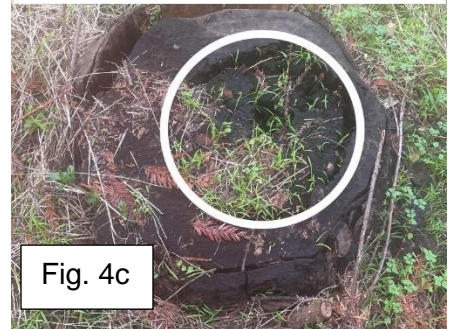
Figures 4b and 4 c – The second growth trees in this group developed brown cubicle rot through their connection to their mother stumps.

The decay extended the to the point where they rendered the stems unstable, and they had to be removed. They may have broken prior to removal. (See Figures 6 & 7)

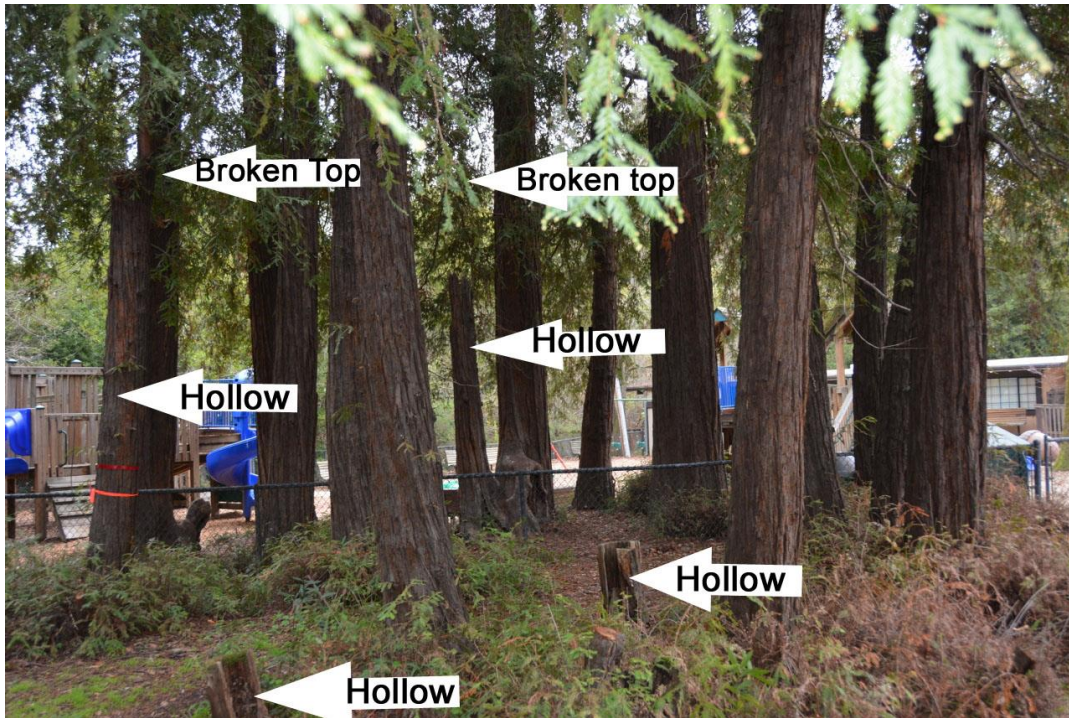
Figure 5 – Many hollow (heart rotted) trees and stumps are scattered throughout the stand. A number of these trees have broken off and others have begun to lean and are a failure threat.

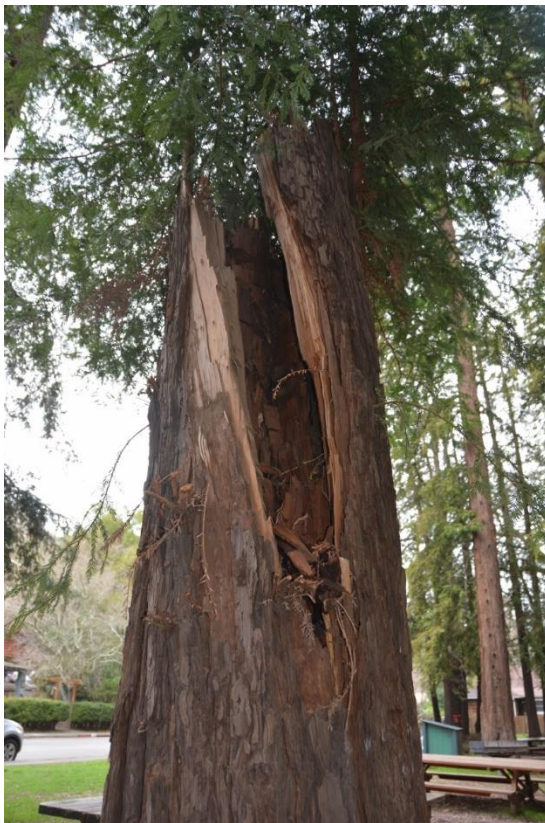
Figure 6 – Recently failed hollow trunk. Brown cubicle rot has decayed heartwood.

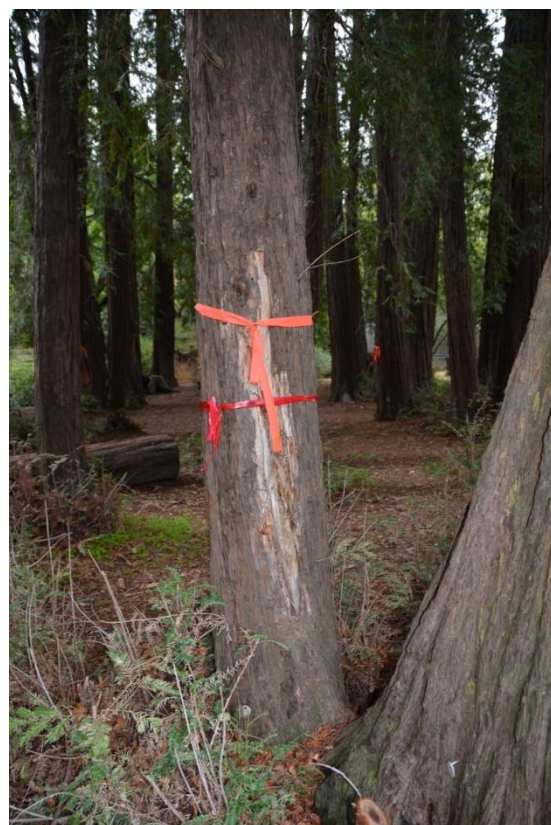
Figure 7 – This hollow tree has assumed a serious lean and the sap wood has died.

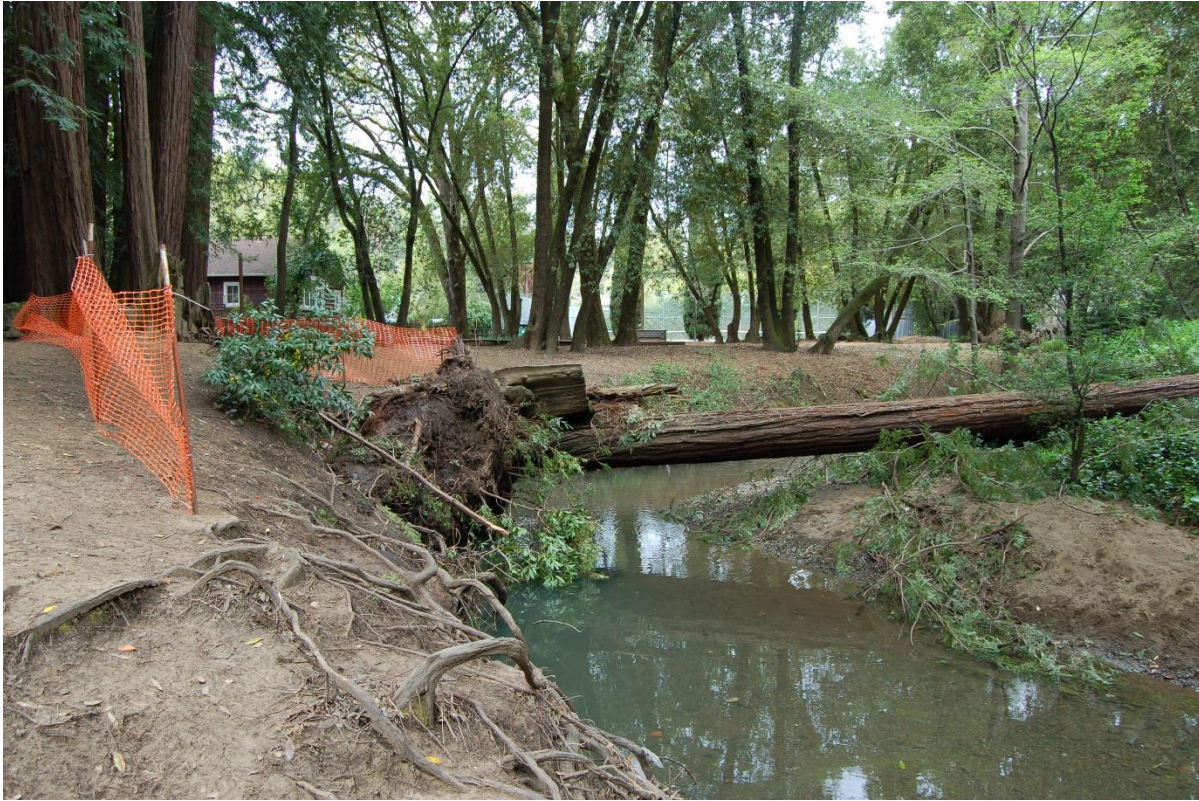
Figure 8a – This second growth stem with a portion of the mother stump attached. It has little space for compression roots toward the creek and no tension roots extending away from the creek, which would be sticking straight up if, post failure, they existed.

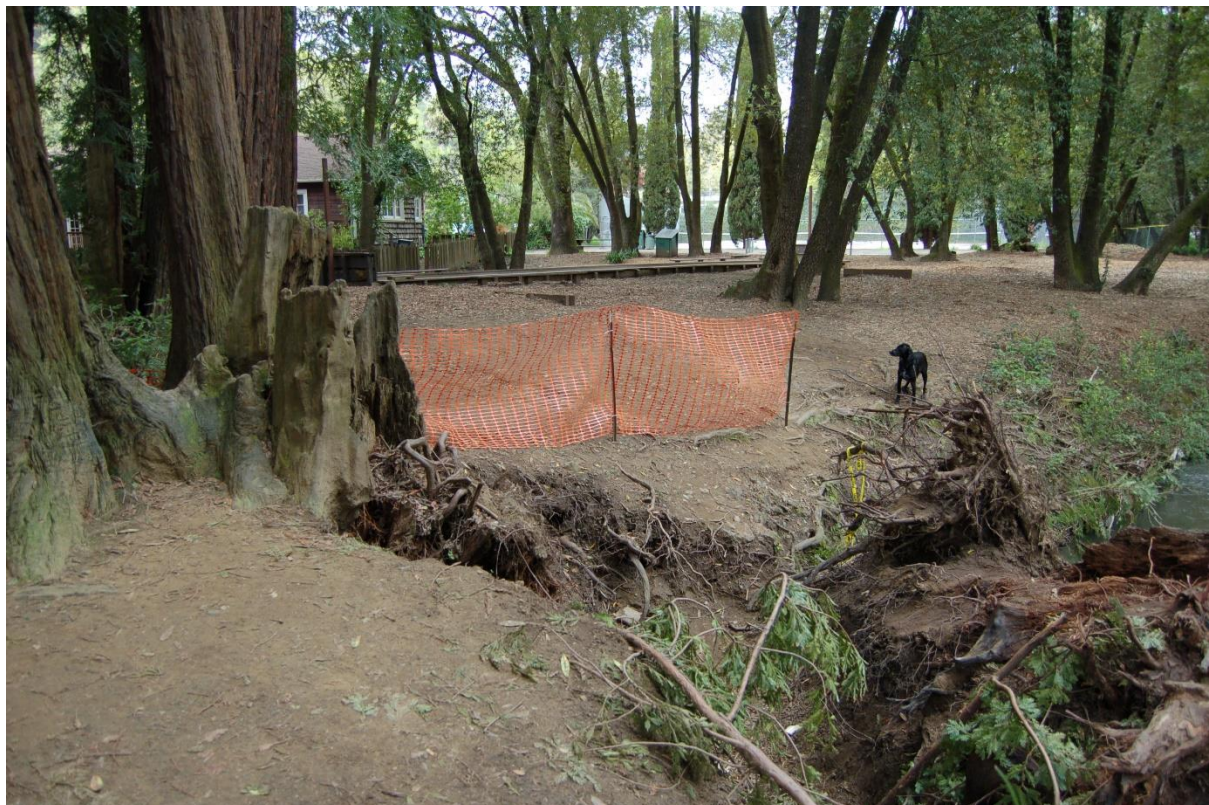
Figure 8b – The close-up photo shows 2 other daughter stems (left), the decayed mother stump in the middle and the “root crown” of the failed stem with no tension roots, lower right.

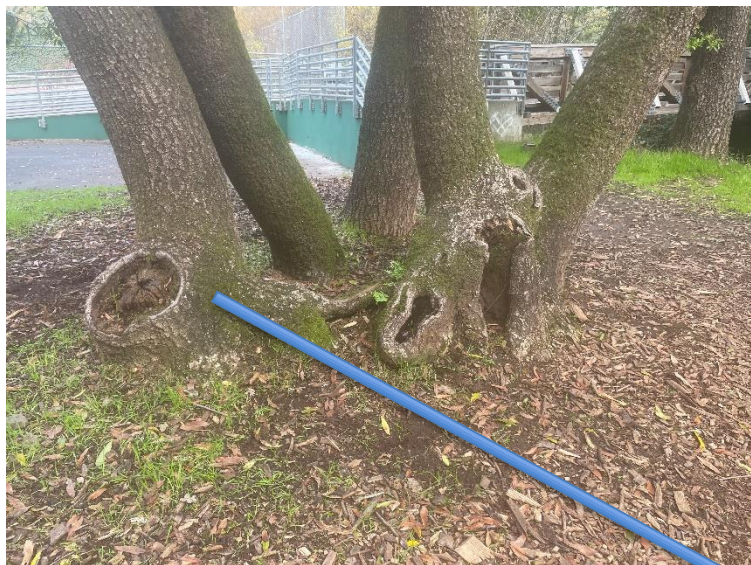
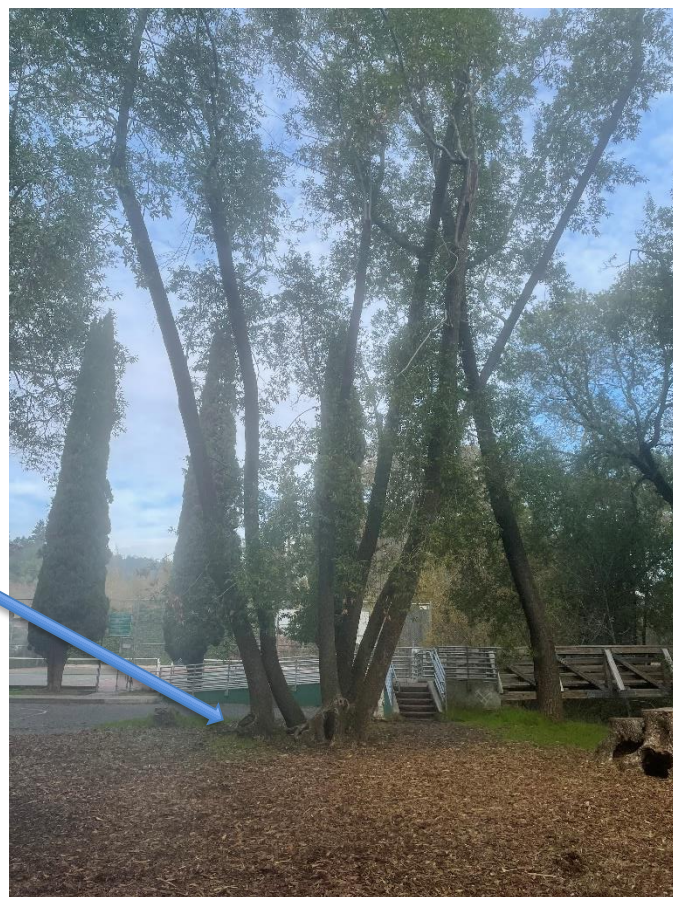
Figures 9a & 9b – Note the multi-stem second growth bays in the background of figure 8b above. Figure 9a shows the decay that migrated from the mother stump into the daughter stems. Figure 9b (right) show how the daughter stems had to develop opposing leans to get adequate light and growing space. This is a recipe for past and future failures.

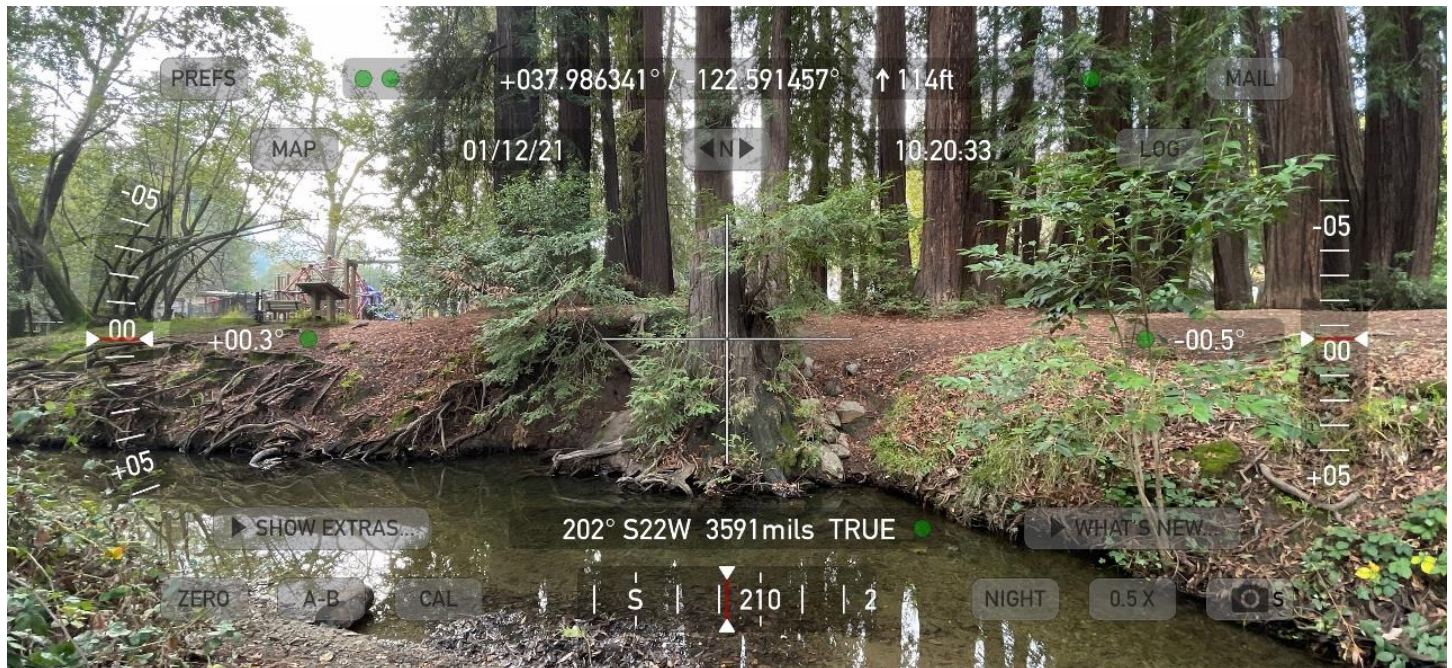
Figure 10 – The stand elevation is six to eight feet above the stream channel. The drought season water table would be below the 114' AMSL and the prolonged mega-drought may have dropped the water table (WT) even deeper and beyond root access to the WT and capillary fringe.

Irrigation will be required for at least the first (2021) drought season to make mulch decay products and fertilizer more available and improve soil permeability. A simple Stand mounted Rainbird-type irrigation may be employed. However, it would have to be moved around manually to provide deep watering to the entire stand irrigation should penetrate the soil to 18 inches below grade. This might require as much as 6 hours of irrigation in the first two cycles.

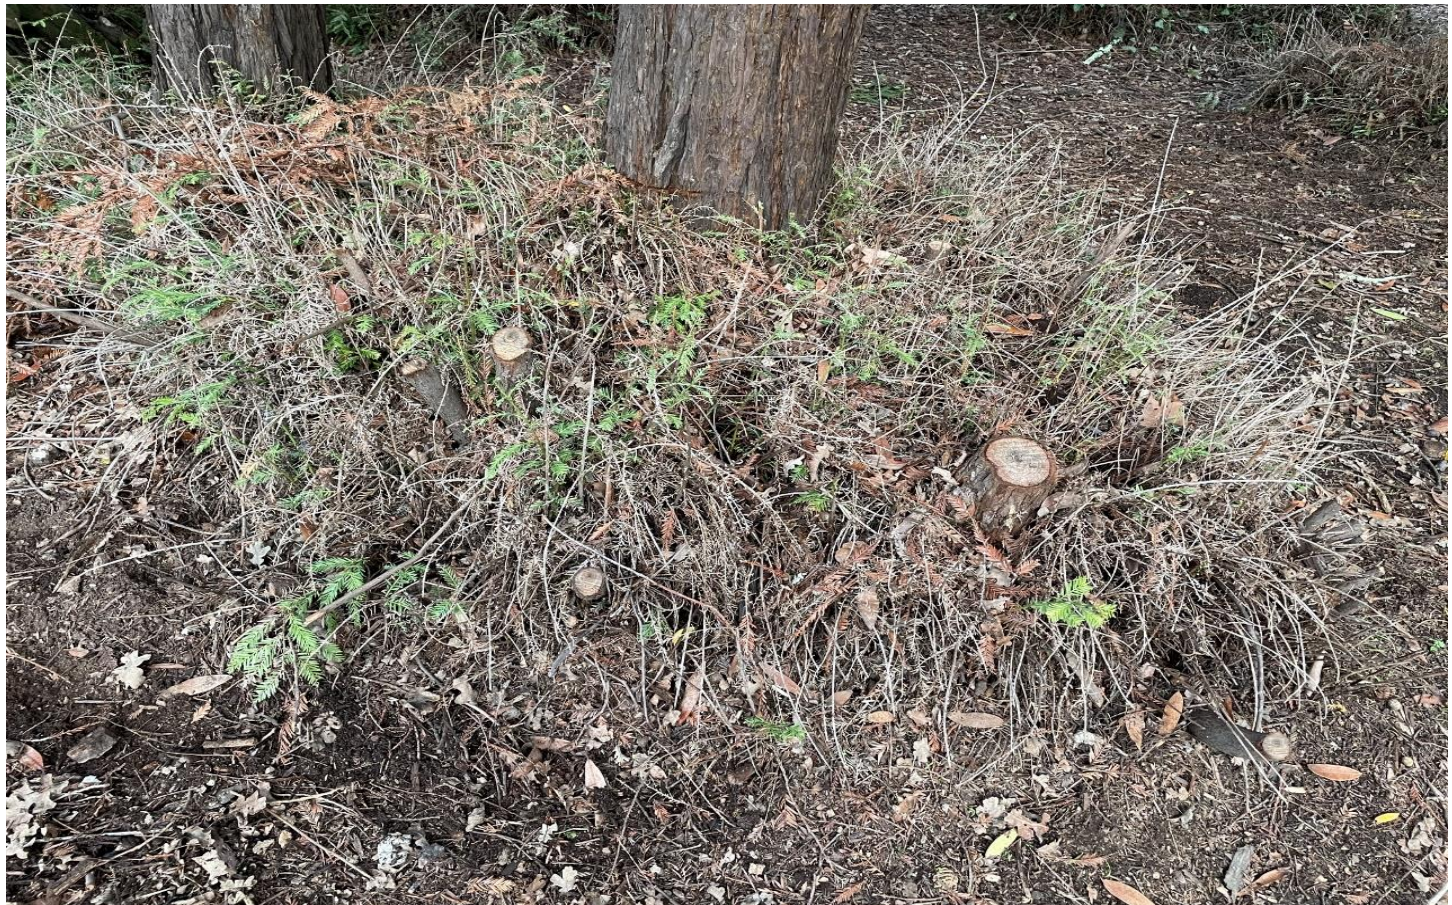
Stand decline has been evident for years but the recent cutting of the sprouts and reproduction has decreased photosynthate production (sugars, tannins and other critical photosynthates) and increased wind movement through the stand reducing the stand's relative humidity, stressing the foliated canopies and drying the soil. It also killed a lot of the sprout growth creating a more highly available fuel around the bases of the trees that could be ignited by air-born embers and damage, or even kill, mature trees (See Figure 11).

Figure 11 – The unauthorized cutting of basal sprouts increased wind through the understory of the stand desiccating the sprouts and soil. This elevates the fire risk to the trees should embers enter the stand and ignite the dead and desiccated basal sprouts. This ill-considered cutting has also impacted the mature trees.

The cutting of vegetative reproduction (large sprouts) and small root crown sprouts should be corrected. The first action would be to remove the dead material to protect the trees from fire char and/or scorch, particularly on the trees with thinner bark. I recommend volunteer training by the Town Arborist for pruning out the dead material. The unprofessional cuts on larger reproduction should also be corrected. The aeration, fertilization and irrigation will encourage new sprout growth, which could grow as fast as three feet in the first year. To encourage rapid growth, we could thin the sprouts for the first couple years to favor the dominant sprouts.
