**January 12, 2022**

Re: Supplemental Geotechnical Evaluation  
Proposed garage  
136 Tamalpais Road, Fairfax, California  
APN 001-121-22  
DAC Project No.: 1458-6321G

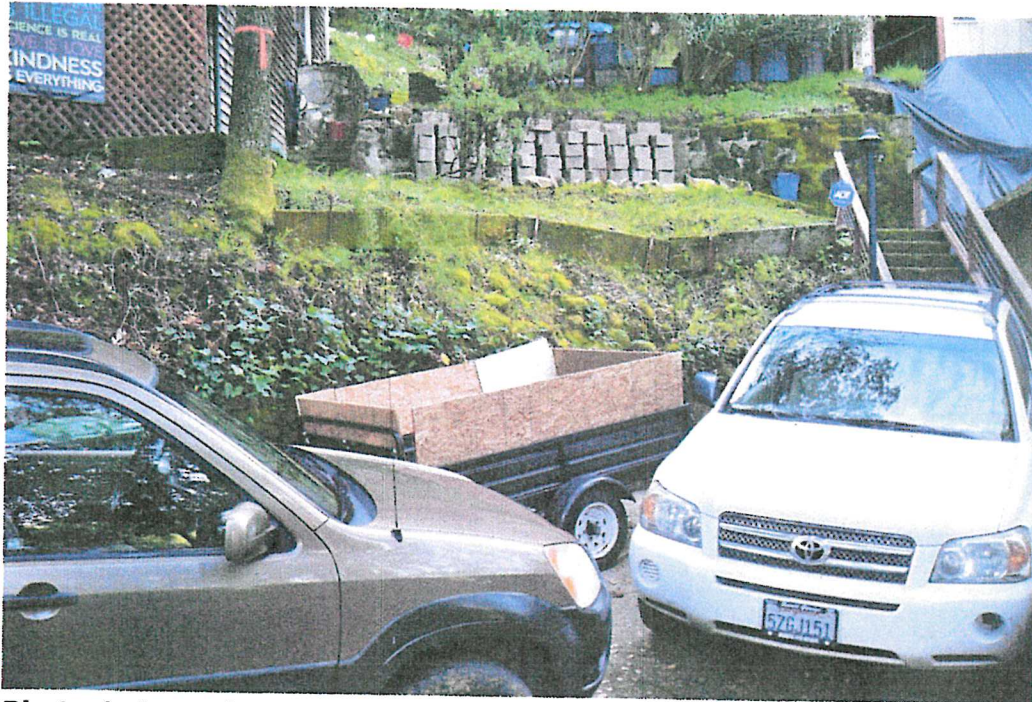
The project is located at 37.9888 north latitude by -122.5971 west longitude. Figure 1 and Photo 1 show the project location and topography. The property is an "uphill" lot: elevations increase upward from the street farther into the lot, southwestward, as shown in Figure 1. There is an existing single-family home on the property. We understand the home was constructed in the late 1910s.

**Photo 1.** Area of proposed garage, looking southwest (uphill). The garage will be constructed between the house seen on the left and the boundary with the neighboring property on the right.

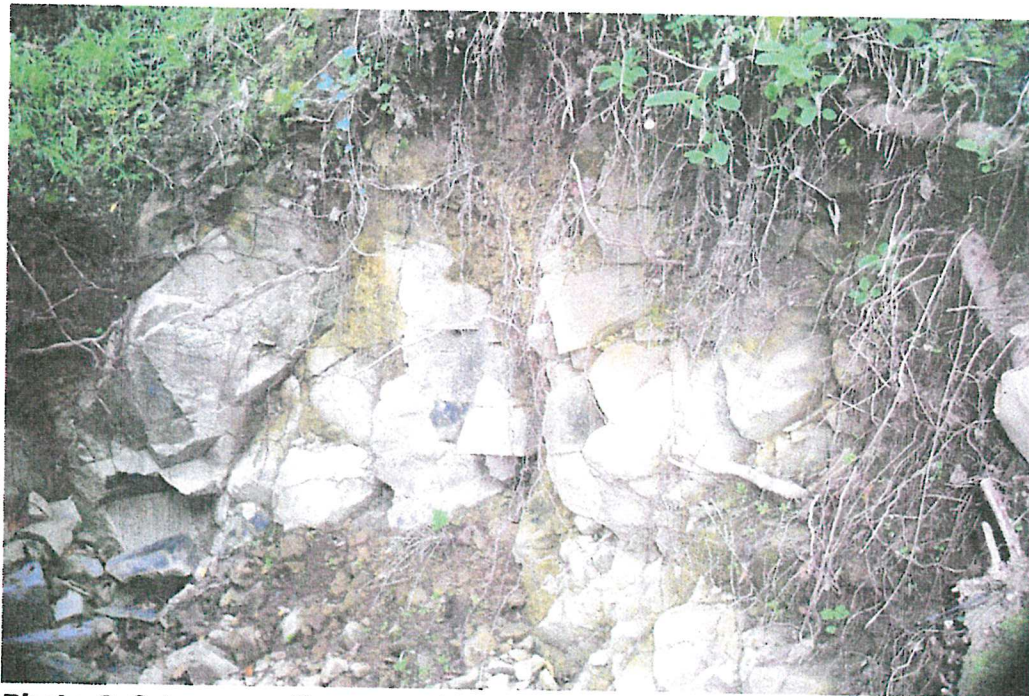
Next to the south corner of the house, we noted a near-vertical cut slope about 7 ft tall exposing the subsurface profile (Photo 2). Approximately 2 ft of soil overlies sandstone bedrock. We recorded four representative attitudes of significant discontinuities in this rock.

**Photo 2.** Cut near south corner of house, exposing bedrock, viewed looking southeast.

The southeast face of the excavation will be adjacent to one wall of the existing residence. It may be anticipated that essentially all of this face will expose bedrock. This rock is criss-crossed by joints and fractures (*fissures* per OSHA<sup>1</sup> definitions), and the rock therefore may be classified as Type B soil per OSHA definitions. We performed a very preliminary, qualitative approximate analysis of the rock discontinuities we observed at the site (Figure 3). Based on the results, the discontinuities exposed in the southeast excavation face could intersect to produce wedges that could slip out of the excavation face. Such slips could (A) injure workers in the garage excavation and (B) undermine the foundation of the house. We therefore recommend that this face of the excavation be temporarily supported, during construction, for example using timber shoring, in accordance with OSHA requirements.

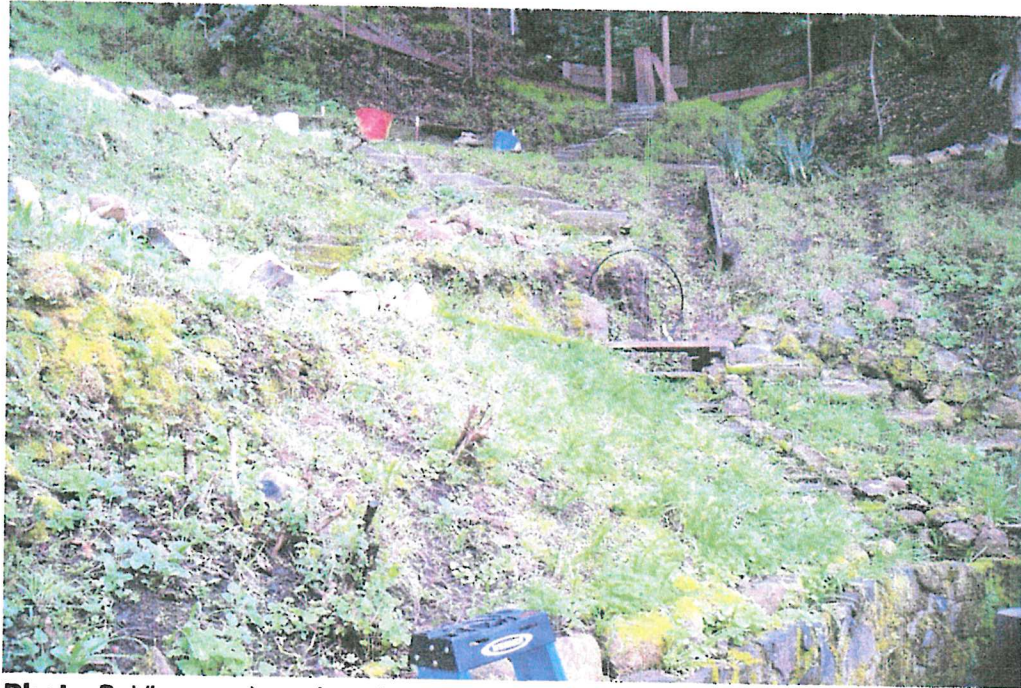
**Photo 3.** View upslope (southwestward) from the terrace. Note lower debris wall (upper right), steep soil-mantled ground to the left, and swale plunging diagonally across view.

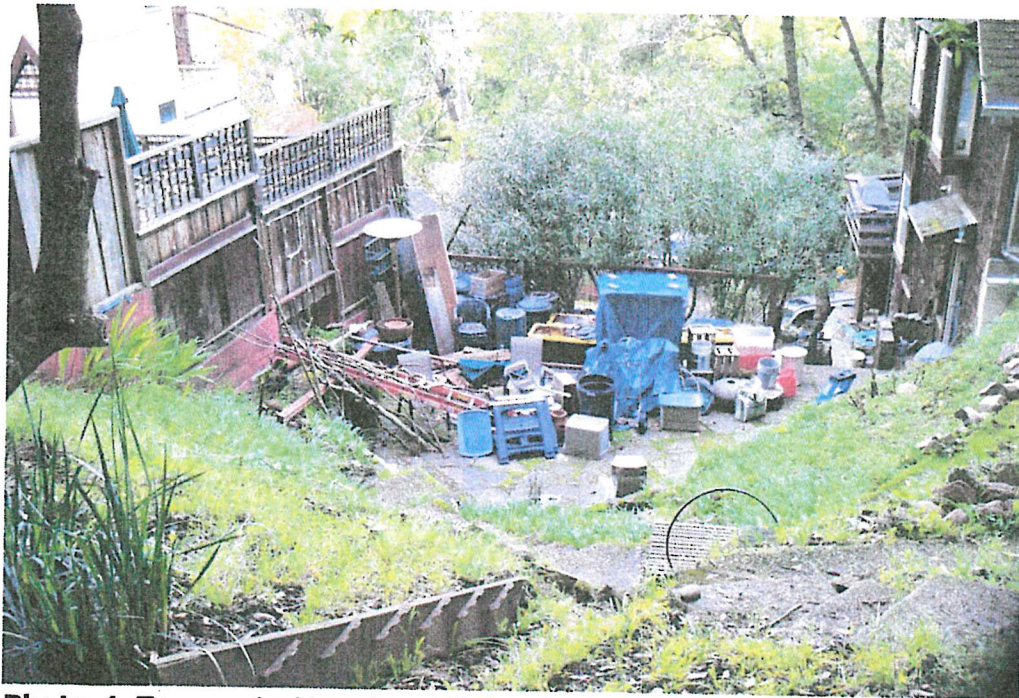
**Photo 4.** Terrace, looking downhill (northeastward) from above. Note swale plunging toward terrace.

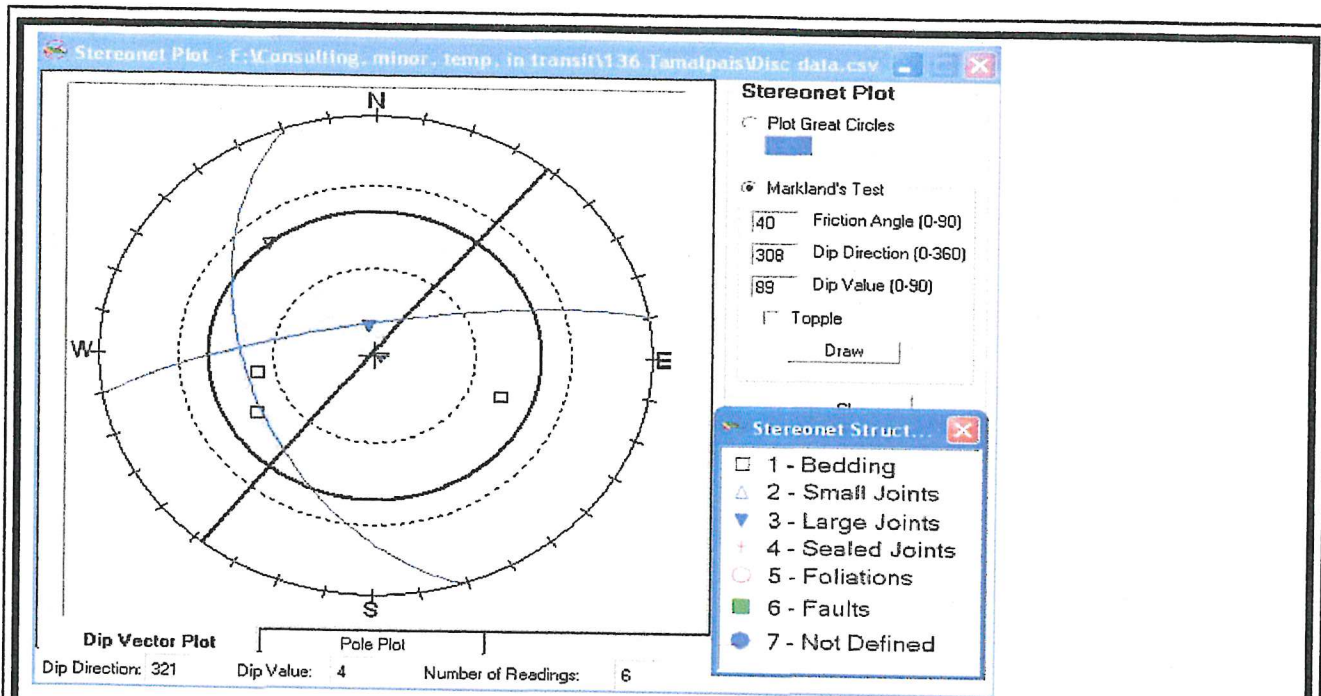
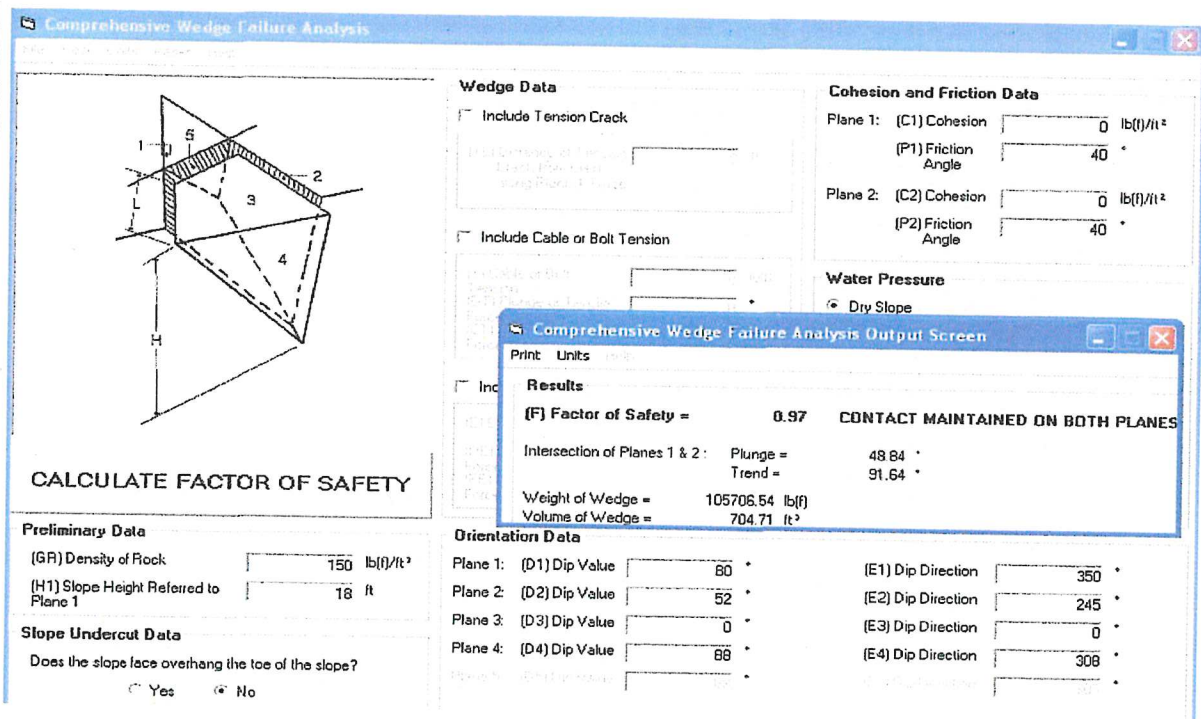
Upper panel: lower-hemisphere stereonet plot of six discontinuities measured at site. Lower panel: preliminary stability analysis of potential wedge failure in southeast excavation face. Software: RockPack III, from RockWare Inc., Golden, CO.
