G-0366-013A
November 7, 2018

Re: **Goshen Landfill**
Corrective Action Design – Cap Repair
October 2018 Monthly Construction Report
SWM File # 18-108-004

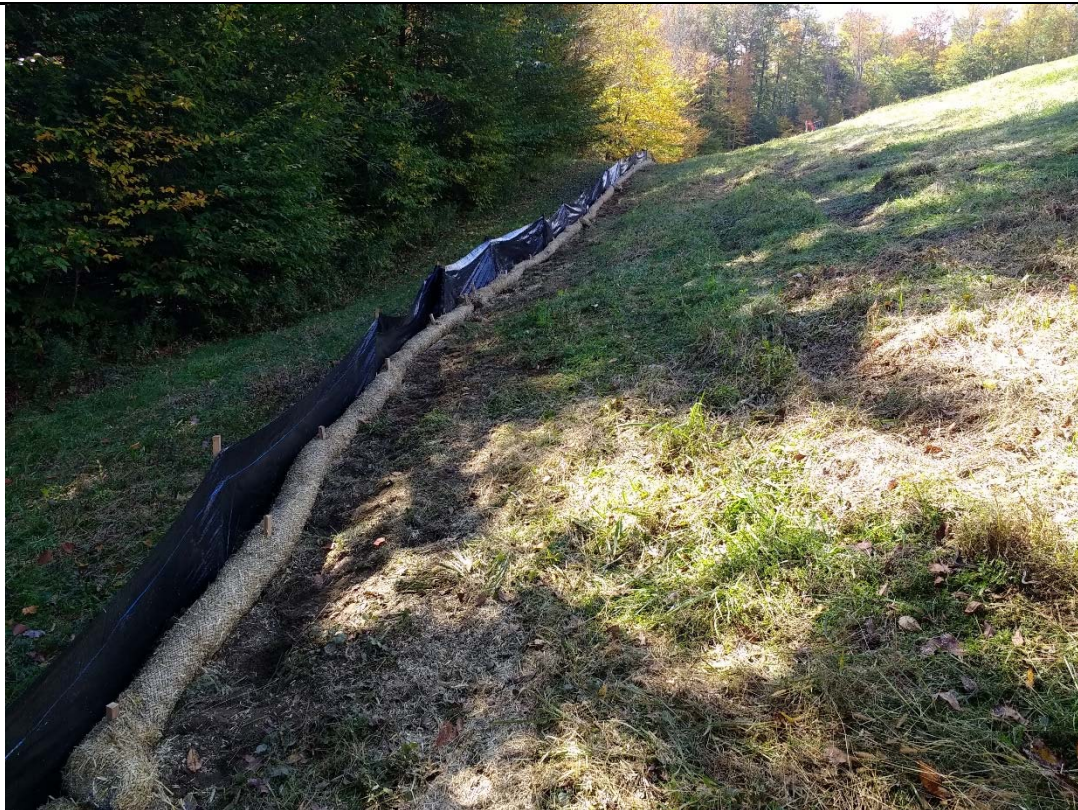
10/10/18: Installation of erosion control measures

- Completed installation of Erosion Control measures along toe of slope/edge of tree line
 - Surveyed limits of existing cap erosion areas
 - Removed cap soils within limits of proposed downslope swale

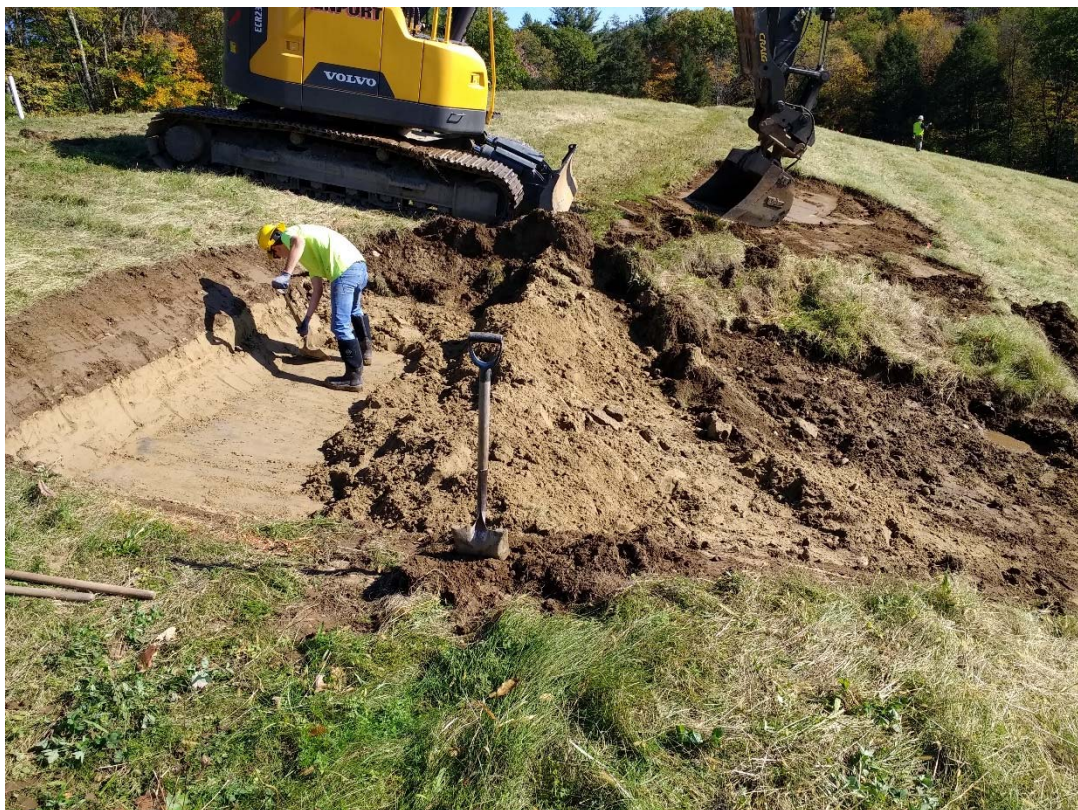
10/17/18: Removal of cap soils within limits of downslope swale

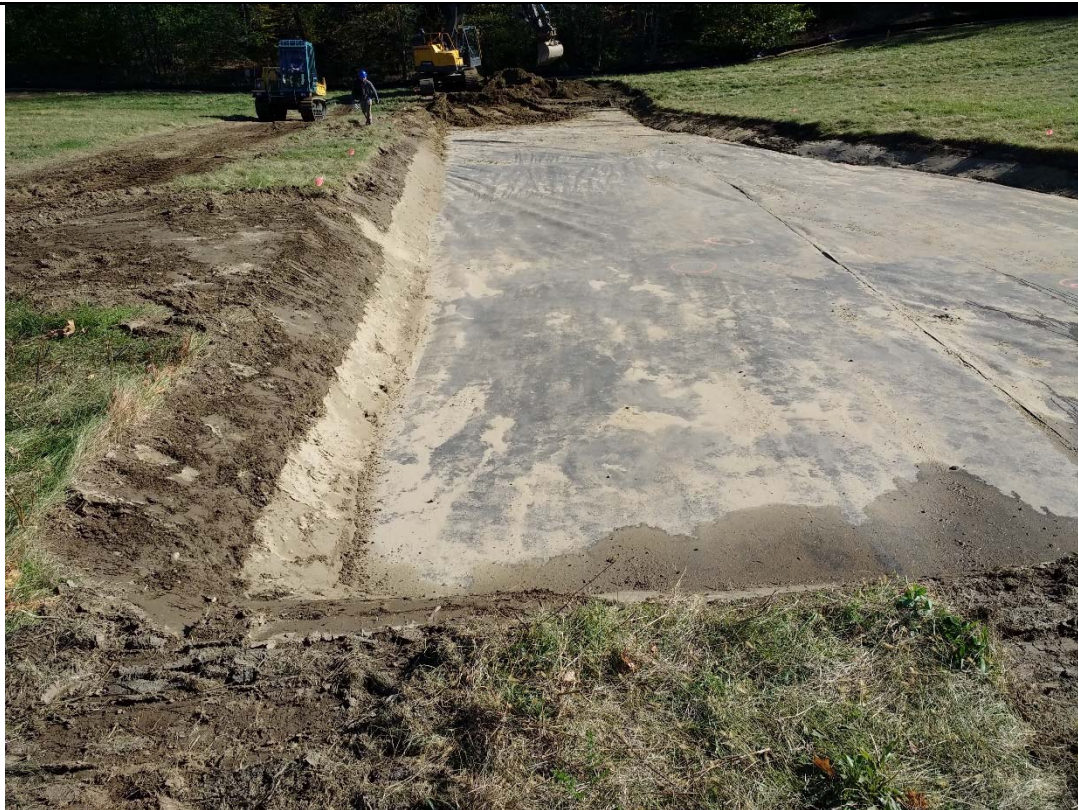
10/18/18: Removal of cap soils within limits of downslope swale

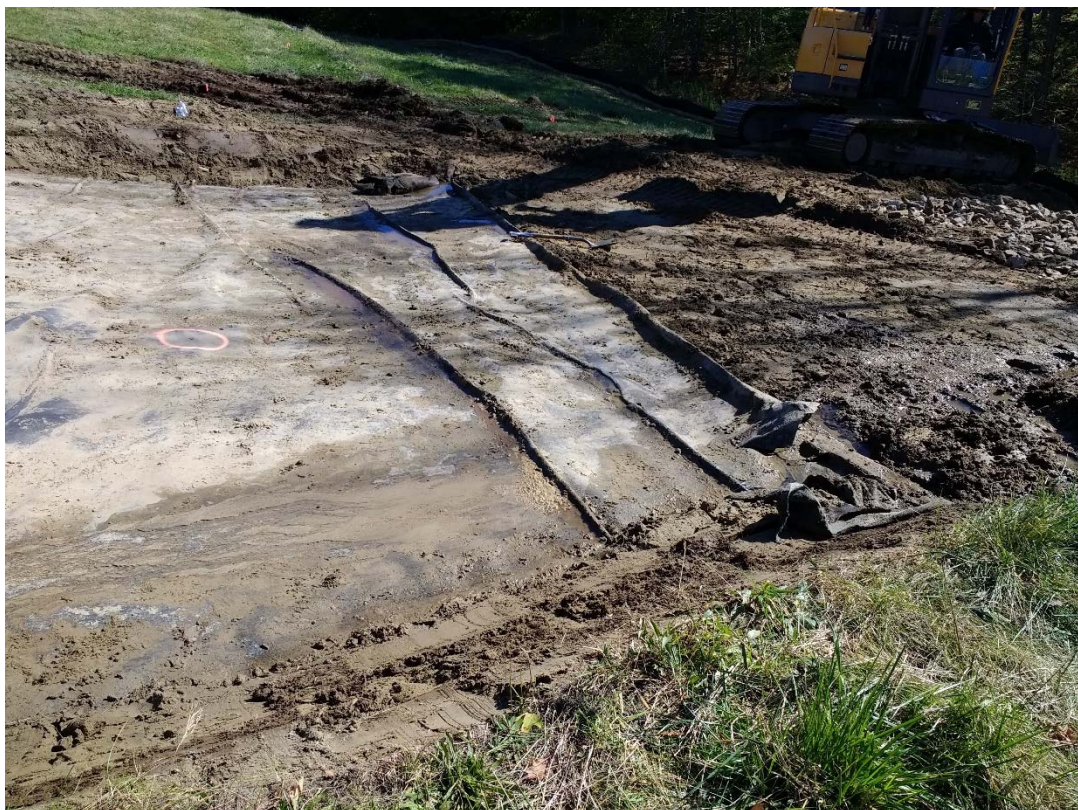
10/18/18: Existing wrinkles in the existing 40-mil cap at toe of slope of proposed downslope swale

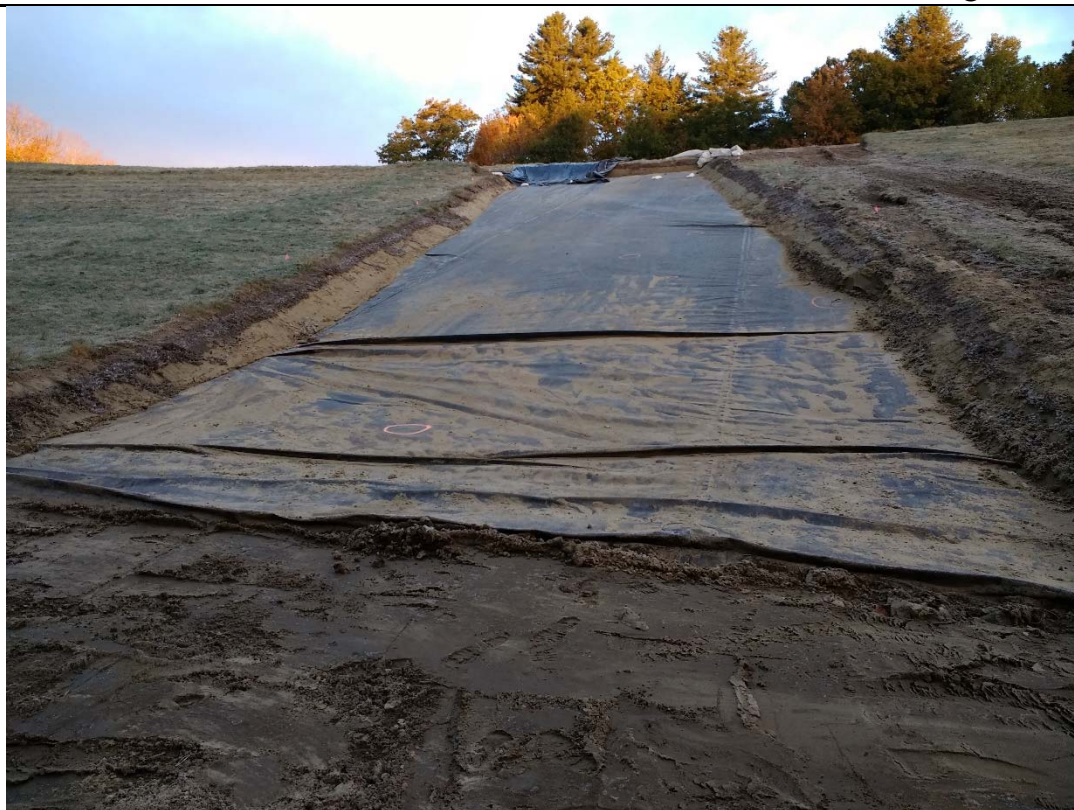
10/22/18: Completed removal of cap soils within downslope swale

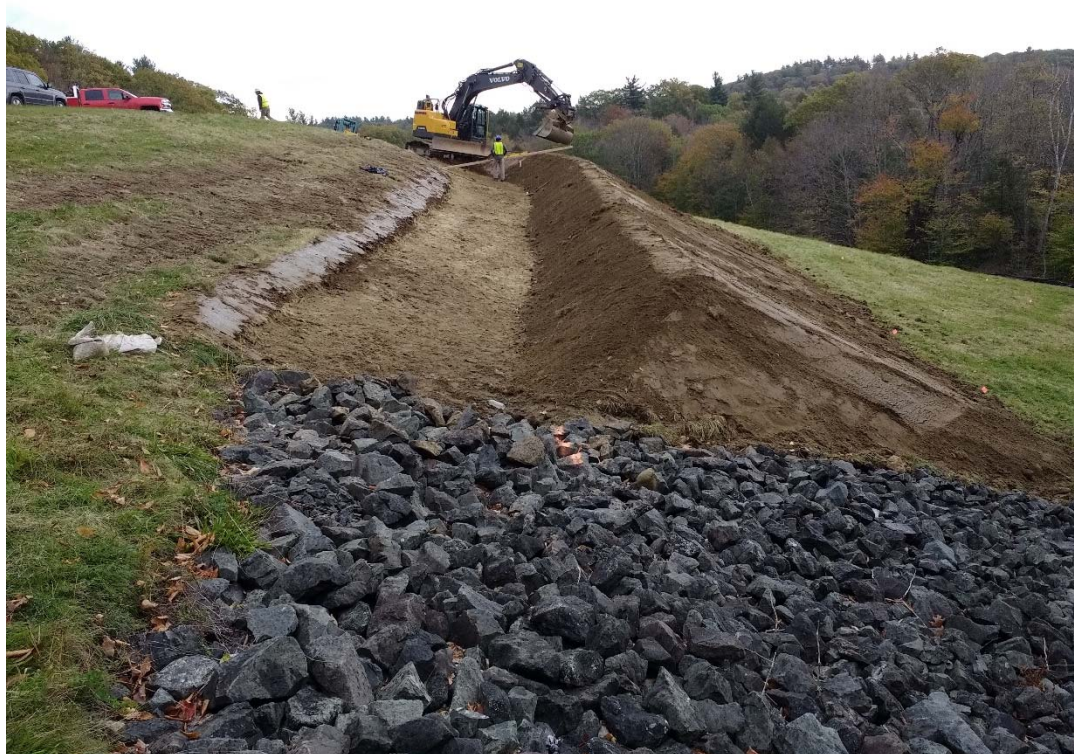
10/23/18: Construction of diversion berm, west of downslope swale at intersection with existing splash pad

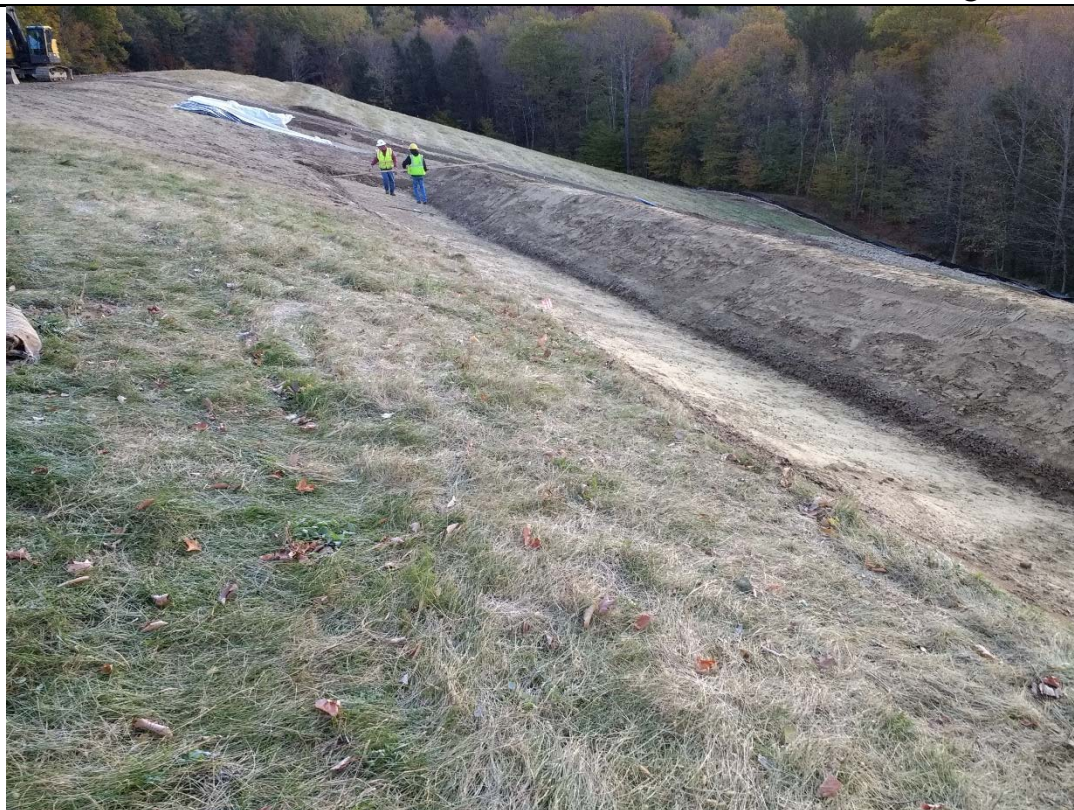
10/26/18: Construction of diversion berm, west of downslope swale at intersection with downslope swale

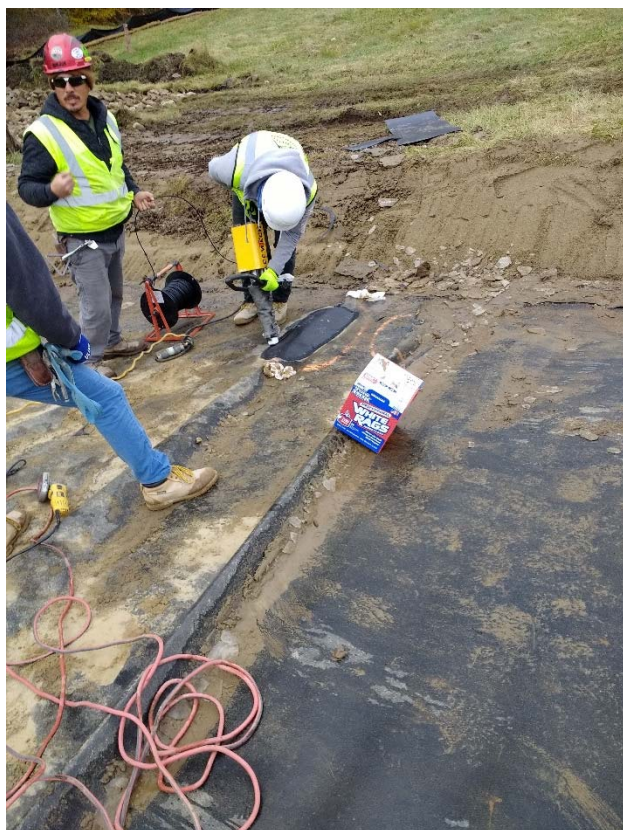
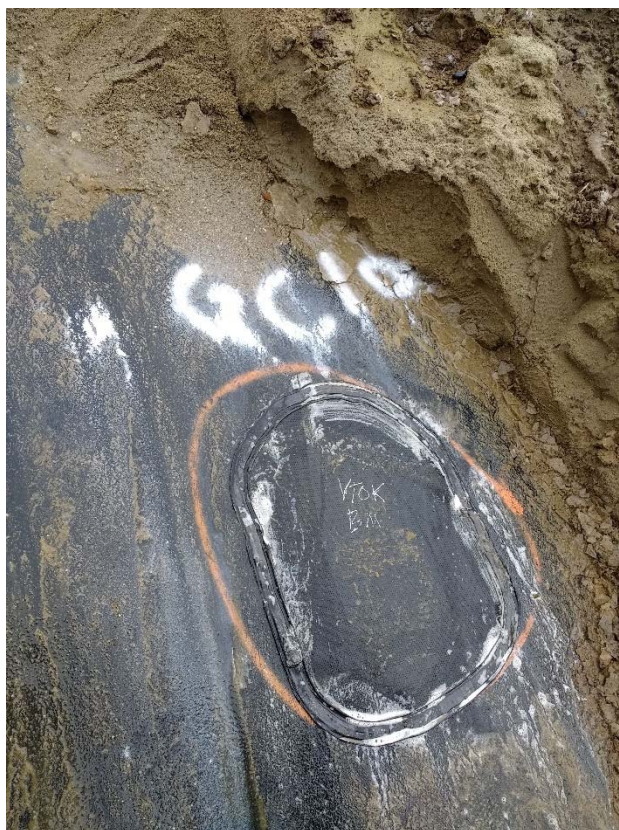
10/31/18: Extrusion welded patch repairs to existing cap

- o New England Liner repaired the damaged areas to the existing 40-mil landfill cap
- o New England Liner completed installation of the channel liner and geocomposite within the downslope swale and diversion berm west of the downslope swale
 - Air testing of all fusion welded seams in the 60-mil channel liners – passed
 - Vacuum testing of all extrusion repair welds - passed

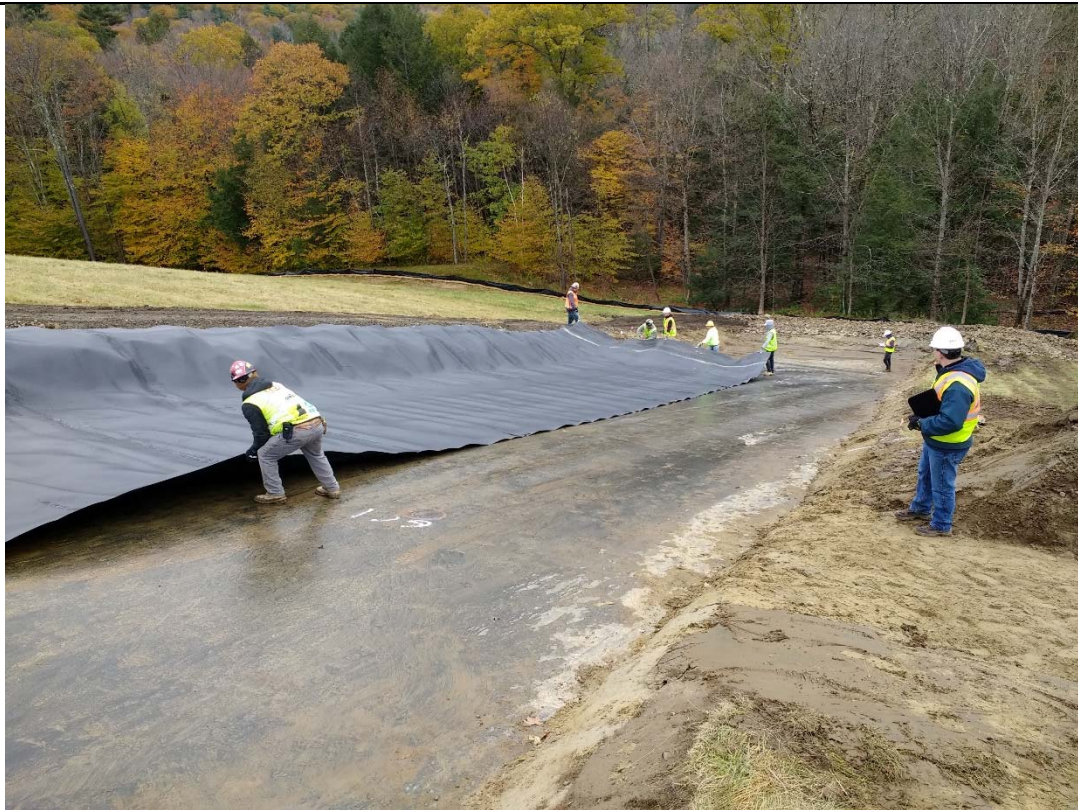
10/31/18: Installation of 60-mil channel liner in downslope swale

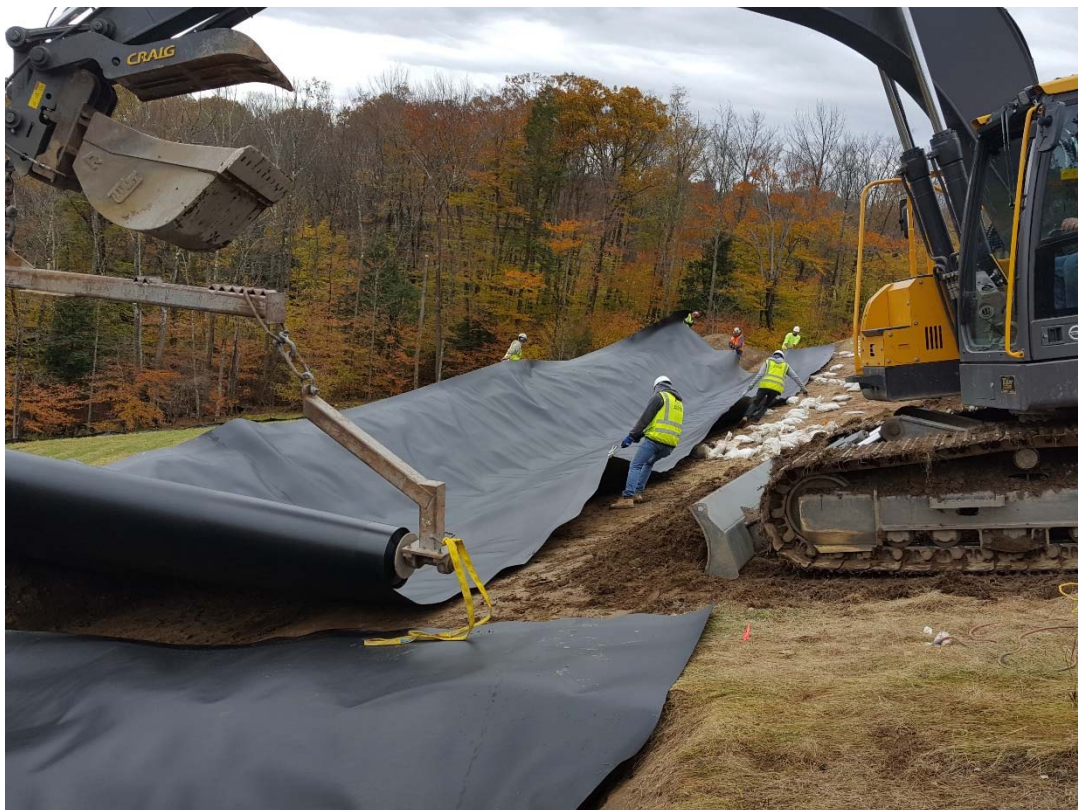
10/31/18: Installation of 60-mil channel liner in diversion berm west of downslope swale

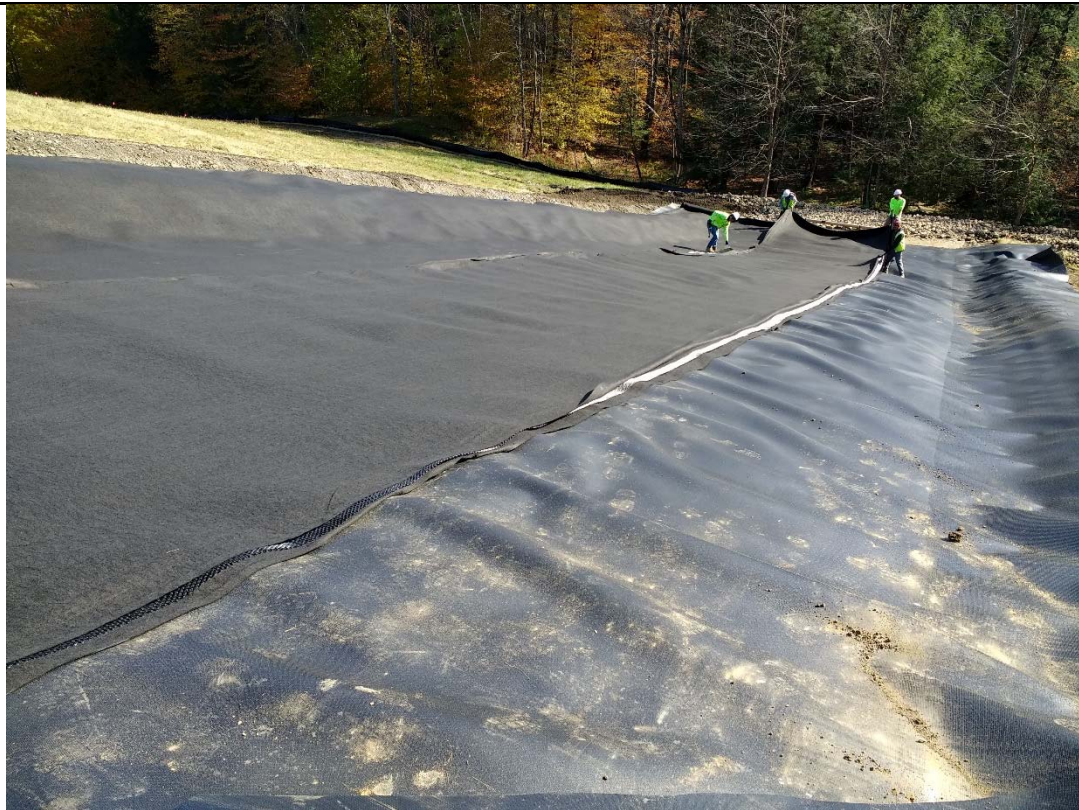
- Deviations from Permit Requirements:
 - The 300-mil thickness geocomposite as called for in Permit Condition 7 was substituted for a 250-mil thickness geocomposite due to an expected delay in receiving 300-mil geocomposite on site.

10/31/18: Installation of 250-mil geocomposite in downslope swale

- Actions taken to correct deviations in Permit requirements:
 - A request to allow for the use of 250-mil geocomposite in the downslope swale and diversion berms was submitted to MassDEP. Approval from MassDEP was received on October 19, 2018 for the use of 250-mil geocomposite in the downslope swale and diversion berms.

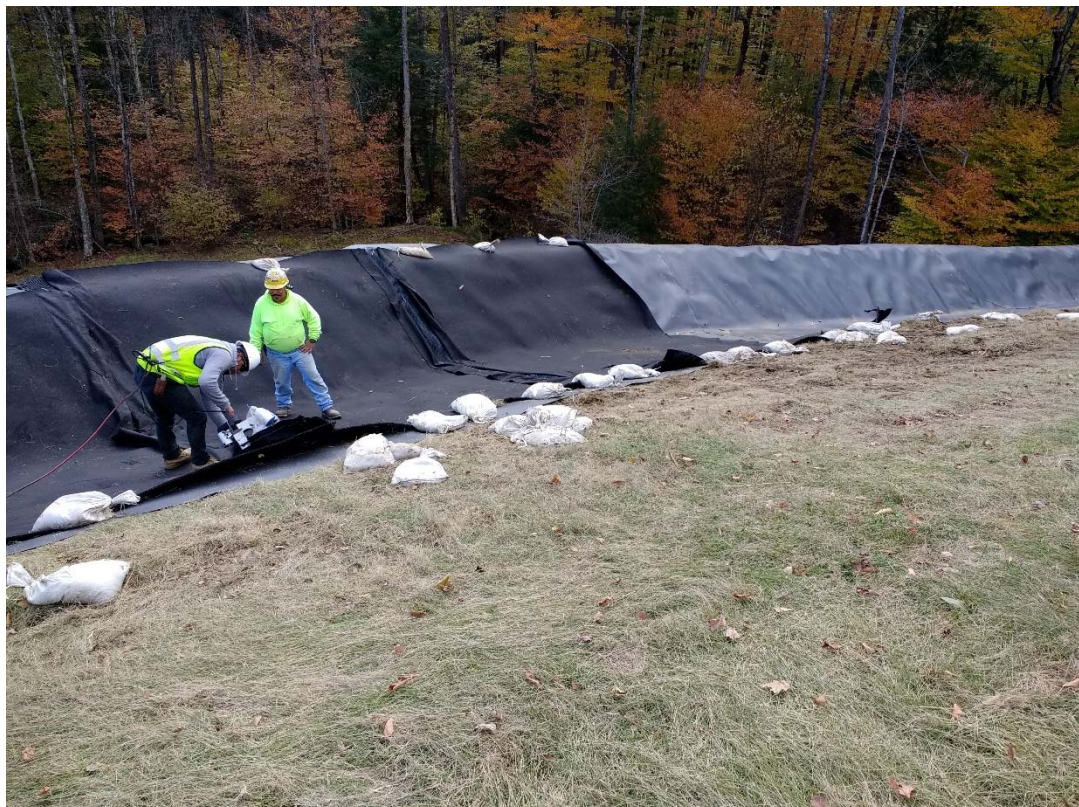
10/31/18: Installation of 250-mil geocomposite in diversion berm west of downslope swale
