G-0366-013A-02-02
December 7, 2018

Re: **Goshen Landfill**
Corrective Action Design – Cap Repair
November 2018 Monthly Construction Report
SWM File # 18-108-004

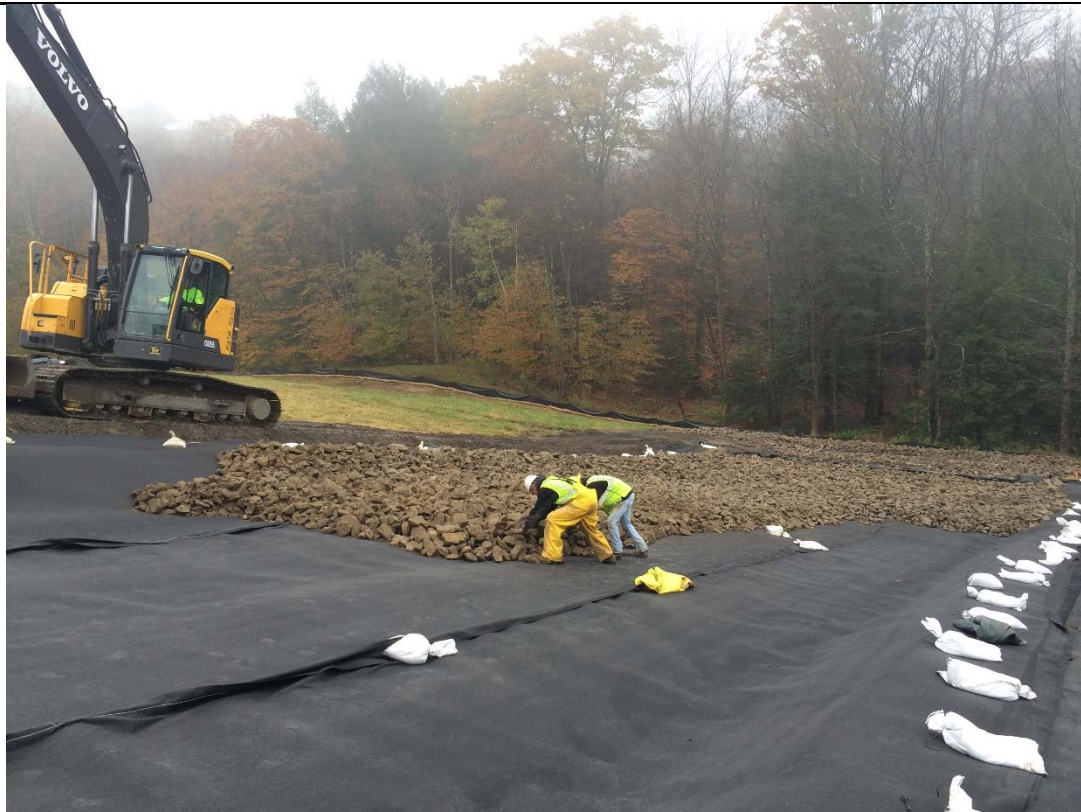
11/1/18: Placement of stone down slope swale

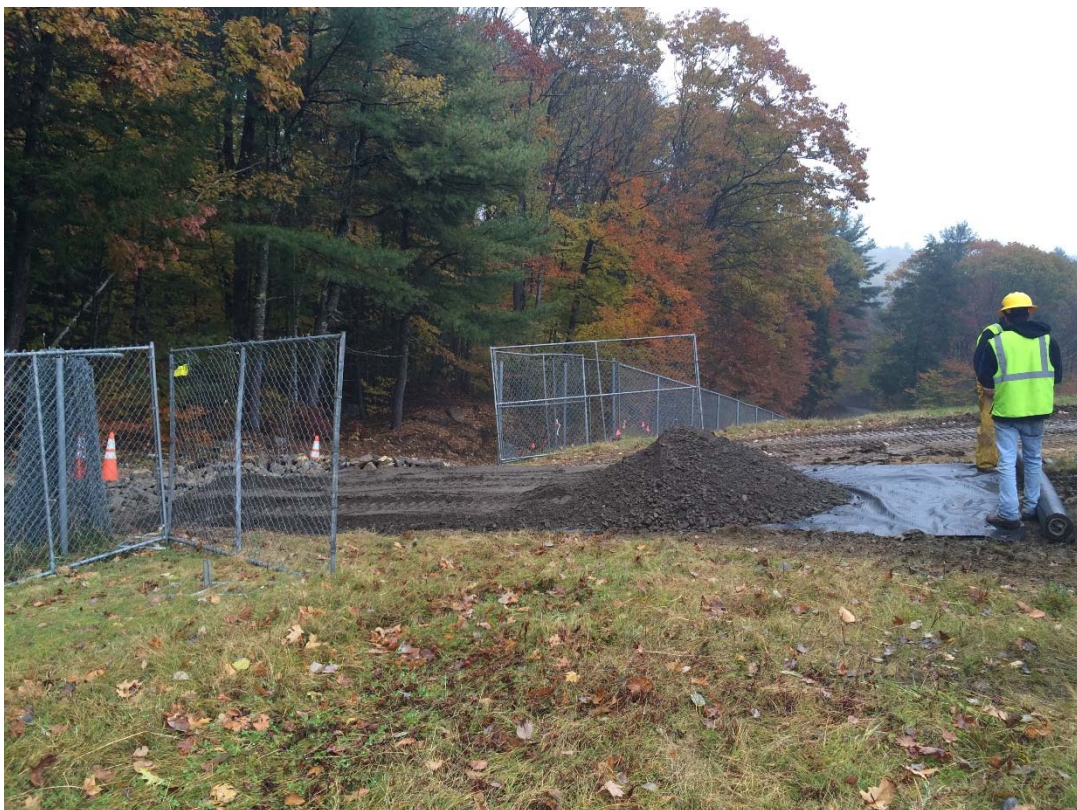
11/1/18: Extension of temporary access road at equipment access gate

- Significant work performed during the month:
 - C.D. Davenport extended the temporary access road with non-woven geotextile and crushed stone from the equipment access gate, along the plateau area of the landfill, to the top of the down slope swale.

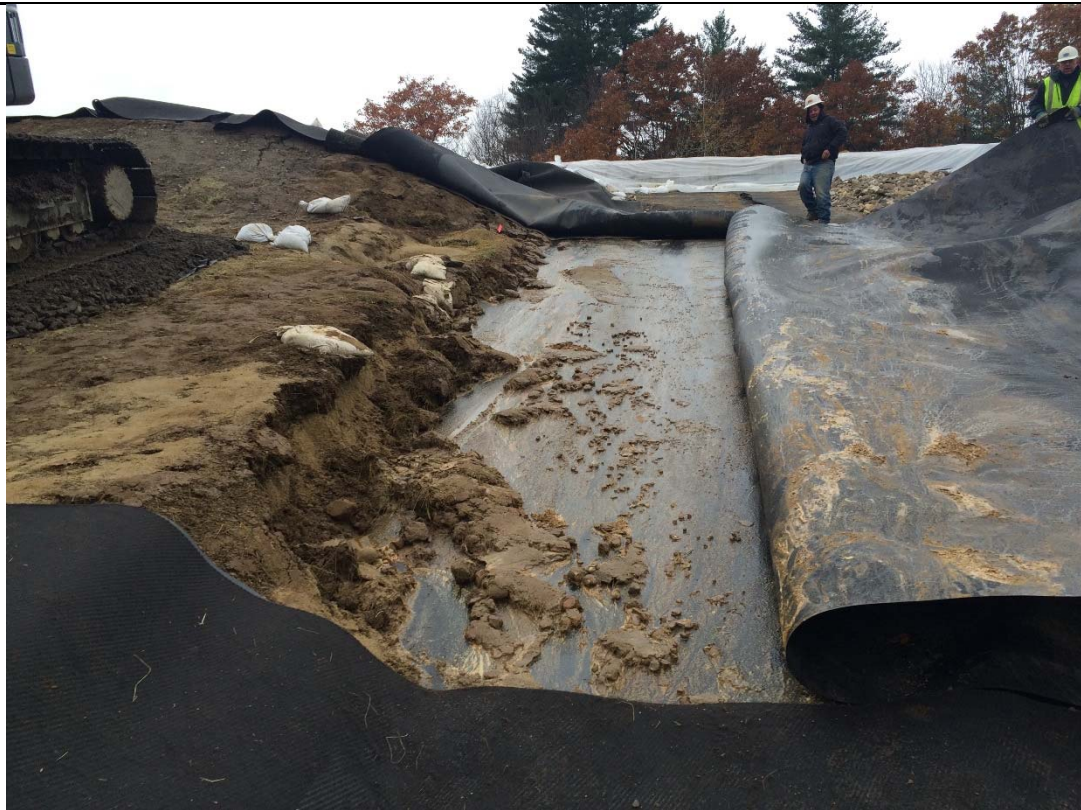
11/5/18: Erosion in down slope swale following rain event. Down slope channel liner and geocomposite has been cut and folded back.

- New England Liner repaired the installed down slope channel liner, geocomposite, and diversion berm channel liner that C.D. Davenport cut during the removal of cap soils that had eroded into the down slope channel during rain events.

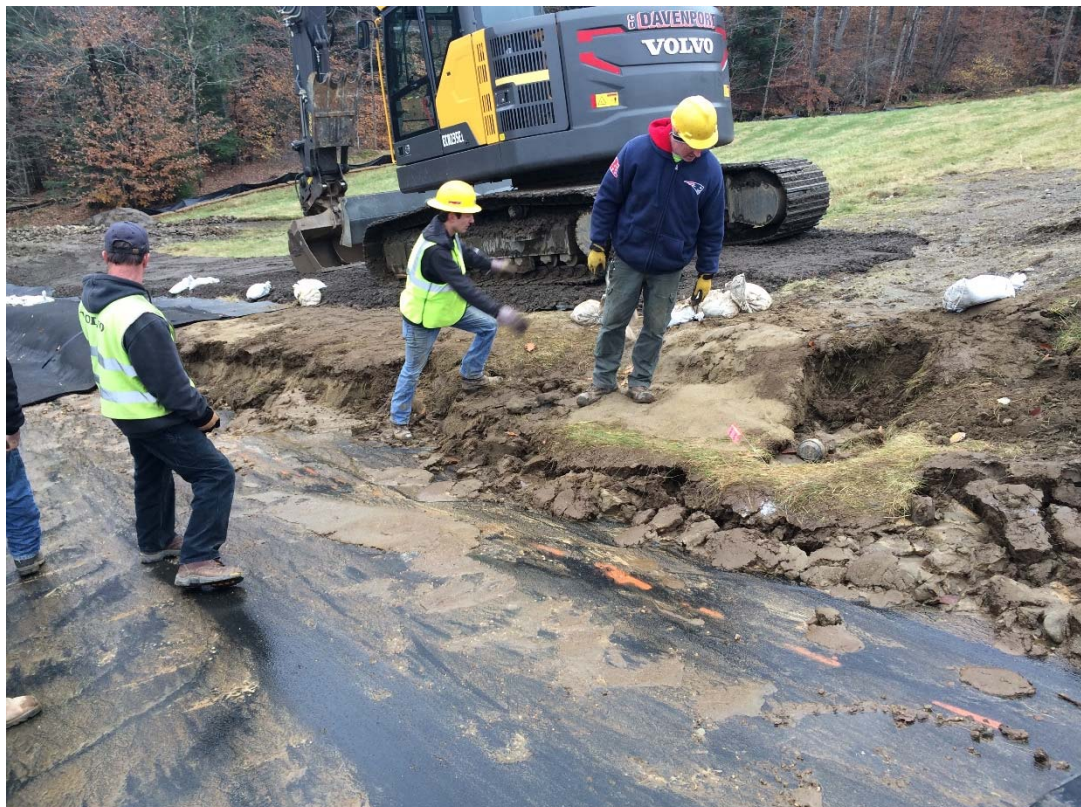
11/5/18: : Side slope of landfill cap in down slope swale following rain event.

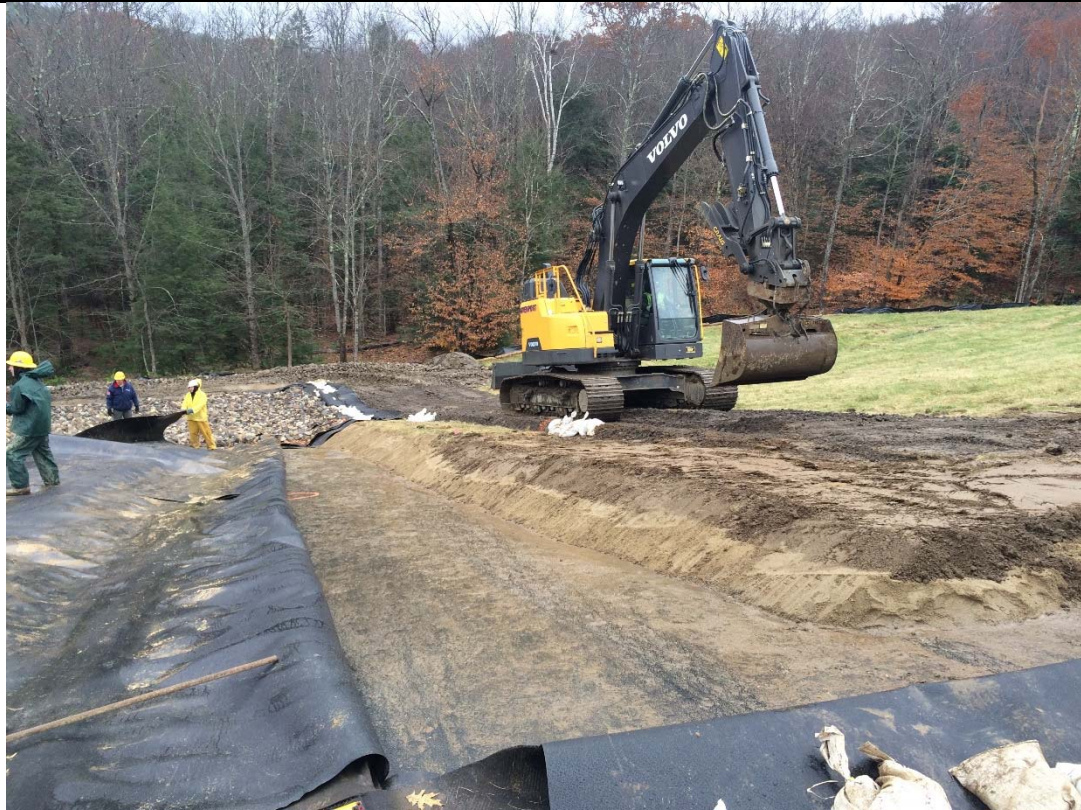
11/5/18: Side slope of landfill cap in down slope swale following removal of eroded materials and repair to side slope.

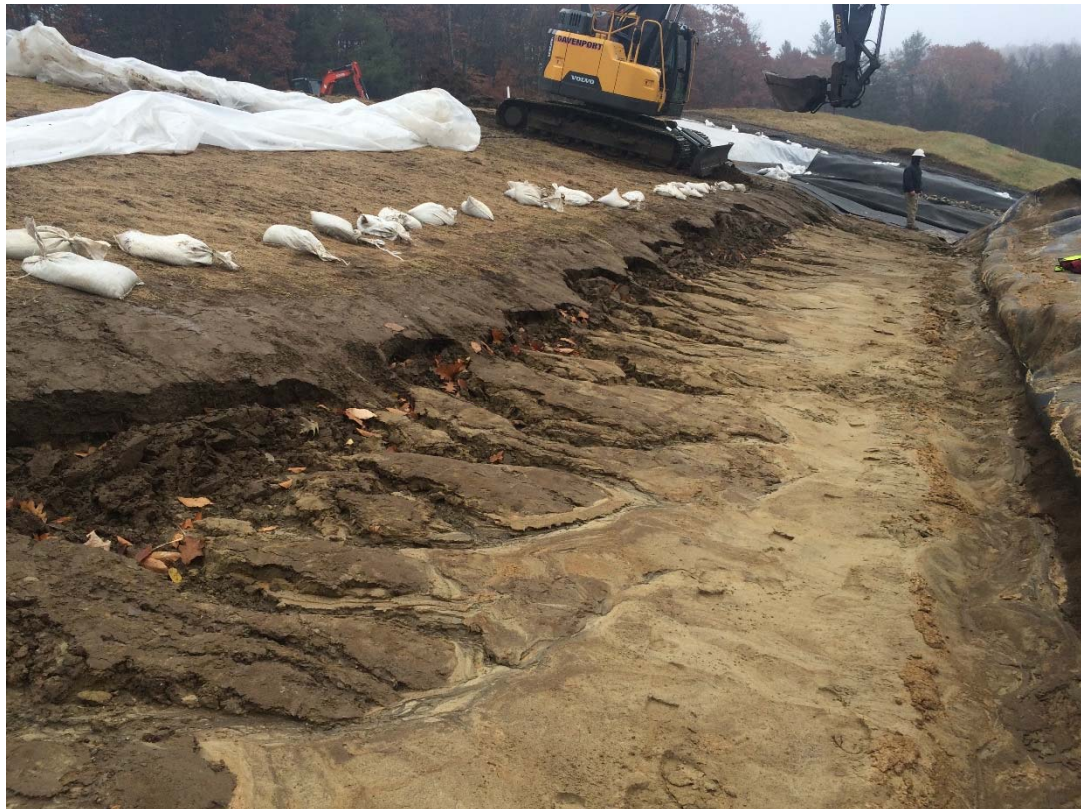
11/6/18: Side slope of landfill and bottom of diversion berm following rain event and removal of channel liner and geocomposite

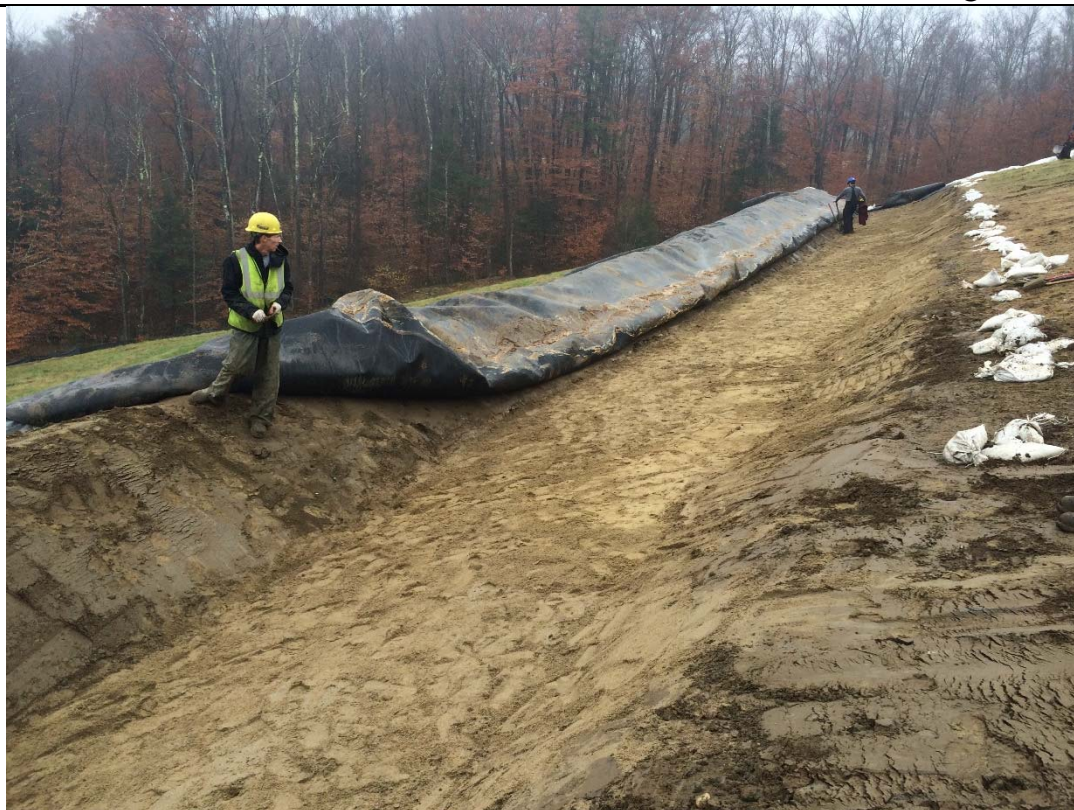
11/6/18: Diversion berm following removal of eroded materials and repair of drainage sand layer and side slope

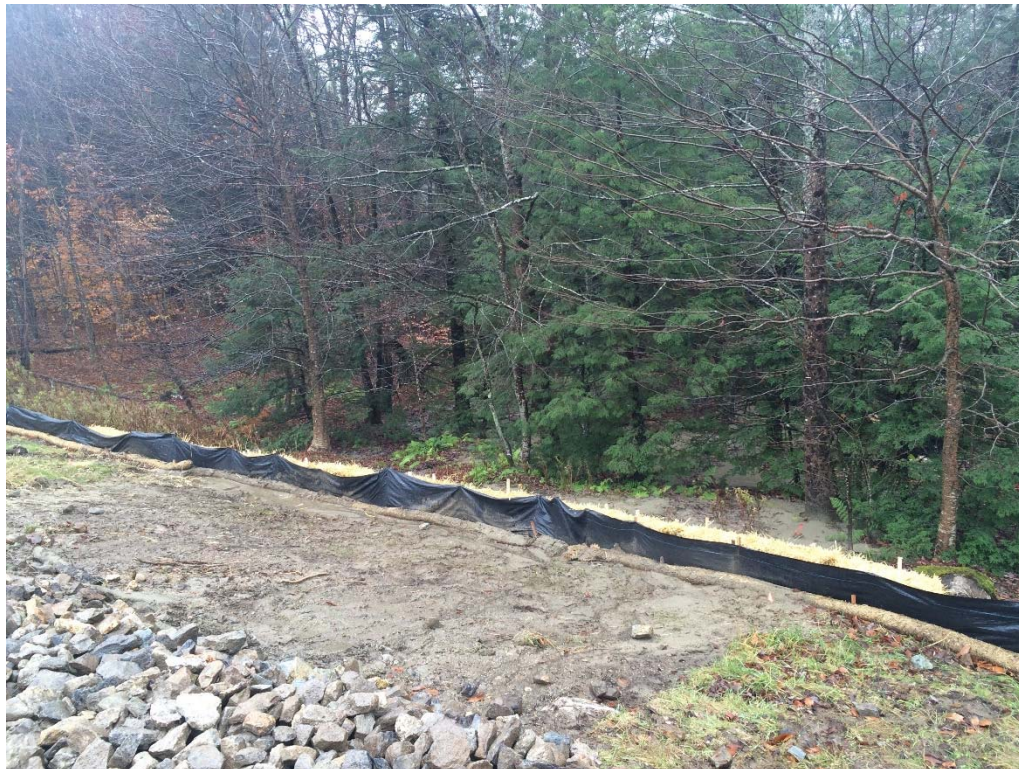
11/6/18: Repaired toe of slope and erosion control barriers at bottom of down slope swale

- Vacuum testing on the welded seams of the repaired down slope and diversion berm channel liners – passed
 - C.D. Davenport removed eroded materials from the wooded area at the toe of slope and reinforced the staked bales and silt fencing.

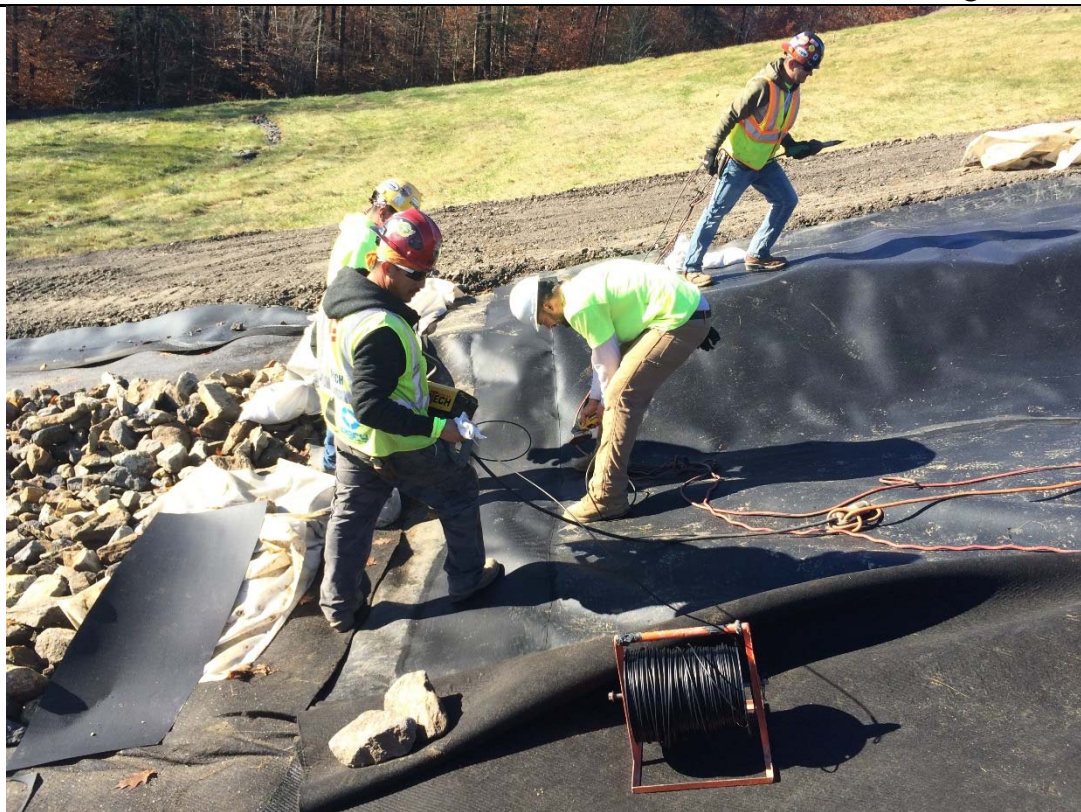
11/7/18: Repairs to channel liner in down slope swale

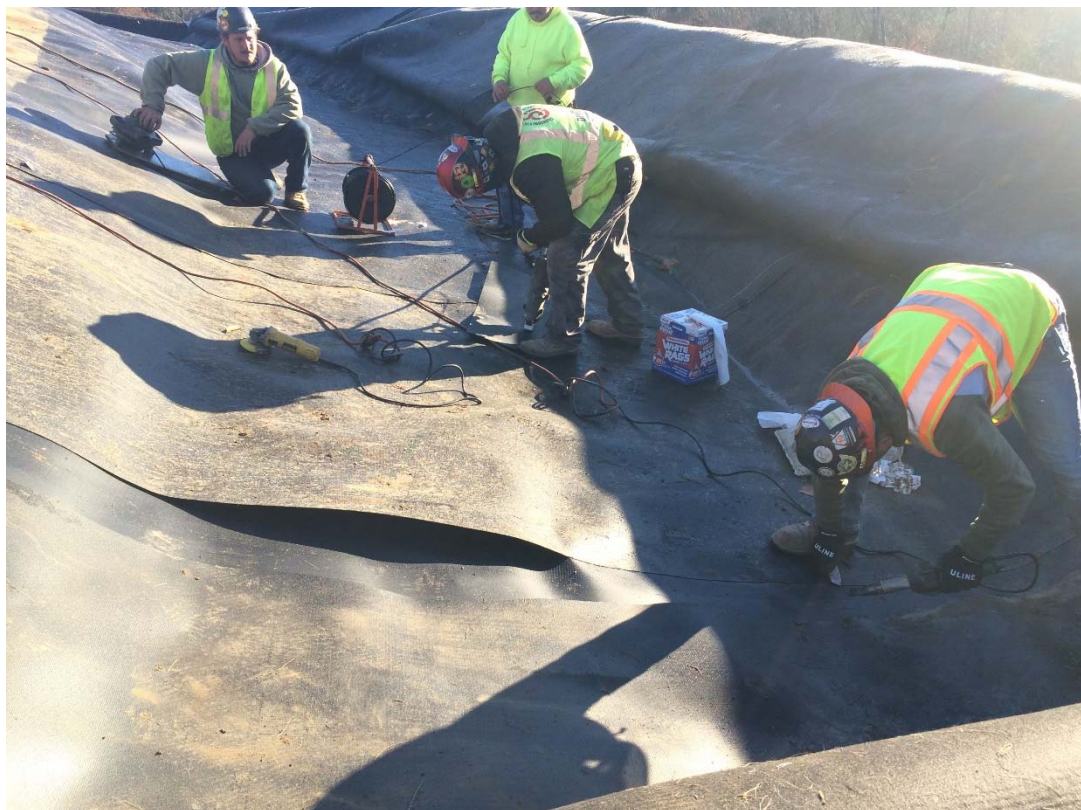
11/7/18: Repairs to channel liner in diversion berm

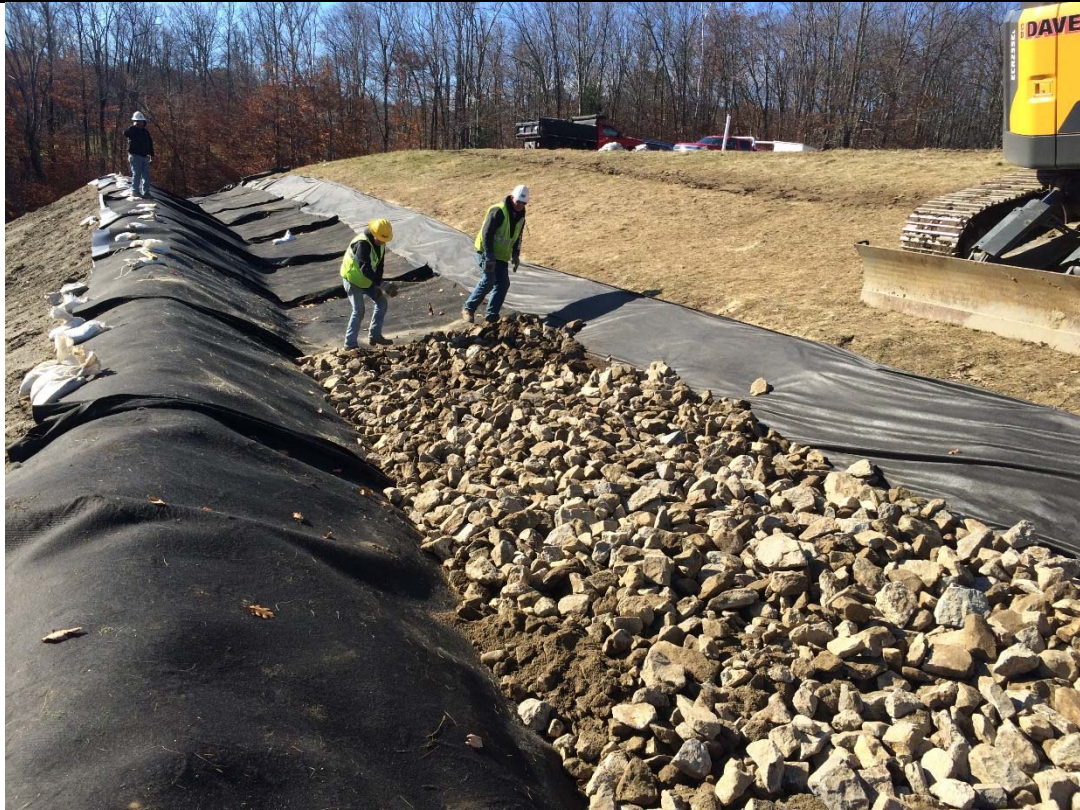
11/8/18: Placement of stone in diversion berm following repairs to channel liners

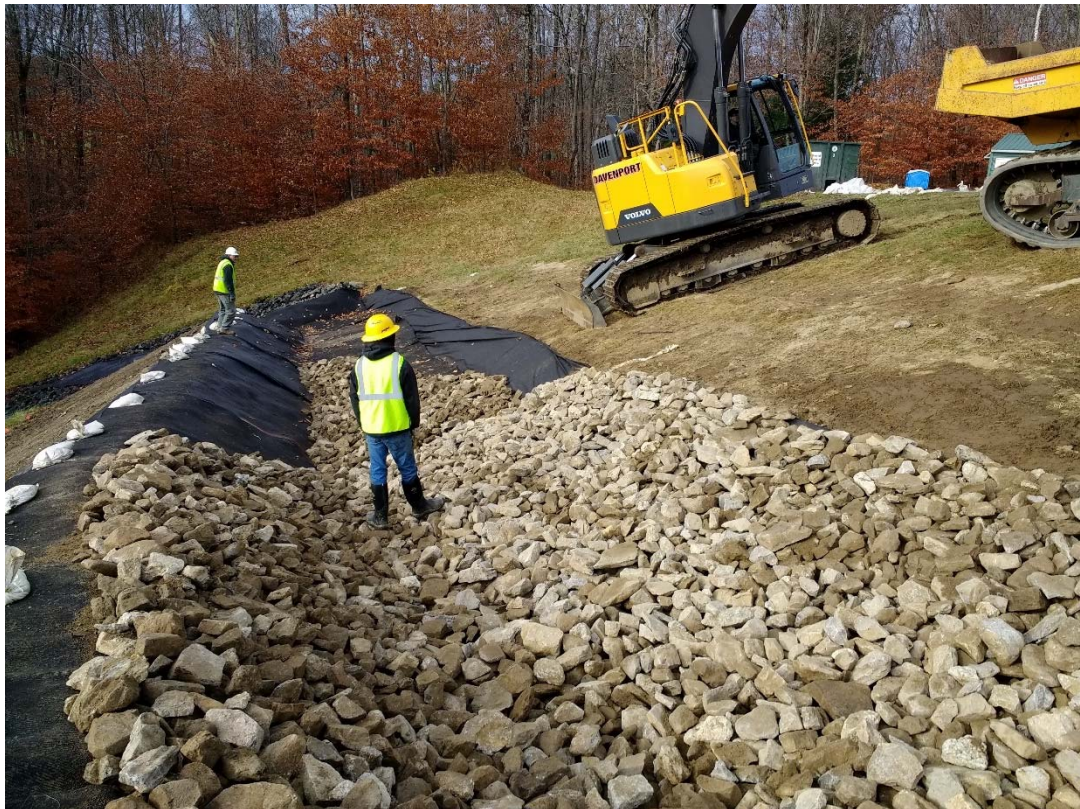
11/9/18: Placement of stone in diversion berm following repairs to channel liners

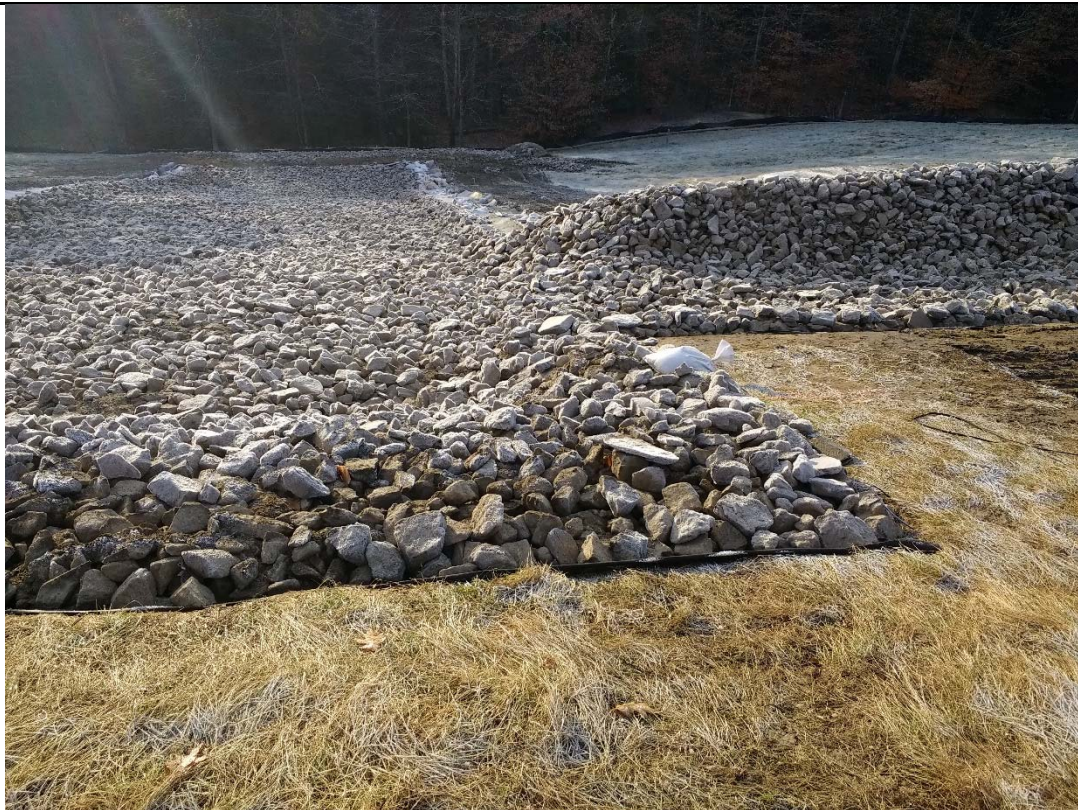
11/9/18: Down slope swale and diversion berm following placement of stone

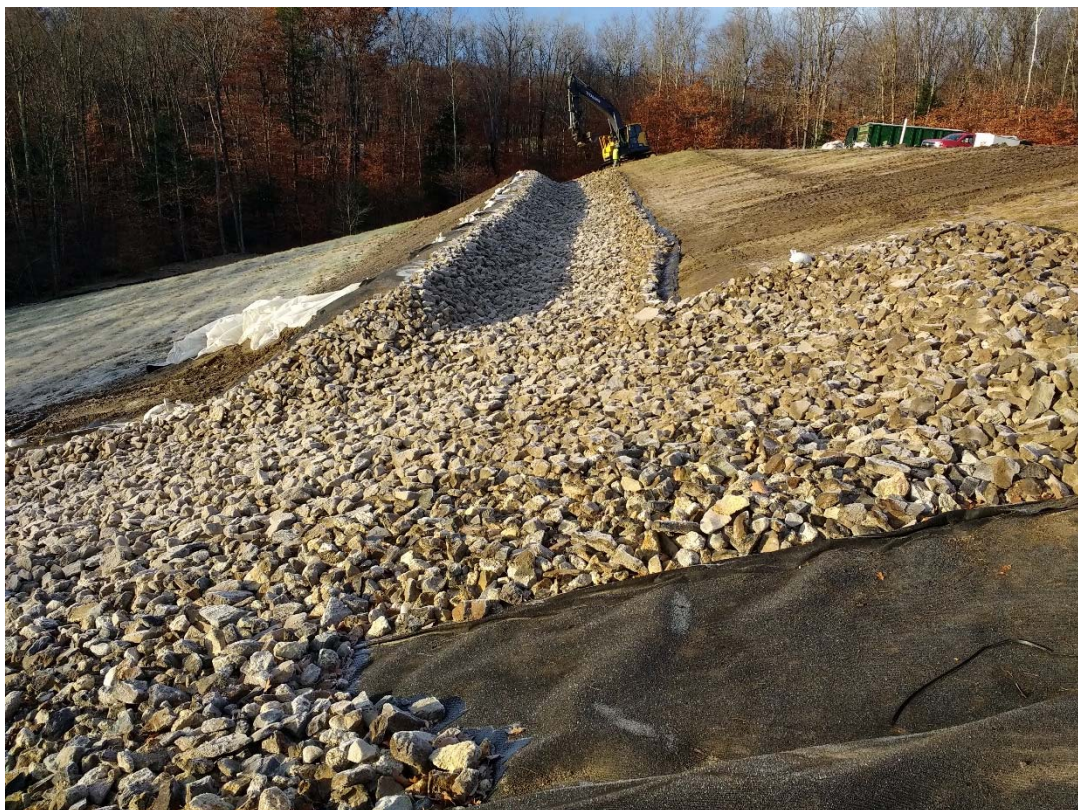
11/9/18: Diversion berm and down slope swale following placement of stone

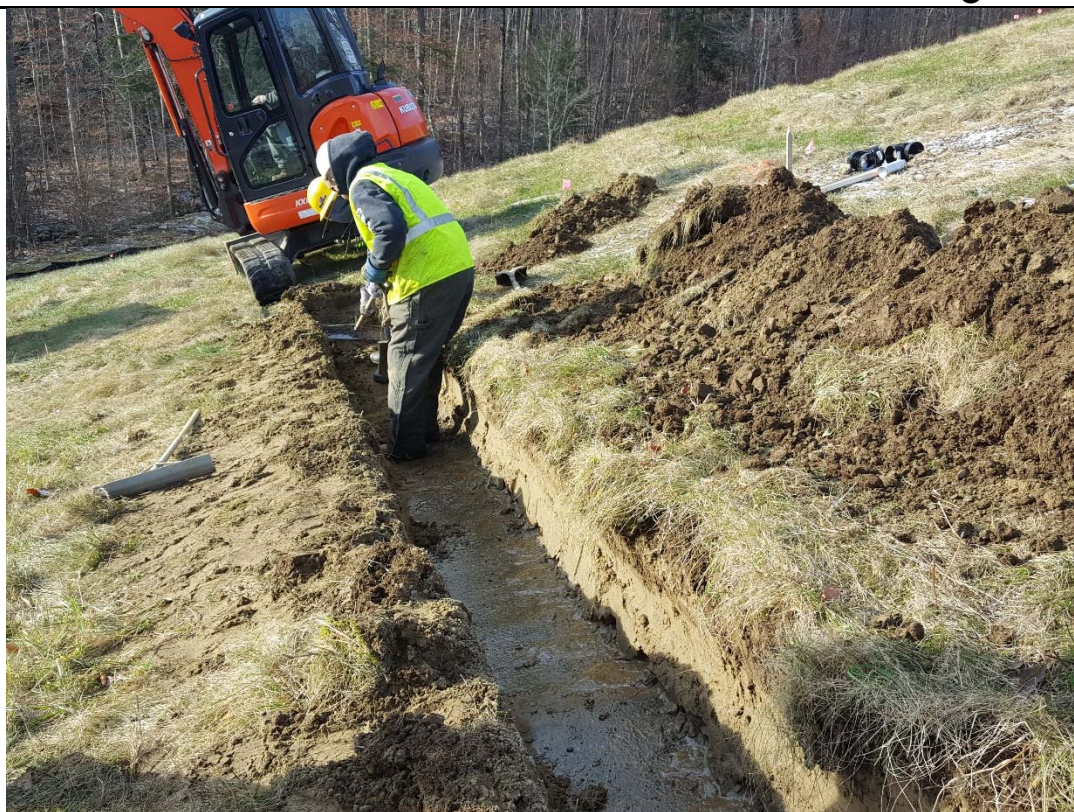
11/14/18: Trench excavation for sub drain piping

- Sub drain piping above the west diversion berm is to be installed in the spring due to additional cap erosion areas that were observed during construction activities. A field sketch of the additional piping layout and installation detail were issued to C.D. Davenport on November 8, 2018.

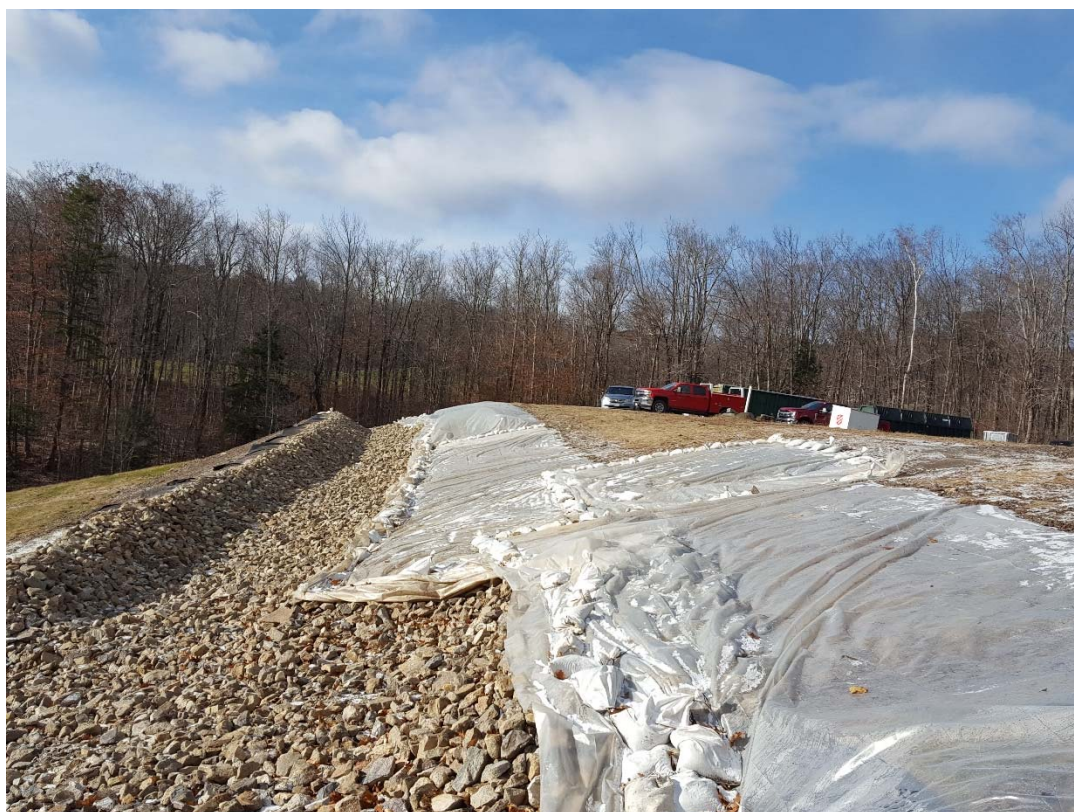
11/14/18: Plastic sheets above diversion berm and down slope swale following placement of stone

- o C.D. Davenport placed plastic sheets and sand bags on the grass slope immediately above the active construction area as an erosion control measure.
- o C.D. Davenport completed placement of the stone in the westerly diversion berm and down slope swale.
- o C.D. Davenport notified the Town that they would be shutting down construction activities on November 15, 2018 for the winter but would be monitoring the site during the shutdown. C.D. Davenport to notify the Town and Tighe & Bond if any issues or changed conditions occur during the shutdown.

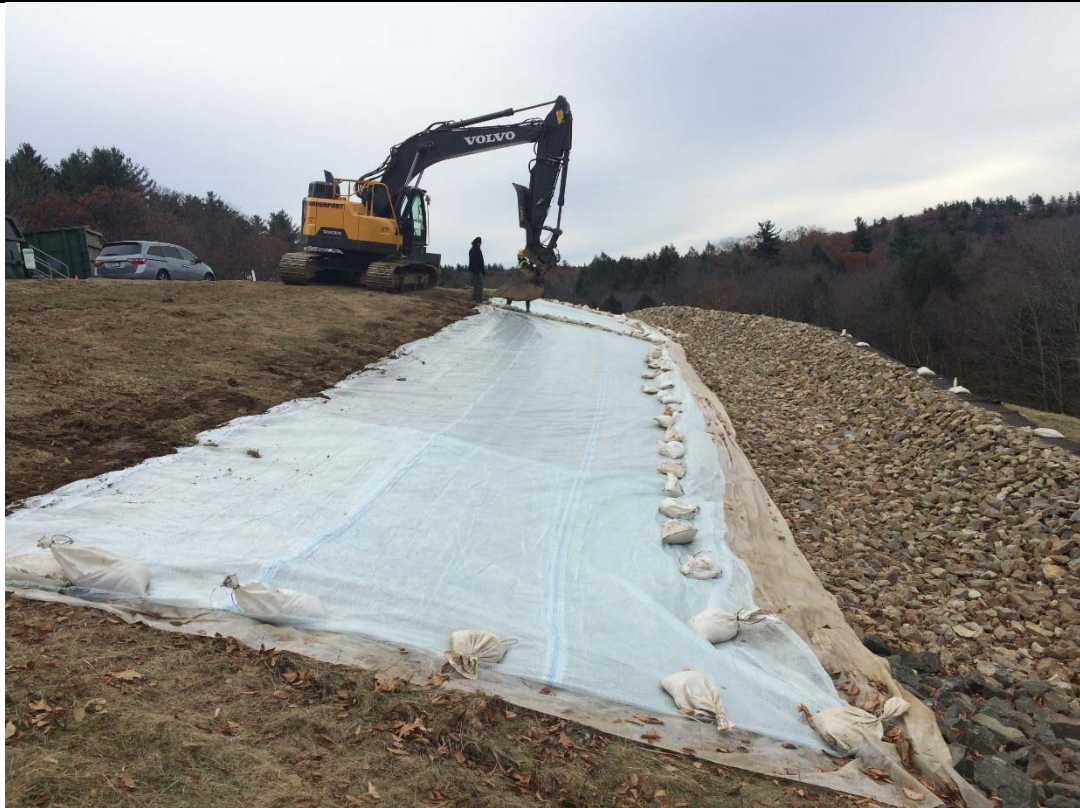
11/15/18: Plastic sheets above diversion berm following placement of stone
