# ***Goshen Historical Commission***

## ***Meeting Minutes***

# TOWN OF GOSHEN, MASSACHUSETTS

December 21, 2015

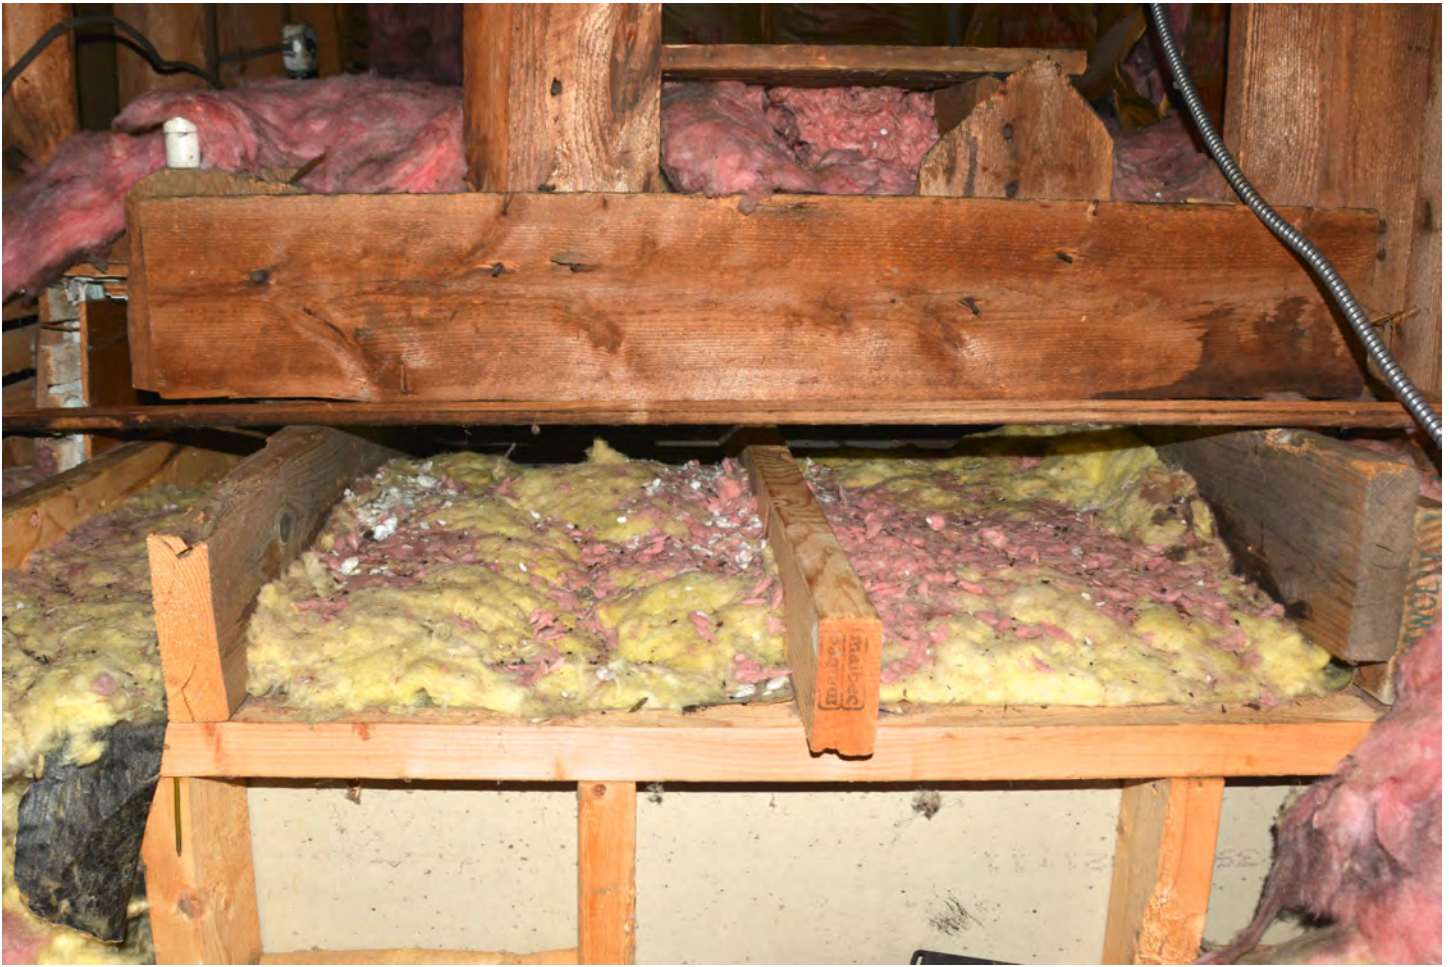
This is the ceiling above the entryway to the museum. Notice how the mice have chewed away pink insulation and scattered it over the yellow insulation. Also notice how the yellow insulation has been matted down as a result.

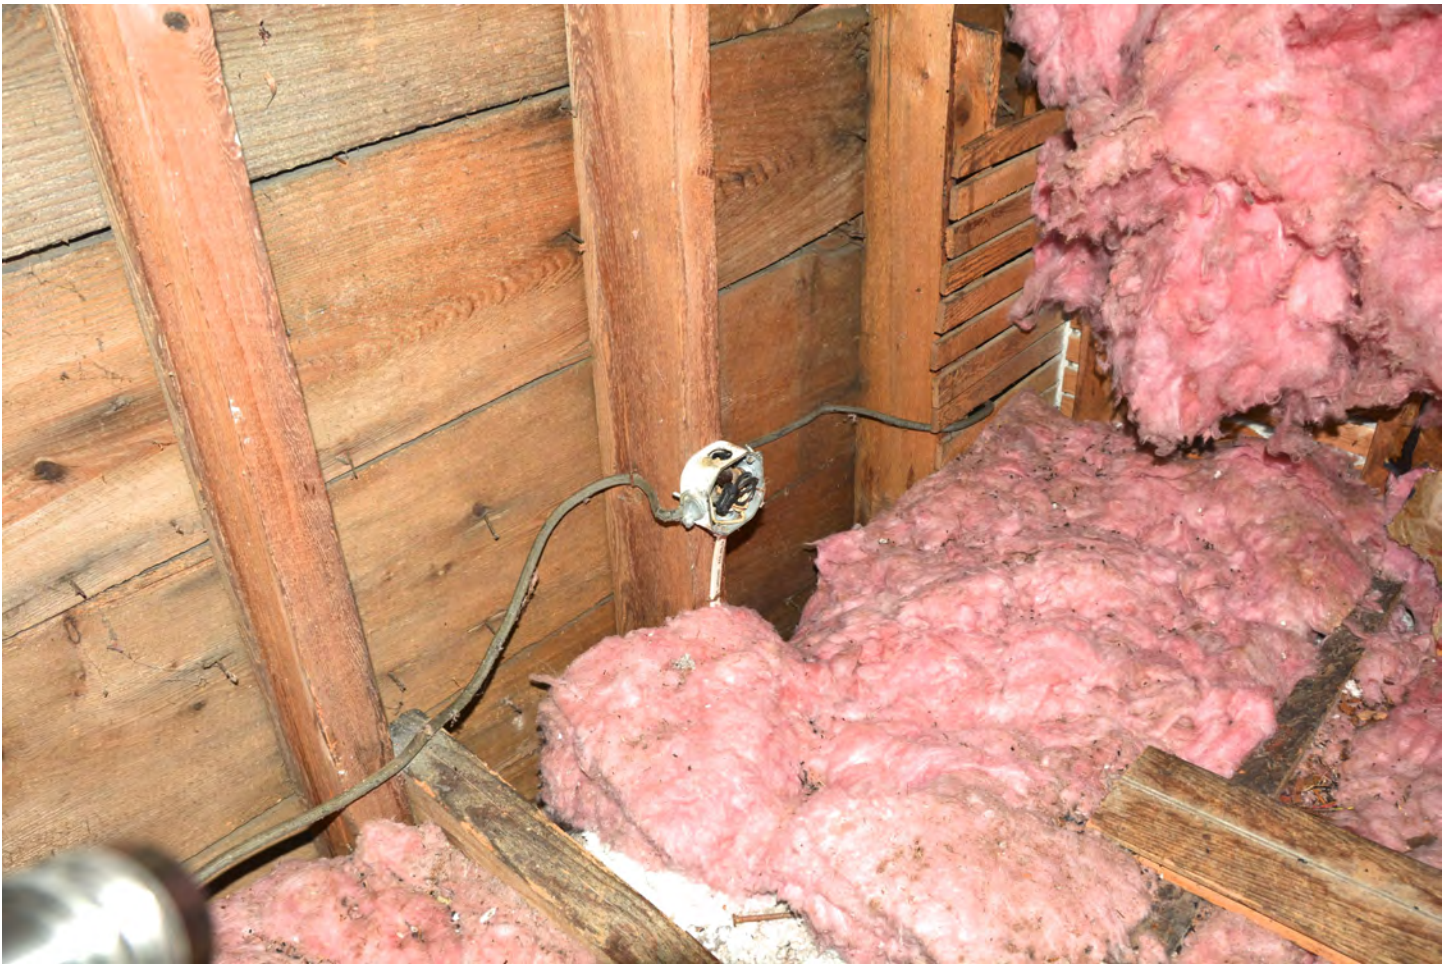
This is a junction box located above the front door which has no cover on it leaving wires exposed.

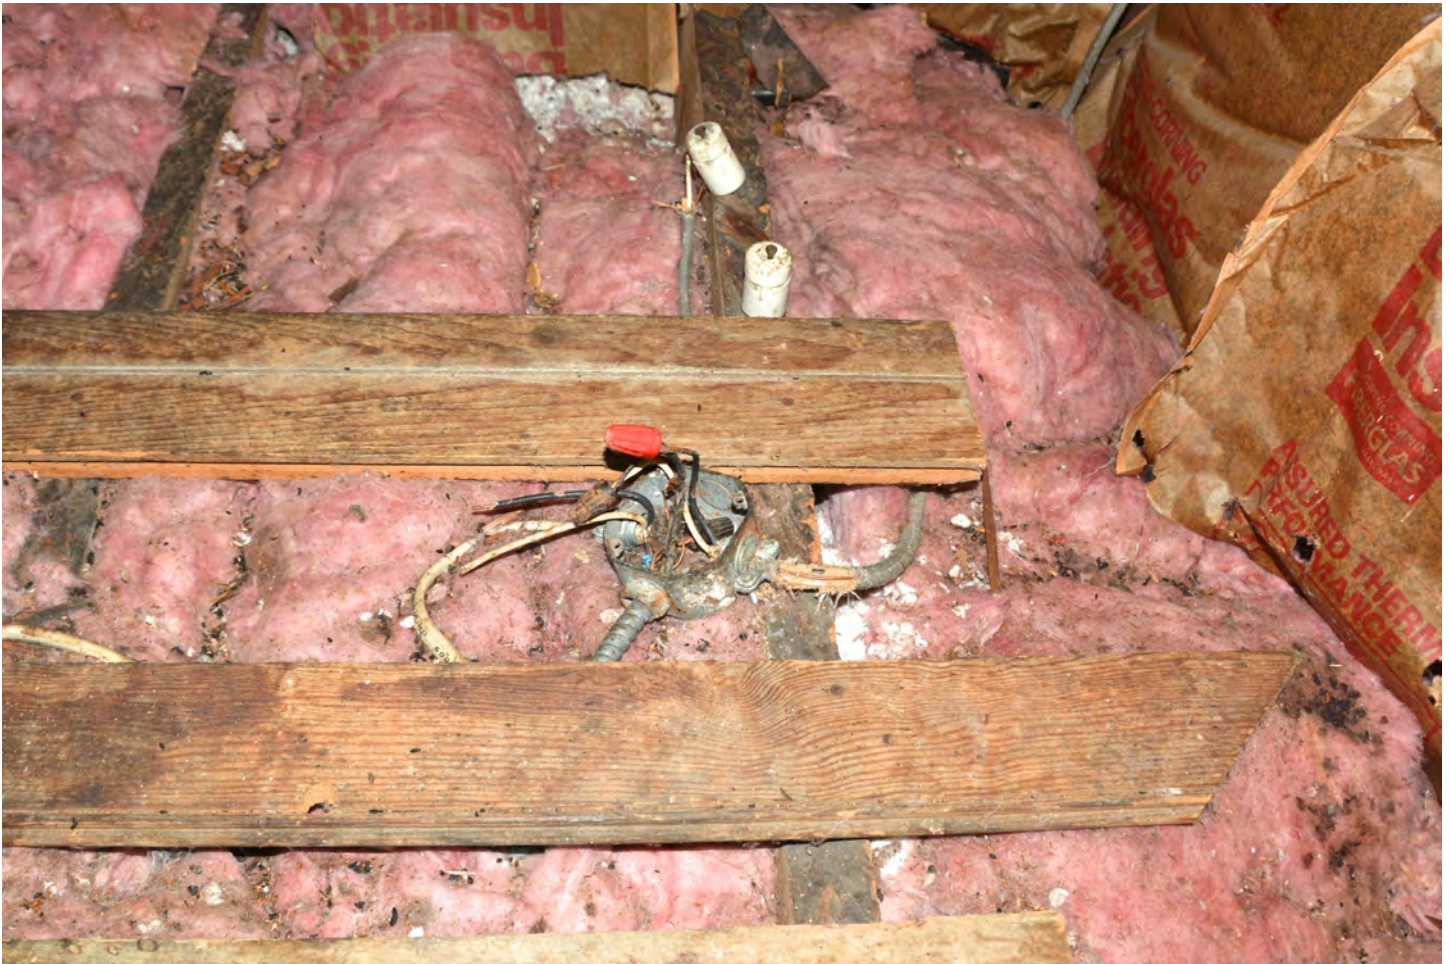
This is a junction box located above the closet ceiling that is also missing a cover. Notice how the wiring insulation has been chewed away exposing the copper wire. There is also a black grounding wire that is not connected to anything.

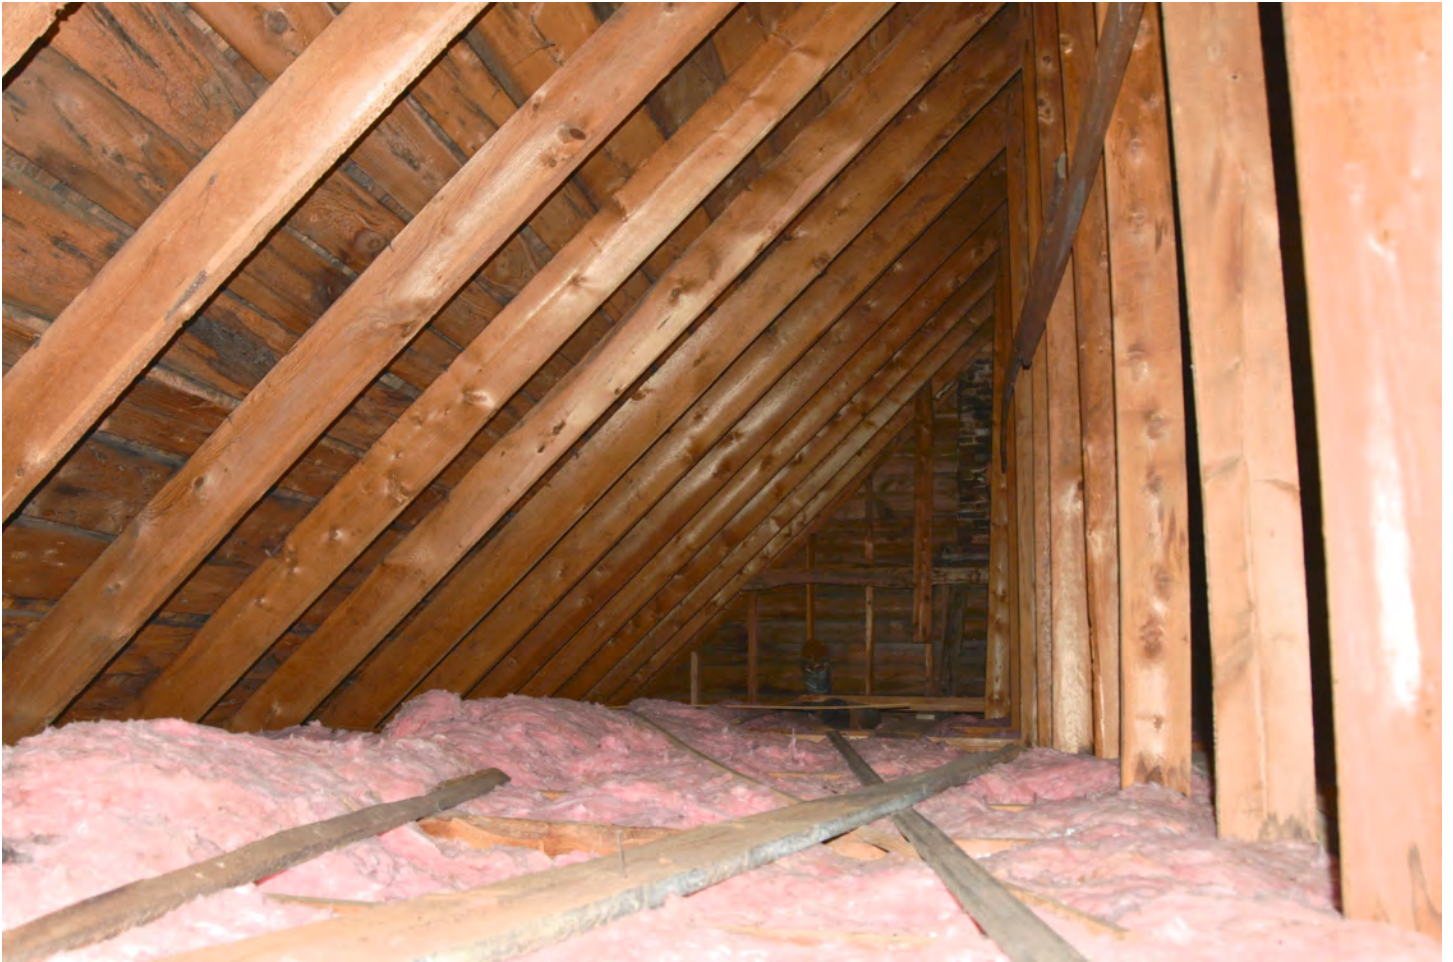
This is a view looking towards the back of the Museum (towards the West) from the front of the Museum. The rafters on the left of this picture face south. Note the 'hump' in the insulation on the left side of the picture. That was caused when the installers placed the insulation directly over electrical wires that are located on top of the ceiling joists.

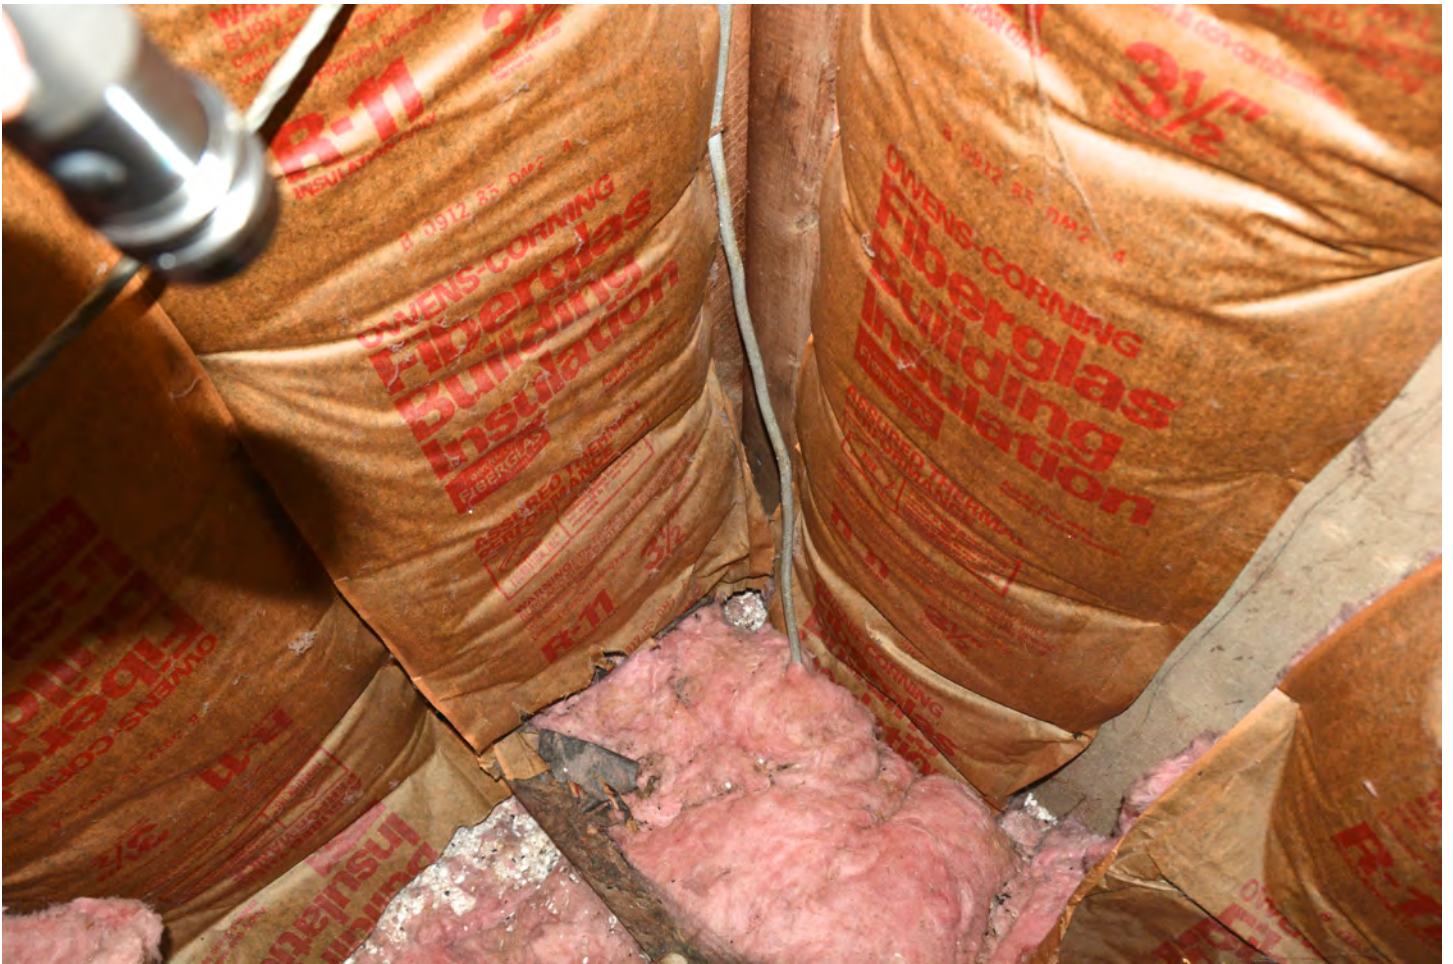
This is a corner of the ceiling above the closet. Note the mouse hole in the insulation in the center of the picture.

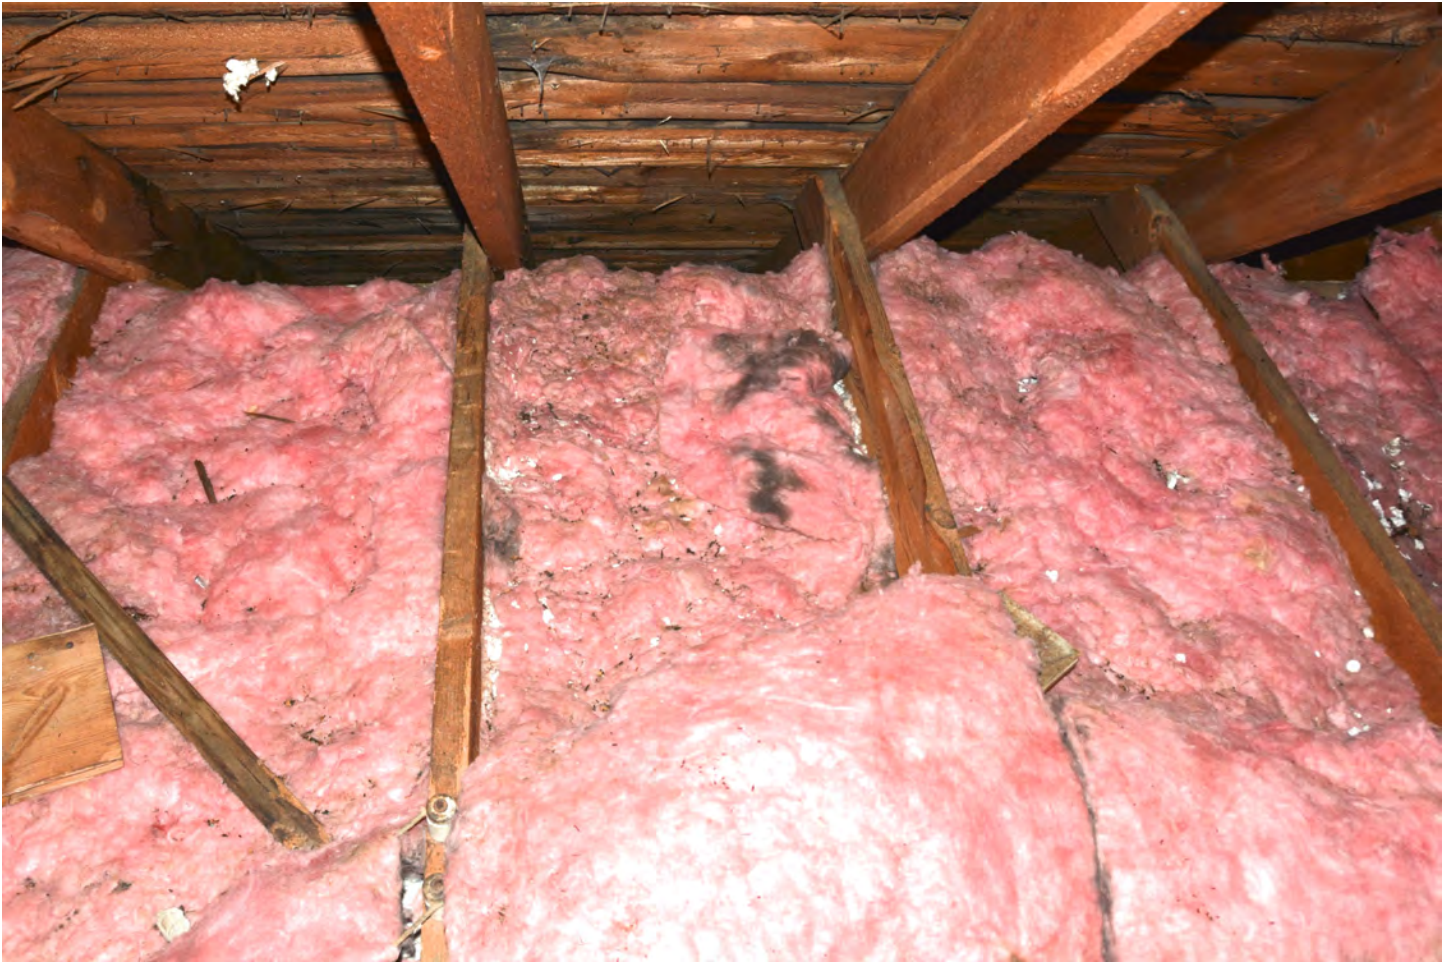
This is the area above where the stain was identified in the ceiling. Note the animal fur in the center of the picture and how the insulation in this section is matted down. Also note the electrical wires that are nailed to the top of the ceiling joists in the bottom left corner of the picture and how the insulation was placed directly on top of it.

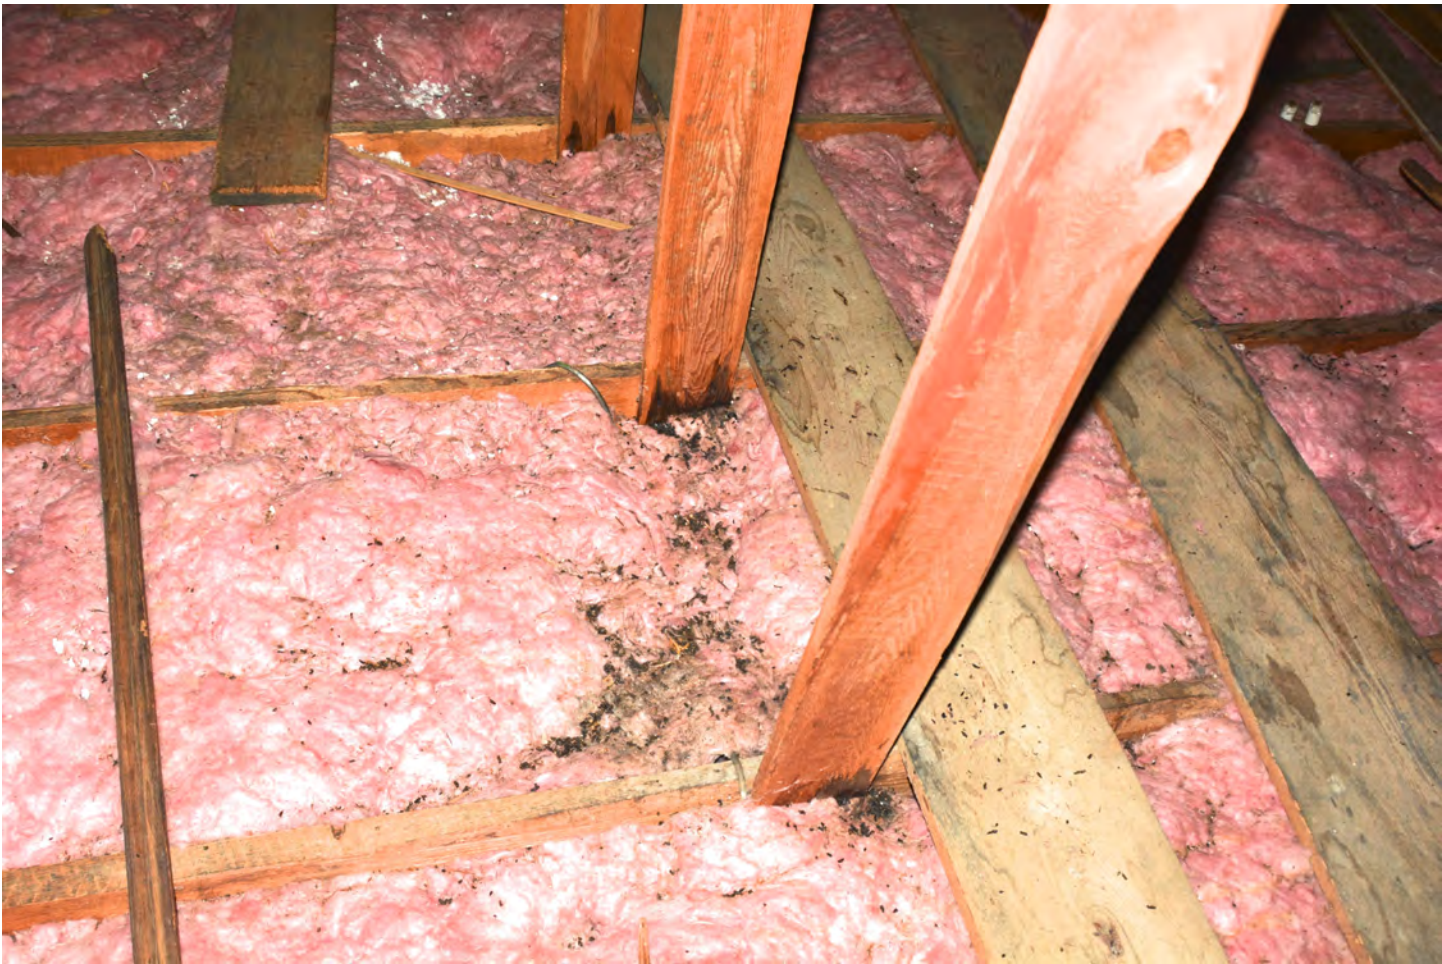
Stains from animal excrement.

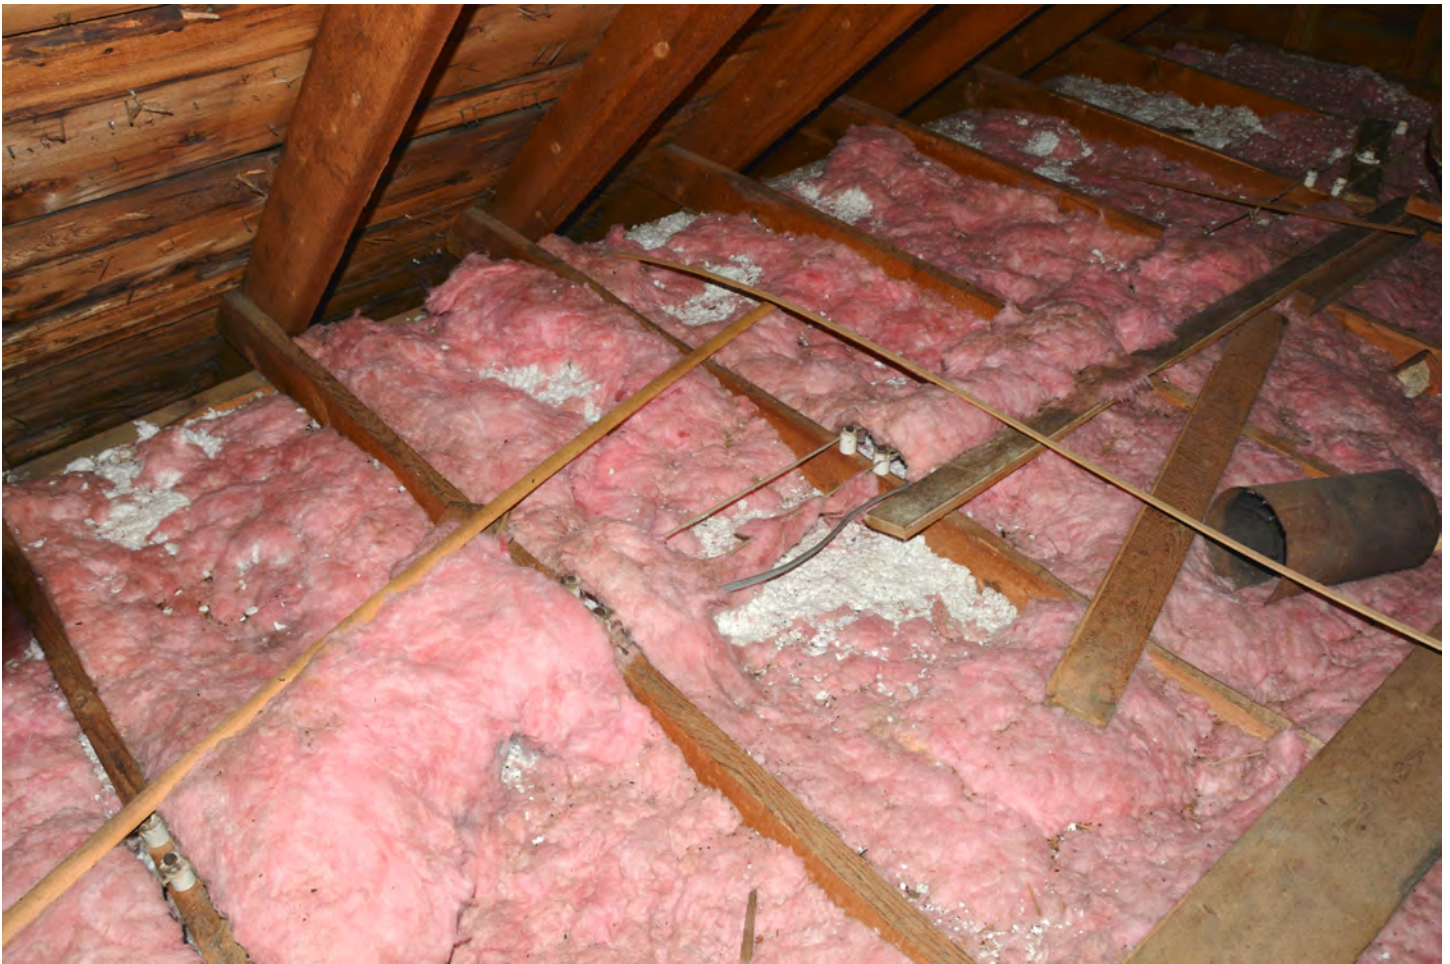
In this picture, you can see how the mice have eaten away at the insulation that was placed on top of the electrical wires and exposing the white insulation (blown in?) below it.

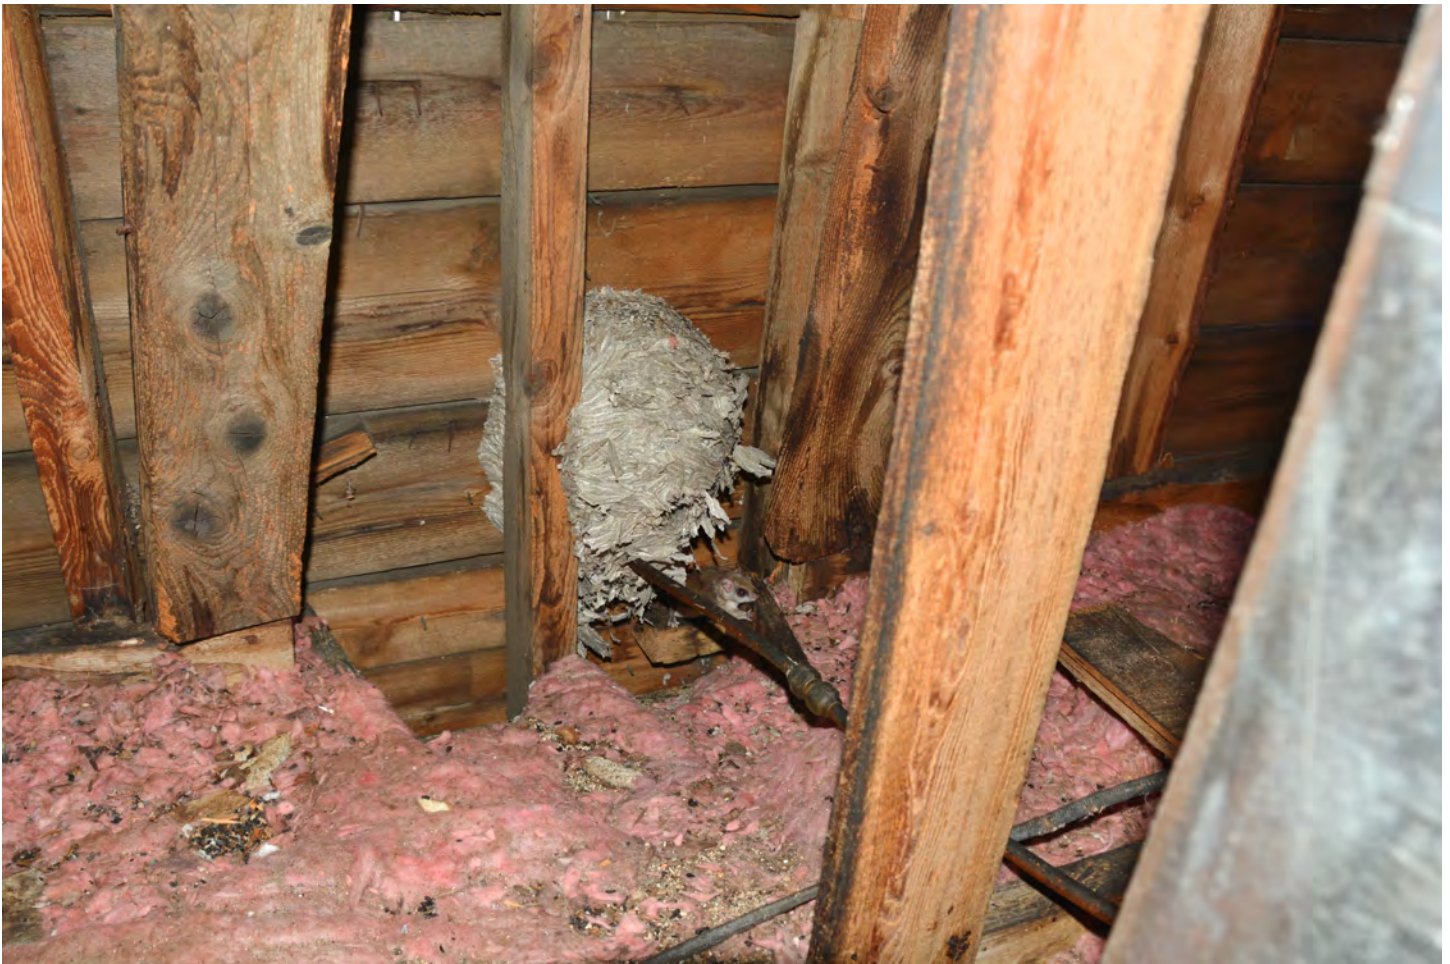
Beehive located at the Western wall of the Museum where the copper tubing that supplies propane fuel to the 1<sup>st</sup> floor burner enters the building.

If you look closely at the base of the beehive, you'll see one of the flying squirrels that have taken up residence. I'm calling this one Scott because he seems to like propane.

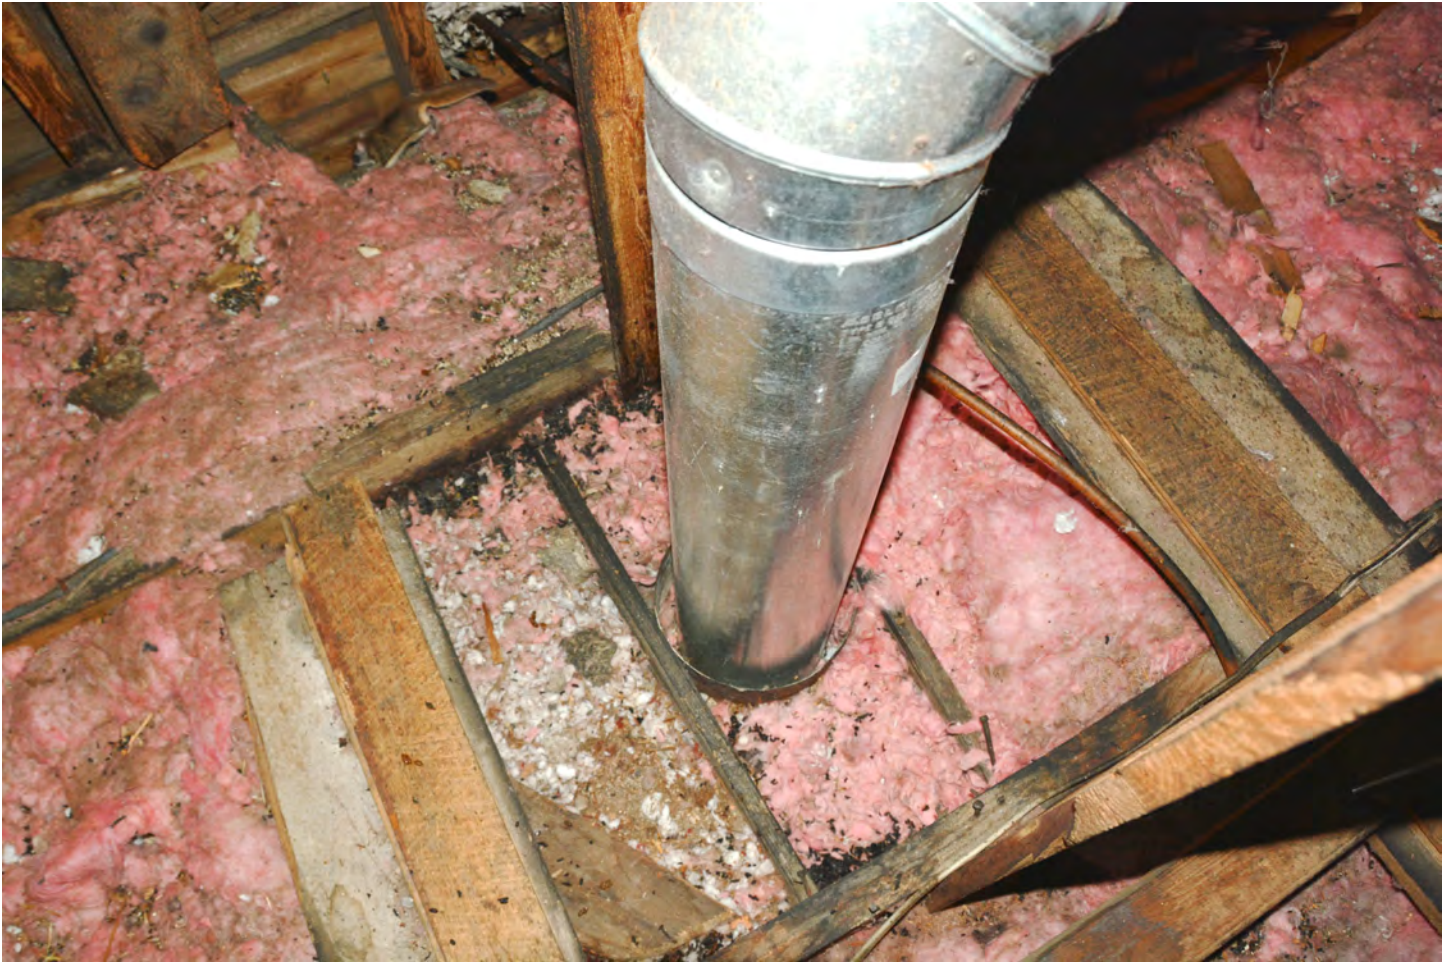
This is the vent pipe for the propane heater that's in the ceiling of the Museum. My main concern here is whether or not there is an appropriate separation between the exhaust pipe and the wooden framing around it. I will follow up with the Building Inspector to seek his opinion.

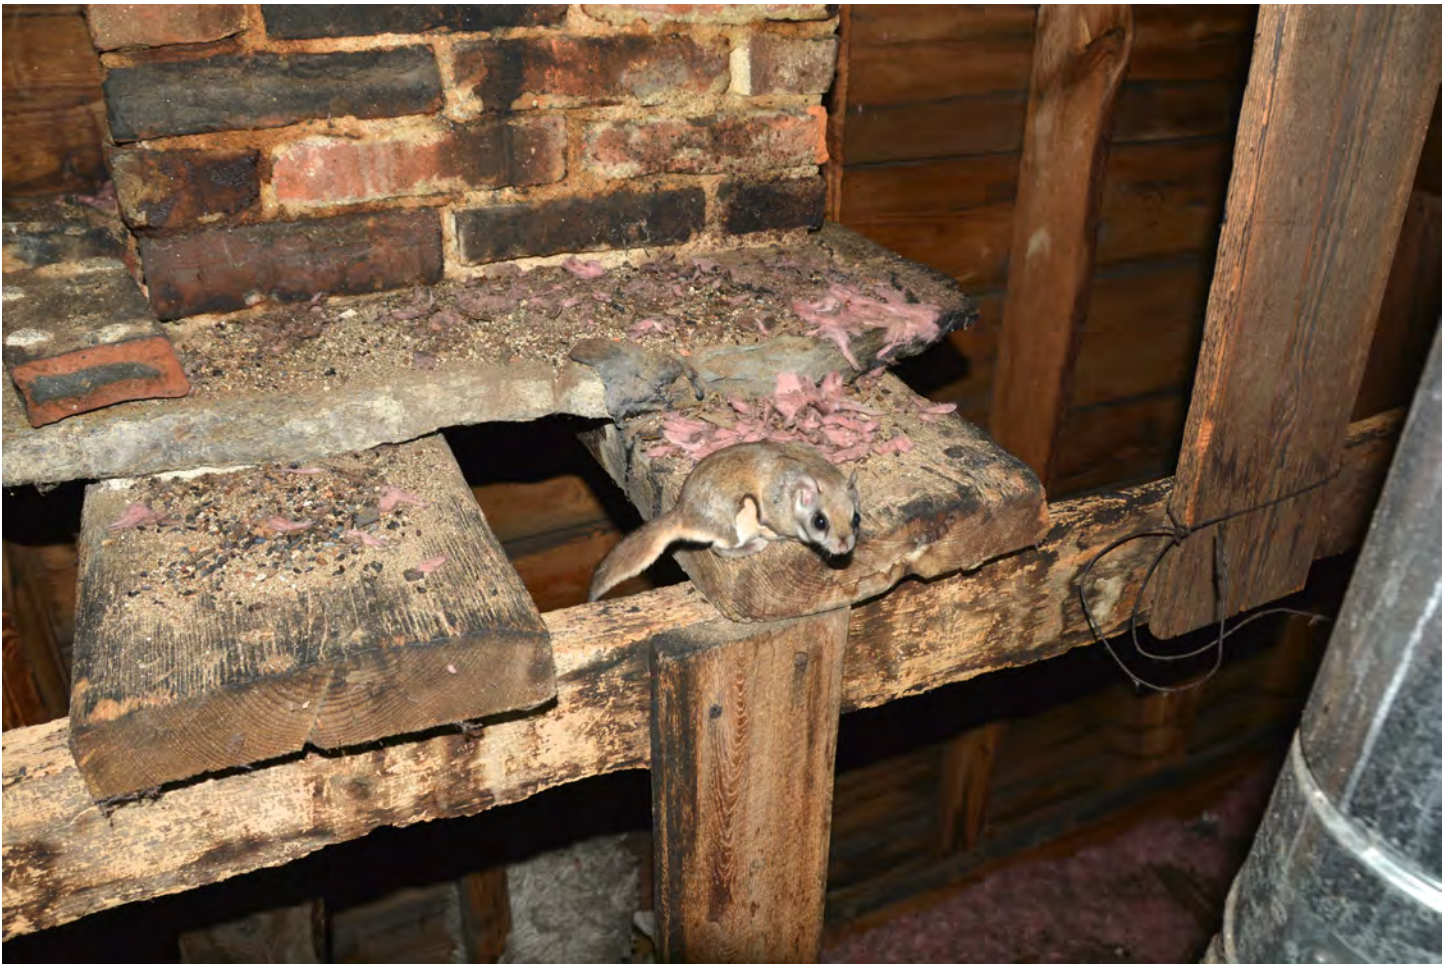
Here is a closer view of 'Scott' – the flying squirrel.

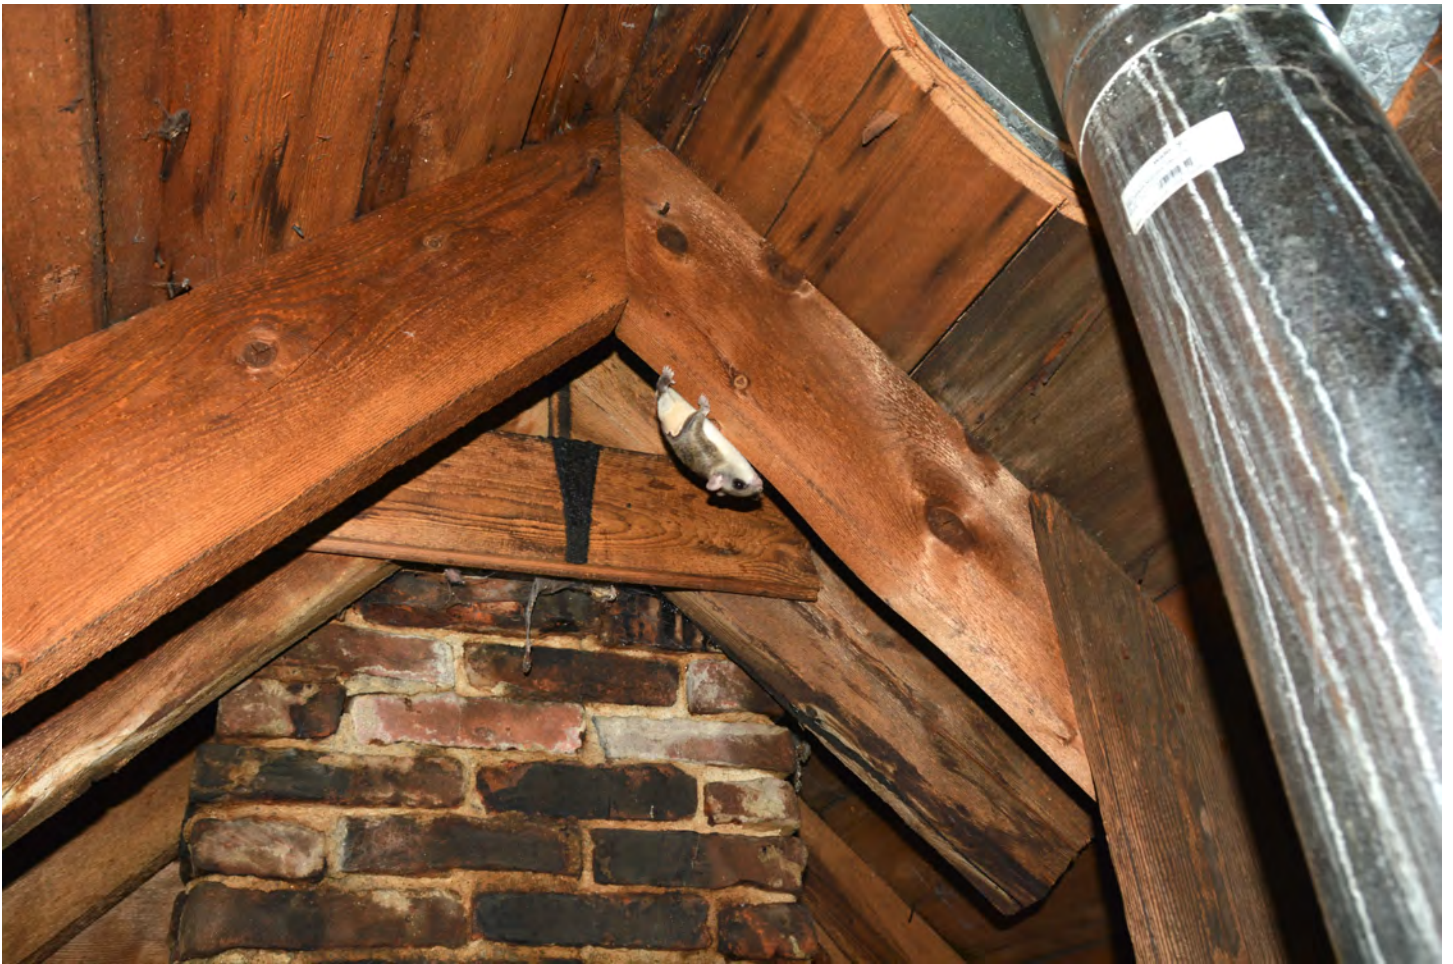
Here is a picture of one of 'Scott's friends near the peak of the roof.

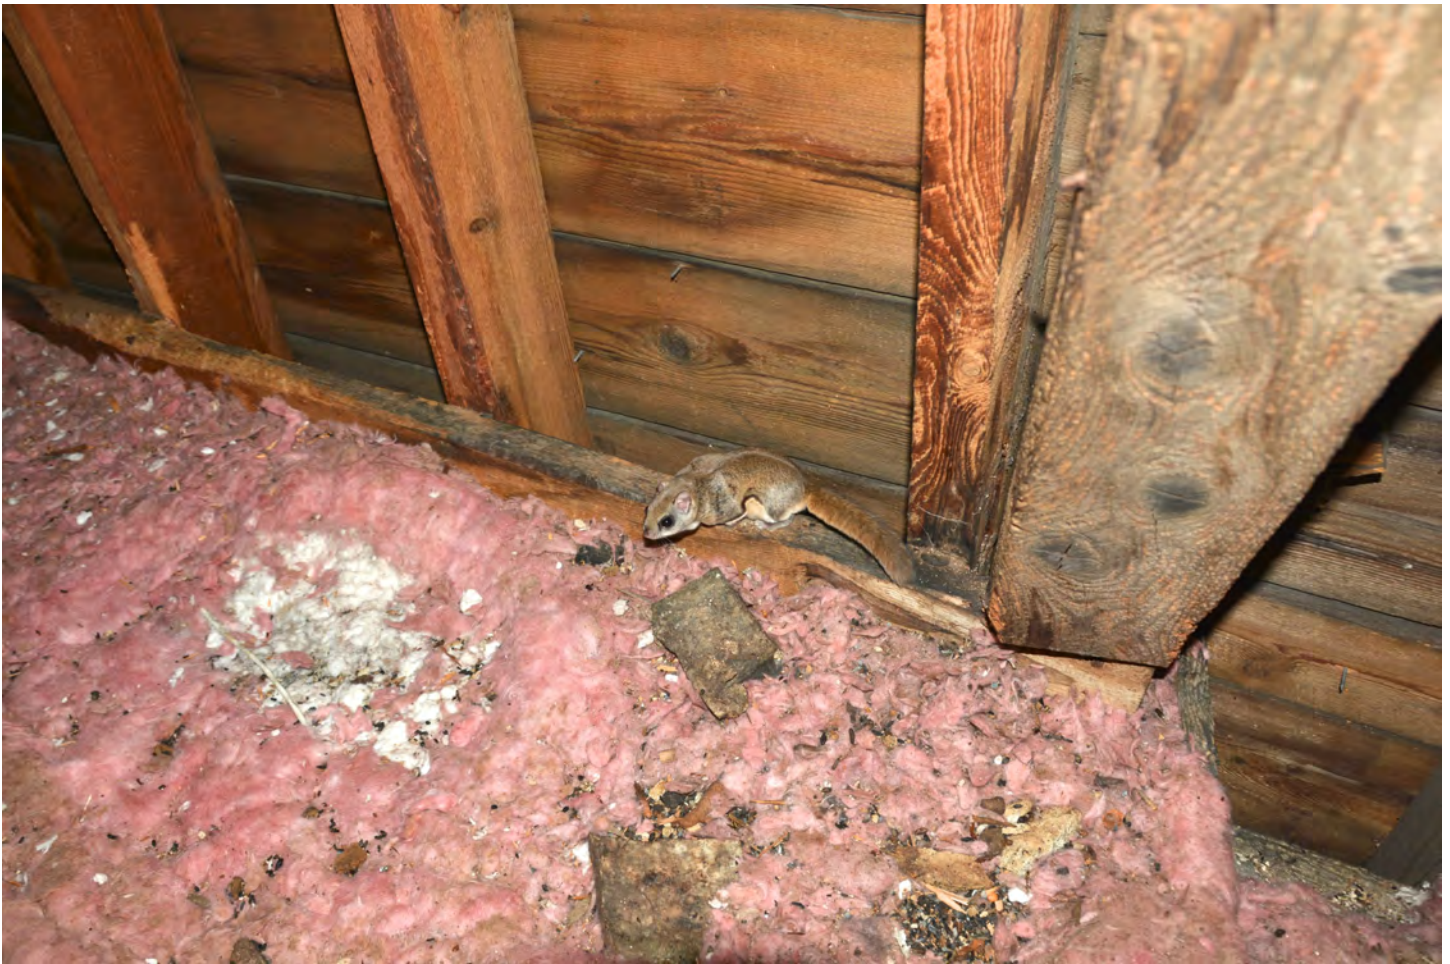
I'm not certain if this was 'Scott' or one of his friends. I got confused after a while because they were scrambling around in the dark as I was taking these pictures. However, notice how the rafters and wall framing in the upper left section of this picture is being chewed on by these critters - not to mention the excrement they're leaving everywhere.

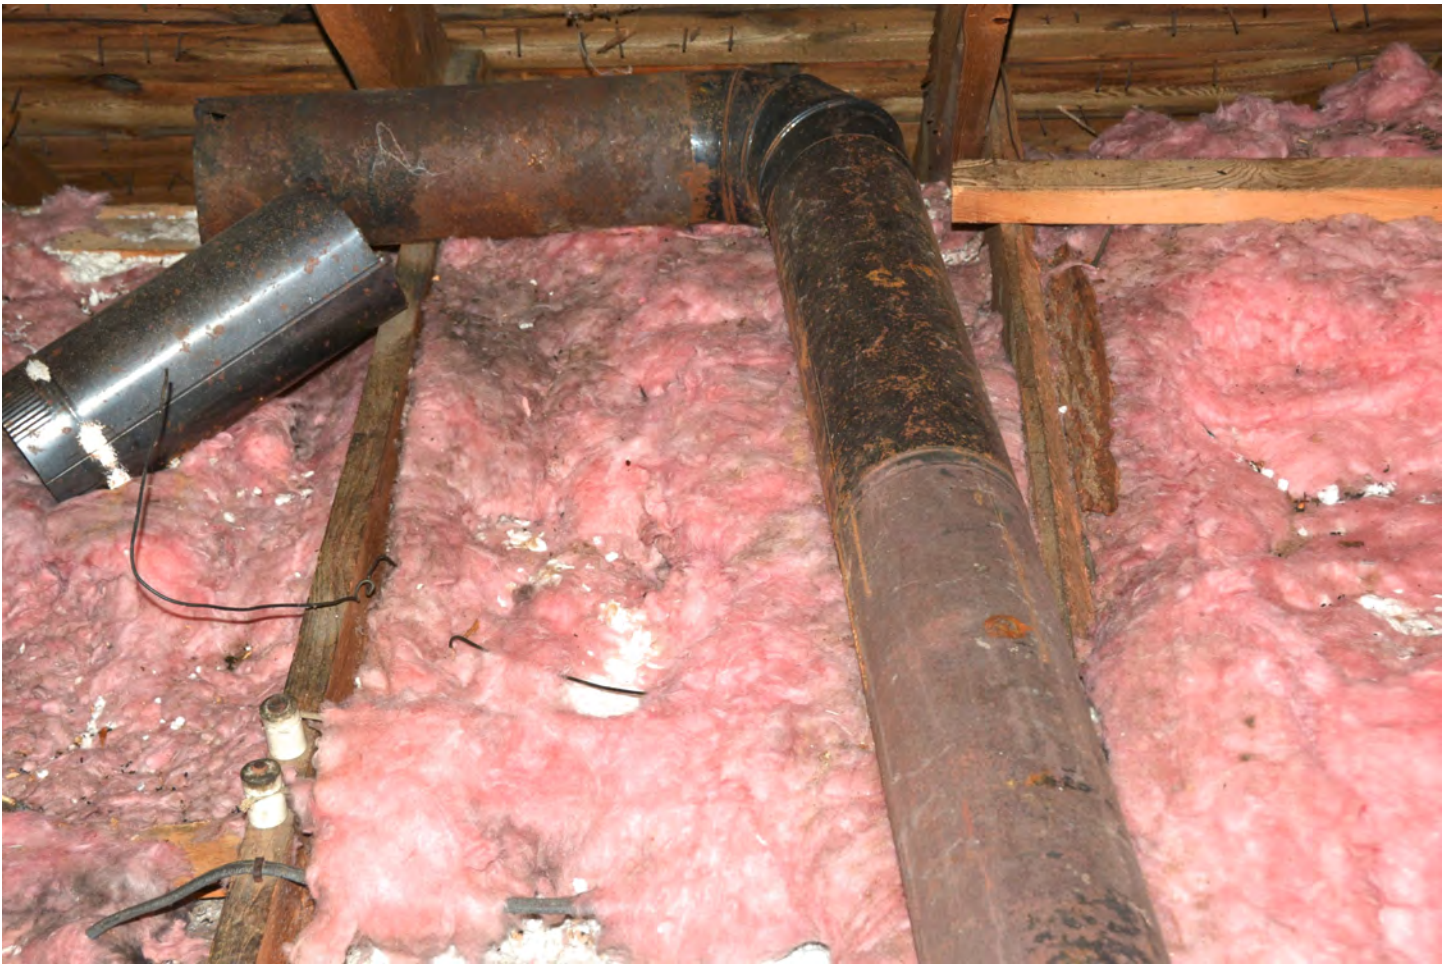
I'm guessing that this was a stovepipe that was a leftover from a previous conversion. It will be removed when I can get someone else there to help me get rid of it.

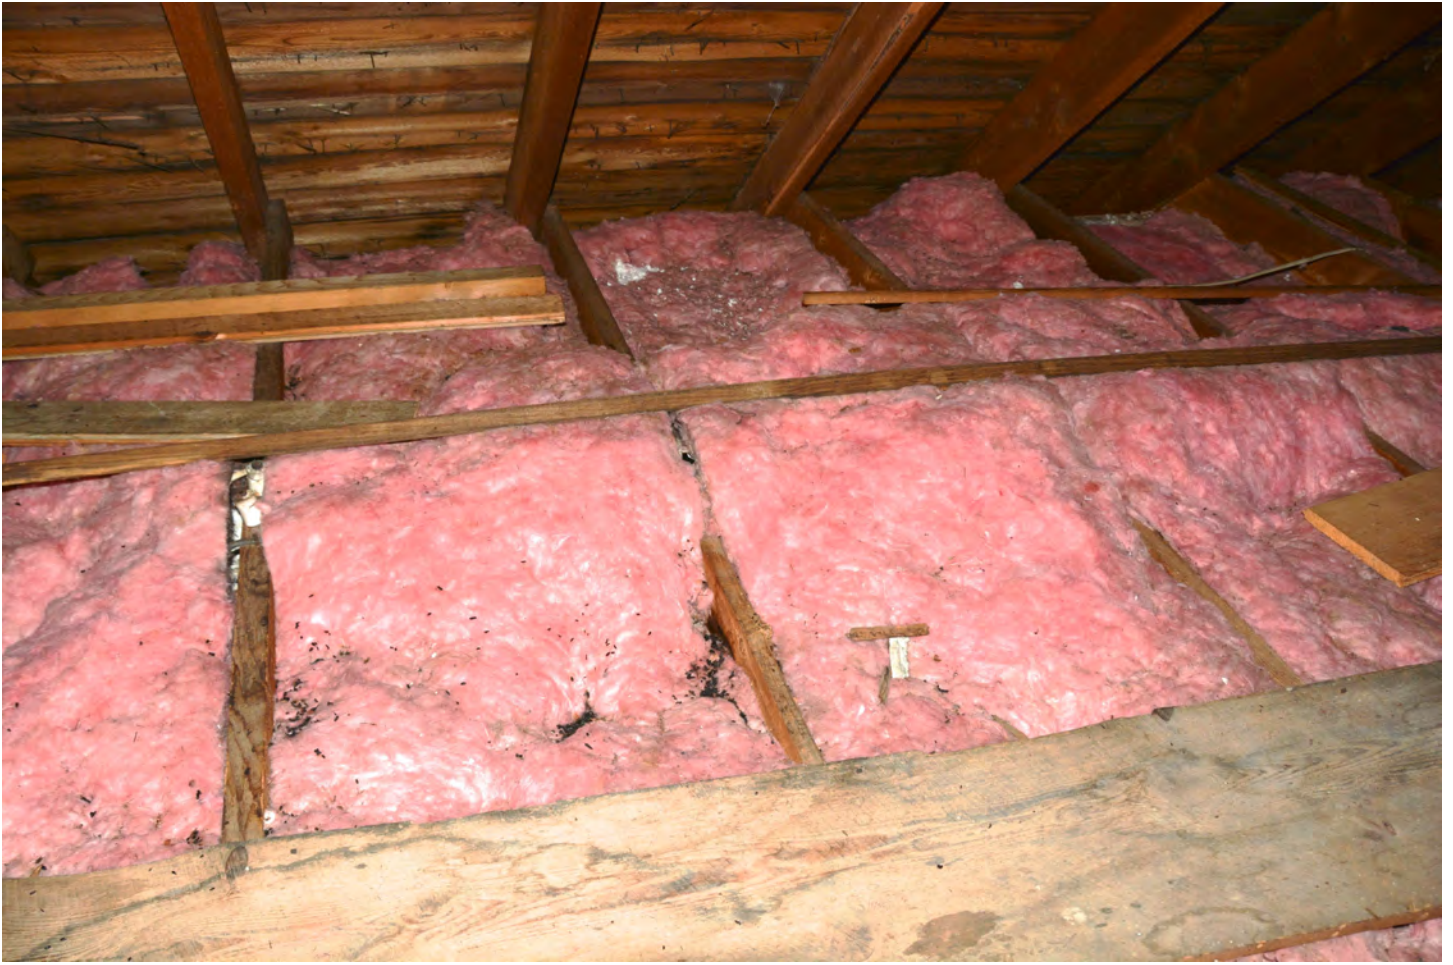
Attic area to the north of the building. Again, notice the animal waste on top of the insulation and the 'hump' where the insulation was placed on top of electrical wires.

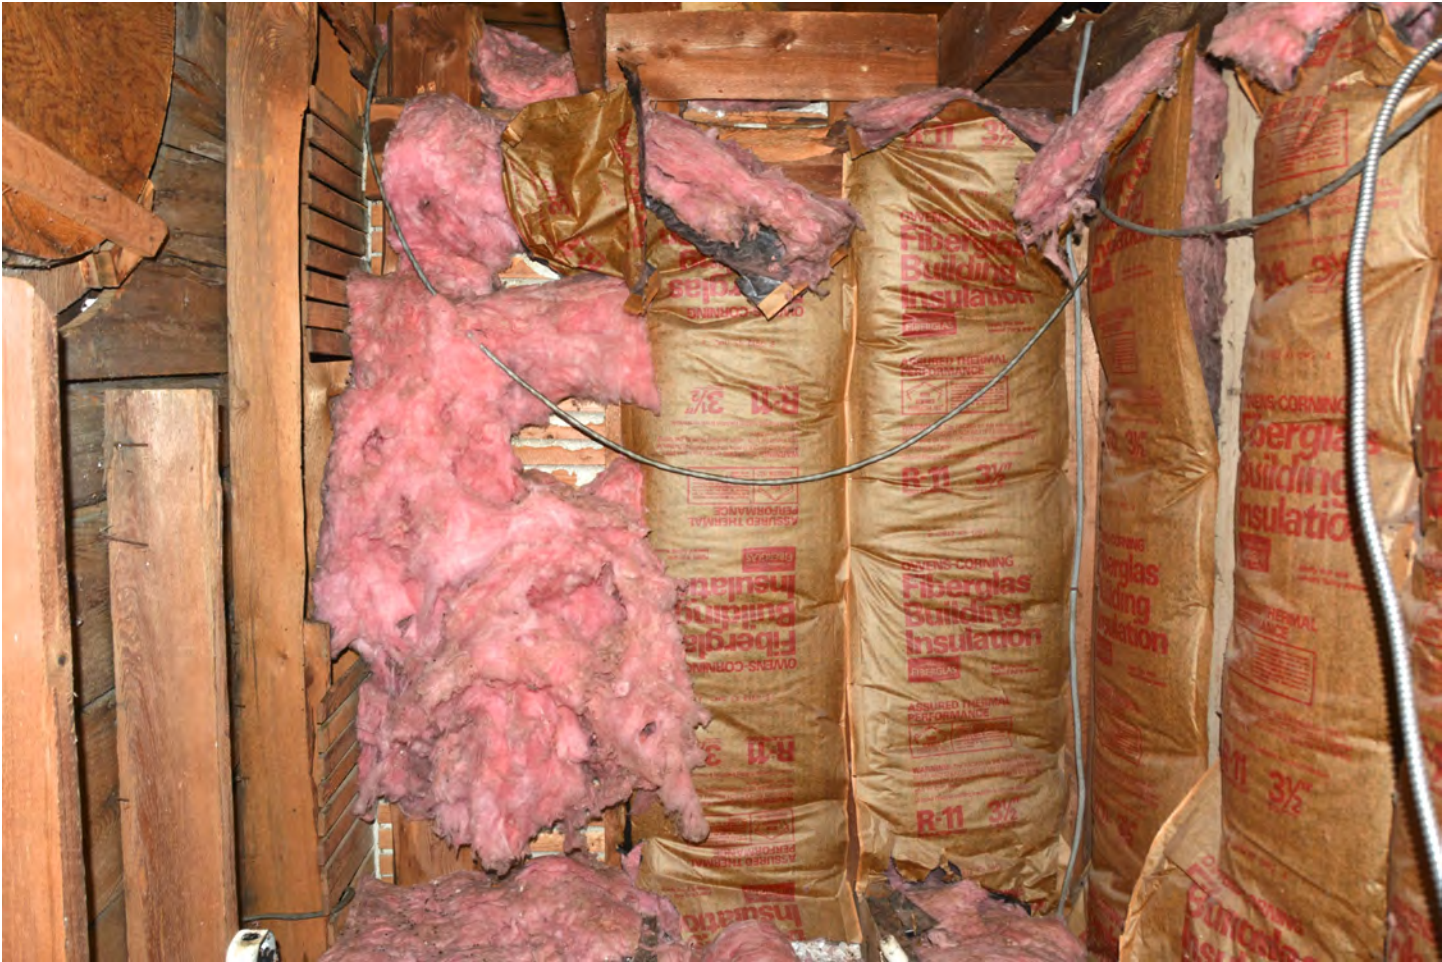
This is the attic area above the closet. As you can see, wall insulation is falling down and needs to be replaced.
