Water Storage Facility 2019 ROV Inspections City of Johnson City

Johnson City, TX

September 2019

Audit Title
City of Johnson City Inspection #1

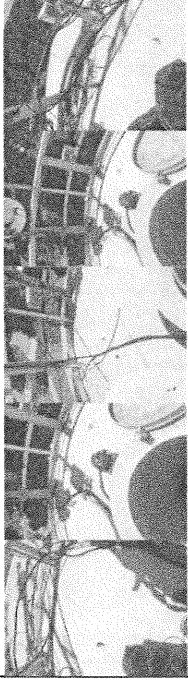
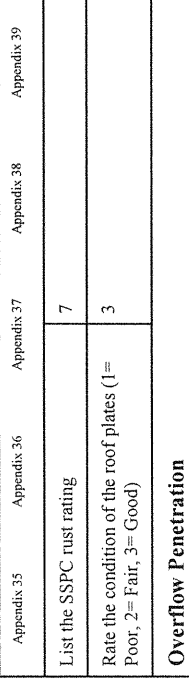
<p>Appendix 36</p>	
List the SSPC rust rating	7		
Rate the condition of the roof plates (1= Poor, 2= Fair, 3= Good)	3		
Overflow Penetration			
Does Overflow pipe penetrate the roof or sidewall plates?	Yes		
Can you safely inspect where the overflow pipe penetrates the roof or sidewall plates?	Yes		
Rate the condition of overflow pipe (1= Poor, 2= Fair, 3= Good)	3		
Photo

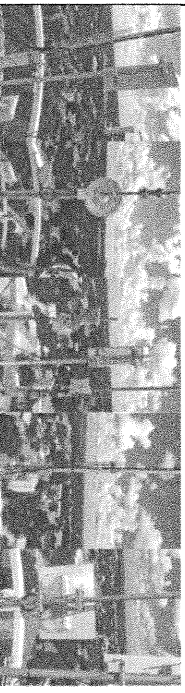
RF Antenna				
Does tank have antennas?	Yes			
Photo of antenna(s)

How many?	9			
Are RF hazard warning signs posted? (FCC requirement)	No			
Is the list for the wireless provider emergency phone numbers posted? (FCC requirement)	No
