PRELIMINARY Consulting Arborist Report & Tree Inventory

6639 Wishingwell Way

Town of Loomis, CA

January 14, 2015

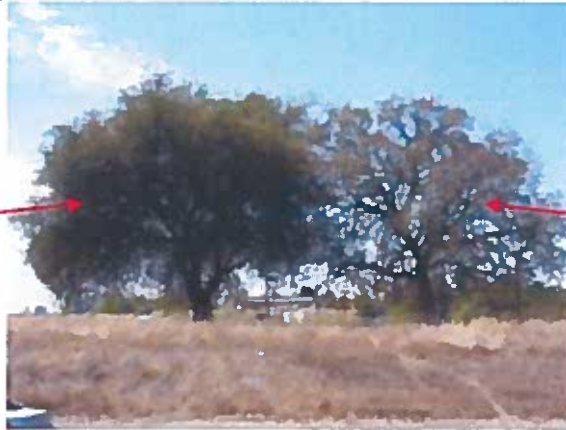
Epicormic growth is a trees response to loss of leave surface from either limb drop, over pruning, or stressful conditions. Epicormic growth is simply the release of latent buds, which begin rapid growth in order to provide as much new leaf surface in the shortest period of time to make up for the loss of leave surface. Epicormic growth prevents the death of the tree in stressful times, but creates a need for additional pruning. It is not the formation of a structurally intact new limb. The new limbs are weakly attached and need support and pruning.

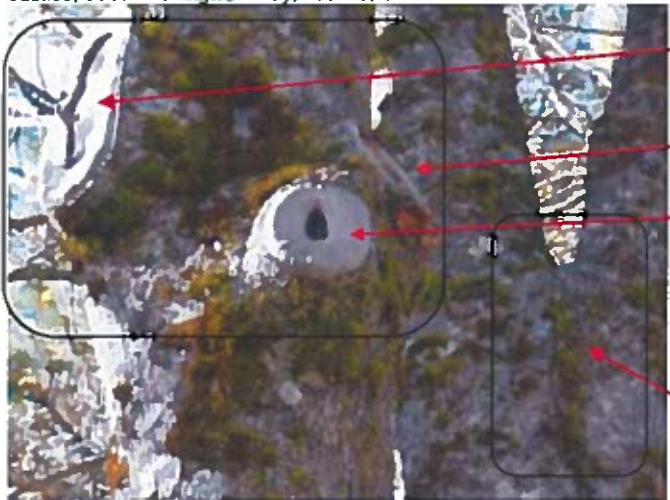
- Two Potential Failure Points**
- Large pruning wound with callous, uneven surface as indication of decay
 - Large pruning wound with advanced decay
 - Smaller pruning wound almost covered, black color could be an indication of decay
- Included Bark**

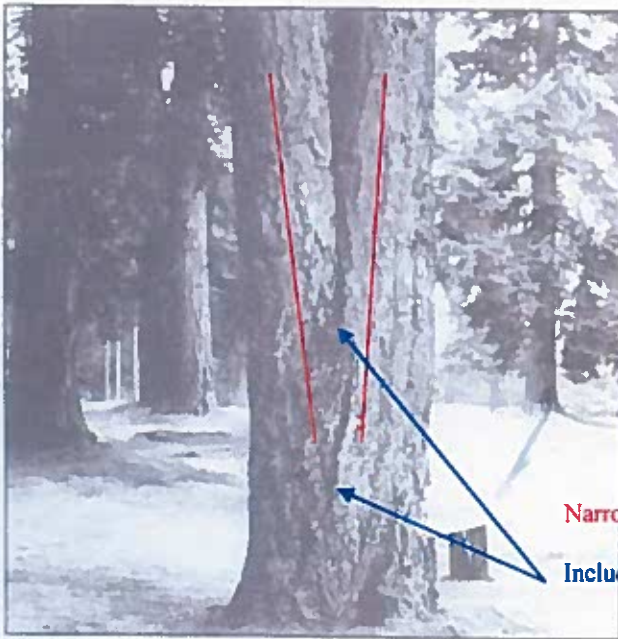
Narrow Angle
Included Bark between the arrows

The tree in this picture has a co-dominant leader at about 3' and included bark up to 7 or 8'. Included bark occurs when two or more limbs have a narrow angle of attachment resulting in bark between the stems – instead of cell to cell structure. This is considered a critical defect in trees and is the cause of many failures.

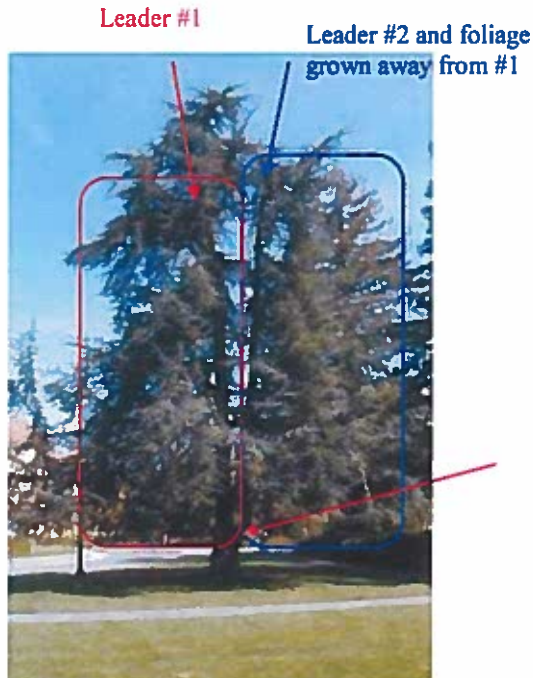
In addition, co-dominant leaders phototropically (due to sunlight) suppress each other's growth. All the limbs are grown away from the main trunk to one side. The weight of the foliage of the tree is distributed asymmetrically placing a greater amount of pressure on the already weak union.

Weak union with the excessive weight of asymmetrical canopies
