April 12, 2017

RE: Arborist Survey for 3264 Taylor Road Project Site, Town of Loomis, Placer County, California

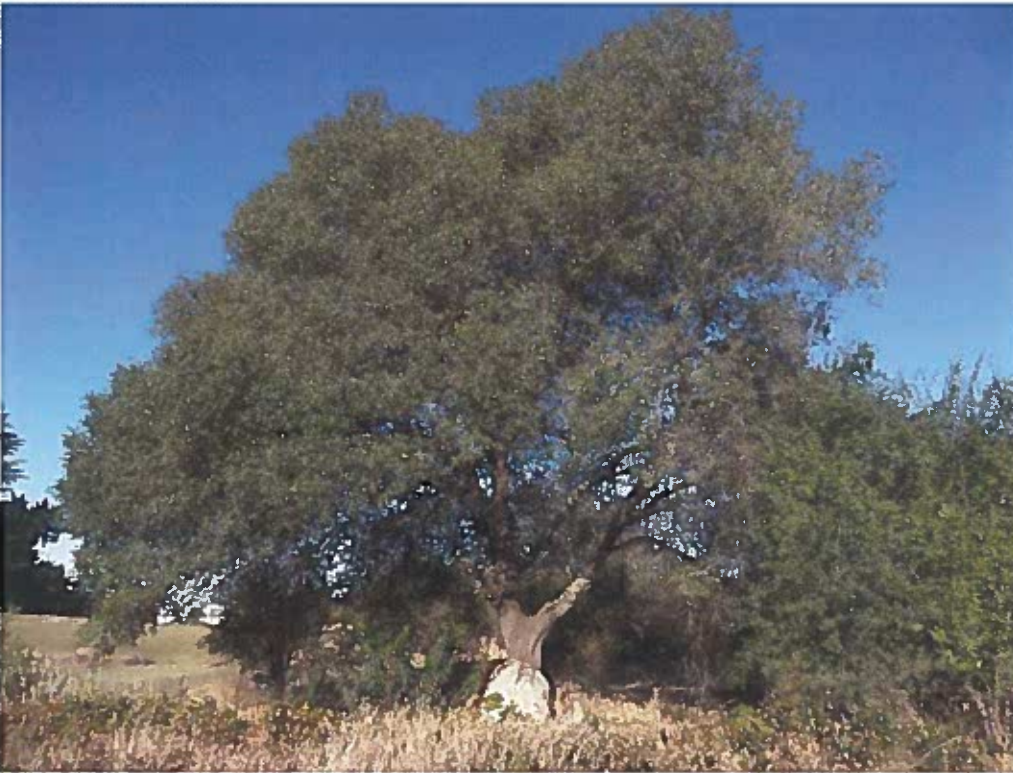
#11 interior live oak

11	Yes	<i>Quercus wislizeni</i>	interior live oak	35	35						56	45	Fair-Good	Fair-Good	Fair	Trunk has slight bend that corrects, some historic pruning cuts, boulder	Temporary	No
