May 22, 2023

## TREE INVENTORY, CONSTRUCTION IMPACT ASSESSMENT AND TREE PROTECTION PLAN

RE: Brace Rd and Sierra College Blvd, Loomis, CA, APN #044-122-005-000, Town of Loomis jurisdiction, California

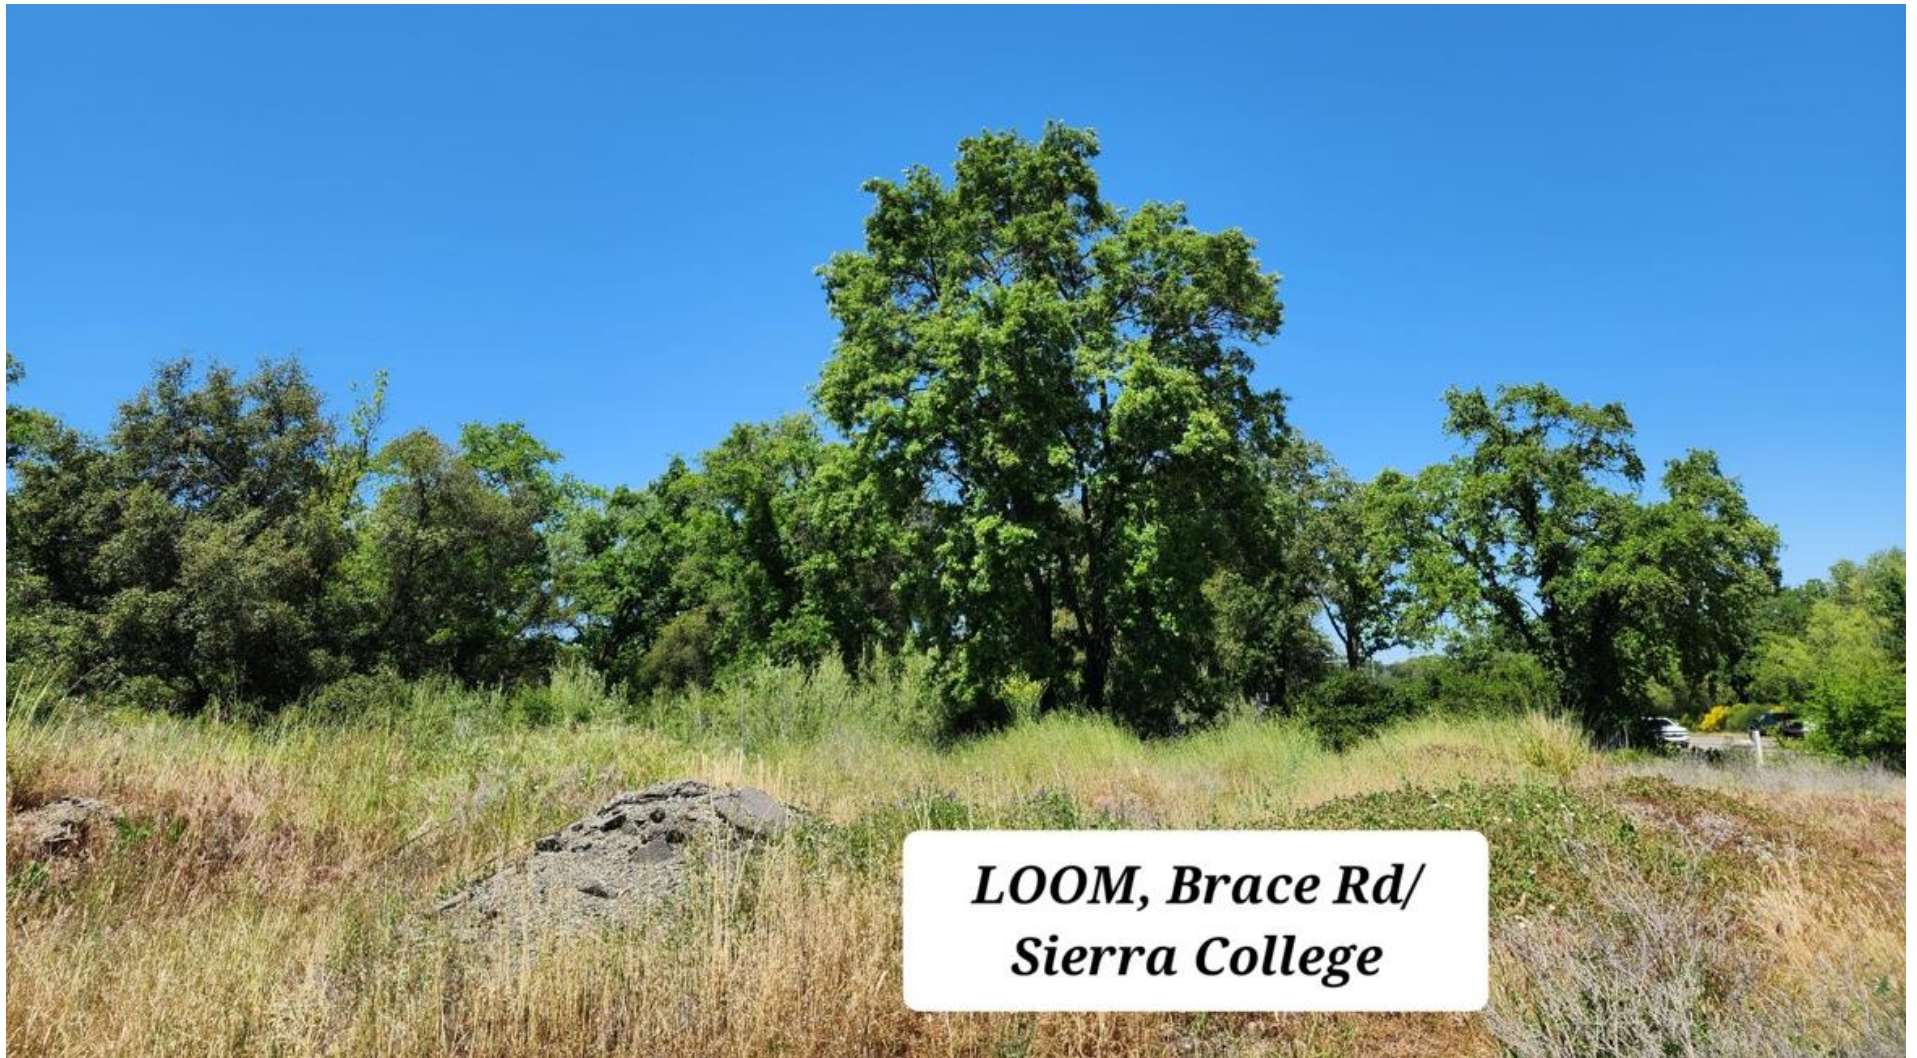
Photo #1 by Tyler Thomson, May 11, 2023. Representing the overall tree makeup of the site.

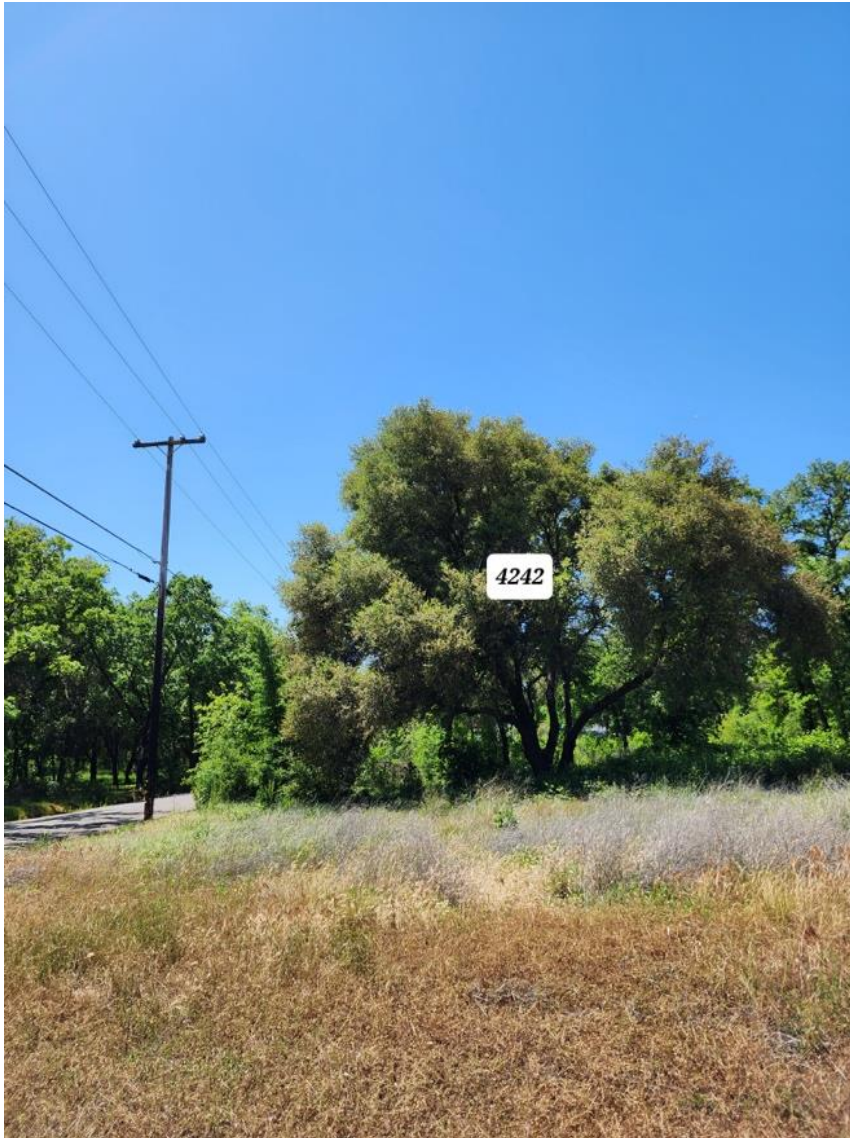
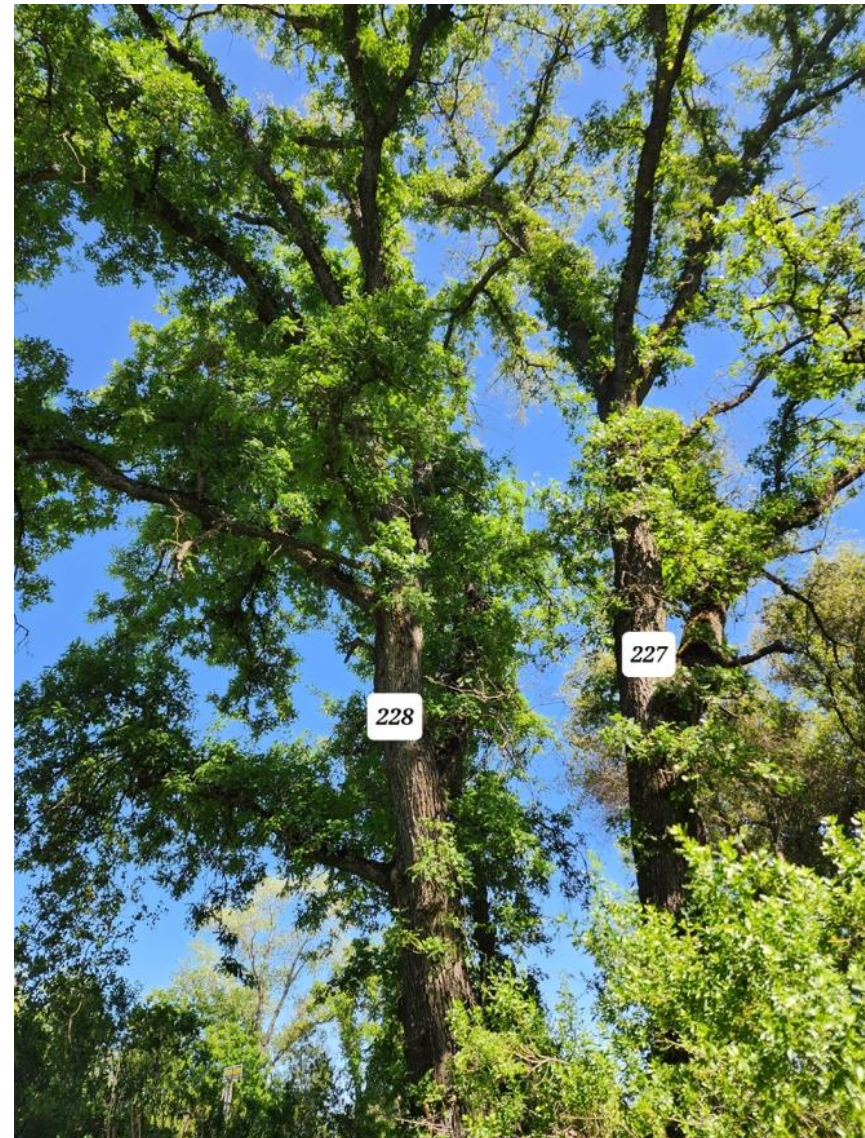
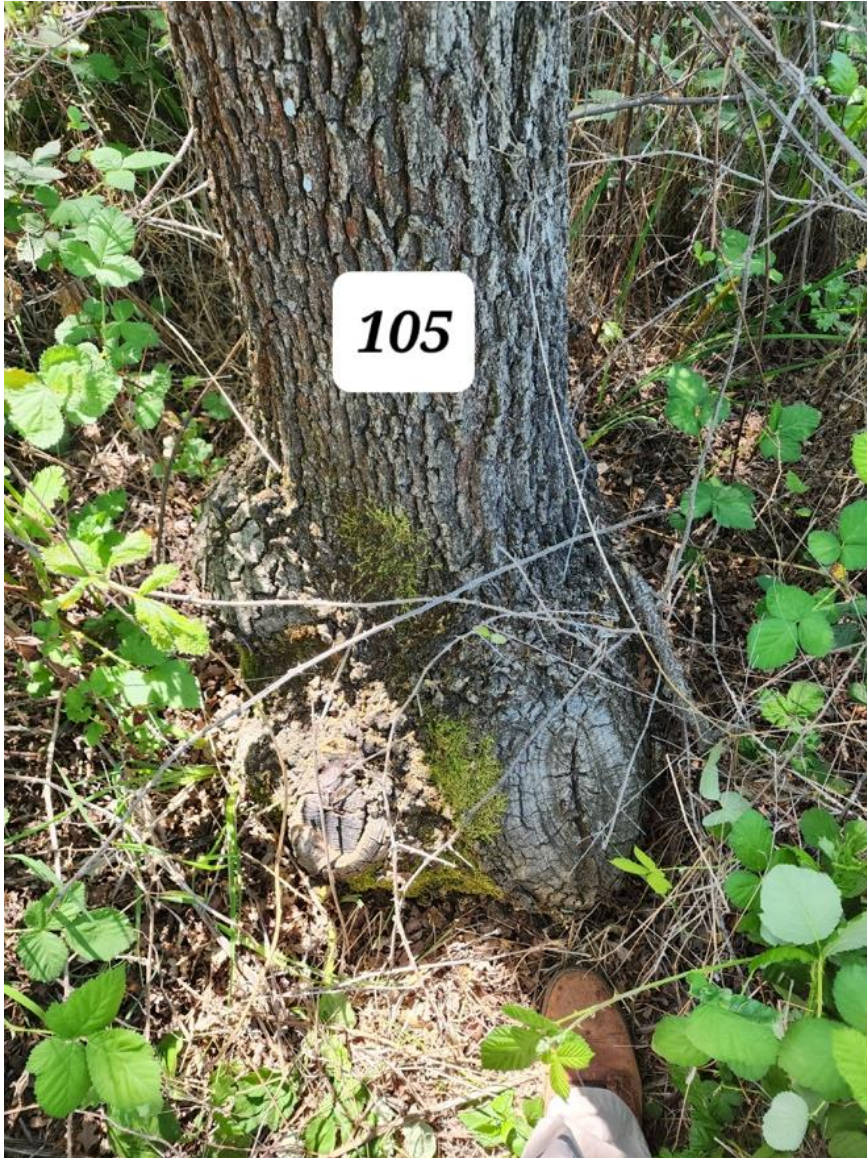
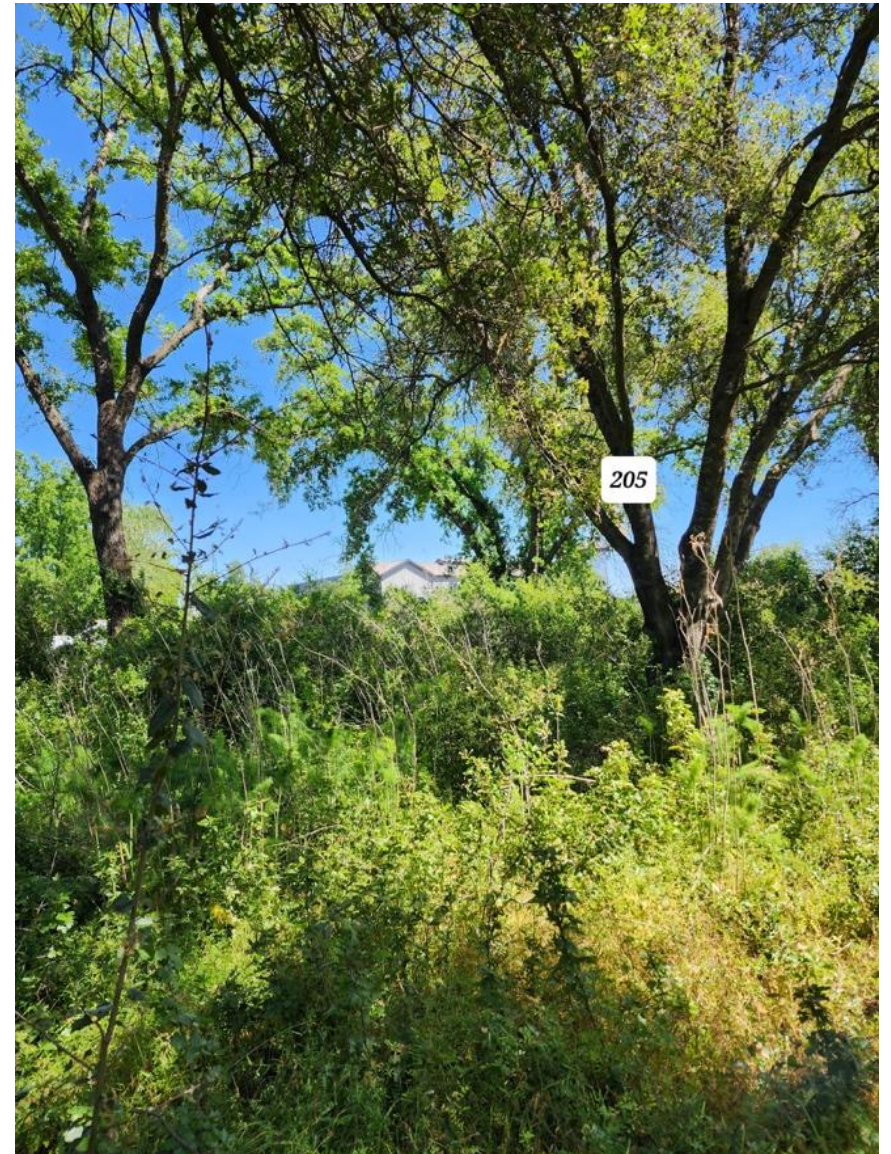
Photos #2 through 5 by Tyler Thomson, May 11, 2023. Photos of individual trees for reference.
