PRELIMINARY ARBORIST REPORT & TREE INVENTORY

RE: 3400 Chisom Trail, Loomis, CA & Vacant Land consisting of 6.6 Acres – APN #043-050-024-000, Town of Loomis jurisdiction, California

APPENDIX 4 – SITE PHOTOGRAPHS by Tyler Thomson, October 9, 2023

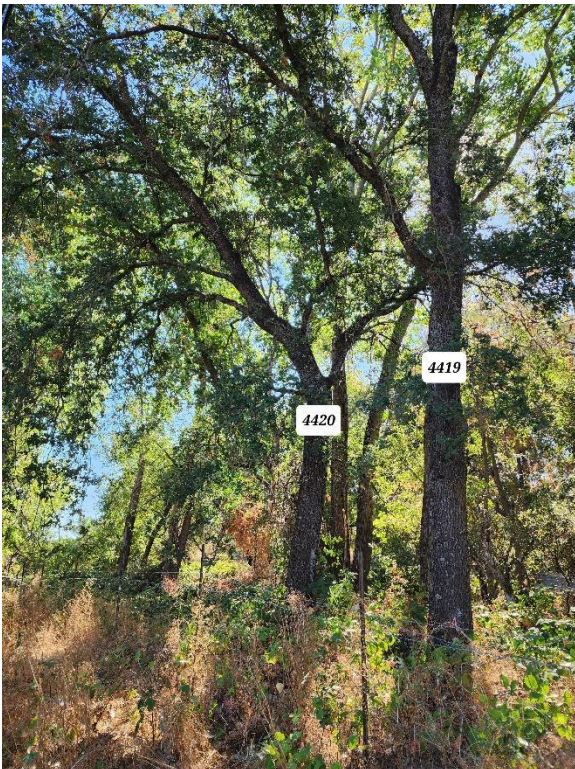
Photo #3, Shows Trees #4420 & #4419 (from right to left)

4420			Yes		Valley oak	<i>Quercus lobata</i>	17.5		54	28	\$0.00 (poor condition)	-	2 Major Structure or Health Problems	no visual defects at base. trunk and canopy leans heavy northeast starting at 18 feet, trunk at great failure risk. healthy foliage.
4421					Cottonwood	<i>Populus sp.</i>	14.5		54	26	\$0.00 (unprotected)	-	3 Fair - Minor Problems	no visible issues at base. strait tall trunk with minor visible defects, high canopy, fair crown balance and foliage health.
4422					Cottonwood	<i>Populus sp.</i>	9		54	24	\$0.00 (unprotected)	-	1 Extreme Structure or	base 85% hollowed out and decayed. tree leans severely north,
